ACCIDENT

Aircraft Type and Registration:	Mudry Cap 10B, G-BXBU	
No & Type of Engines:	1 Lycoming AEIO-360-B2F piston engine	
Year of Manufacture:	1980 (Serial no: 103)	
Date & Time (UTC):	12 August 2021 at 0920 hrs	
Location:	Lower Colley Farm, Buckland St Mary, Somerset	
Type of Flight:	Private	
Persons on Board:	Crew - 1	Passengers - 1
Injuries:	Crew - 1 (Fatal)	Passengers - 1 (Fatal)
Nature of Damage:	Aircraft destroyed	
Commander's Licence:	Private Pilot's Licence	
Commander's Age:	69 years	
Commander's Flying Experience:	1411 hours (of which 648 were on type) Last 90 days - 15 hours Last 28 days - 4 hours	
Information Source:	AAIB Field Investigation

Synopsis

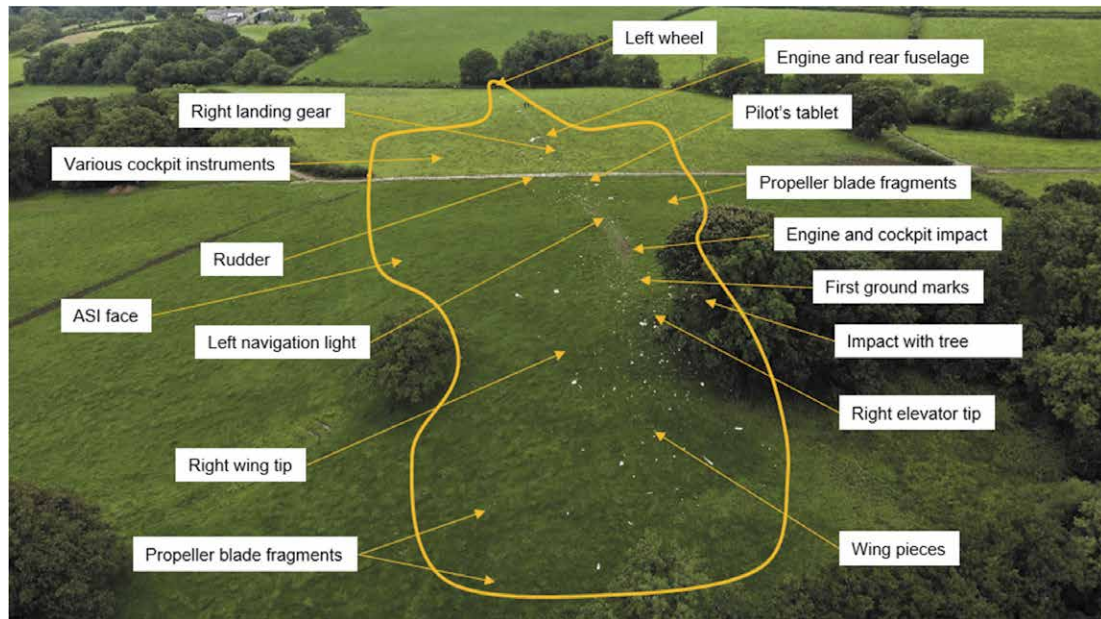
Figure 5

The oak tree at the northern end of the accident site was approximately 20 – 25 m tall with a large swathe cut through it at about 15 m from ground level. Several large boughs had been broken and some pieces of wreckage were lodged in the tree. The ground to the south and east contained broken branches and further wreckage, including wing and fuselage structure, shards of clear plastic from the canopy, and fragments of the propeller (Figure 5).

Accident site looking from the north showing wreckage distribution and boundary

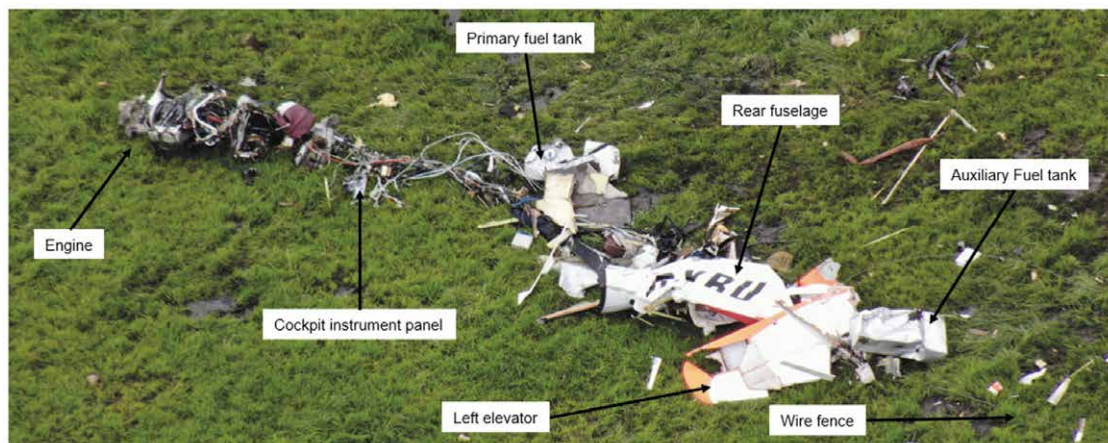
Figure 6

To the south of the concrete roadway was the engine and rear fuselage (Figure 6). The engine was attached to the cockpit instrument panels and rear fuselage by flight control and electrical cables. The primary fuel tank had ruptured and was empty whereas the auxiliary fuel tank was intact and still contained a small quantity of fuel.

Engine and rear fuselage

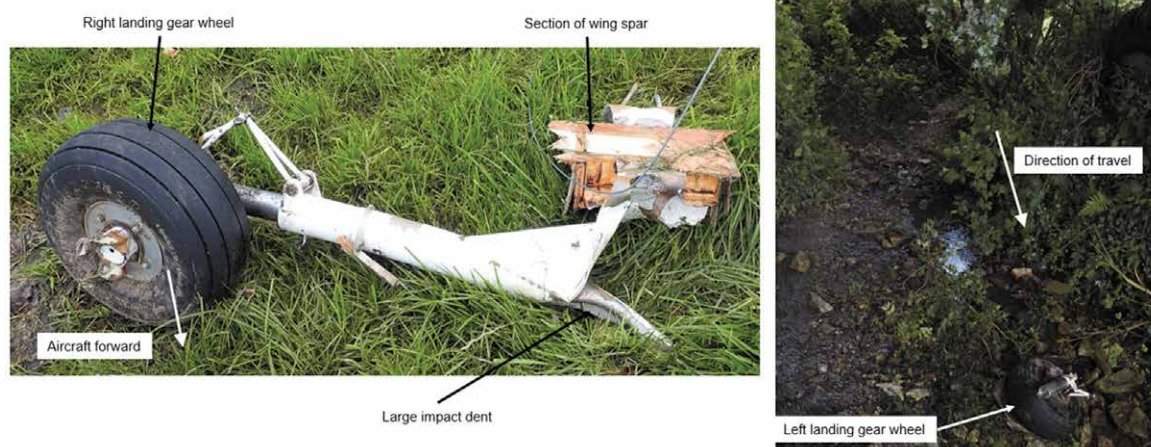
Figure 7
Main landing gear wheels

Inspection of the seat belts revealed they were still done up and that all the structural attachments had either failed in overload or become detached from the structure so that they were no longer capable of restraining the occupants. The right landing gear leg was found close to the rear fuselage section and was complete including a small section of wing spar (Figure 7).

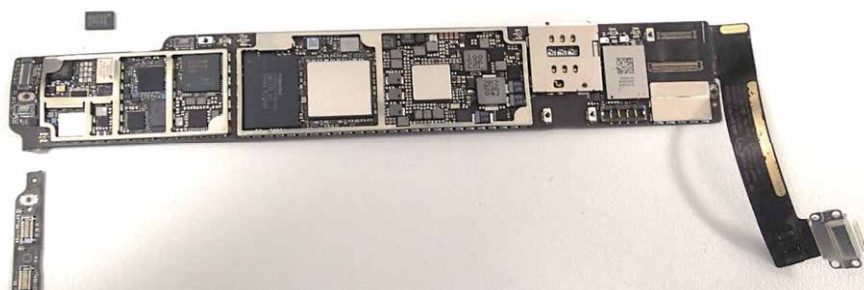
Figure 8
Tablet logic board

A heavily damaged tablet device was recovered from the aircraft. The main logic board had become twisted with a part of it ripped off. Some of the integrated circuits had been damaged and some detached. Damage was largely focused on one end of the board and included a distorted circuit board with the left narrow part detached, a detached chip and a cracked chip (Figure 8). Despite the damage, a specialist organisation was able to recover data from the item.
