**ACCIDENT**

<b>Aircraft Type and Registration:</b>	Pitts S-1S, G-BOXV	
<b>No &amp; Type of Engines:</b>	1 Superior XP-IO-360-A1HC3 piston engine	
<b>Year of Manufacture:</b>	1984 (Serial no: 7-0433)	
<b>Date &amp; Time (UTC):</b>	26 August 2022 at 0904 hrs	
<b>Location:</b>	Shobdon Airfield, Herefordshire	
<b>Type of Flight:</b>	Private	
<b>Persons on Board:</b>	Crew - 1	Passengers - None
<b>Injuries:</b>	Crew - 1 (Fatal)	Passengers - N/A
<b>Nature of Damage:</b>	Destroyed	
<b>Commander's Licence:</b>	Commercial Pilot's Licence	
<b>Commander's Age:</b>	59 years	
<b>Commander's Flying Experience:</b>	1,978 hours (of which 530 were on type) Last 90 days - 26 hours Last 28 days - 8 hours	
<b>Information Source:</b>	AAIB Field Investigation

**Synopsis**

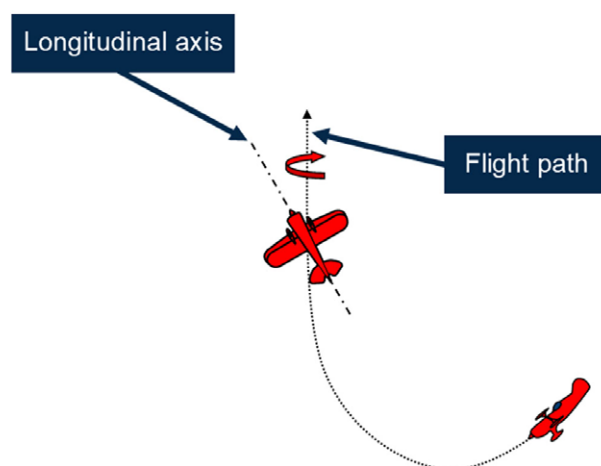
**Figure 1**

G-BOXV took off from Runway 26 at approximately 0900 hrs. The pilot turned left on departure and climbed to position the aircraft south of the runway before commencing his aerobatic manoeuvring. Mobile phone video taken by an eyewitness showed the aircraft completing three distinct aerobatic manoeuvre combinations before, when approaching the eastern end of the airfield, it pulled up into a vertical climb from approximately 420 ±50 ft agl on a broadly easterly heading. While the aircraft did not stay in the video frame for all the subsequent manoeuvring, it could be seen that the aircraft was rolled left through approximately 450° as it climbed. The nature of the rolling motion indicated the pilot likely had some left rudder applied during the roll because G-BOXV's longitudinal axis was not closely aligned with the aircraft's upward flight path (Figure 1).

Pull up into vertical roll  
(not to scale)

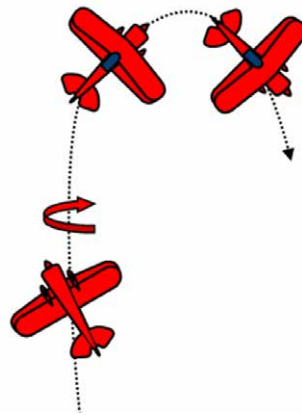
**Figure 2**

The aircraft continued climbing until reaching an estimated apex height of 1,100 ±200 ft agl. At the top of the manoeuvre G-BOXV was banked to approximately 90° right wing low with the nose 30°- 45° above the horizon. The nose of the aircraft then dropped progressively lower while the bank was maintained (Figure 2). During the transition from nose-up to nose-down, G-BOXV's nose appeared to fall more due to gravity than as the result of significant rudder application generating the right yaw.

Apex of the climbing manoeuvre  
(not to scale)

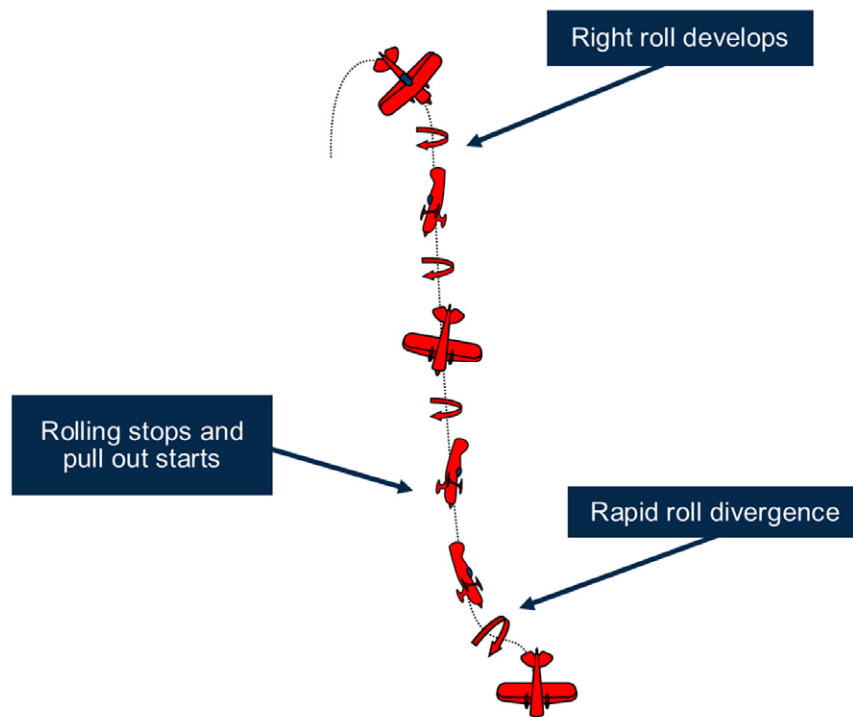
**Figure 3**

As the nose dropped through an estimated 45° nose-down, the aircraft began rolling right and the nose dropped further to approximately 80° nose-down (Figure 3). The aircraft continued rolling right, passing 360° of roll in approximately 2½ seconds. Audio recording from the mobile telephone footage corroborated eyewitness evidence that the engine rpm reduced, likely to idle, shortly after the aircraft began rolling during the descent.

Downwards flight path  
(not to scale)

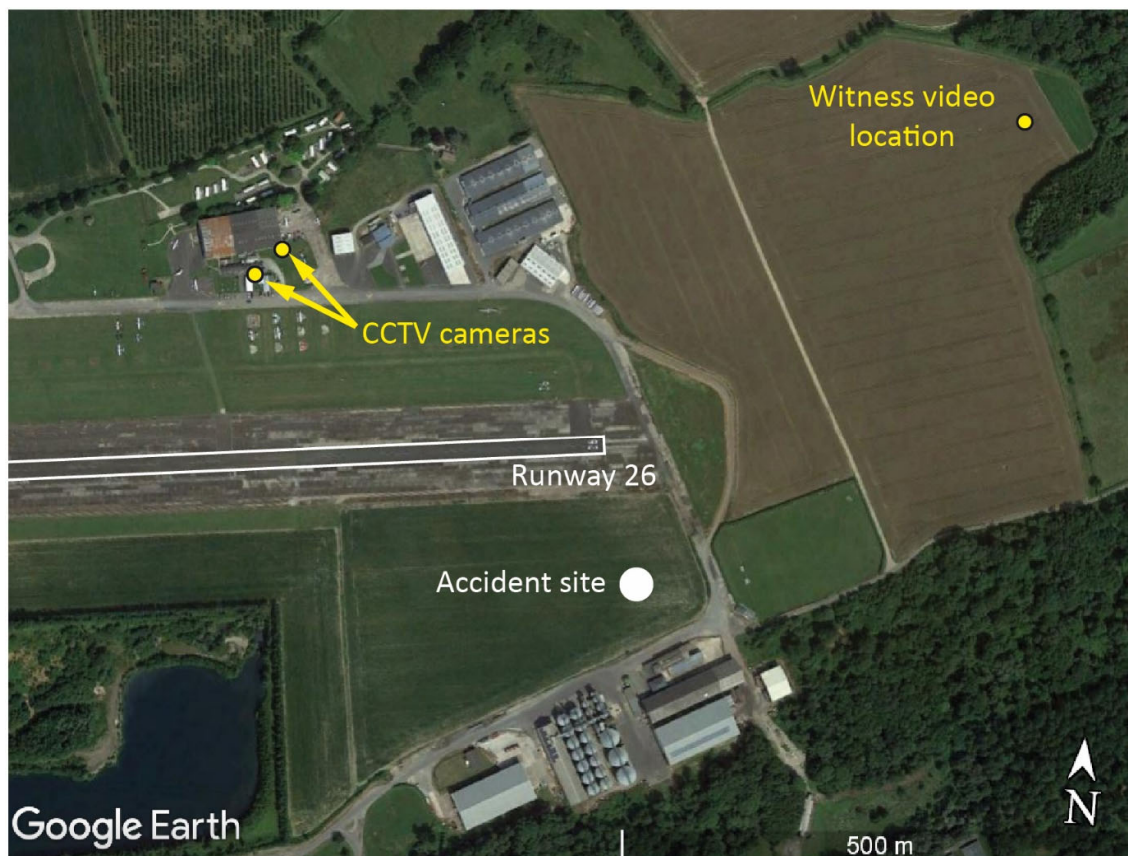
**Figure 4**

The aircraft struck the ground in a recently harvested and drilled crop field approximately 130 m south of the threshold of Runway 26 at Shobdon (Figure 4). An intense post-impact fire destroyed most of the aircraft.

Sources of video recordings

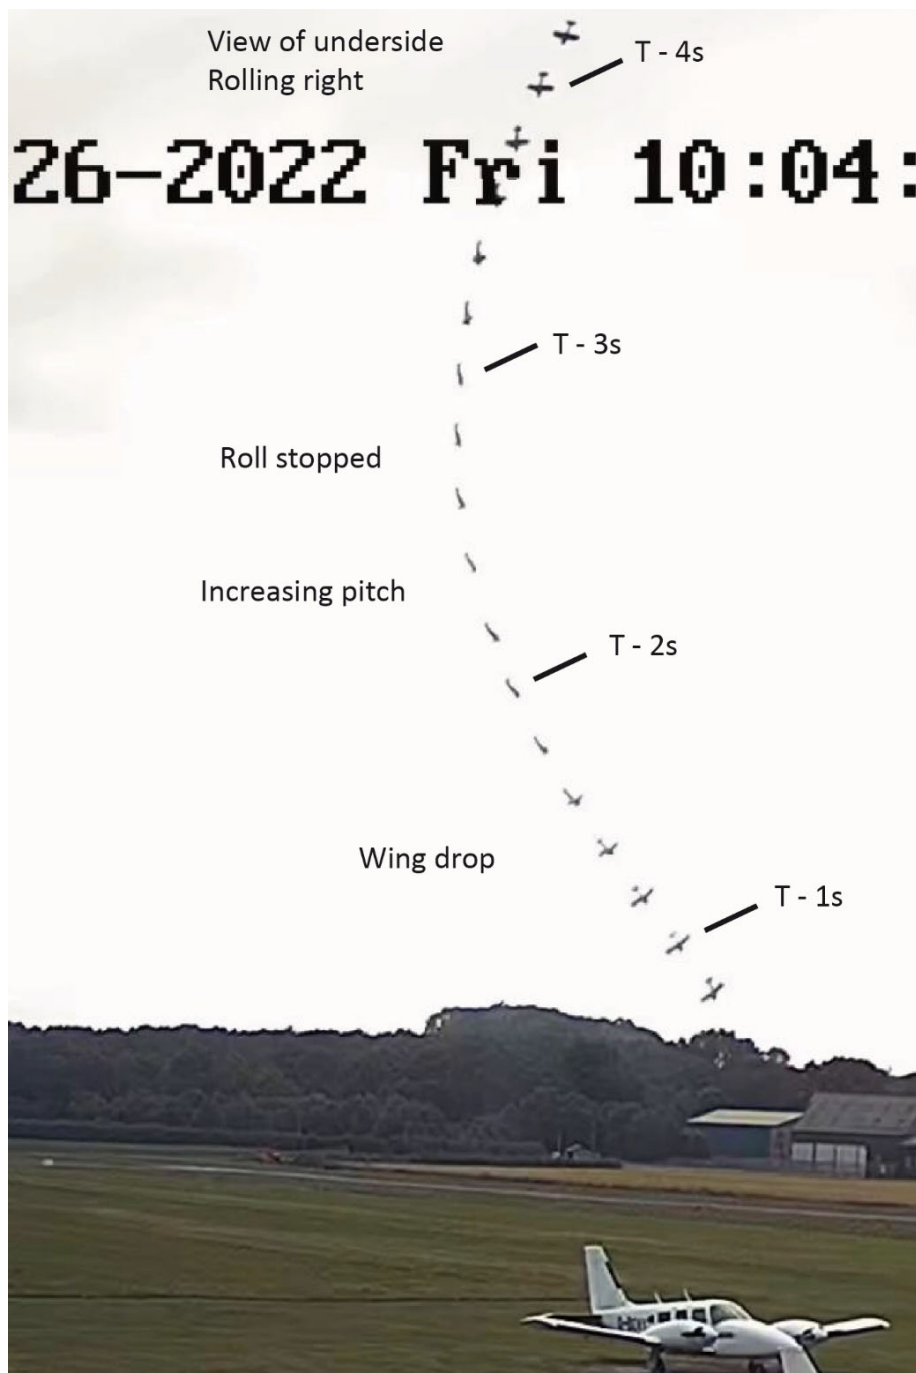
**Figure 5**

CCTV cameras captured the lower parts of some of the manoeuvres and the impact with the ground. The field of view of the CCTV cameras did not extend up enough to capture higher parts of the manoeuvres flown, including the final accident manoeuvre. Figure 5 shows the final descent captured on CCTV.

Compound image of cropped CCTV snapshots 0.2 seconds apart until 0.8 seconds before contact with the ground

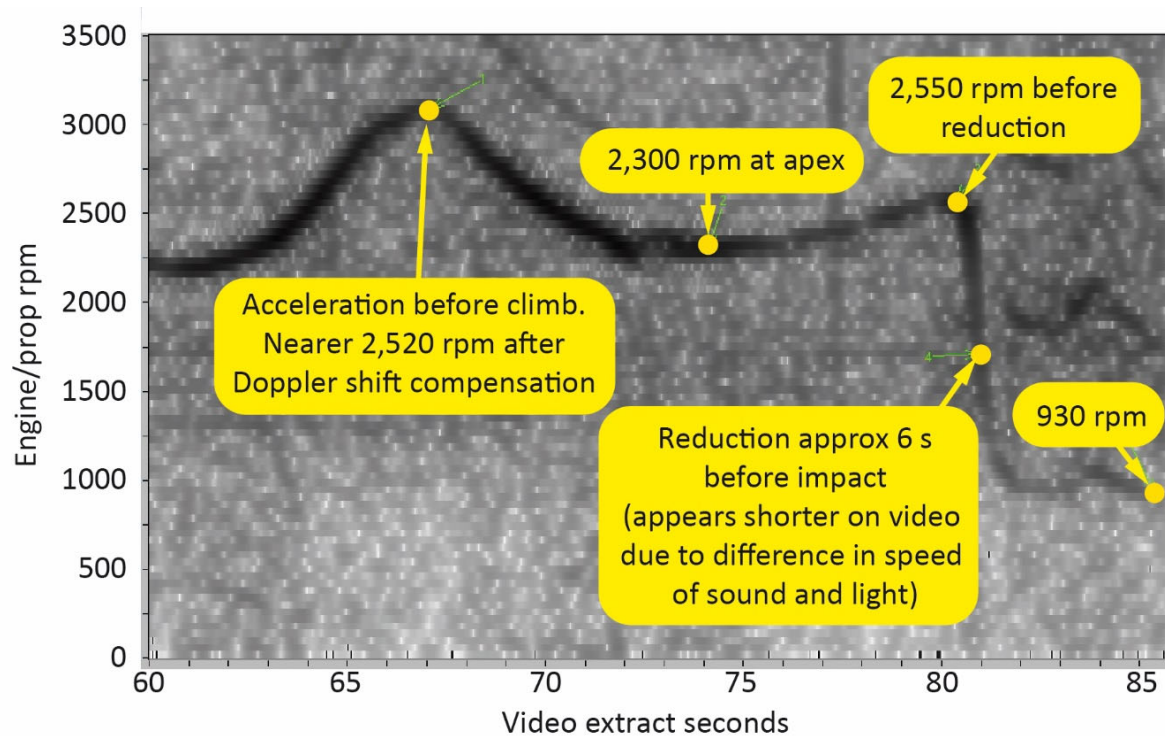
**Figure 6**

The mobile phone video also captured the sound of the propeller (Figure 6). The frequency of the recorded tone is related to the speed of the propeller but is also affected by doppler shift due to the aircraft moving towards or away from the recording device. In this case the frequency shift was predominantly due to the initial speed of the aircraft at the start of the manoeuvre being largely towards the recording position. With fixed pitch propellers, such as the one in use, the speed of the propeller is affected by airspeed and the throttle position.

The audio recorded a sharp drop in propeller speed which, after factoring in the time taken for the sound to travel from the aircraft to the mobile phone, was about six seconds before impact. No sound of the impact was identified as the audio was swamped at this point by voices at the recording location.

Spectrum analysis of the audio track of the mobile phone recording showing tone due to propeller blade noise. Scale halved to reflect propeller rpm rather than blade passes per minute

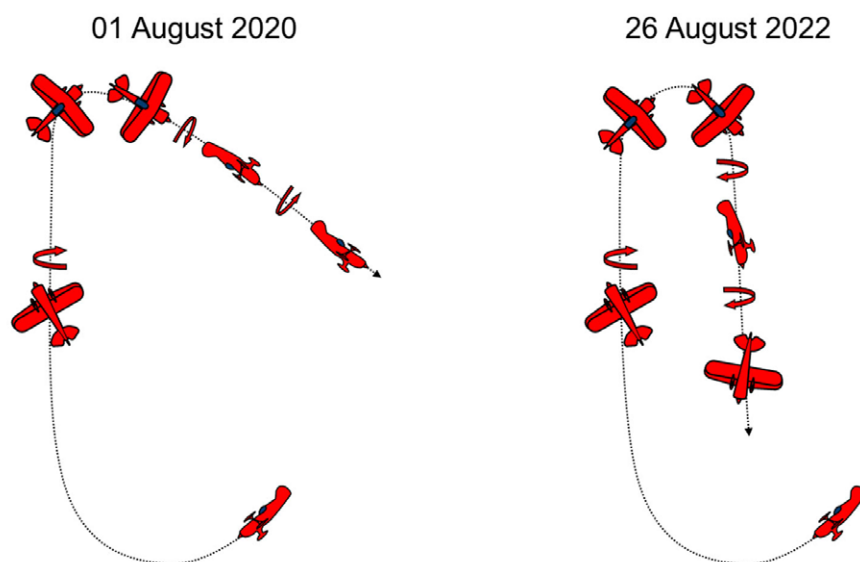
**Figure 10**

While no supporting documentation could be found, the investigation was provided with video footage taken on 1 August 2020 of the pilot flying a climbing manoeuvre like that which preceded the accident. This video showed the aircraft pulling up into the vertical before rolling left through 450°. This roll, like the one in the accident manoeuvre, was off-axis to the left and finished with a steeply banked 'knife-edge' over the top. As the aircraft's nose dropped below the horizon, the pilot held the pitch attitude at approximately 45° nose-down with the aircraft inverted for about one second before rolling erect and continuing the 45° descent. In the August 2020 video, the transition from nose-up to nose-down was more dynamic than on the accident flight; visually, the aircraft appeared to have more airspeed approaching the apex and the right yaw looked more positively controlled. Additionally, on

the accident flight the aircraft remained close to 90° angle of bank as the nose dropped, while for the August 2020 manoeuvre, the bank angle was closer to 120°, thus requiring less yaw but more pitch to bring the nose down to the desired angle. A simplistic comparison of the accident manoeuvre with the one from 1 August 2020 is shown at Figure 10.

Comparison of 1 August 2020 manoeuvre and accident manoeuvre  
(not to scale)
