## Carbon monoxide poisoning on board the sports cruiser *Emma Louise* resulting in two fatalities at Port Hamble Marina, River Hamble, England on 11 January 2022

### SUMMARY

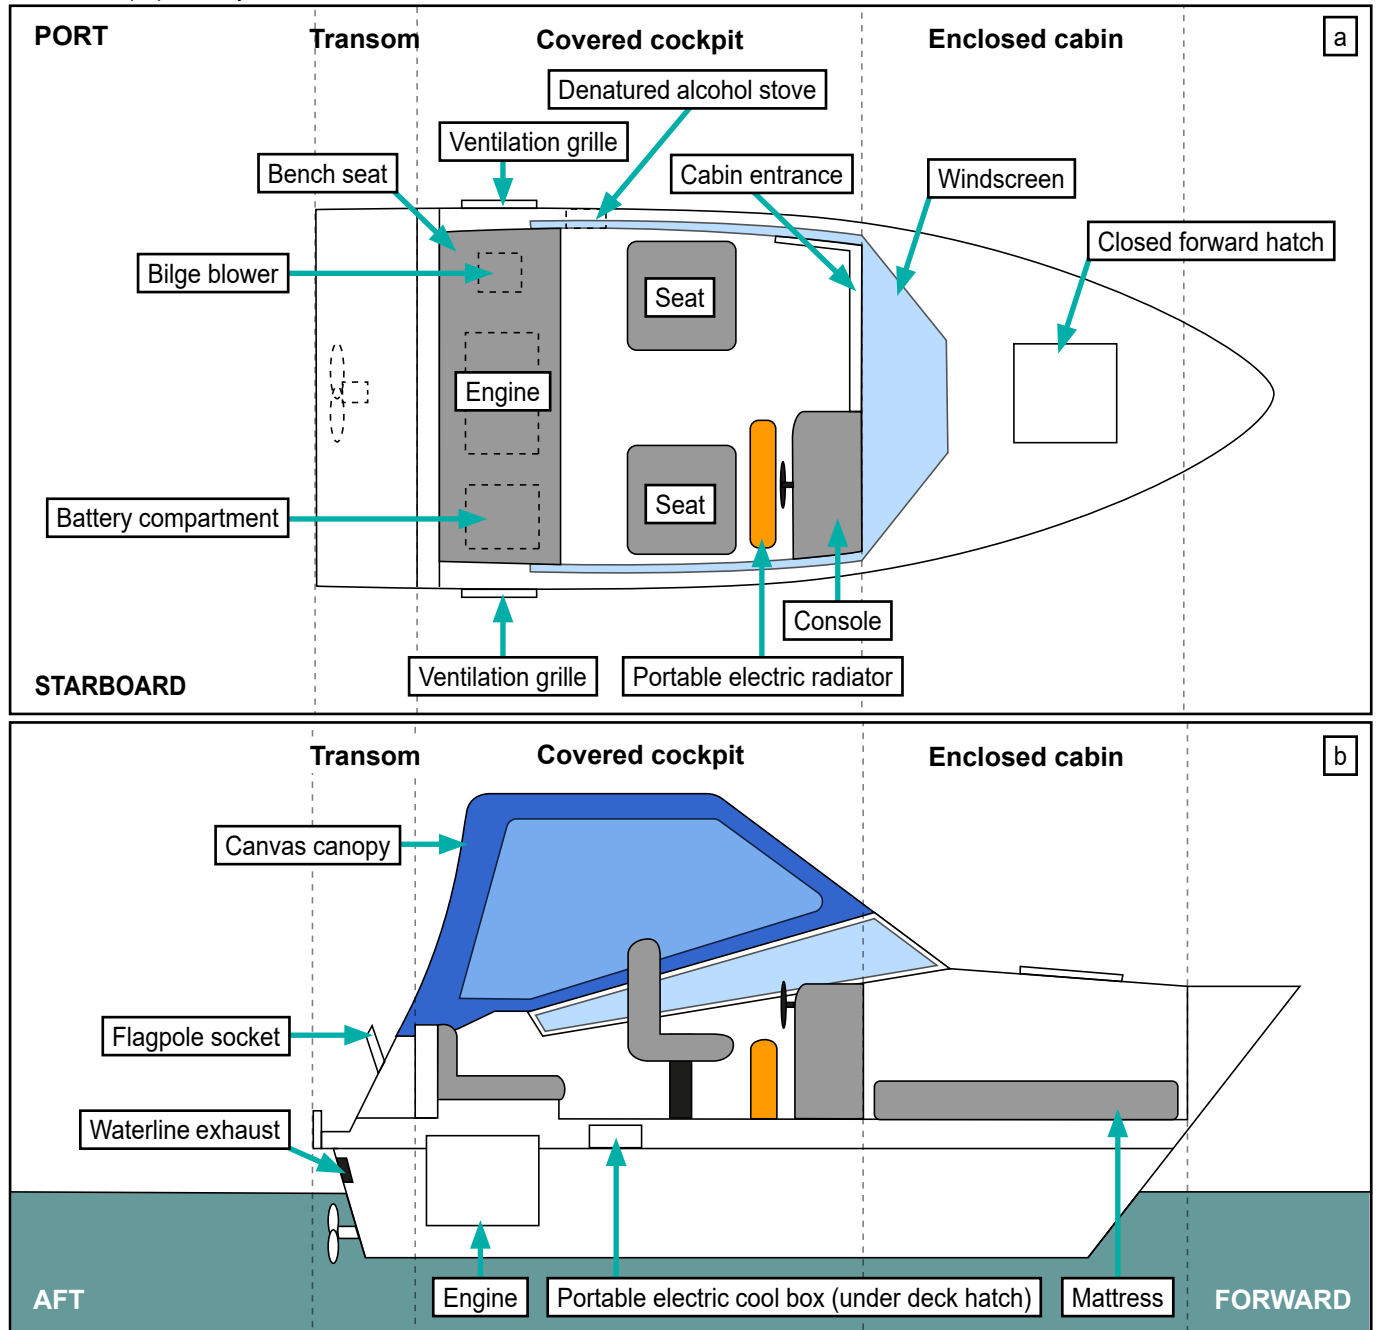
**Figure 1: Emma Louise plan (a) and side elevation (b)**

The boat had a cockpit area with a cushioned transverse bench seat to aft, below which the engine was fitted into a separate compartment (**Figure 1**). The cockpit had two pedestal mounted seats; the helm and boat controls were mounted in a console in front of the starboard seat. There was a low wraparound

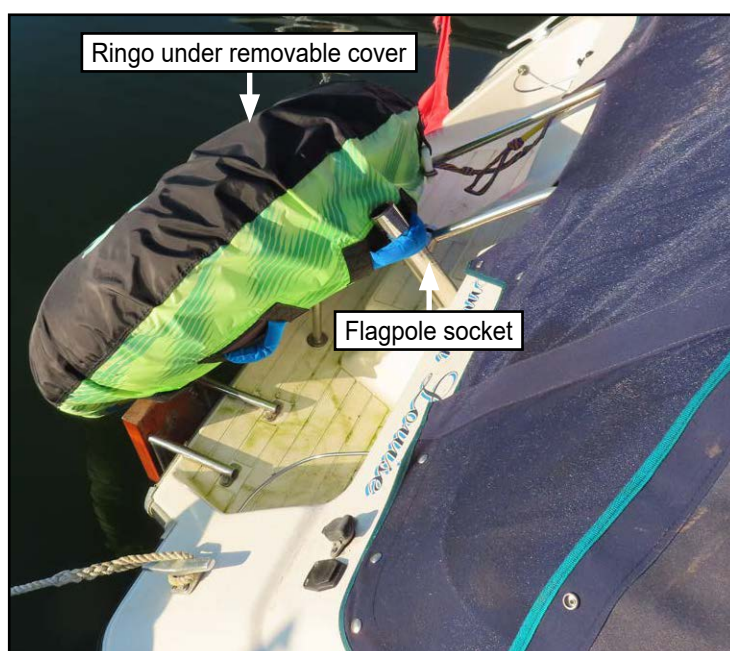
**Figure 2:** *Emma Louise*'s transom with ringo hanging from flagpole socket

An inflatable towable ski ring (known as a ringo) was suspended from a flagpole socket at the transom of *Emma Louise* (**Figure 2**). The ringo was protected by a removeable cover. The 240 VAC shore supply cable was plugged into a socket on the pontoon; the portable electric radiator was switched on and was warm.

- It is likely that the exhaust gas was funnelled into the covered cockpit of *Emma Louise* by an inflatable towable ski ring that was suspended at the transom.

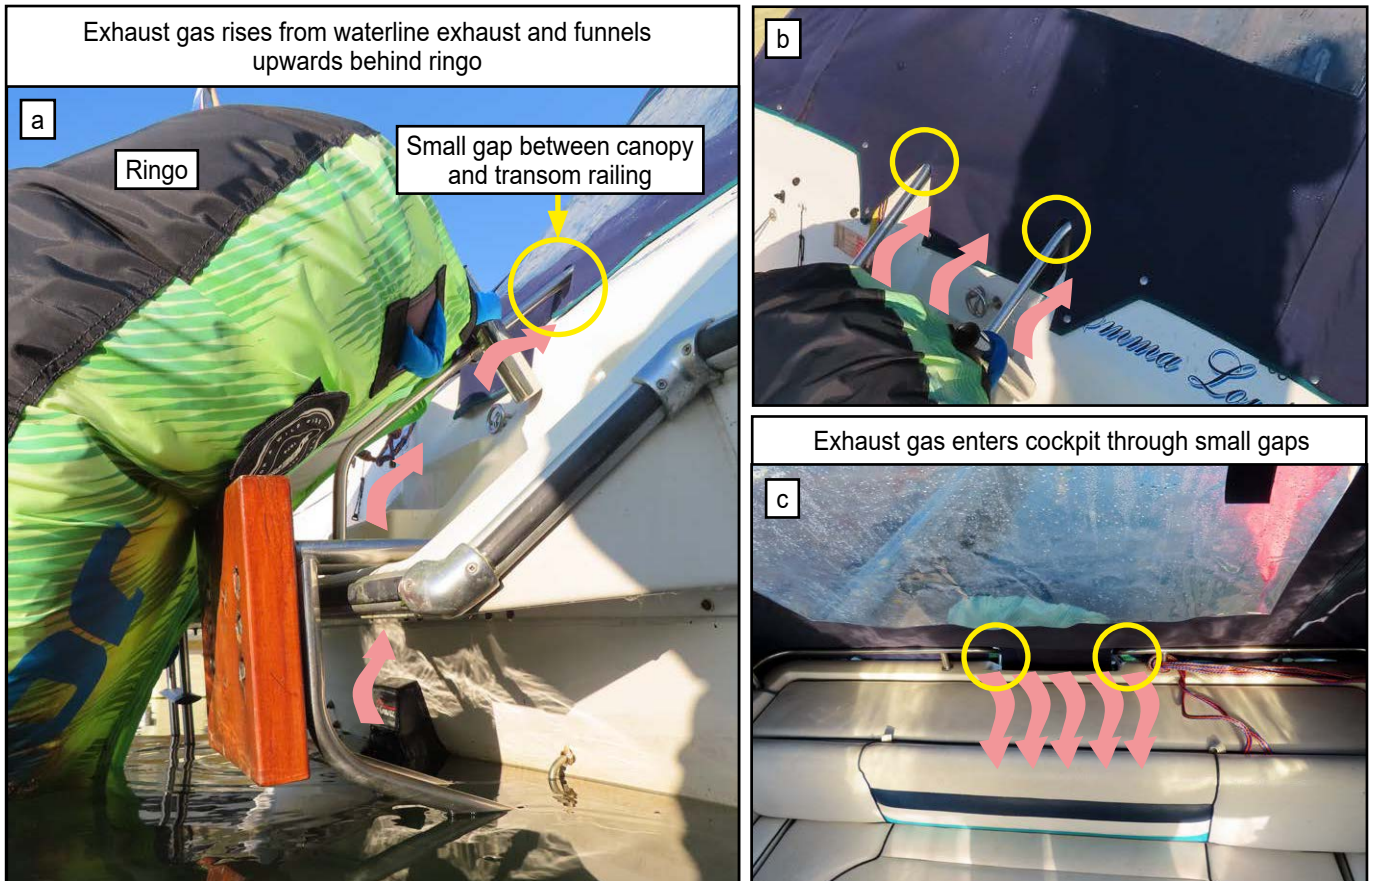
**Figure 3:** Representation of the likely passage of exhaust gas from waterline exhaust (a) into covered cockpit (b and c) based on the FLIR OGI camera

The tests confirmed that the engine exhaust exited freely into the atmosphere at the waterline (**Figure 3a**), indicating that the boat's draught and the lack of swell did not set up a back pressure on the exhaust that might have affected engine performance. The amount of CO in the atmosphere at the exhaust during the tests ( $\leq 7000$ ppm) and the lack of black smoke in the exhaust gas emitted did not provide any indication that the engine, which had been replaced in the year before the accident, was defective.

Although atmospheric conditions on the evening of the accident were not identical to the MAIB post-accident tests, it is likely that the passage of the exhaust gas into the boat would have been similar. When the engine was started it is probable that the warm exhaust gas rose and was funnelled between the ringo and the boat's transom up to the lower edge of the canopy, where it then seeped into the cockpit through the small gaps around the transom railing (**Figure 5**). The CO rich and O<sub>2</sub> deficient atmosphere that was detected above the aft bench seat during the tests showed the potential for the incoming gas to degrade the atmosphere in the cockpit. Although CO is only slightly lighter than air, it is possible that convection currents rising from the warm portable electric radiator caused the CO within the exhaust gas to mix with the air and distribute within the cockpit, which was fully enclosed by the canopy. The canopy was intact, fully closed up and well-fitted to the hull and windscreen, while the forward hatch was closed and the engine bilge blower was not running. Consequently, it is likely that only a small amount of the polluted atmosphere would have been refreshed with clean air.

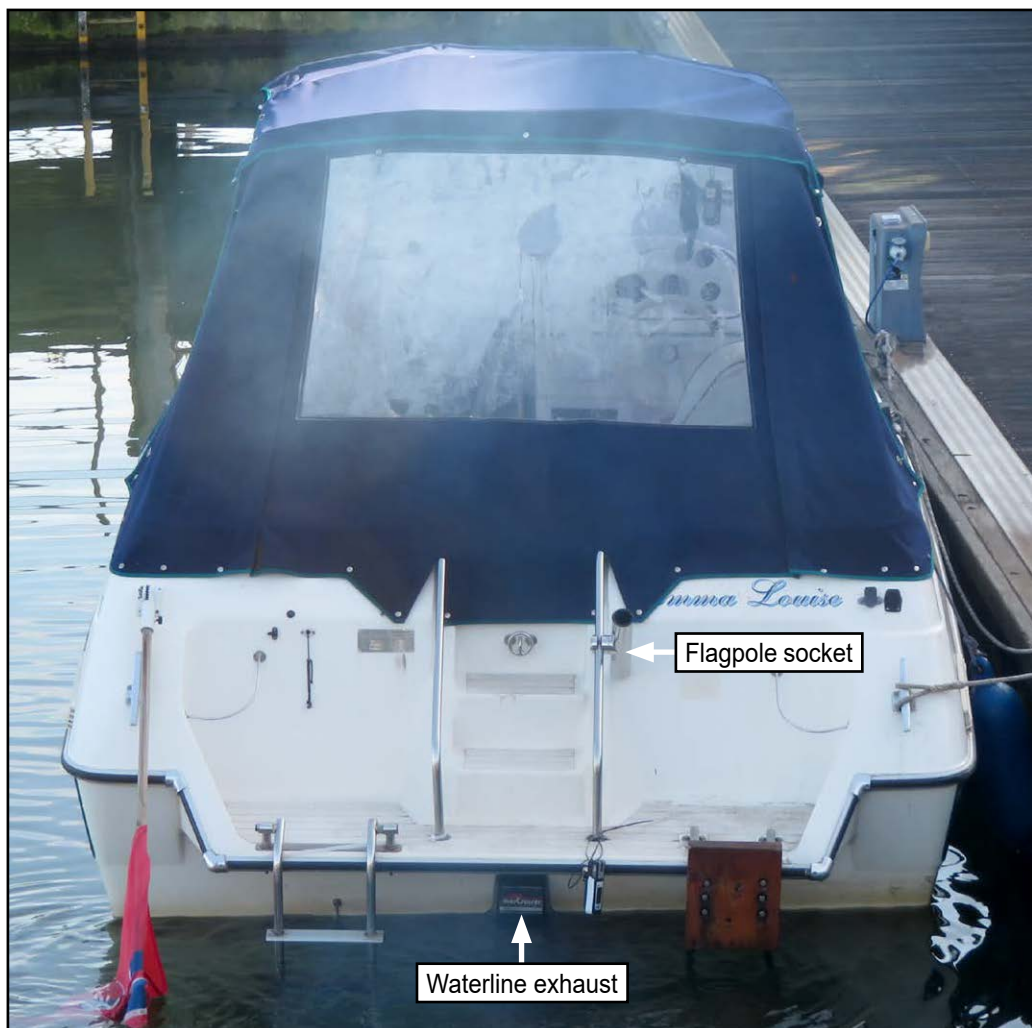
**Figure 4:** Emma Louise's transom with ringo removed

A further test was carried out with the covered ringo removed from the transom (**Figure 4**) using the same CO detectors. The CO levels in the cockpit reached 200ppm after about 14 minutes before settling at around 300ppm after 30 minutes.

Although the MAIB tests demonstrated that some exhaust gas did transfer into the cockpit when the engine was running with the ringo removed, it is likely that the two men's exposure to CO would have been at a much lower level that probably would not have resulted in their deaths. CO is always present within the exhaust of an engine that runs on fossil fuel; however, the risk of CO poisoning can be reduced if a boat's engine is not run while the vessel is stationary and canopies and cabins are well ventilated.

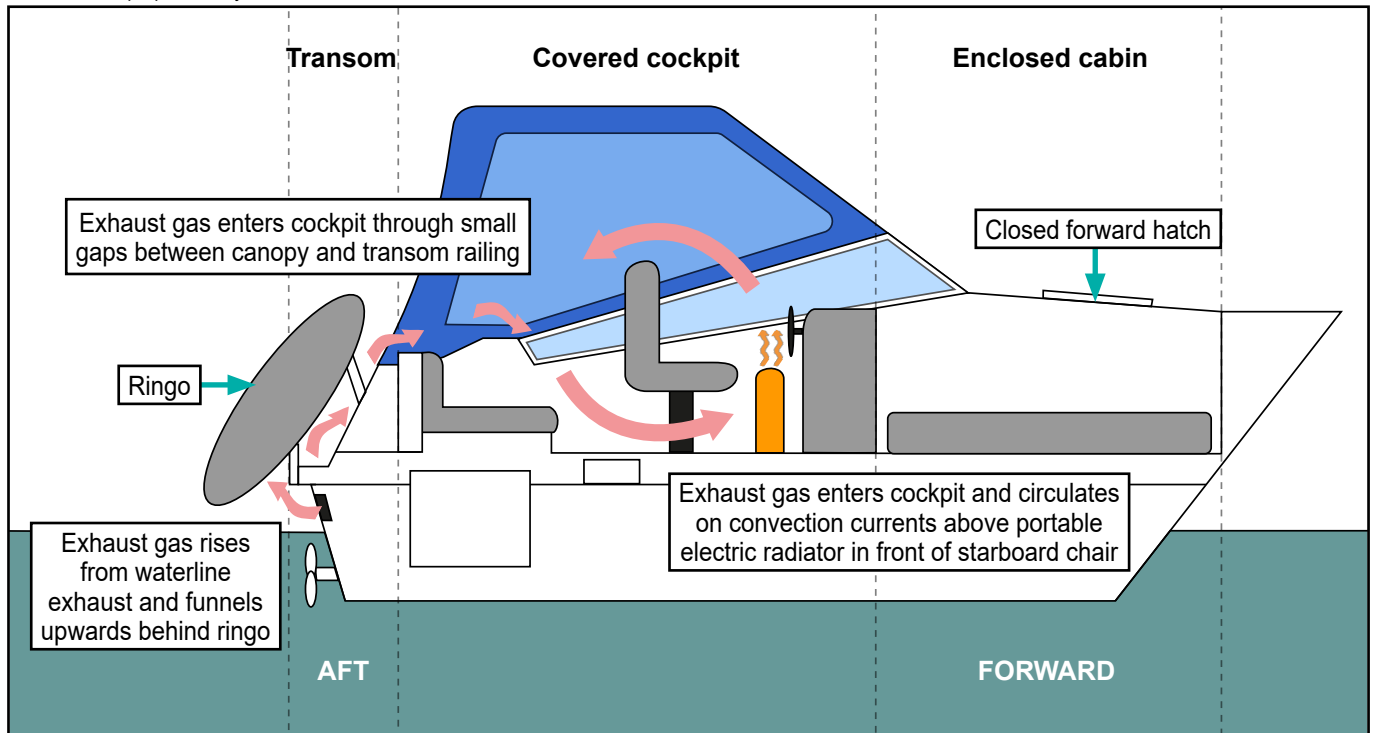
**Figure 5:** Representation of possible path of exhaust gas within *Emma Louise's* covered cockpit area

The air quality in the cockpit's atmosphere is likely to have deteriorated relatively quickly. The as found position of the two men suggested that the owner of *Emma Louise* was sitting on the aft bench seat and his brother-in-law was in the seat behind the helm at the time of the accident. Neither man was significantly under the influence of alcohol, so it is unlikely that their alcohol intake had a major effect on their physiology. It is possible that the air at their head height was sufficiently saturated with CO and CO<sub>2</sub> and was slightly deficient in O<sub>2</sub>; this would have likely caused both men to fall unconscious at a similar time. The absence of mobile phone activity after 1800 and the fact that the meal and wine were untouched suggest that they fell unconscious not long after they arrived on board *Emma Louise*. The levels of accumulated CO identified during the MAIB tests combined with CO<sub>2</sub> and air that was slightly deficient in O<sub>2</sub> showed that similar exposure to the two men was sufficient for them to remain unconscious and for their blood COHb to rise above 70%, thereby causing their deaths later that evening.

- It is possible that convection currents rising from the warm portable electric radiator caused the CO within the exhaust gas to distribute within the cockpit.
