## ACCIDENT

| <b>Aircraft Type and Registration:</b> | Robin DR400/140B, G-BDUY | |
| <b>Date &amp; Time (UTC):</b> | 16 June 2022 at 0850 hrs | |
| <b>Location:</b> | East Kirkby Aviation Centre, Lincolnshire | |

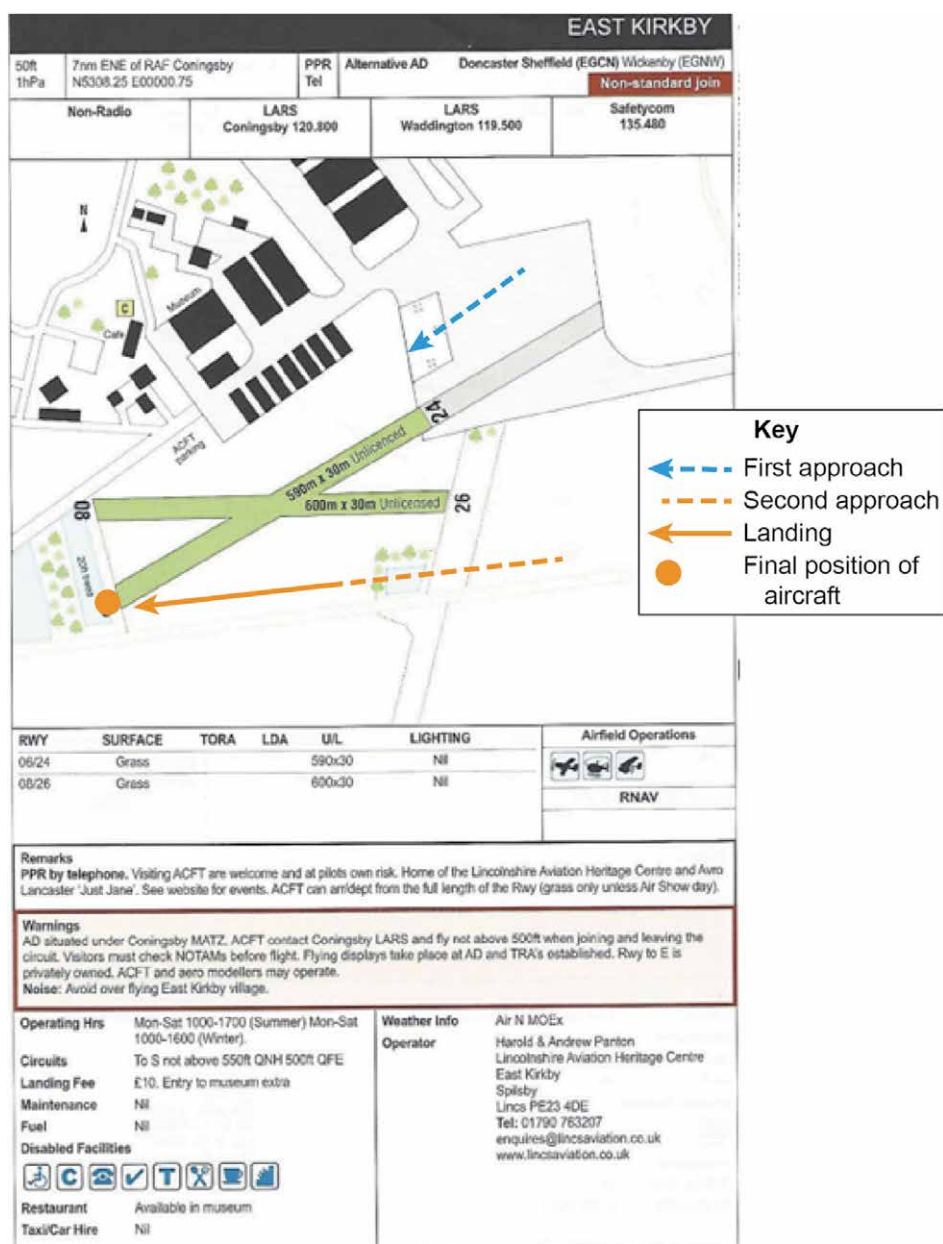
**Figure 1**

G-BDUY had flown in a group of aircraft from Hatton to East Kirkby airfield. The pilot reported that during the final approach he saw a Lancaster aircraft parked on what he thought was Runway 24. He performed a go-around and joined left downwind for Runway 26, at the 500 ft aal circuit height specified on the airfield chart he was using (Figure 1).

The pilot explained that during that approach he was focussed on overflying some trees near his intended landing point. During touchdown he realised the remaining landing distance was too short (Figure 1). Because of more trees straight ahead, he applied maximum braking – rather than performing a go-around – and came to rest on a grassy bank at the edge of the airfield.

Chart used by pilot annotated with the approaches flown, and the landing<sup>1,2</sup>

<sup>2</sup> Note chart specified circuit height of 500 ft.

There were significant differences between the airfield chart, promulgated on the airfield's website, and the chart used by the pilot. The latter specified a lower circuit height and did not refer to the special telephone briefing required for landing on Runway 24. Neither chart would necessarily conform to satellite imagery of the airfield or information provided in a navigation app, particularly regarding the absence of runway markings.

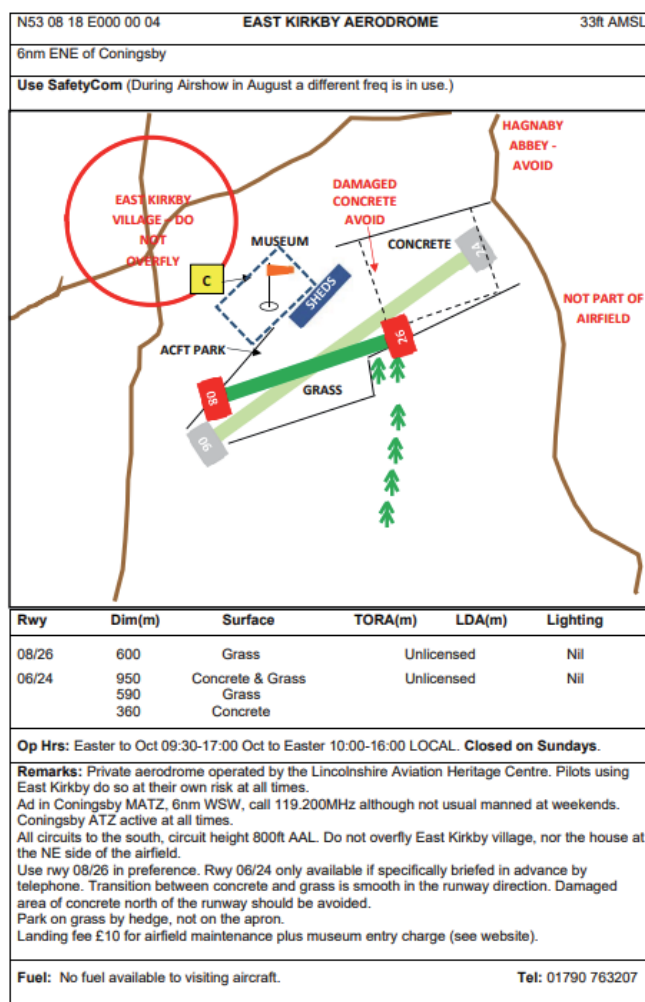
**Figure 2**

Chart promulgated on the airfield's website<sup>3</sup>

<sup>3</sup> Note chart specified circuit height of 800 ft.
