Annual Safety Review 2022

Air Accidents Investigation Branch
Farnborough House
Berkshire Copse Road
Aldershot
Hampshire
GU11 2HH.

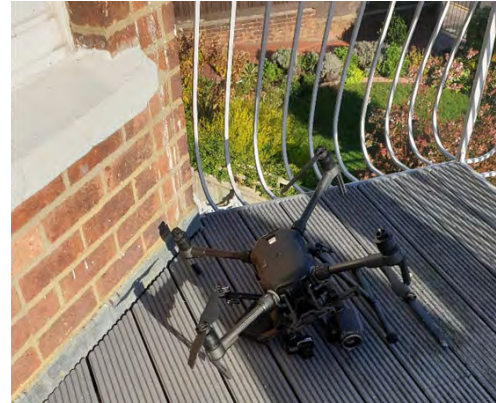
The quadcopter unmanned aircraft (UA) was being flown over the city of Poole during a police operation when the wind at 400 ft exceeded the forecast wind, the manufacturer's wind limit and the maximum restricted speed of the UA. The UA drifted beyond visual line of sight and then communication with it was lost. When the battery level was low it entered an auto-land mode but collided with the wall of a house, damaging its propeller blades before coming to rest on a balcony. The investigation revealed that shortly after takeoff one of the UA's two batteries had disconnected which resulted in its maximum speed being restricted, but this restriction is not referenced in the user manual and neither the remote pilot nor operator were aware of it. When the UA detected that the manufacturer's wind limit had been exceeded, the message triggered on the pilot's controller display was 'Fly with caution, strong wind' instead of advising the pilot that the limit had been exceeded and that the UA should be landed as soon as possible. Three Safety Recommendations were made to the UAS manufacturer and one to the CAA on Visual Line of Sight guidance.

Damage to UA

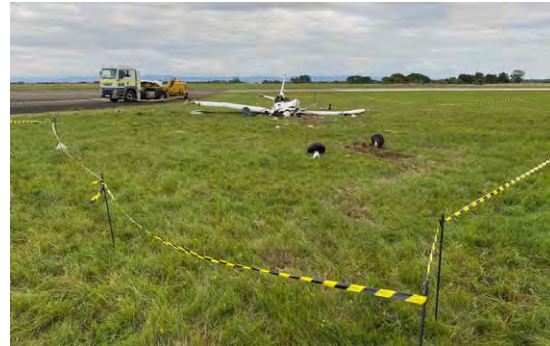
The aircraft suffered a partial loss of engine power very shortly after takeoff from Runway 23 at Teesside International Airport. The pilot, believing the aircraft was outside the airport boundary, attempted a turnback to the airport to land. The aircraft stalled during the turn and struck the ground west of the runway near the Runway 05 threshold. The three occupants all sustained serious injuries.

Accident site, looking south with the Runway 05 threshold behind

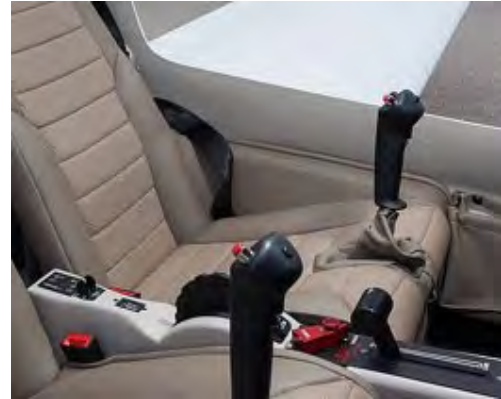
The pilot was seriously injured when the aircraft stalled and then struck the ground shortly after takeoff from a height of about 100-200 ft. It had been loaded with five containers of de-icing fluid, contrary to the approved training organisation's prohibition on the carriage of cargo and dangerous goods. One container, loaded in the front right footwell close to the flying controls, limited the control stick's available forward movement.

Flight control stick DA 40 NG

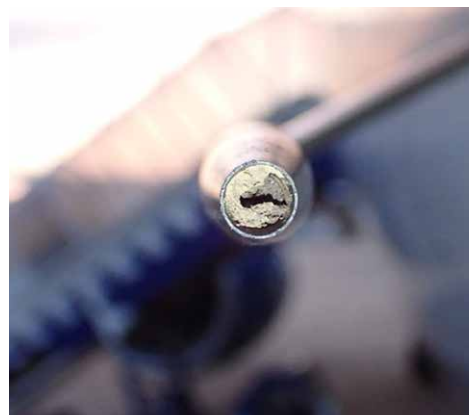
Between 9 June 2021 and 19 July 2021, several aircraft suffered from abnormal pitot/static system events, two of which resulted in rejected takeoffs. The AAIB investigation identified the cause to be the nesting activity of certain species of wasps and bees within pitot probes. The investigation report addressed the likely reasons as to why there was a concentration of such events over a relatively short period of time.

G-YMMR blocked pitot tube

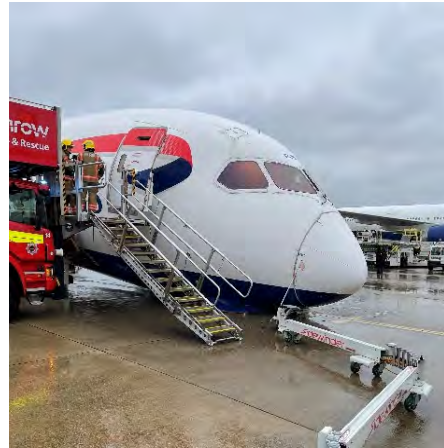
The aircraft was on stand being prepared for a cargo flight from London Heathrow to Frankfurt. A ground maintenance team was working to address three fault messages associated with the Nose Landing Gear (NLG) doors while the flight crew prepared the aircraft for the flight. The Dispatch Deviation Guide confirmed that rectification of the defects could be deferred to a later date providing the landing gear was recycled to confirm the NLG doors functioned correctly. To prevent the landing gear from retracting when UP was selected, the landing gear downlock pins were fitted. However, when the lead engineer selected the landing gear lever to UP, the NLG retracted. The aircraft's nose struck the ground causing significant damage to the lower front section of the aircraft and inflicting minor injuries on the co-pilot and one of the cargo loading team.

View of the right side of the aircraft following NLG retraction

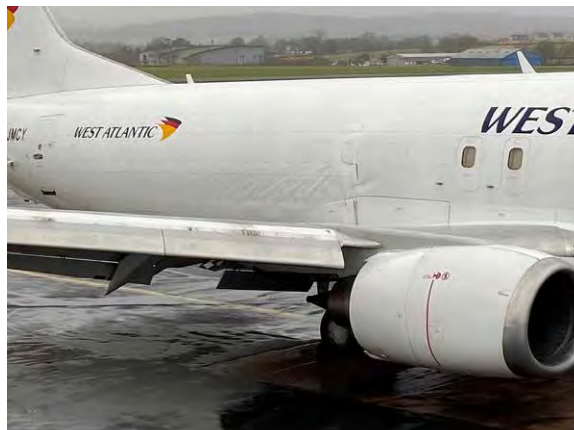
During an ILS approach at Exeter Airport, the aircraft became unstable after the point where the crew had declared it stable and continued with the approach. During the final 500 ft the rate of descent exceeded the required 500 ft stable approach maximum on four occasions. All but the first of these excursions were accompanied by GPWS “SINK RATE” alert. The subsequent hard landing resulted in extensive damage to the aircraft. There were no injuries.

Photograph looking aft showing distortion of the rear fuselage and rippling in the skin

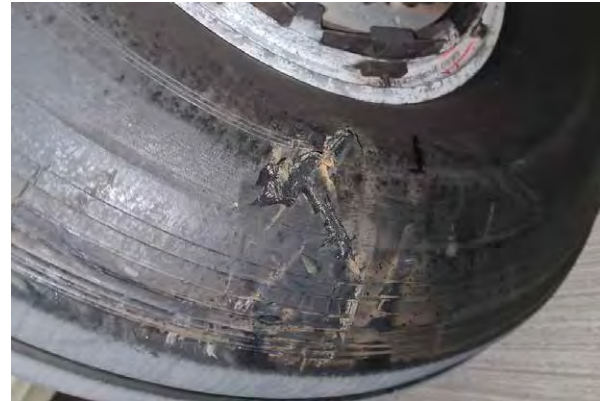
After an uneventful pushback, the towbar was left on the taxiway in front of the aircraft. Soon after the aircraft commenced taxiing, its left landing gear went over the towbar. The missing towbar was noticed when the ground crew returned the tug to the towbar parking area. The aircraft was subsequently stopped from taking off to allow an inspection to take place. Damage was found to two landing gear tyres, which were replaced before the aircraft departed.

Damage to one of the landing gear tyres

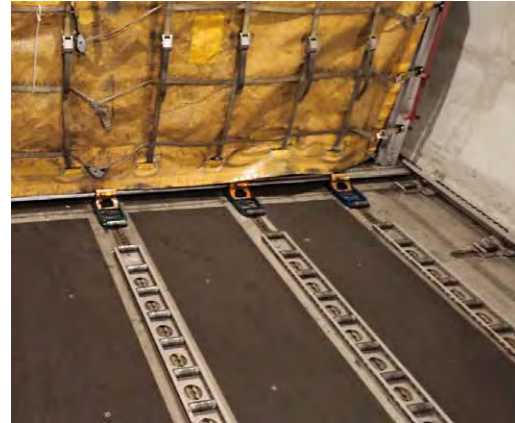
An investigation by the ground handling organisation found that the locks to the rear of the ULD had not been raised and that there were no independent checks during the loading to verify that the locks had been correctly raised.

ULD rails and locking mechanisms

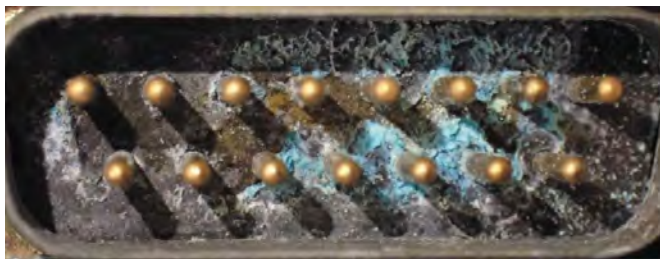
Contamination and corrosion on the audio warning unit connector

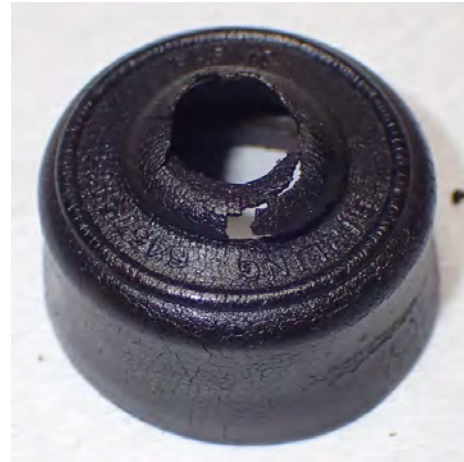
A dust seal from one master cylinder showing degraded condition

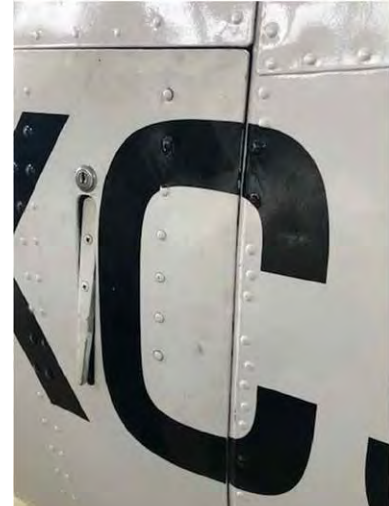
Protruding state of the lower cabin door handle observed during testing
(image courtesy of 2Excel)

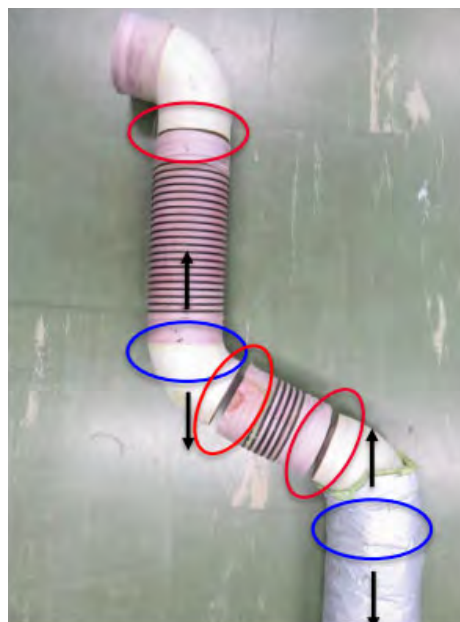
Failed heating duct
from G-MCGU

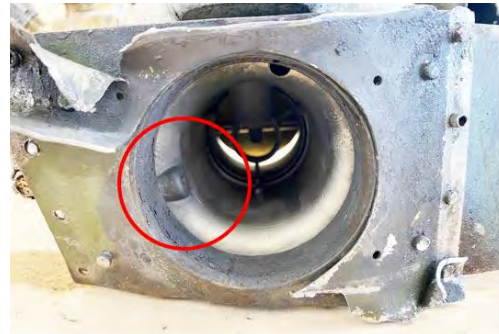
Missing accelerator pump discharge tube from G-BBSA carburettor

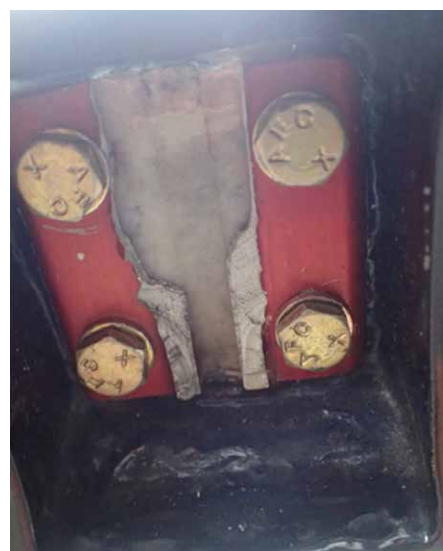
Parts of the failed centre hinge attachment for the right aileron before removal from wing

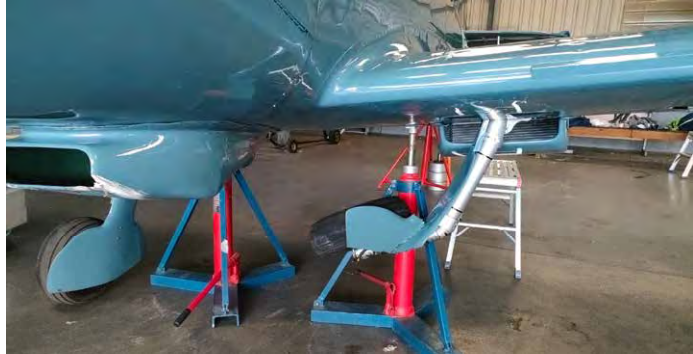
Landing gear damage
(photograph used with permission)

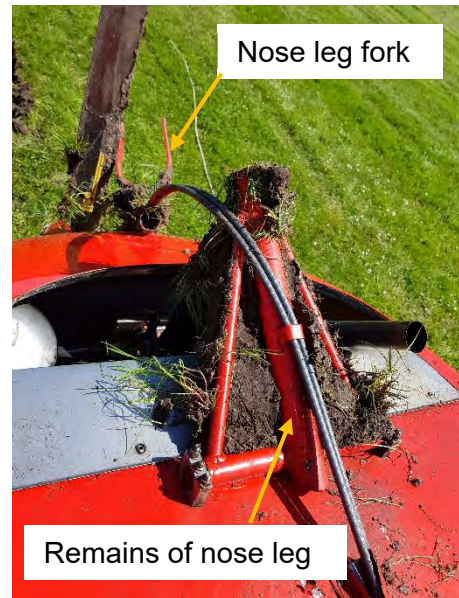
Snapped nose leg

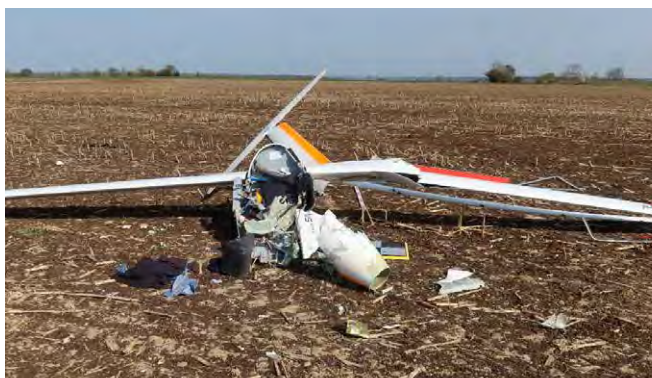
Damage to aircraft
