AAIB Bulletin

5/2023

Published 11 May 2023

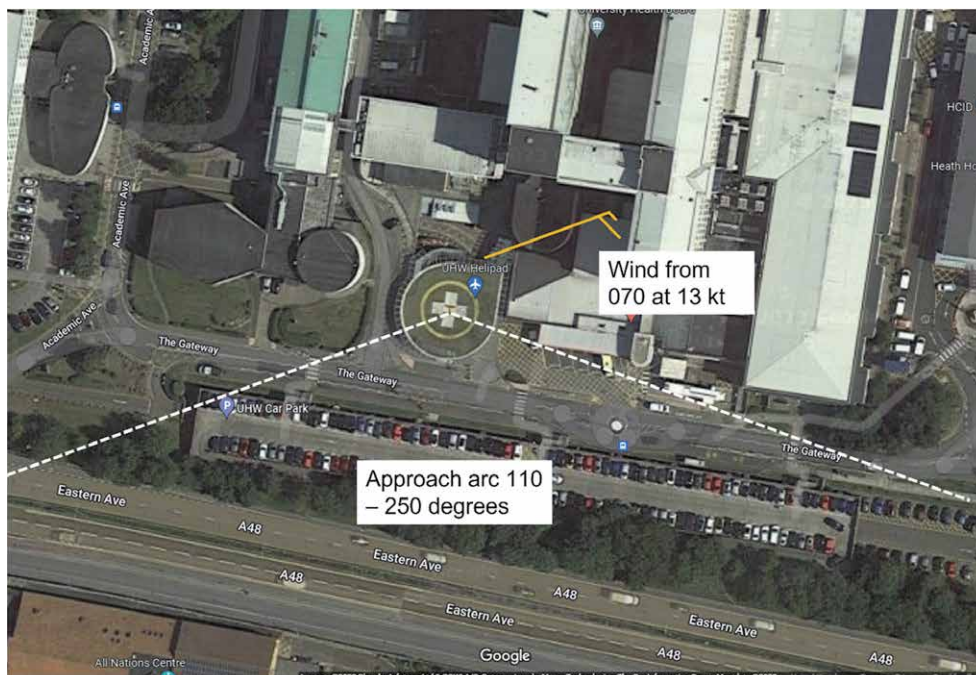
Figure 1

The helipad at the Cardiff hospital is 30 m in diameter and 30 ft above ground level. It is an elevated site that requires firefighting personnel to be present during landings. The hospital procedure also requires pedestrian and traffic management during helicopter movements. At this site, the presence of lights turned on at the helipad is the primary cue for pilots to confirm that the site is available and prepared for a landing.

Aerial view of the Cardiff hospital helicopter landing site

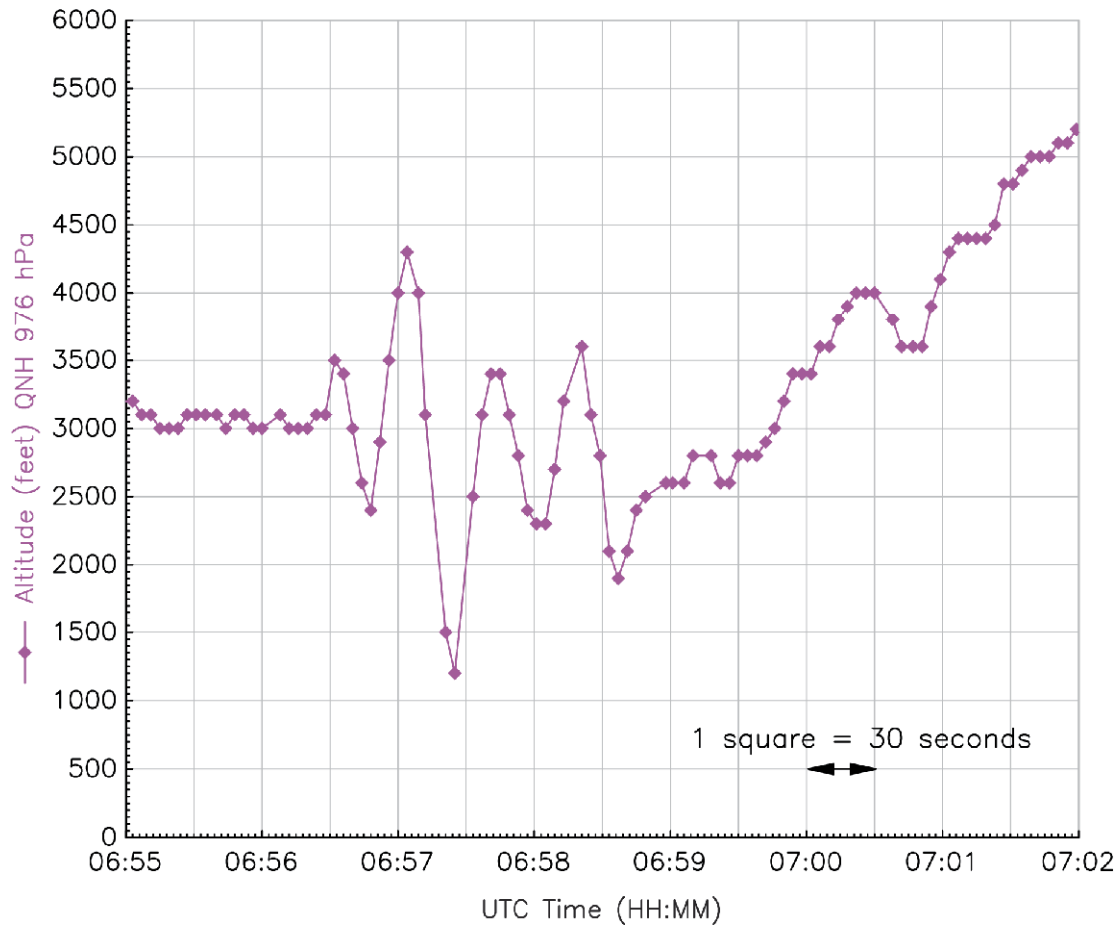
Figure 1 was created from radar data and shows the altitude variation as the pilot flew through the turbulence.

Plot of altitude variation from radar data during the turbulence encounter.

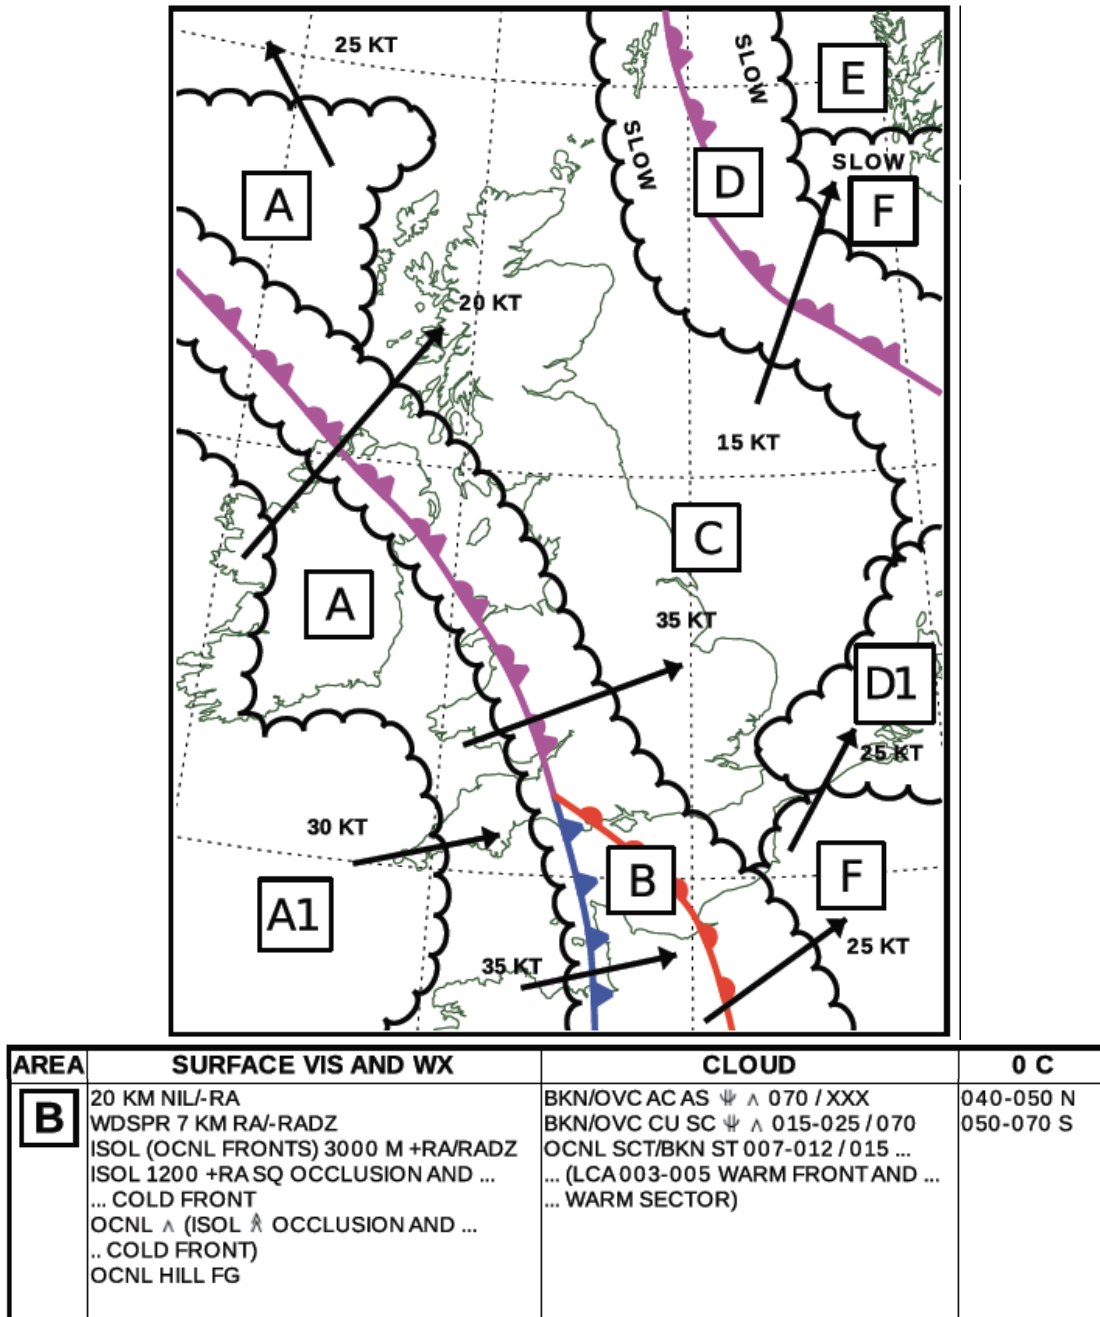
Figure 2 shows the Met Office Form 215 which was included in the briefing pack. The chart shows the occluded front tracking across the Irish Sea. The Isle of Man is in Area B. The forecast suggests there would be isolated heavy rain squalls with visibility reduced to 1,200 m, and occasional moderate turbulence and isolated severe turbulence associated with the cold front and occlusion.

Extract from the Met Office F215 valid on the 23 November between 0200 hrs and 1100 hrs (front positions valid at 0600 hrs)

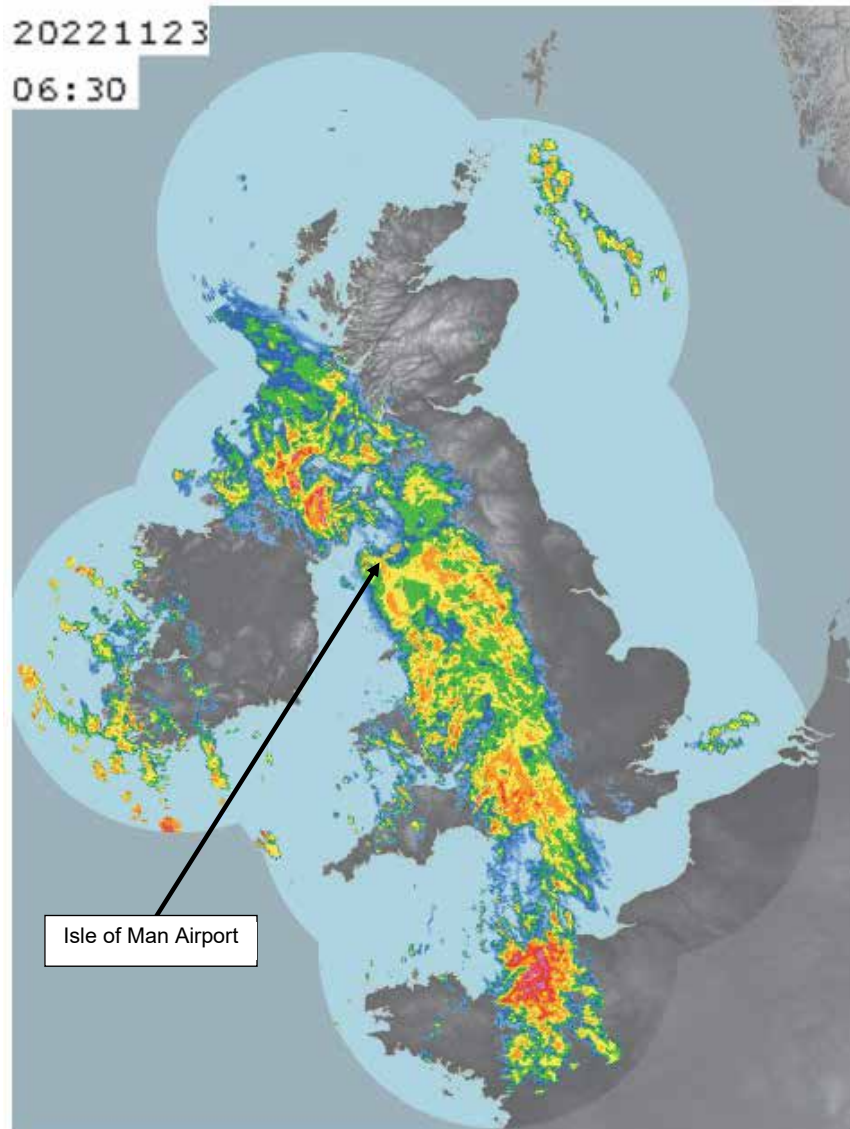
Figure 3 shows a radar image taken at 0630 hrs. The bright colours indicate significant precipitation along the frontal system.

The radar image (Figure 3) showed the rear edge of the rain band was very near to the Isle of Man at 0630 hrs. It shows some very bright colours in the area, as well as along most of the front, indicating heavier rainfall and a very active frontal system.

Weather radar image of the UK at 0630 hrs on 23 November 2022

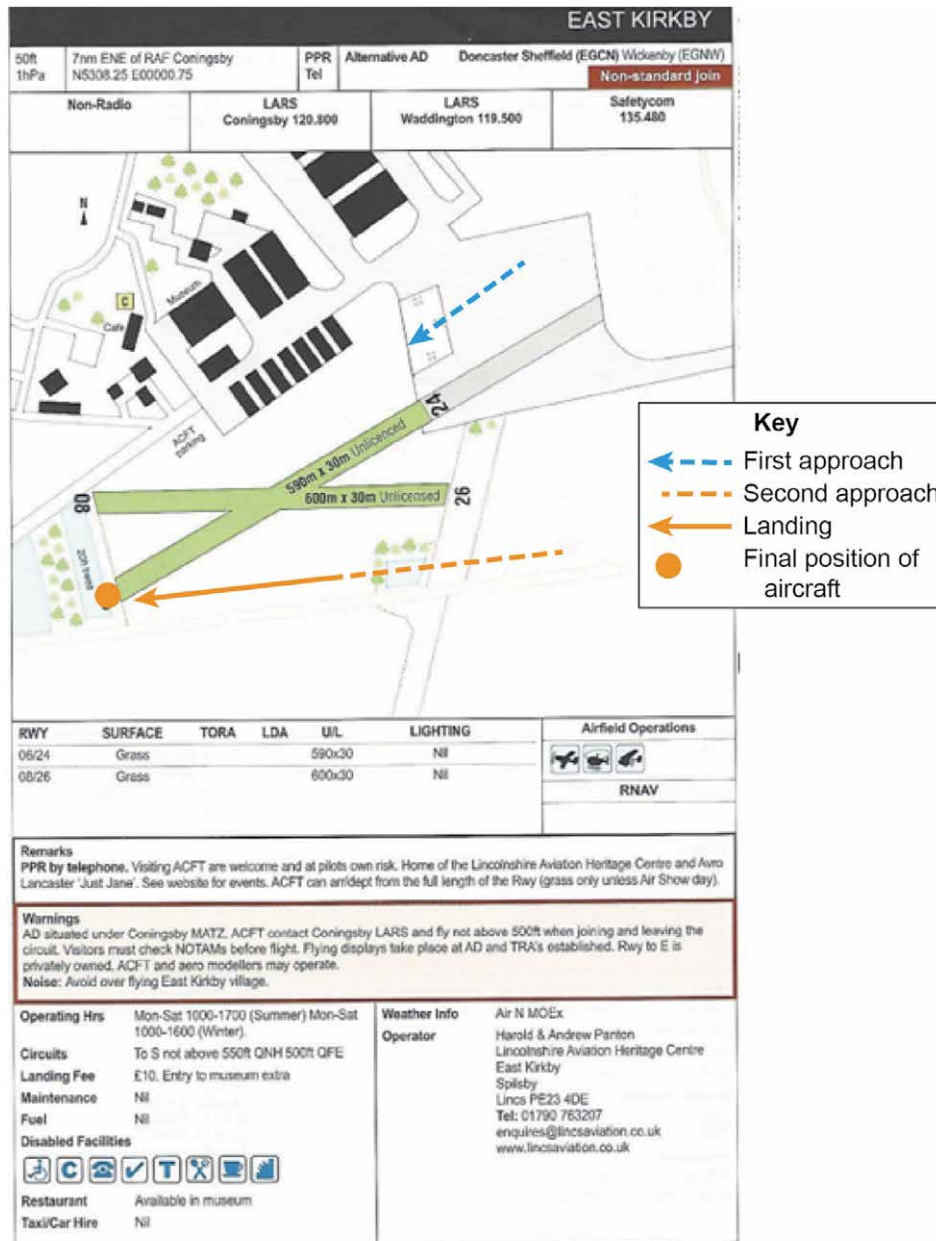
Figure 1

Chart used by pilot annotated with the approaches flown, and the landing^{1,2}

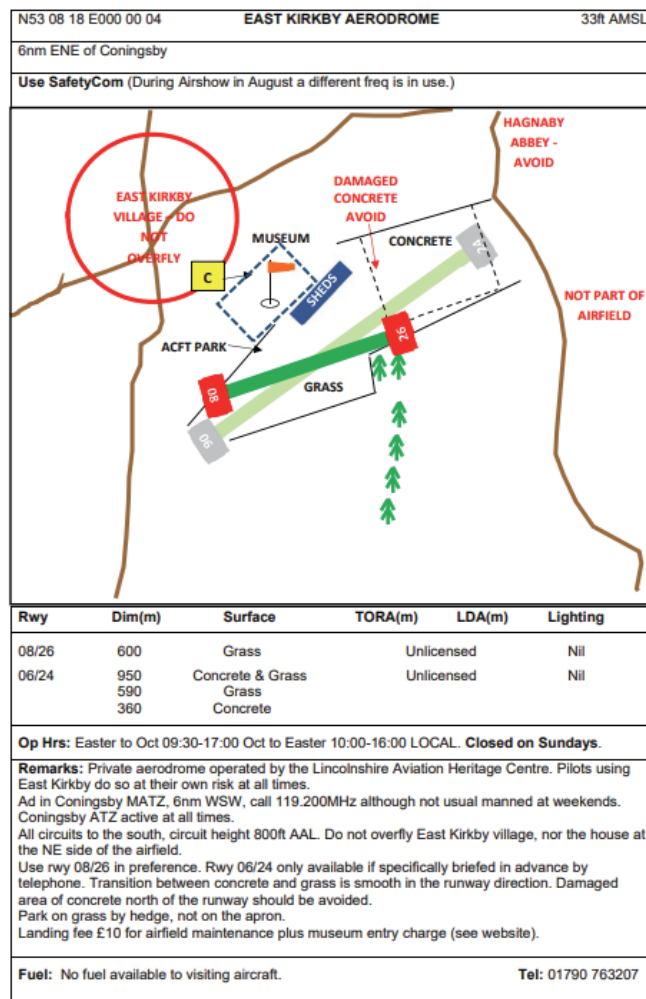
Figure 2

Chart promulgated on the airfield's website³

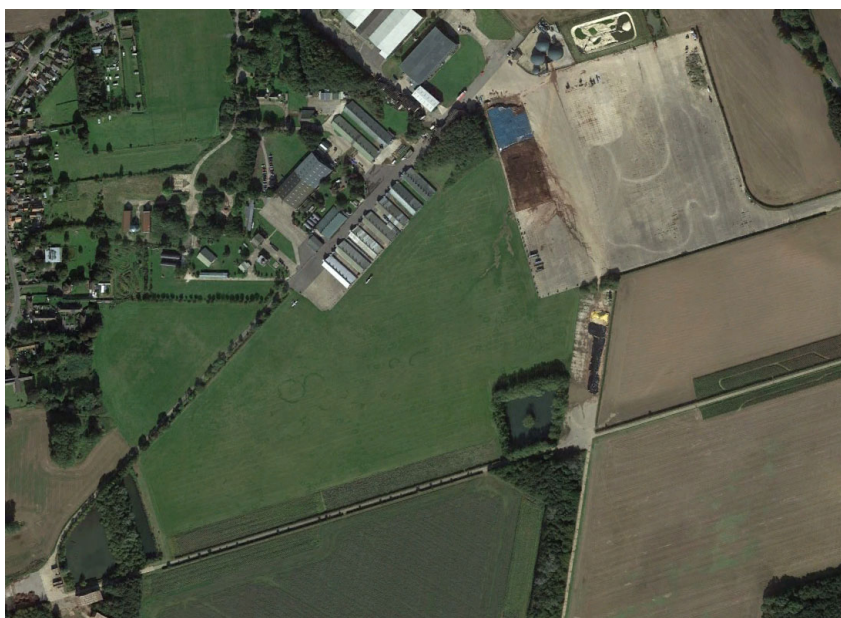
Figure 3

The pilot reported realising while approaching East Kirkby that it looked significantly different to what he was expecting, using his chart. Rather than having marked runways, it was a triangular shaped field of evenly mown grass (Figure 3). The low circuit height with no overhead join made it difficult to identify the runway.

Satellite image of East Kirkby⁴

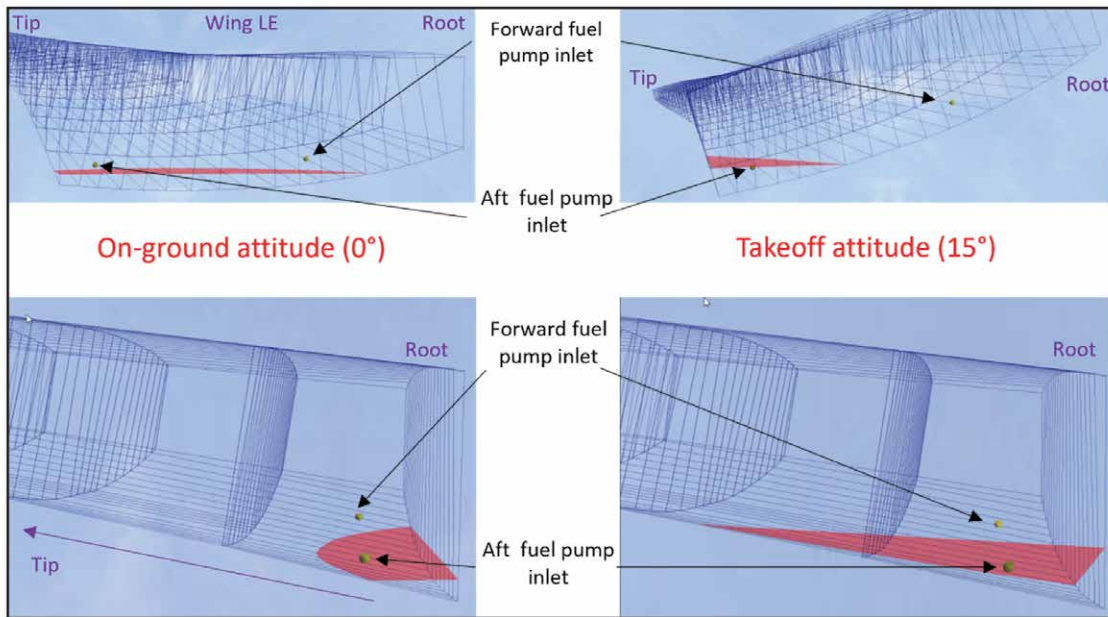
Figure 9

View of the left wing fuel tank at the root showing the fuel pump inlet positions in relation to approximately 30 kg of Kathon (shown in red) (images courtesy of Airbus)
