ACCIDENT

Aircraft Type and Registration:	Piper PA-32-300, G-KNOW
No & Type of Engines:	1 Lycoming IO-540-K1G5 piston engine
Year of Manufacture:	1978 (Serial no: 32-7840111)
Date & Time (UTC):	11 February 2022 at 1300 hrs
Location:	Steyning Valley, South Downs Way, East Sussex
Type of Flight:	Private
Persons on Board:	Crew - 1 Passengers - 1
Injuries:	Crew - 1 (Serious) Passengers - 1 (Serious)
Nature of Damage:	Significant damage to fuselage, wings, engine and propeller. Beyond economic repair
Commander's Licence:	Private Pilot's Licence
Commander's Age:	63 years
Commander's Flying Experience:	698 hours (of which 180 were on type) Last 90 days - 2 hours Last 28 days - 2 hours
Information Source:	AAIB Field Investigation

Synopsis

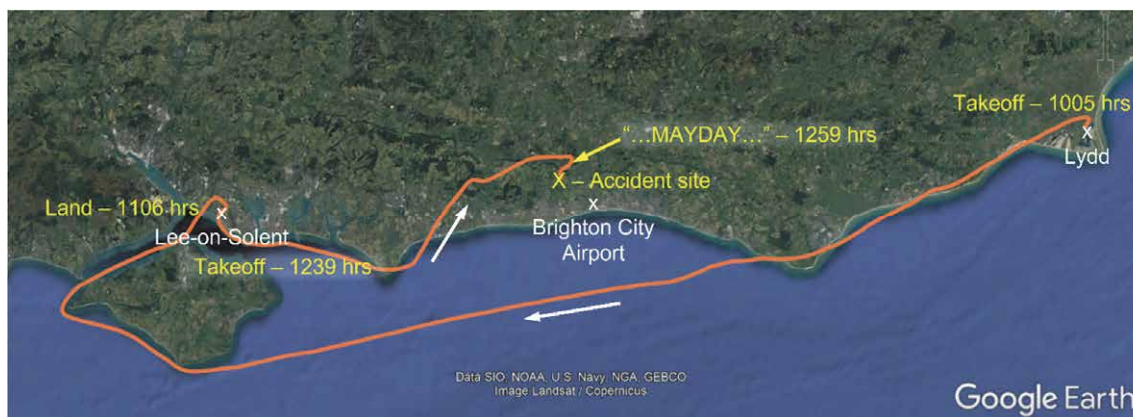
Figure 1

On the day of the accident the pilot and a passenger set out to fly from Lydd Airport to Lee-on-Solent Airport, and back. The accident occurred during the return flight (Figure 1).

Route flown on the day of the accident

G-KNOW took off from Lee-on-Solent at 1239 hrs and followed the coast eastbound, before routing inland (Figure 1). The passenger, who could not fully recall the accident, reported believing they went inland to see a landmark.

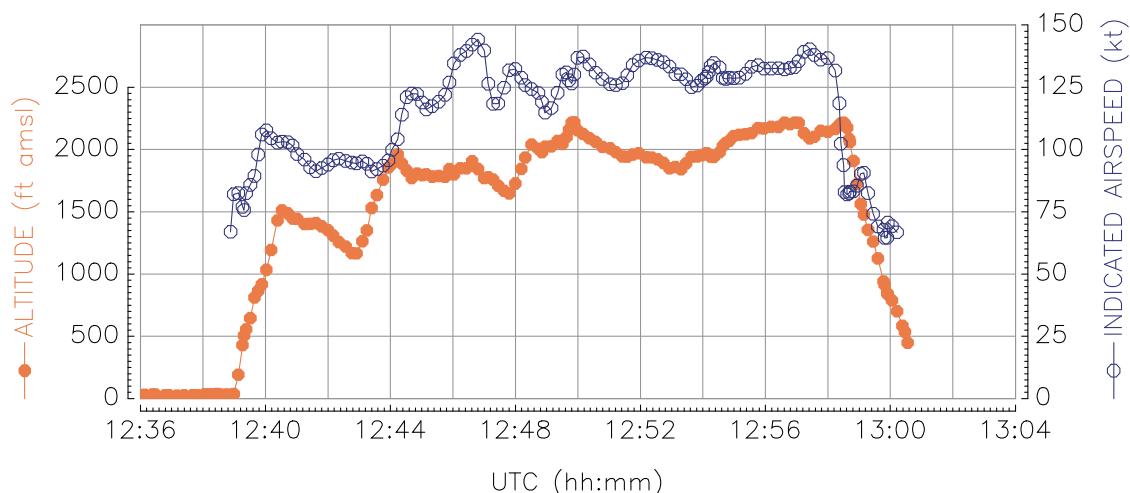
For the accident flight, the aircraft was airborne for 21 minutes, and the GPS was powered up 13 minutes before takeoff. Figure 2 shows that the aircraft’s cruise height varied around 2,000 ft amsl and an average calculated airspeed of 130 KIAS.

Accident flight GPS altitude and calculated IAS

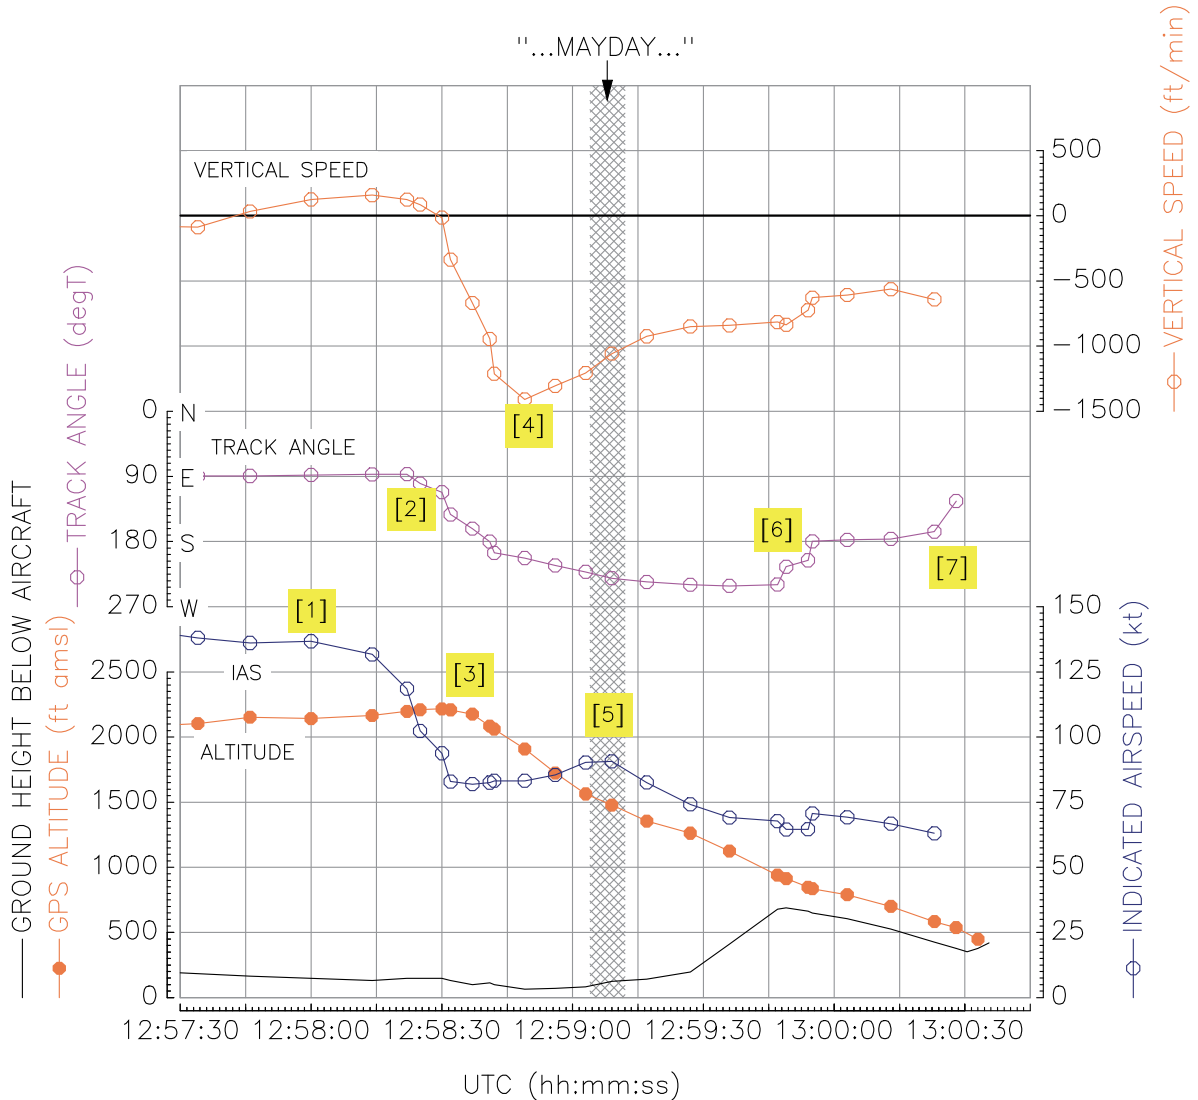
Figure 3 details the GPS altitude and GPS derived data, and Figure 4 the ground track, for the last three minutes of the flight. The figures start at 1257:30 hrs just before the Mode A squawk⁴ changed from 7011 (Southampton listening squawk) to 7000, with the aircraft tracking parallel to the northern border of the South Downs National Park, at approximately 2,100 ft amsl and about 136 KIAS. Points highlighted in the figures are:

UTC (hh:mm:ss)	Description
12:58:00	Altitude remained between 2,100 and 2,200 ft amsl while IAS started to decrease from 137 kt [1].
12:58:22	Start of turn towards southwest [2].
12:58:32	IAS reached about 83 kt and aircraft started to descend [3]. The descent rate peaked at 1,400 ft/min 17 seconds later [4] before reducing to about 850 ft/min.
12:59:04	Aircraft descended through 1,500 ft amsl and IAS increased to 91 kt as the pilot transmitted a MAYDAY call [5].
12:59:47	At about 950 ft amsl the aircraft turned left turn over high ground (240 ft below the aircraft) towards Steyning Valley, and then descended along its western ridgeline at rate of around 600 ft/min and airspeed of about 70 KIAS and slowing [6].
13:00:23	At about 160 ft agl, and near the end of the valley, the aircraft turned left towards the rising ground on the opposite side of the valley [7].

The ground-track distance from point [1] to the accident site was about 3.65 nm. From point [3], when the aircraft's speed reduced to 83 KIAS, the distance was 2.54 nm, with a corresponding height loss of about 1,760 ft.

Figure 3
GPS altitude and derived data for last 3 minutes of the accident flight

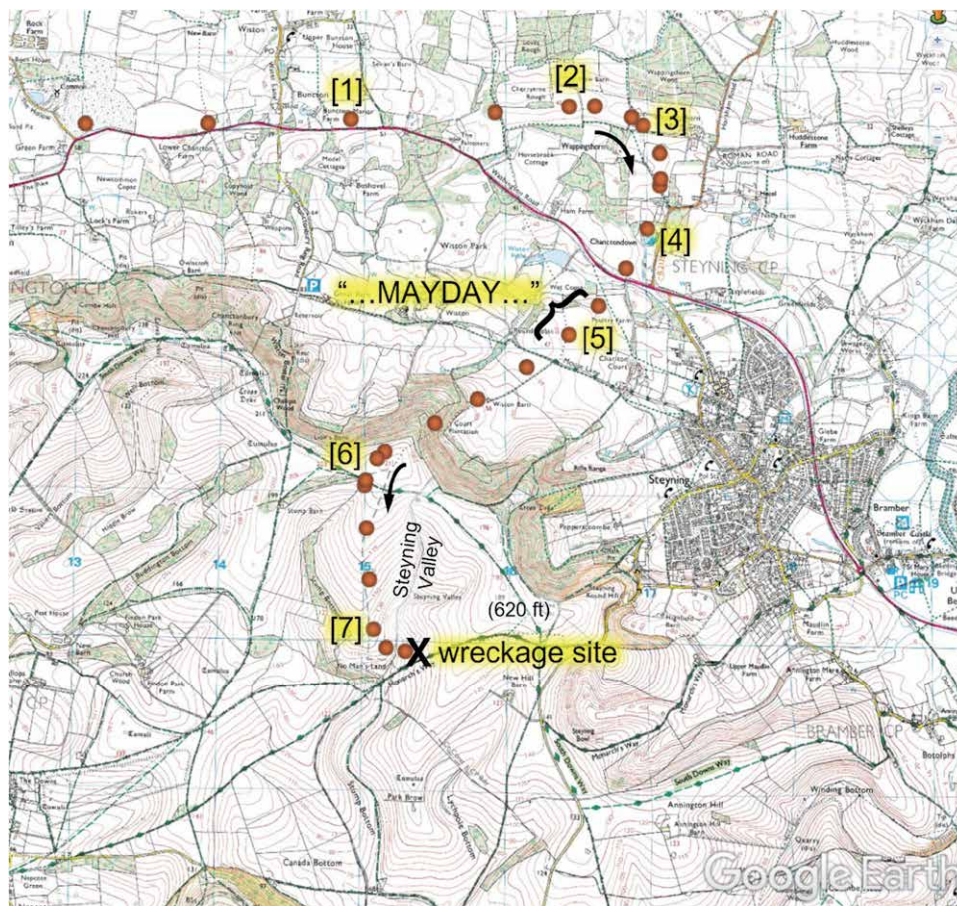
Figure 4

Ground track for last 3 minutes of the accident flight

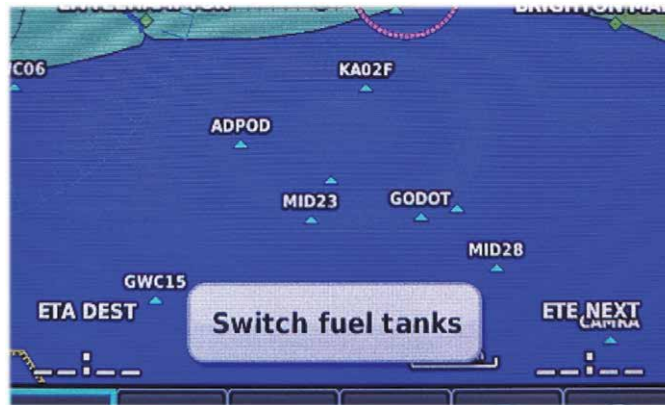
Figure 5

A switch fuel tanks alarm (fuel alarm) feature of the GPS unit was active and setup to display a 'Switch fuel tanks' message on the unit's screen every 15 minutes (Figure 5). The message could be cancelled by touching it and would be displayed again 15 minutes after it was last displayed (ie if a message was left on for 10 minutes before being cancelled it would display again after another 5 minutes). The GPS unit also allowed an audio alert – a single beep – which would sound at the same time the message was displayed; however, this option had been selected off.

GPS unit's 'Switch fuel tanks' alarm message

The pilot said he normally switched fuel tanks in response to the fuel alarm, the audio for which was found after the accident to be OFF. While the screen message would still have presented, the absence of that “intrusive” sound indicates why the otherwise observant passenger did not notice any alarms, and probably reduced the pilot’s fuel awareness. The engine stopped around 19 minutes into the return flight. Given the pilot normally took off using the fuller fuel tank, he possibly switched to the emptier one shortly before the engine stopped, in response to the first fuel screen message.

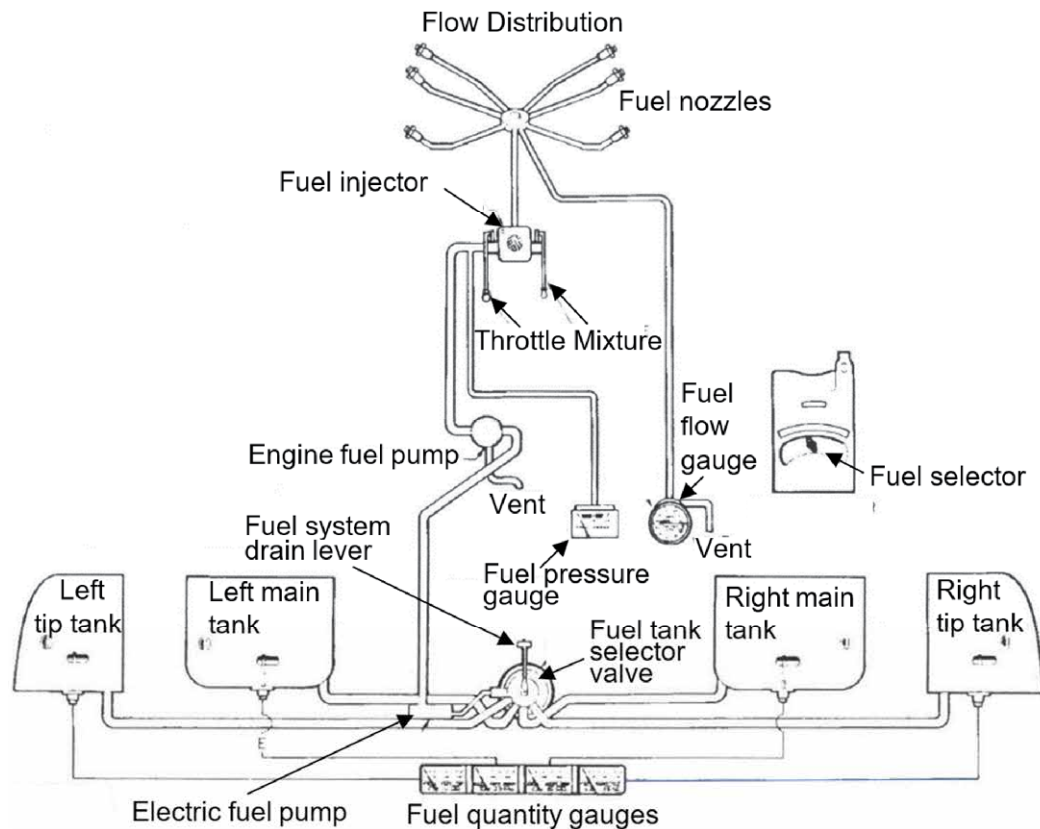
Figure 7

G-KNOW's fuel system layout comprised of two metal main fuel tanks (main tanks), one in each wing, and two resin-impregnated fibreglass wing tip tanks (tip tanks). The fuel tanks were manually selected by moving a fuel selector lever located below the centre console to one of five positions. The lever could be positioned to OFF, left tip tank (LEFT TIP), left main tank (LEFT MAIN), right main tank (RIGHT MAIN) and right tip tank (RIGHT TIP). The lever was connected via a rod to a fuel selector valve located below the floor underneath the two forward passenger seats in the rear cockpit. The valve had five detents, each one corresponding to one of the fuel tank selections. The valve also had a fuel strainer and drain lever to allow fuel to be drained from each of the tanks and connecting pipes depending on tank selection.

Fuel system diagram for G-KNOW

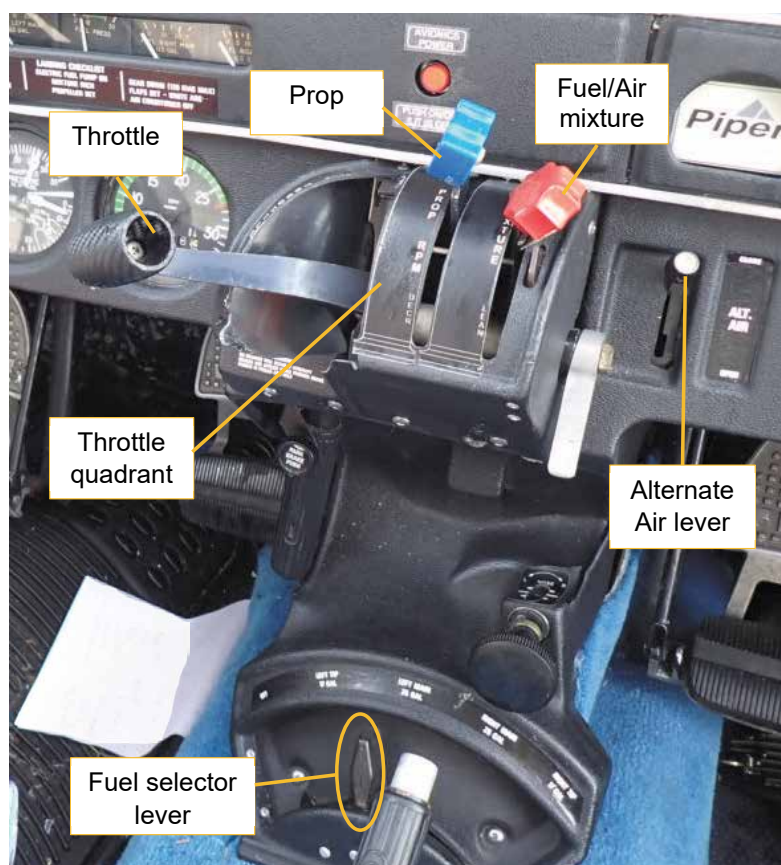
Figure 8

Examination of the cockpit at the accident site revealed the fuel selector lever was positioned between LEFT TIP (left-wing tip fuel tank), and LEFT MAIN (left main fuel tank), (Figure 8). Force was needed to move the lever to OFF, but it would not stay in position and sprang back between LEFT TIP and LEFT MAIN. From this position, moving the lever two 'clicks' to the right selected the RIGHT MAIN fuel tank and the lever remained in position. The switches on the main switch panel to the left of the cockpit and the ignition switches were set to OFF. The flap lever between the front seats was positioned in the first notch of the selection mechanism, indicating 10° flap was selected¹⁷. Although the flaps were selected to 10°, the flap control surfaces were in the up position (0° flap). On the engine control quadrant, the throttle lever was set just above IDLE and was bent and jammed in this position. The throttle housing was also deformed and torn. The fuel mixture lever was positioned just below RICH and the propeller lever was pushed fully forward to INCR (increase). To the right of the quadrant, the Alternate Air (Alt. Air) lever was in the CLOSED position.

Fuel selector lever position, throttle quadrant and Alt. Air lever

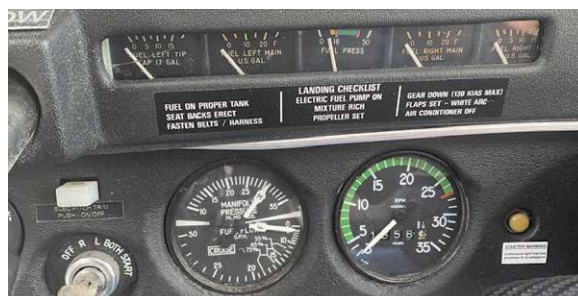
Figure 11

G-KNOW analogue fuel information²⁴

The investigation did not establish whether the pilot updated the EMU fuel quantity, and consequently how accurate it was. That total quantity does not account for separate tanks. Therefore, while cockpit gauges can be imprecise, they pictorially represent individual tank quantities and should be continuously observed, particularly when switching tanks and when fuel becomes low in a tank.

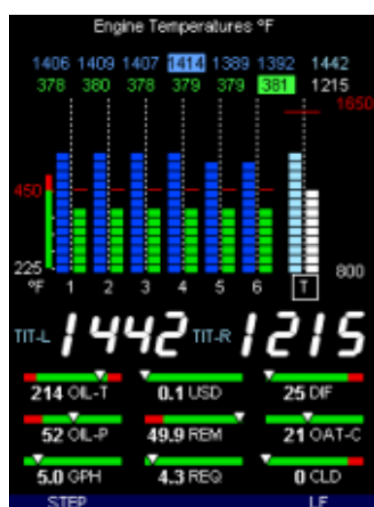
Figure 12

Typical display configuration of the EMU²⁵
