ACCIDENT

Aircraft Type and Registration:	1) Boeing 777-300(ER), HL-7782 2) Boeing 757-256, TF-FIK
No & Type of Engines:	1) 2 GE Aviation GE90 turbofan engines 2) 2 Rolls Royce RB211 turbofan engines
Year of Manufacture:	1) 2009 (Serial no: 37643) 2) 1999 (Serial no: 26254)
Date & Time (UTC):	28 September 2022 at 1850 hrs
Location:	London Heathrow Airport
Type of Flight:	1) Commercial Air Transport (Passenger) 2) Commercial Air Transport (Passenger)
Persons on Board:	1) Crew - 18 Passengers - 199 2) Crew - 6 Passengers - Unknown
Injuries:	1) Crew - None Passengers - None 2) Crew - None Passengers - None
Nature of Damage:	1) Left wingtip damage 2) Damage to the rudder
Commander's Licence:	1) Airline Transport Pilot's Licence 2) Airline Transport Pilot's Licence
Commander's Age:	1) 52 years 2) 55 years
Commander's Flying Experience:	1) 10,561 hours (of which 3,384 were on type) Last 90 days – 249 hours Last 28 days – 73 hours 2) 15,500 hours (of which 12,500 were on type) Last 90 days – 160 hours Last 28 days – 50 hours

Synopsis

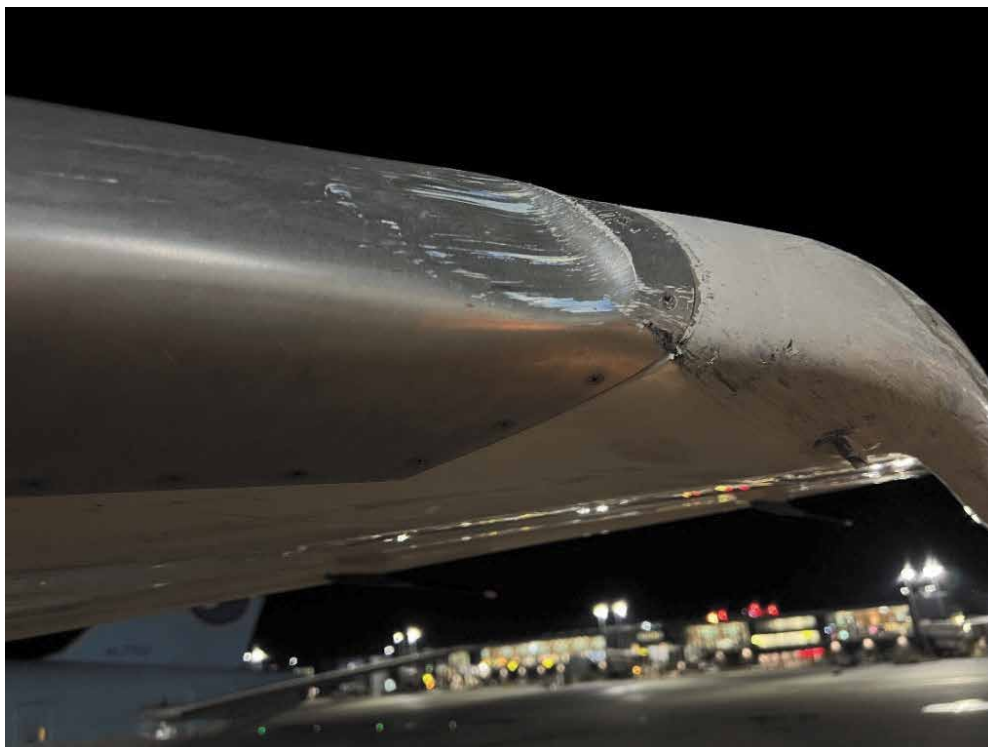
ATC initiated the ground incident procedure and both aircraft were inspected. The inspection confirmed there was damage to the left wingtip of the B777 and to the rudder of the B757. The B777 was shut down on the taxiway and passengers were disembarked to busses and into the terminal. The B757 passengers disembarked normally.

Figures 2 and 3 show the damage to the B777 left wingtip. Figure 4 shows the damage to the B757 rudder.

Figure 2
Boeing 777 left wing tip

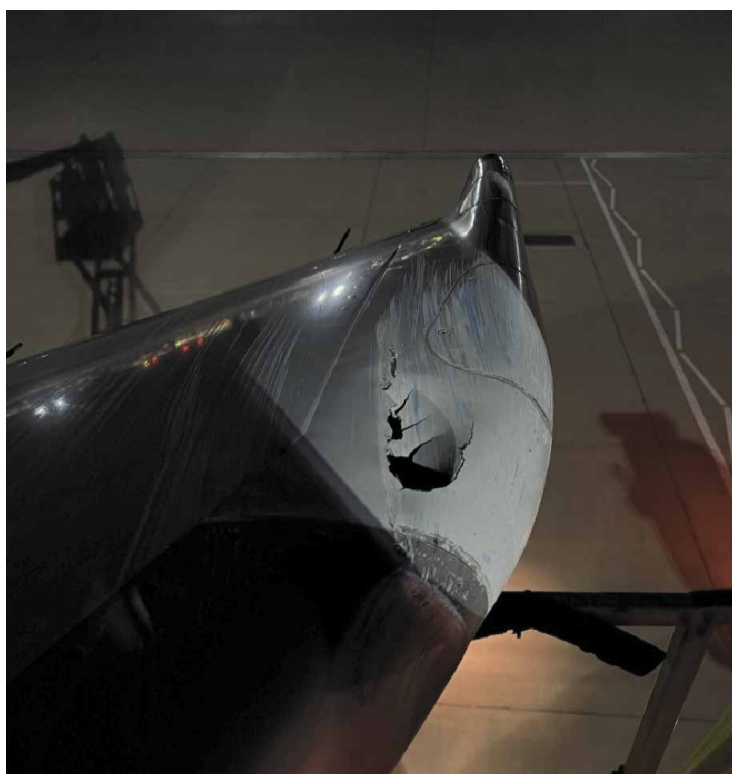
Figure 3
Boeing 777 left wing tip from above

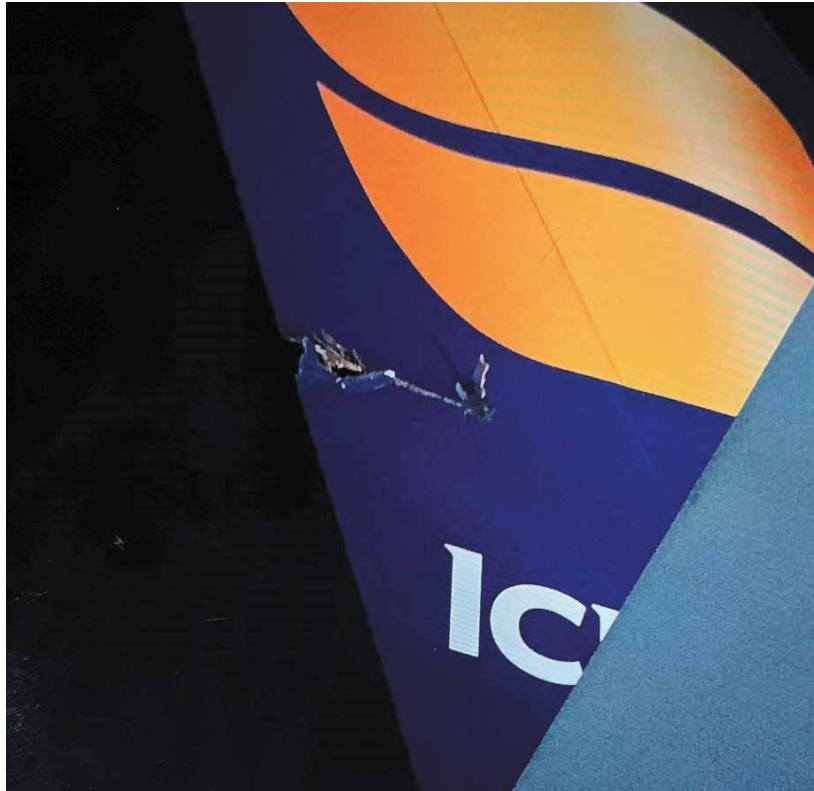
Figure 4
Boeing 757 rudder

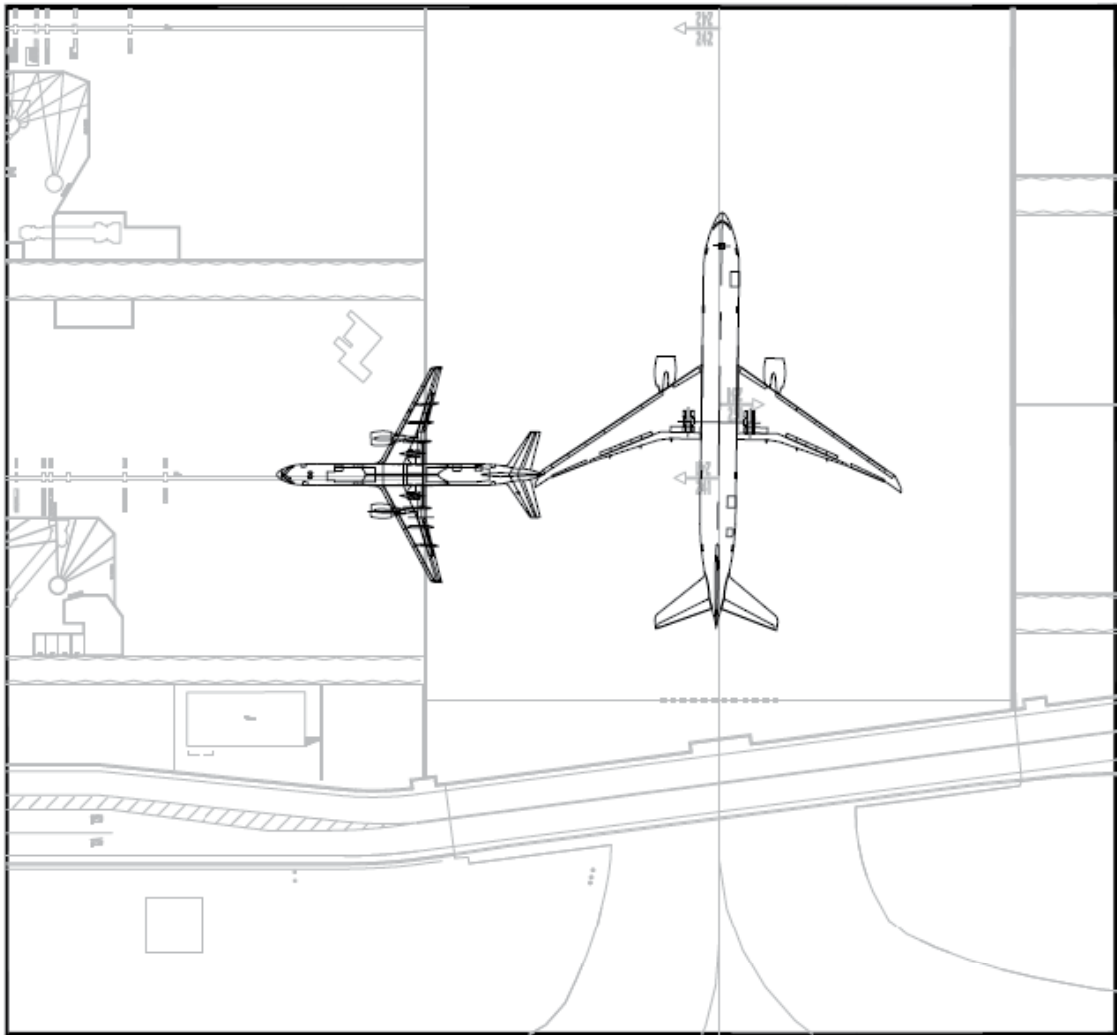
Aerodrome CCTV and footage was obtained from the leader vehicle dashcams. This confirmed the B757 anti-collision light was on and working normally when the accident occurred. Figure 5 was created by the airport operator and shows the approximate position of each aircraft when the collision occurred.

Approximate positions of the B777 and B757 when the collision occurred
(image used with permission)

Heathrow ATC cannot see this parking stand from the visual control tower, and ground radar did not show the B757 once it had turned onto stand, so ATC had no way to know the aircraft was not fully parked. The AAIB has previously reported on ground collisions where pilots thought they had safe separation because they had an ATC clearance. ATC try to inform pilots if they become aware of a hazard, but they can only do this if they know about the hazard. Whilst it remains the pilot's responsibility to ensure sufficient wing tip clearance exists, it is not possible to see the wingtips of a B777-300 from the flight deck, as they are 32.4 m outbound and approximately 47 m behind the flight deck. Parking stands are delineated with a double white line, and if anything is protruding beyond these lines wing tip clearance cannot be assured. A significant proportion of the B757 was over the lines and protruding into the taxiway as illustrated in Figure 5.

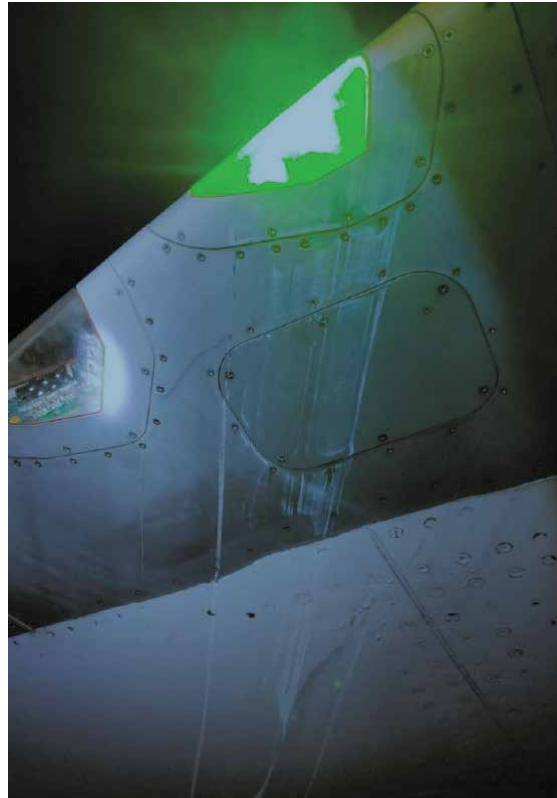
A similar event occurred six weeks before this event, on 16 August 2022. A Boeing 787-900 was parking on Stand 244 when the stand guidance system failed. The aircraft stopped short of the final position to await a marshaller. As the marshaller arrived and starting to marshal the aircraft, a Boeing 787-800 was taxiing south along Taxiway Lima. The right wingtip of the Boeing 787-800 collided with the tail of the Boeing 787-900. Initially no one realised a collision had occurred and the Boeing 787-800 took off without the flight crew knowing the aircraft was damaged. Figure 10 shows the damage to the Boeing 787-800, discovered after landing.

Damage to a Boeing 787-800 after a similar collision

Following this event, the Heathrow Air Navigation Service Provider (ANSP) issued a Safety Alert to remind operators about the AIP entry regarding VDGS. The Safety Alert was highlighted at the Heathrow Flight Operations Safety Committee and in several other forums.
