## ACCIDENT

<b>Aircraft Type and Registration:</b>	Cessna Citation 560XL, EC-KPB
<b>No &amp; Type of Engines:</b>	2 Pratt and Whitney PW545C turbofan engines
<b>Year of Manufacture:</b>	2008
<b>Date &amp; Time (UTC):</b>	1 June 2022 at 1420 hrs
<b>Location:</b>	RAF Northolt, South Ruislip, Middlesex
<b>Type of Flight:</b>	Commercial Air Transport
<b>Persons on Board:</b>	Crew - 2                      Passengers - 3
<b>Injuries:</b>	Crew - None                      Passengers - None
<b>Nature of Damage:</b>	Detached nosewheel and fractured nose gear forks
<b>Commander's Licence:</b>	Airline Transport Pilot's Licence
<b>Commander's Age:</b>	48 years
<b>Commander's Flying Experience:</b>	3,800 hours (of which 850 were on type) Last 90 days - 243 hours Last 28 days - 78 hours
<b>Information Source:</b>	Aircraft Accident Report Form submitted by the pilot and additional enquiries with the operator

## Synopsis

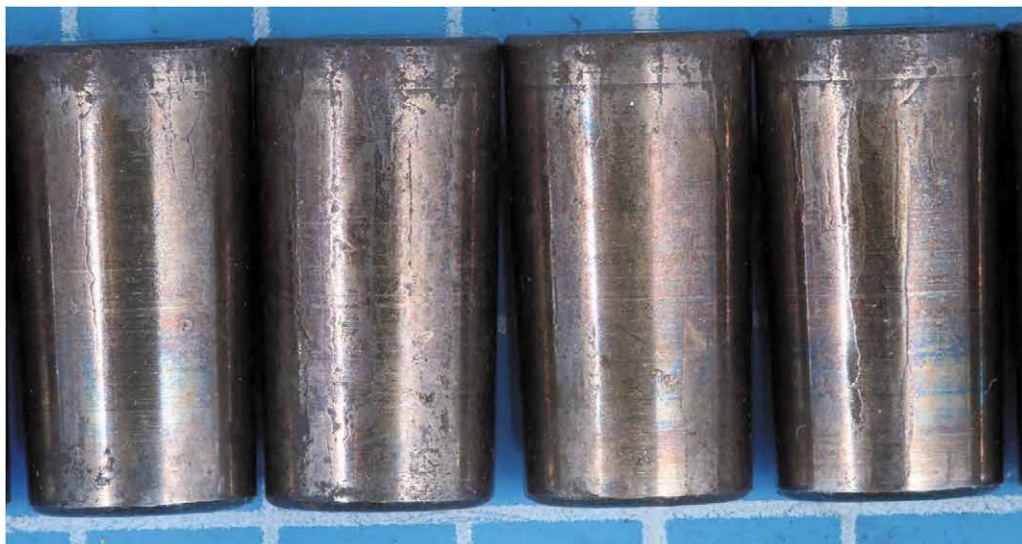
**Figure 3**

One of the conical bearings in the wheel assembly had failed. Due to the extensive damage to the bearing, laboratory examination could not determine the cause of the failure; however, examination of the non-failed bearing identified evidence of multiple lines of material pitting along the length of the rollers and a band of corrosion pitting around the shoulder (Figure 3). Similar indications on the cone (Figure 4) and cup were noted. This was indicative of corrosion pickup between the rollers and races, the linear pitting was particularly indicative of corrosion whilst the bearing was stationary. As both bearings operated in the same environment, it is likely the failed bearing would also have been corroded.

Roller bearings from the non-failed bearing, exhibiting linear and circumferential pitting

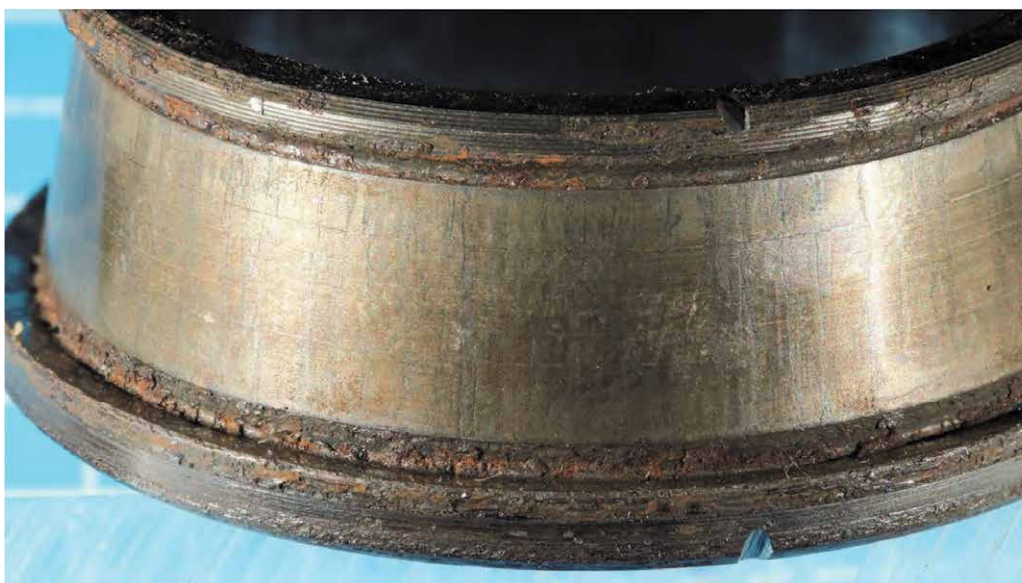
**Figure 4**

Roller bearing cone from the non-failed bearing, exhibiting linear pitting and corrosion around the track shoulder indicating the onset of corrosion
