ACCIDENT

Aircraft Type and Registration:	DJI Mavic 2 Enterprise	
No & Type of Engines:	Four electric motors	
Year of Manufacture:	Unknown	
Date & Time (UTC):	7 August 2022 at 1648 hrs	
Location:	Bangor Train Station Car Park, Gwynedd	
Type of Flight:	Emergency Services Operations	
Persons on Board:	Crew - None	Passengers - None
Injuries:	Crew - N/A	Passengers - N/A
Nature of Damage:	Damaged beyond economic repair	
Commander's Licence:	Other	
Commander's Age:	37 years	
Commander's Flying Experience:	7 hours (of which 4 were on type) Last 90 days - 1 hour Last 28 days - 1 hour	
Information Source:	Aircraft Accident Report Form submitted by the pilot and further enquiries by the AAIB

Synopsis

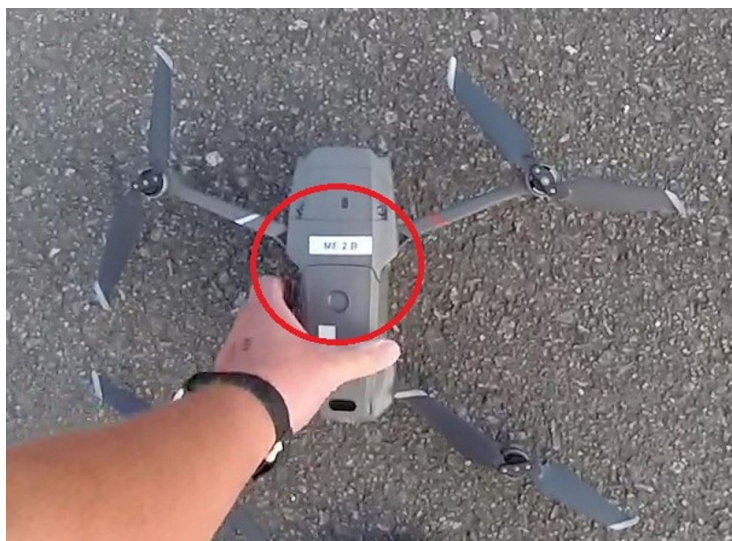
Figure 2

The remote pilot was wearing a video camera (bodycam) which showed him setting the aircraft on the ground prior to takeoff (Figure 2). The operator and remote pilot reported that this image shows that the gap between the battery and airframe is larger than it should be when the battery is correctly installed. This picture was sent to the aircraft manufacturer and they stated that it was not possible to judge from this image if the battery was partially attached or not, or whether it was swollen or not.

Image from the pilot's bodycam prior to takeoff

The operator believed that the pre-flight checks were probably rushed and that the body worn camera image showed the battery not fully engaged. The aircraft manufacturer could not confirm whether it was fully engaged, but it is possible that it was not. It is also possible that the battery was engaged at that time, but that the latching mechanism or battery were slightly worn from use which led to an in-flight disconnection. There was no indication that the battery was swollen or had exceeded the temperature limit.

The operator has shared the learning from this accident with all its UAS pilots and reminded them of their responsibility to turn on their body worn camera before they carry out the UAS pre-flight checks so that the checks are captured, and of their responsibility to take time on the UAS checks that are completed at a local air base to ensure the aircraft is fit for use.

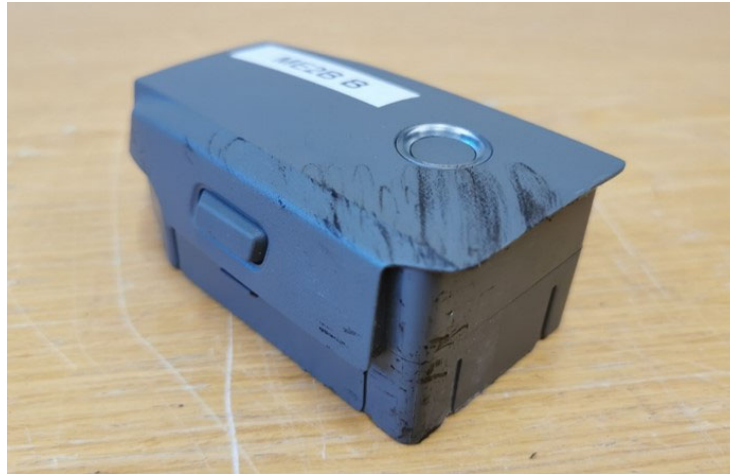
The aircraft had suffered damage to its underside, with damage to the motor arms and the camera/gimbal assembly. The battery had black scuff marks (Figure 3). The operator re-installed the battery into the aircraft which showed that the scuff marks did not form a line with any marks on the aircraft's upper surface (Figure 4). This showed that the marks were made on the battery after it had separated from the airframe. However, the damage to the battery was not consistent with it falling from a height of more than 20 m on to a solid roof; there were no dents. It was also only about 1.3 m away from the airframe, so it is probable that the battery separated when the airframe struck the roof.

Figure 3
Battery from the accident Mavic

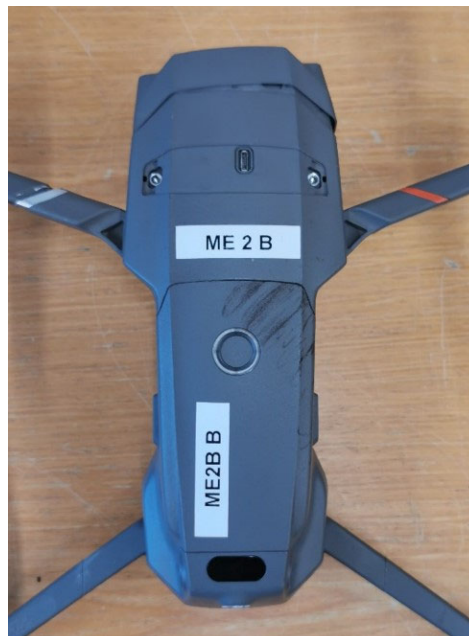
Figure 4
Accident battery re-installed in accident Mavic
