ACCIDENT

Aircraft Type and Registration:	DJI Mavic 2 Enterprise Zoom	
No & Type of Engines:	4 DJI electric engines	
Year of Manufacture:	Unknown (Serial no: 276DFB5001QU7B)	
Date & Time (UTC):	5 December 2022 at 1430 hrs	
Location:	Garstang, Lancashire	
Type of Flight:	Commercial Operations (UAS)	
Persons on Board:	Crew - N/A	Passengers - N/A
Injuries:	Crew - N/A	Passengers - N/A
Nature of Damage:	Damage to propellers and body	
Commander's Licence:	Other	
Commander's Age:	50 years	
Commander's Flying Experience:	257 hours (of which 35 were on type) Last 90 days - 26 hours Last 28 days - 9 hours	
Information Source:	Aircraft Accident Report Form submitted by the pilot

During an aerial survey flight, the UAS detected a rapid loss of battery power and initiated an immediate automatic landing. Whilst descending, its flight behaviour became erratic, control was lost to the remote pilot, and the UA struck an uninvolved person before hitting the ground. It was not possible to determine a cause for the loss of battery power or the flight behaviour. There may have been an opportunity during flight control checks to consider unexpected battery discharge rate as a reason to abort the flight

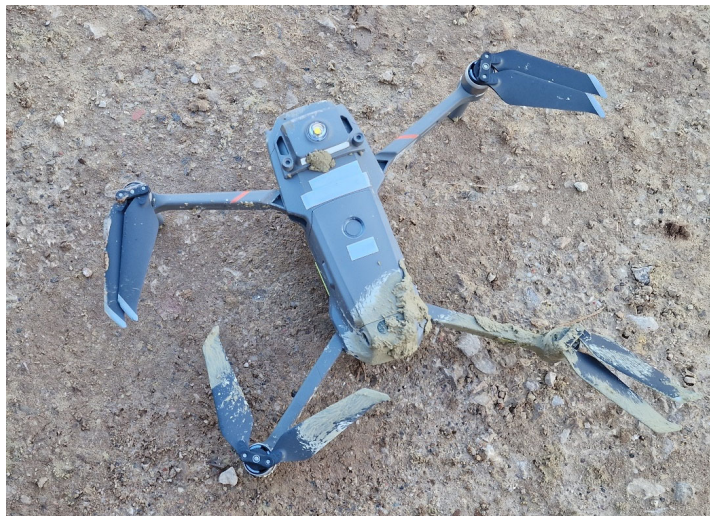
Figure 1

The UA was observed to fly in an erratic manner, and the pilot stated he had limited lateral control available to enable him to fly it into a clear area. It came close to houses under construction and stopped responding to control inputs. The pilot described it as then “appearing to descend too fast, despite the propellers spinning”, before going out of sight behind some construction materials. The UA struck a site worker on their arm, dropped into some cement, and fell to the ground. The site worker was not injured.

UA after falling to the ground

The UA was sent to an authorised repair facility for assessment. No discrepancies could be found with the battery condition, and the battery's integral charge level indicator showed 50-75% charge. The battery appeared to have been seated correctly and no physical defects were found with the UA that could have caused the loss of control.

The UAS measured a high loss of battery power in a short space of time, leading to an uncontrolled landing where the distance between the UA and uninvolved people and structures was compromised. This sequence of events resulted in the UA striking an uninvolved person. It was not possible to determine a cause of the UA's detecting a loss of battery power or its flight behaviour.

Whilst the displayed level of power remaining was sufficient for the planned flight, there may have been an opportunity during flight control checks for the pilot to consider the abnormal battery discharge rate was likely to continue, and to abort the flight.
