9. Wrong side failures of signalling

Purpose of this summary

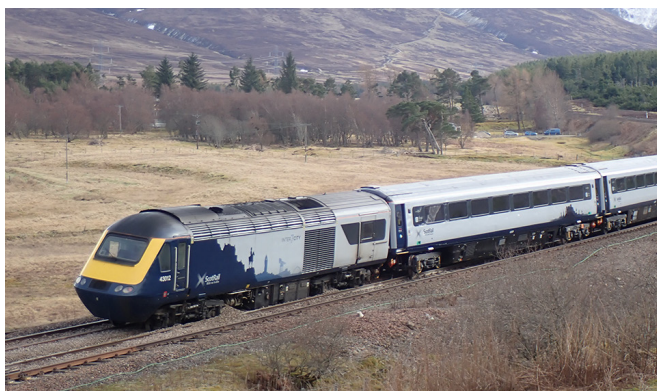
Derailment of a train at Dalwhinnie in 2021.

At Dalwhinnie ([RAIB report 10/2022](#)) in 2021, unwanted electrical connections were retained inside a point machine following its replacement nine months earlier. These connections were intended to allow the machine to be adapted for different operational environments.

The need to alter the internal wiring of the machine for its intended usage was not identified when the renewal work was planned, nor did the prescribed checks required as part of a like-for-like replacement process identify the wiring discrepancy. The last opportunity to identify the wiring error during testing before the points were handed back was not effective because it was interrupted and testing work was overlooked.
