Near miss at Teignmouth Boat Yard, Devon, 14 February 2023

Summary of the incident

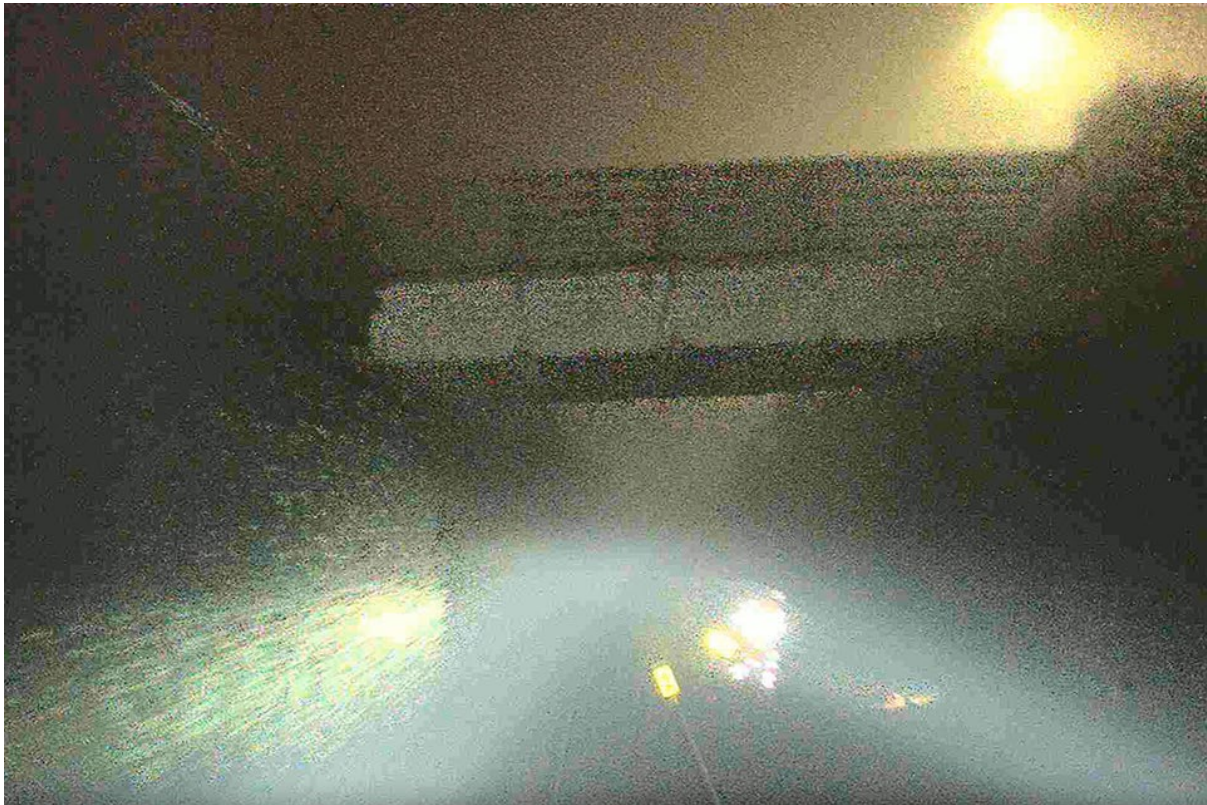
The track worker involved was placing a work site marker board on the six-foot rail of the down main when the near miss occurred. Although uninjured, the track worker was forced to jump into an adjacent line to avoid being struck. The train involved collided with the work site marker board less than two seconds after the track worker jumped clear.

A forward-facing CCTV image of the incident taken from train 1C34 (image courtesy of GWR).

The incident occurred because the track worker had incorrectly assumed that the down main line they were placing the marker board on had been blocked to rail traffic. Although the marker board was placed following several conversations between the track worker and the responsible Engineering Supervisor (ES), none of these conversations prevented the incident from occurring.

After walking a short distance along the track, the track worker began to fix the first marker board to the six-foot rail of the down main line on which, unknown to them, 1C36 was now approaching. As the train got nearer, it rounded a curve at around 55 mph (88 km/h) and the track worker then came into the driver's view. The driver immediately sounded the train's warning horn. On hearing the train, the track worker jumped into the adjacent line which was also still open to traffic. Less than two seconds later, the marker board was struck by the passing train.
