ACCIDENT

Aircraft Type and Registration:	Guimbal Cabri G2, G-CJEK
No & Type of Engines:	1 Lycoming O-360-J2A piston engine
Year of Manufacture:	2016 (Serial no: 1151)
Date & Time (UTC):	20 June 2022 at 1059 hrs
Location:	Near Burton in Lonsdale, North Yorkshire
Type of Flight:	Private
Persons on Board:	Crew - 1 Passengers - 1
Injuries:	Crew - 1 (Fatal) Passengers - 1 (Fatal)
Nature of Damage:	Helicopter destroyed
Commander's Licence:	Private Pilot's Licence (Helicopter)
Commander's Age:	66 years
Commander's Flying Experience:	Approximately 538 hours (of which approximately 258 were on type) Last 90 days – Not available Last 28 days – Not available
Information Source:	AAIB Field Investigation

Synopsis

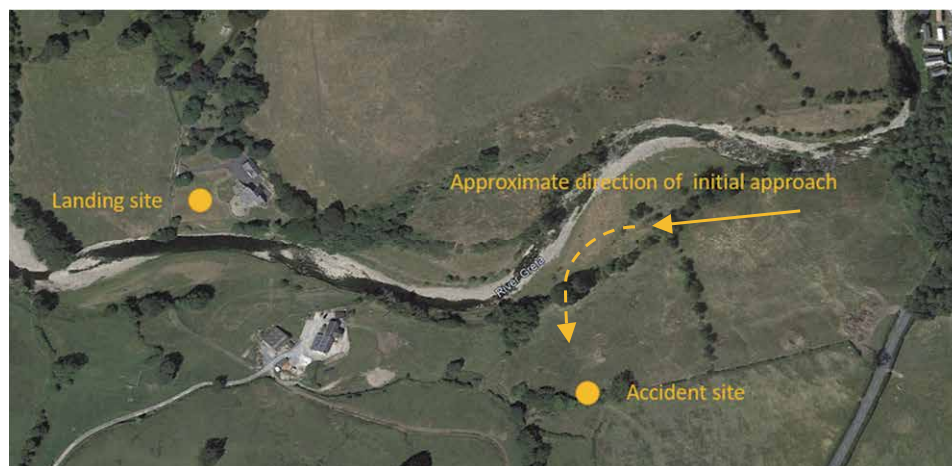
Figure 2

There was limited closed-circuit television (CCTV) recorded from a nearby farmhouse which captured short periods of the helicopter’s flight path prior to the accident. It showed the helicopter initially flying in a westerly direction (Figure 2) before it began what appeared to be a controlled left turn. The helicopter then continued heading approximately south, with decreasing groundspeed and climbed from an approximate height of 70 ft before the turn to about 130 ft when it went out of view of the CCTV.

Approximate direction of initial approach

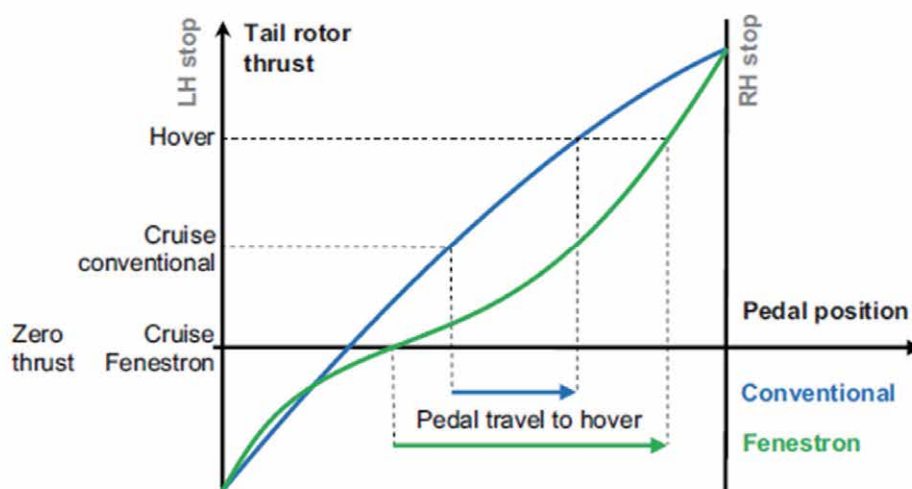
Figure 3

SL 12-001 states the Cabri G2 is immune to stall and to what is commonly referred to as 'loss of tail rotor effectiveness' (LTE). It highlights the need for pilots to use a much greater pedal input for a given tail rotor thrust than that which would be required in helicopters with a conventional tail rotor (Figure 3) and the need for pilots to react to uncommanded yaw without delay.

Comparison of thrust curves for identical performance tail rotors Conventional/Fenestron
