ACCIDENT

Aircraft Type and Registration:	Pitts S-1C (Modified), G-BTOO	
No & Type of Engines:	1 Superior XP-IO-320-A3AD3 piston engine	
Year of Manufacture:	1966	
Date & Time (UTC):	27 March 2022 at 1600 hrs	
Location:	Popham Airfield, Hampshire	
Type of Flight:	Test Flight	
Persons on Board:	Crew - 1	Passengers - None
Injuries:	Crew - 1 (Serious)	Passengers - N/A
Nature of Damage:	Substantial	
Commander's Licence:	FAA Private Pilot's Licence	
Commander's Age:	59 years	
Commander's Flying Experience:	339 hours (of which 188 were on type) Last 90 days - 1 hour 20 minutes Last 28 days - 1 hour 20 minutes	
Information Source:	AAIB Field Investigation

Synopsis

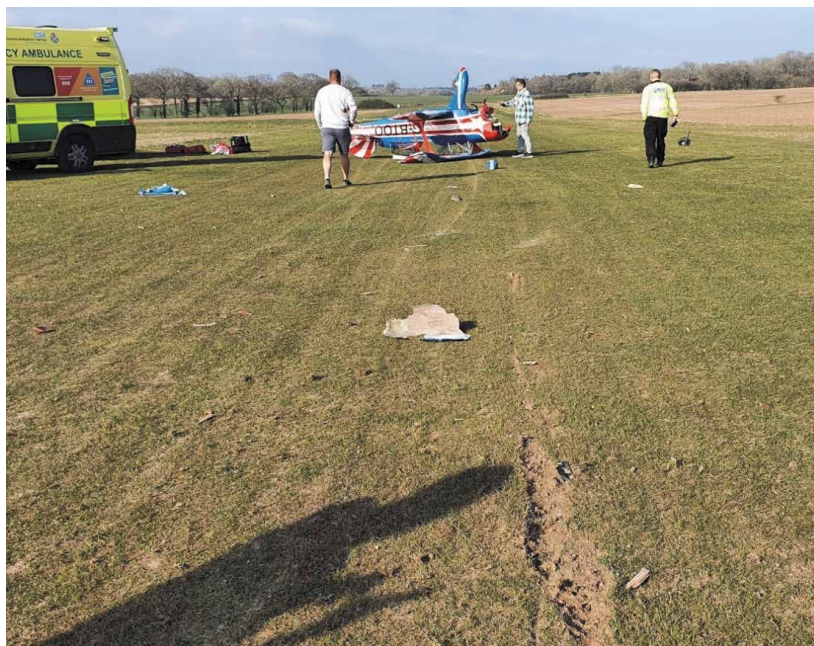
The aircraft came to rest on Runway 03 at Popham. Figure 1 shows some of the ground markings and the aircraft's final resting position. The AAIB did not attend the site initially and airfield staff recovered the aircraft to its hangar, using a trailer.

View along Runway 03 at Popham
Image used with permission

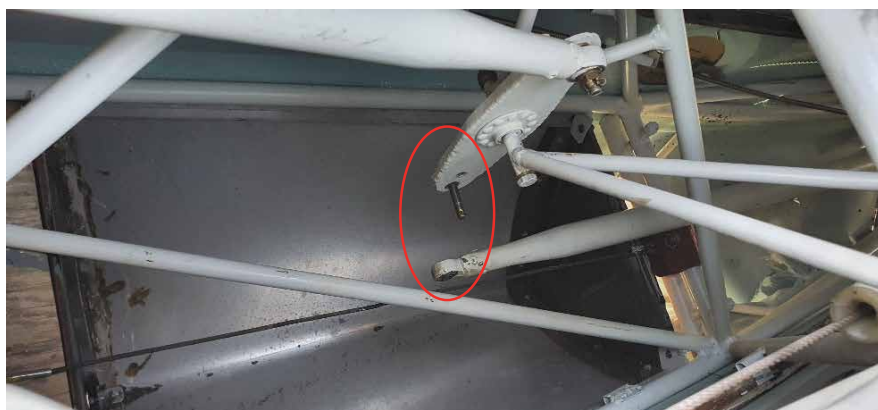
Figure 2

There were no access panels close to a bellcrank in the elevator control linkage, but it could be seen through a hole in the lower fuselage fabric, created during the accident (Figure 2). One of the push rods was no longer connected to the bellcrank which resulted in the loss of elevator control.

Showing bellcrank and disconnected pivot joint after recovery to the hangar, view looking towards top of fuselage, cockpit is to the left
Image used with permission

The disconnected bolt for the pushrod to the elevator was found in the bellcrank hole furthest from the pivot point. It could not be confirmed whether this was the hole it was in at the time of the accident, as damage to the paint around both bolt holes indicated a bolt had been fitted in both positions. The bolt showed signs of a nut having been fitted. Neither the nut nor a split pin was found, but the fuselage is open at the rear. The other push rod connected to the bellcrank was connected to the control column. Its bolt and the bell crank mounting bolt were secured with a nut and split pin as was the central pivot bolt.

One of the pushrods in the elevator control system was found disconnected, its attaching bolt was present, but its securing castellated nut and split pin were not found. The bolt showed signs of having had a nut fitted but it seems most likely that the nut had come undone due to no split pin being fitted to prevent the nut from undoing. Once the nut had loosened and detached, there was nothing to prevent the pushrod end fitting falling off the bolt and detaching from the bellcrank.

Both holes on the side of the bellcrank with the disconnected joint showed signs of having had a bolt fitted, as the paint was damaged around both holes. It seems that at some time both the holes had been used for the push rod.

The loss of elevator control was caused by a bolted pivot joint in the elevator control system coming undone. This was most likely due to the lack of a split pin to secure the bolt's castellated nut.
