ACCIDENT

Aircraft Type and Registration:	Vans RV-9A, G-CCGU	
No & Type of Engines:	1 Lycoming O-320-D1A piston engine	
Year of Manufacture:	2003 (Serial no: PFA 320-13798)	
Date & Time (UTC):	2 March 2023 at 1212 hrs	
Location:	Henstridge Airfield, Somerset	
Type of Flight:	Private	
Persons on Board:	Crew - 1	Passengers - 1
Injuries:	Crew - 1 (Minor)	Passengers - 1 (Serious)
Nature of Damage:	Damage to both wings, rudder, engine propeller, engine cowling, engine mounting, and firewall. Canopy destroyed	
Commander's Licence:	Light Aircraft Pilot's Licence	
Commander's Age:	81 years	
Commander's Flying Experience:	1,106 hours (of which 791 were on type) Last 90 days - 8 hours Last 28 days - 2 hours	
Information Source:	Aircraft Accident Report Form submitted by the pilot

Synopsis

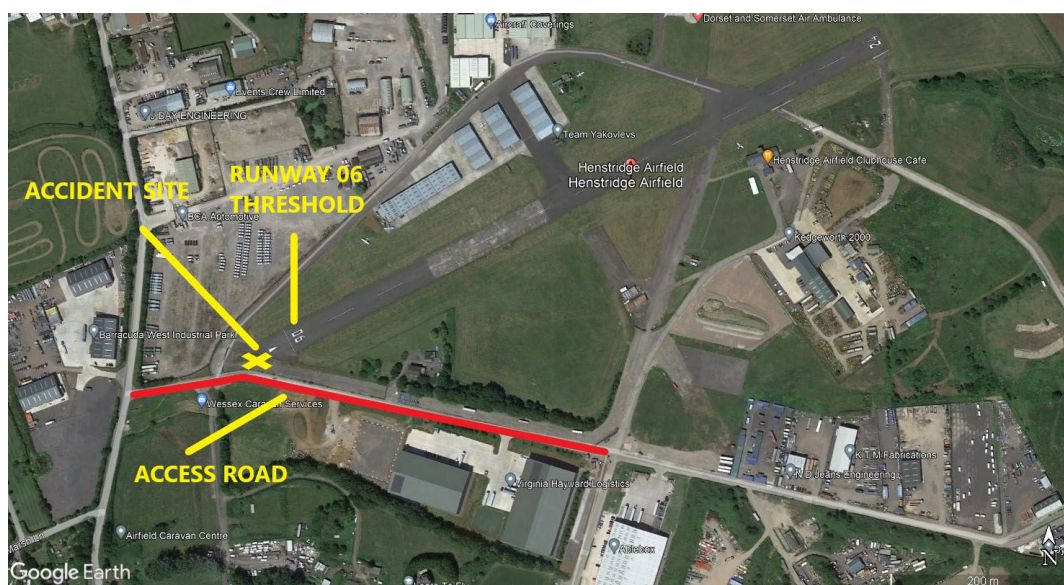
The accident happened at the unlicensed Henstridge Airfield in Somerset. The aircraft was approaching Runway 06 which is 728 m long and has a threshold displaced by 22 m. The access road leads to an industrial site on the south side of the airfield and sees a significant amount of traffic, including approximately 300 HGV movements per day. The road converges with the runway centreline from the left at an angle of approximately 20°. With the HGV converging from the left at a shallow angle and the low wing configuration of the aircraft the pilot's view of the road was significantly impeded. The accident site was approximately 70 m from the runway threshold. The access road and accident site are shown on the overhead view of the airfield at Figure 3.

Figure 3
Henstridge Airfield and accident site

The airfield operator decided to displace the threshold of Runway 06 by a further 100 m. The point at which the incident occurred would now be approximately 170 m from the threshold, the obstacle clearance surface would be 7 m above the road, and Runway 06 at Henstridge would fulfil the obstacle clearance requirements of CAP 168. A 3° path drawn from the new threshold would cross the road approximately 9 m agl.

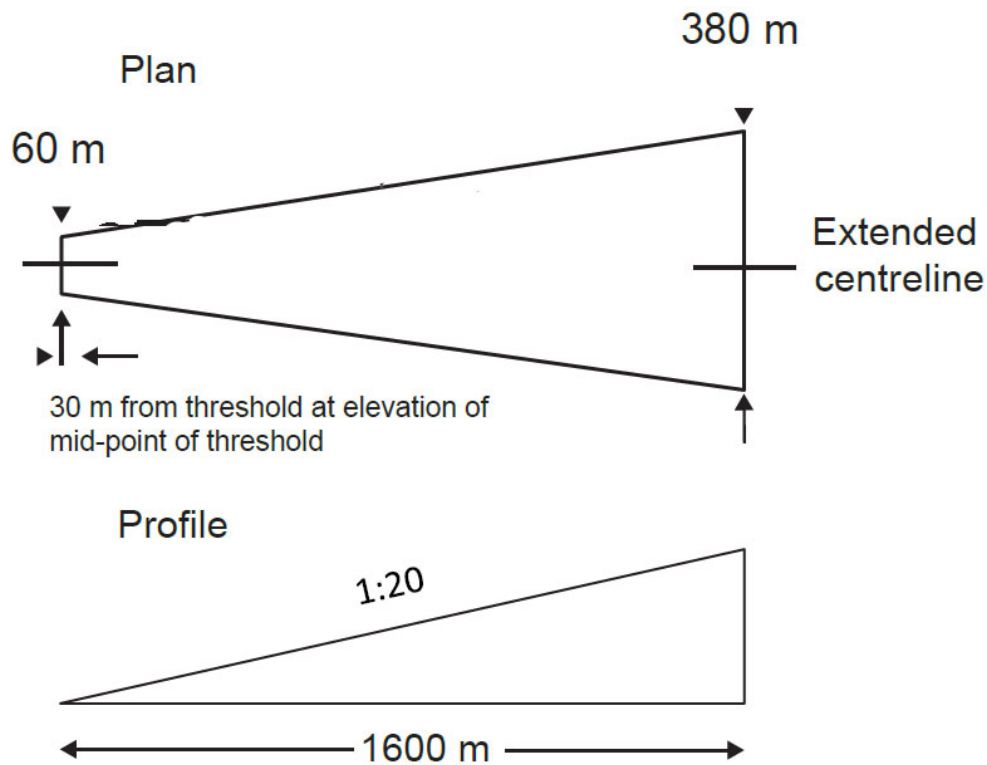
Obstacles are not permitted to penetrate a surface defined as shown in Figure 4. The surface begins 30 m from the threshold and then has a 1 in 20 slope. The collision at Henstridge occurred approximately 70 m from the threshold therefore anything more than 2 m tall would penetrate the obstacle clearance surface. A 3° representative approach path drawn from the threshold would cross the road 3.7 m above ground.

Figure 4
Approach Surface Diagram
