Fatal man overboard from the lone-operated creel fishing vessel *Harriet J* (AH180) west of Fast Castle Head, south-east Scotland on 28 August 2021

SUMMARY

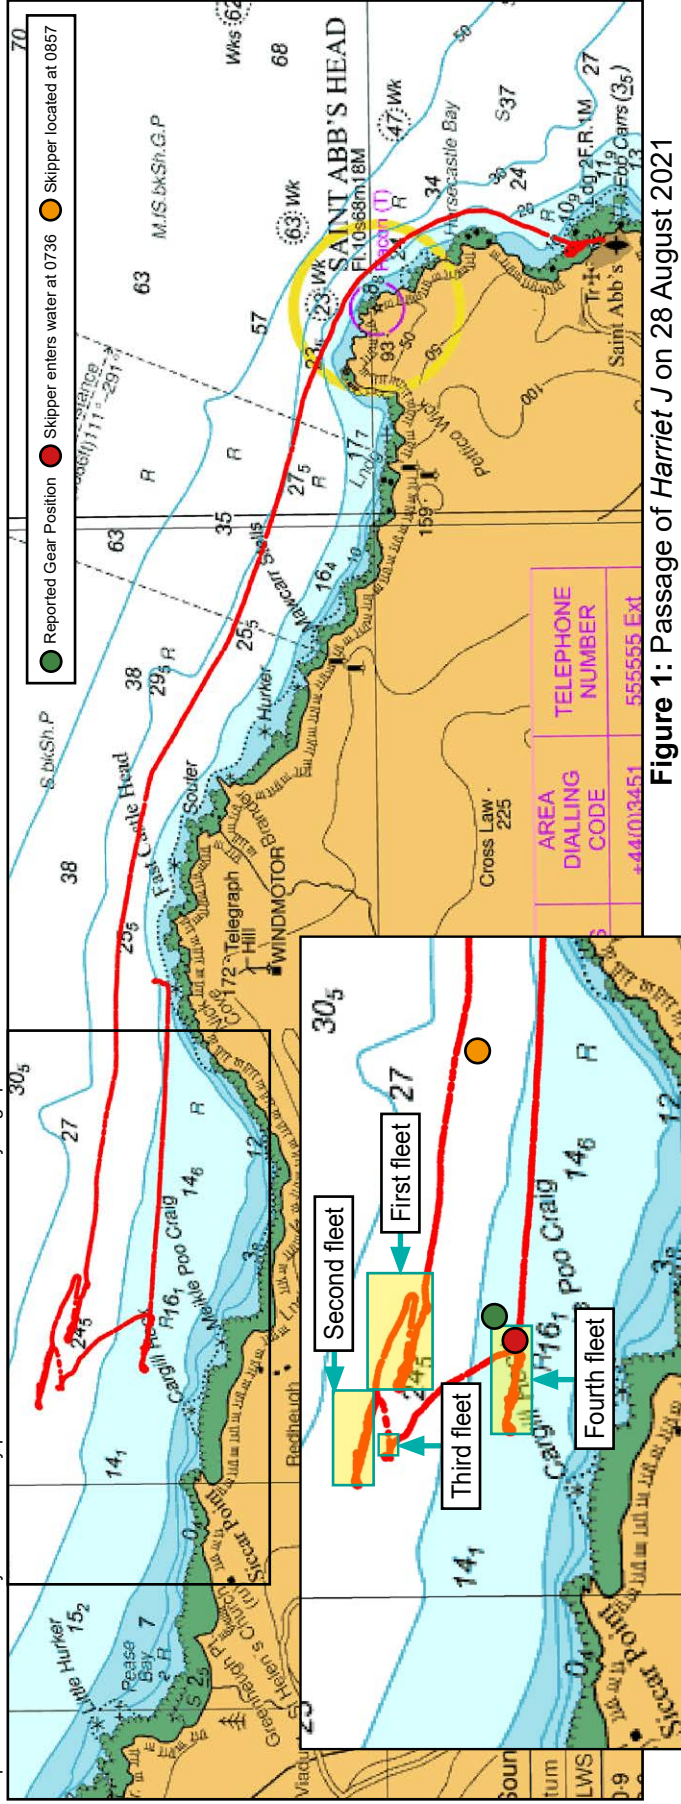
Figure 1: Passage of Harriet J on 28 August 2021

At 0435, the vessels left St Abbs in the dark and proceeded west around St Abbs Head and along the coast towards Siccar Point (**Figure 1**). While *Skua* started hauling creels in the bay near Fast Castle Head, *Danny Boy* and *Harriet J* headed further west with *Danny Boy* working further offshore. The skippers of the three vessels talked over very high frequency radio (VHF) throughout the morning.

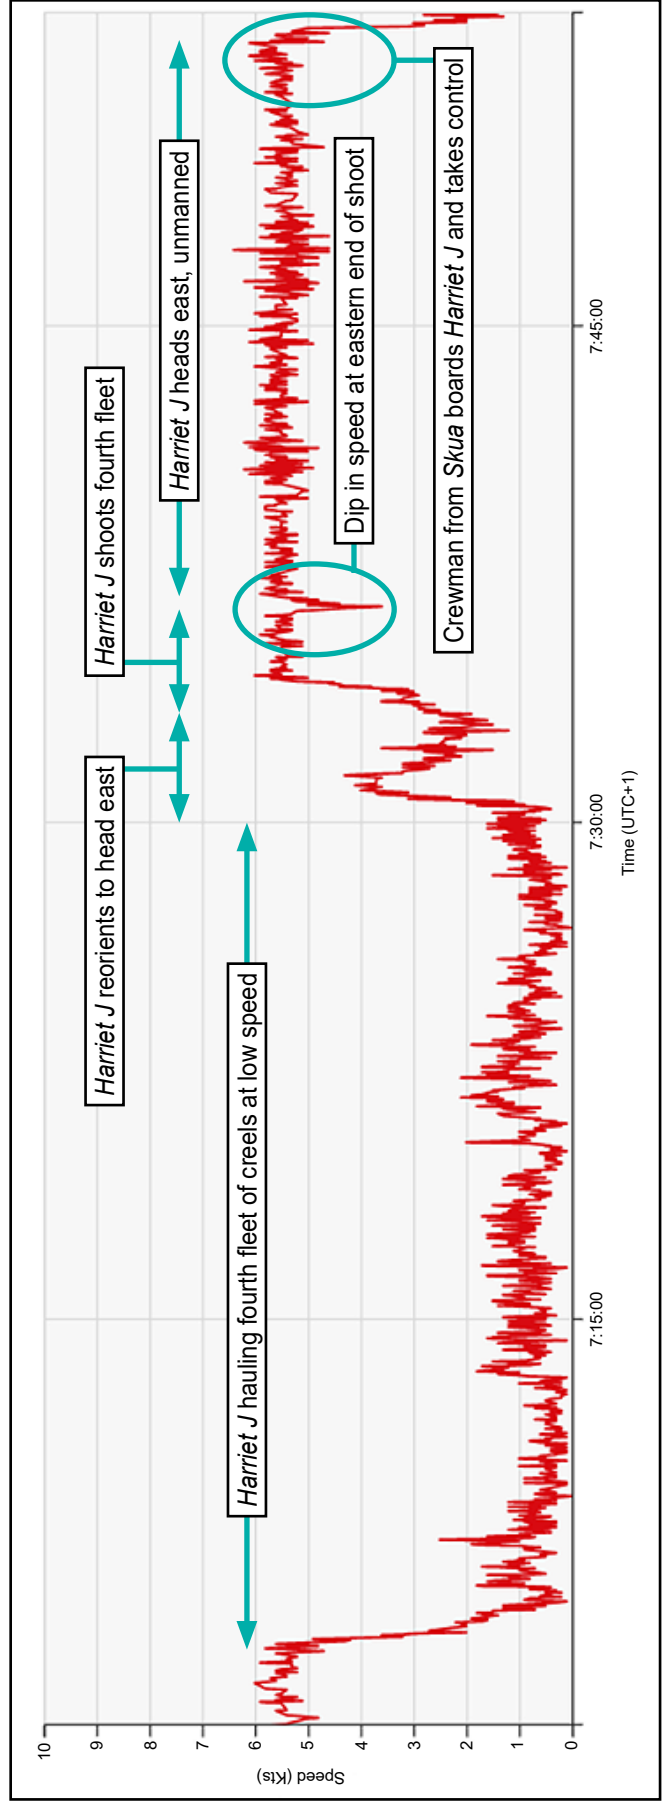
Figure 2: Harriet J's speed profile on 28 August 2021

At 0736, the track of *Harriet J* showed a notable dip in speed from 5.4kts while shooting the fourth fleet of creels (**Figure 2**). This speed dip occurred close to the position of the broken flag found by the skipper of *Danny Boy*.

The force needed to slow *Harriet J* was significant and is most likely to have arisen from the passage of the gear from the vessel during shooting being halted, then released. The force required to break the marker float's bamboo pole was discounted as being sufficient to cause such a reduction in vessel speed. It is therefore likely that either a creel or the second chain weight became snagged on the deck of *Harriet J*.

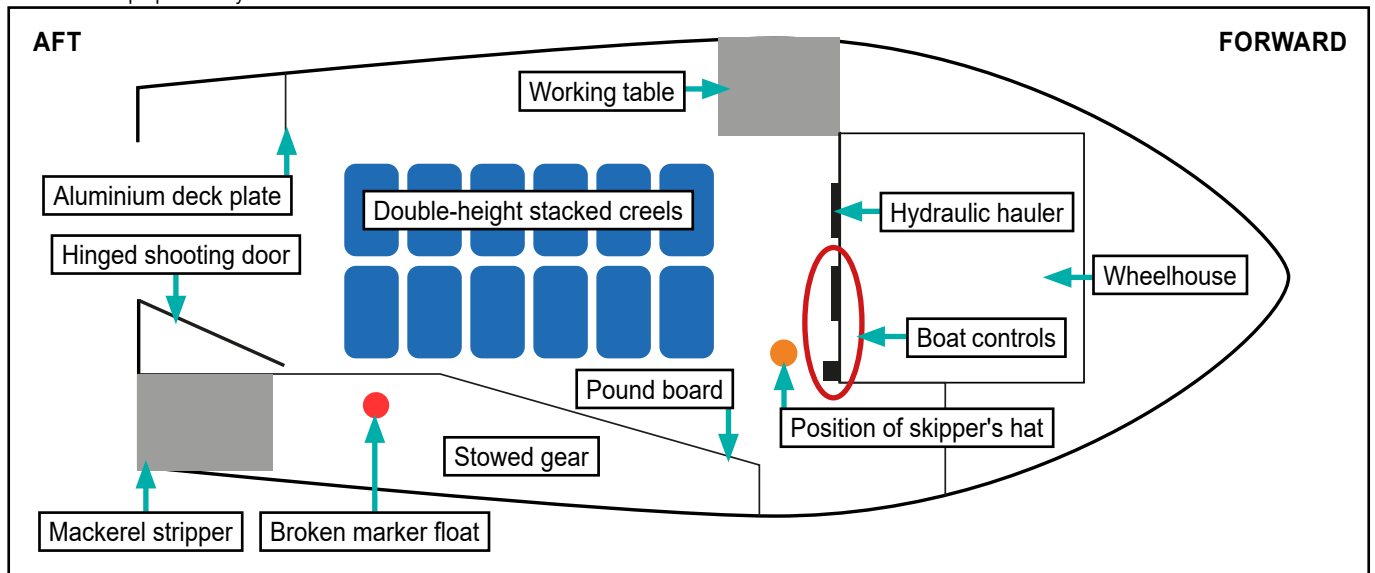
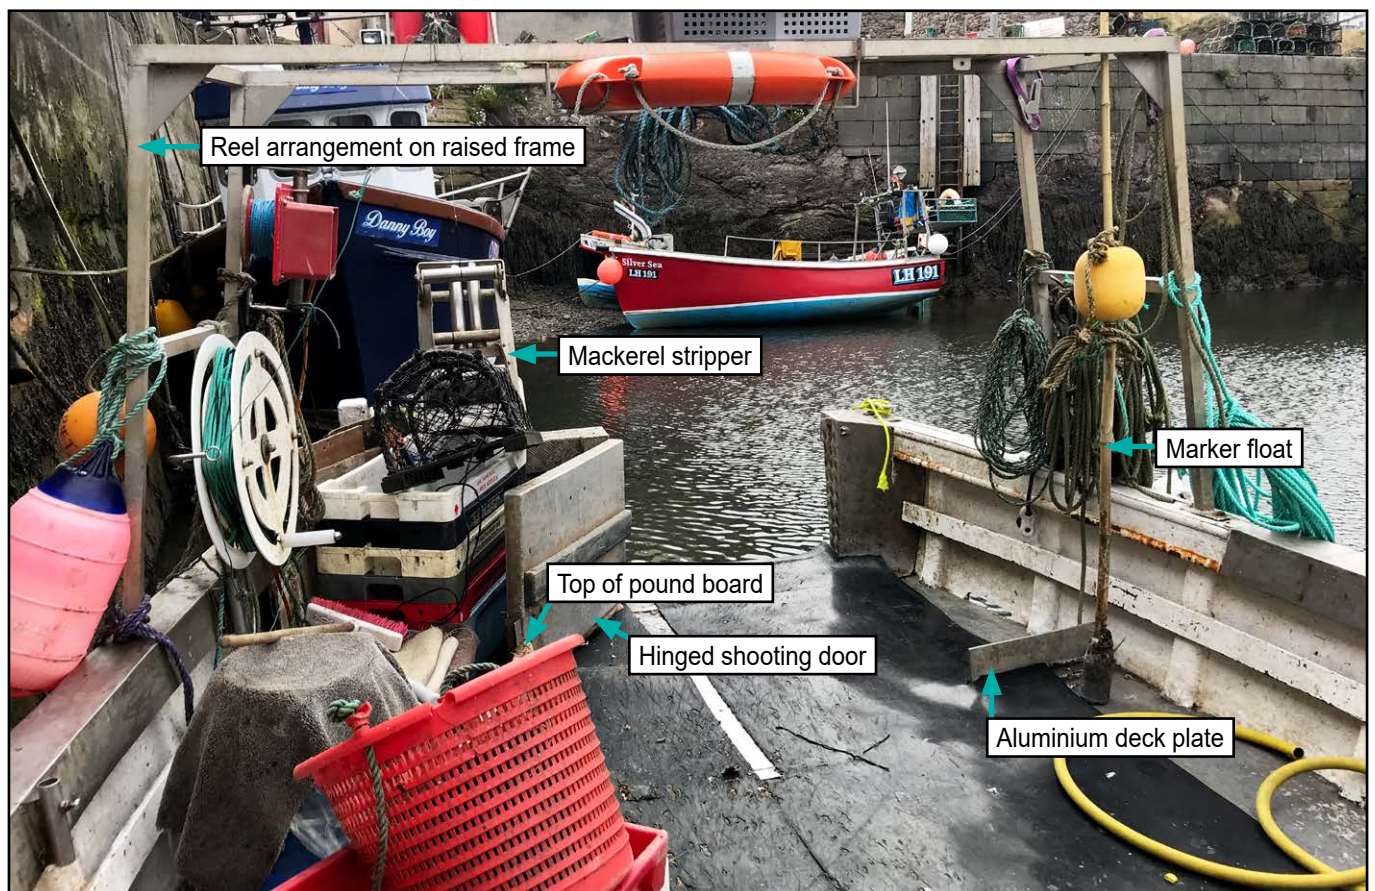
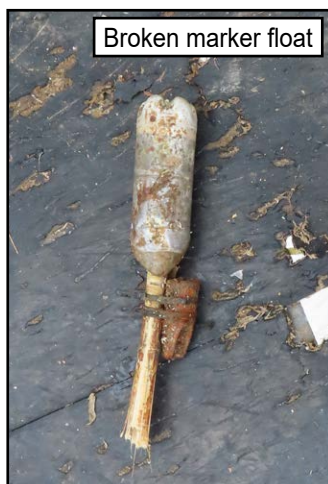
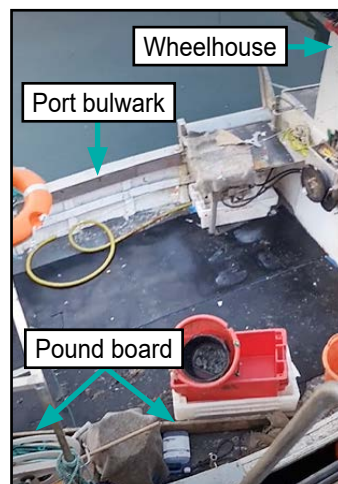
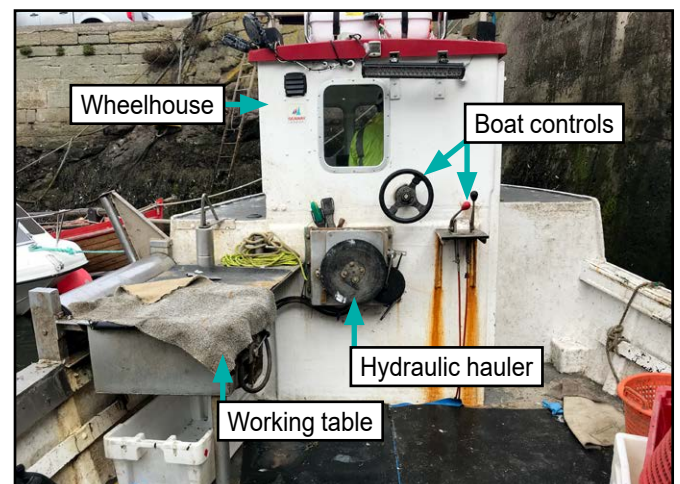
Figure 3: Harriet J's deck arrangement

At 0754, *Skua* manoeuvred alongside the starboard side of *Harriet J* and pushed the vessel to the north to prevent it running aground. The crew member from *Skua* was then able to board *Harriet J* and take control. He confirmed that the skipper was not on board. He found a woollen hat at the forward end of the working deck (**Figure 3**).

Harriet J was a 7.19m creel fishing vessel built in 1997 and registered in Arbroath. It was constructed of glass reinforced plastic, with some portions clad in aluminium. It was propelled by a single 32 kilowatt diesel engine sited in a compartment below the open rear working deck. The engine and rudder could be controlled either from inside the wheelhouse, by wheel or a heading control system, or by a set of controls located next to the hydraulic hauler and working table at the forward end of the deck (**Figure 3**).

The layout of the working deck on *Harriet J*, and the equipment stowed behind the pound board, meant that it was impossible for the skipper to access the deck to free a snag without placing himself near to the fishing gear.

Given the nature of the skipper's head injury, it is likely that he struck part of the vessel as he was pulled from his feet and through the shooting door. The position of the woollen hat found by *Skua's* crew member suggested that he might have been towards the forward end of the deck when he fell. The skipper was able to free himself from his boot at some point, meaning it was likely that he was still conscious when he went overboard.

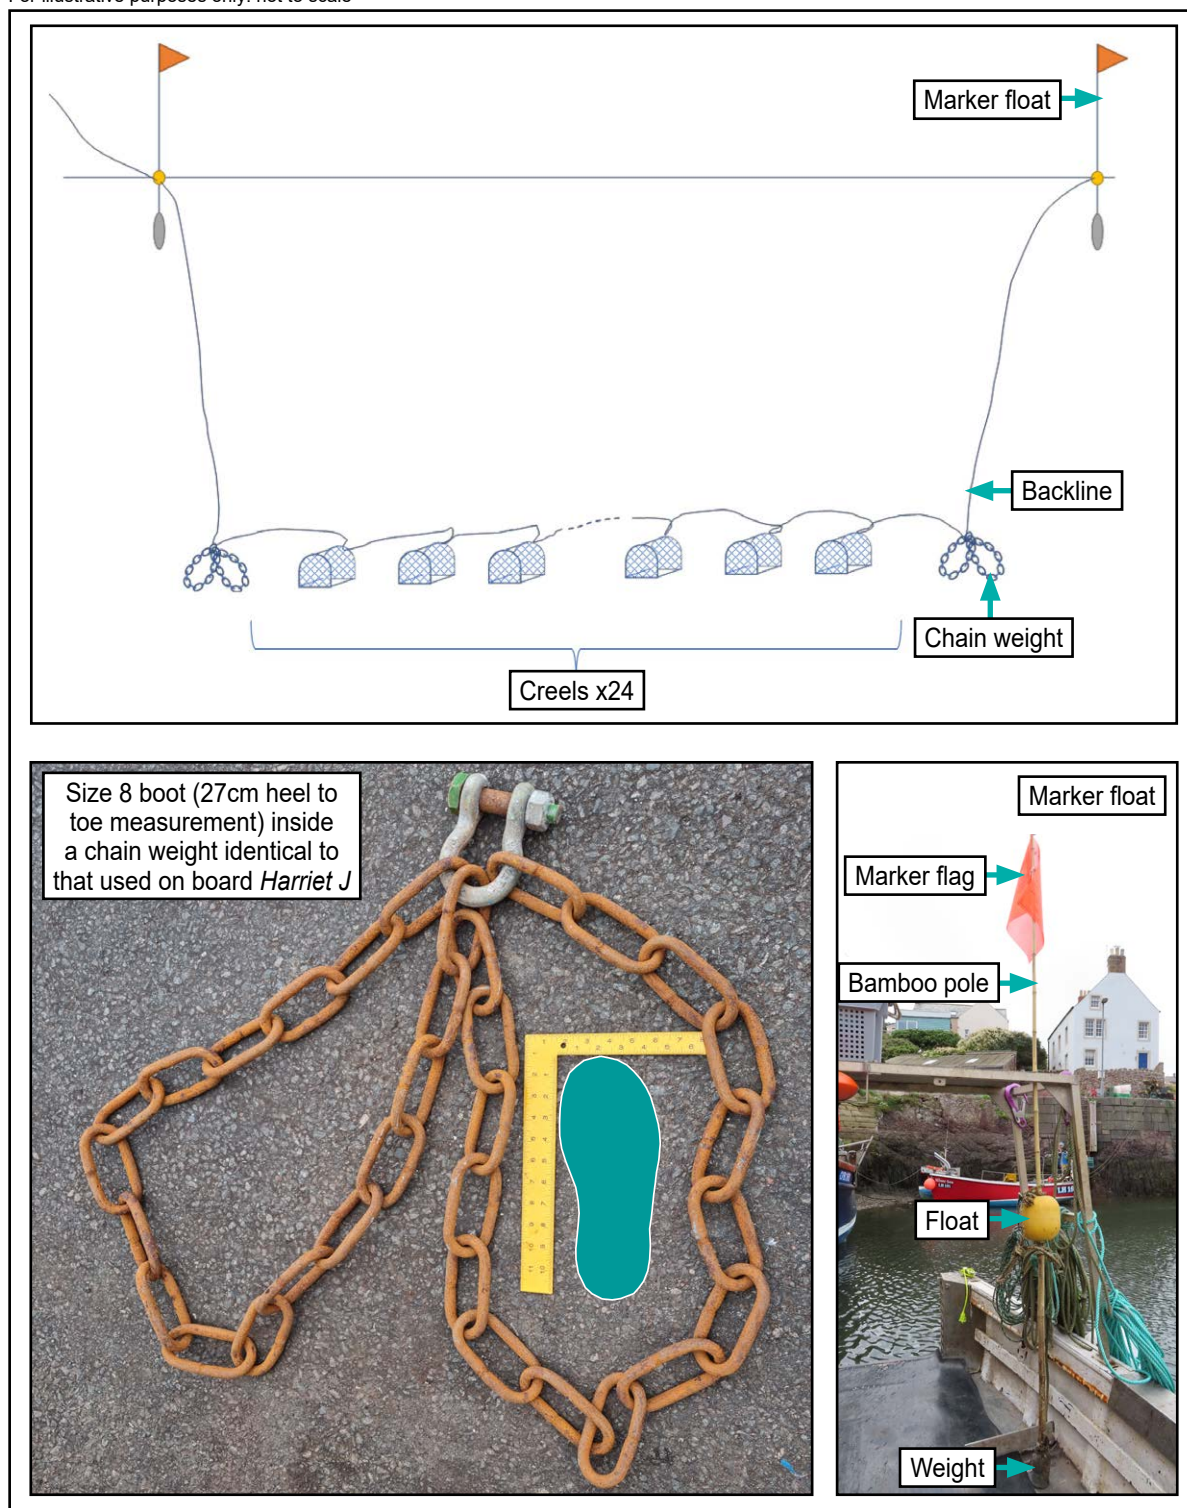
Figure 4: *Harriet J's* fishing arrangement

The vessel's creel fleets were made up of several components attached to a backline (**Figure 4**). A marker float in a dan buoy arrangement was located at each end of the fleet and comprised a weight, made from a plastic bottle filled with cement, into which a 4m bamboo pole was set. The pole was fitted with a float halfway along its length and topped with an orange flag, which stood about 2m clear of the sea surface.

The practice of kicking snagged gear to release it was reportedly common and it is likely that, when the skipper moved into the working area to release a snag, his booted right foot became entrapped in the chain loop, as found by the skipper of *Danny Boy* (**Figure 4**).

The chain weights used on the gear formed a natural bight; this created a snagging and entrapment hazard, but had not been identified as a risk.
