# Passenger dragged at Beeston Centre tram stop, Nottingham, 22 February 2023

## Summary of the accident

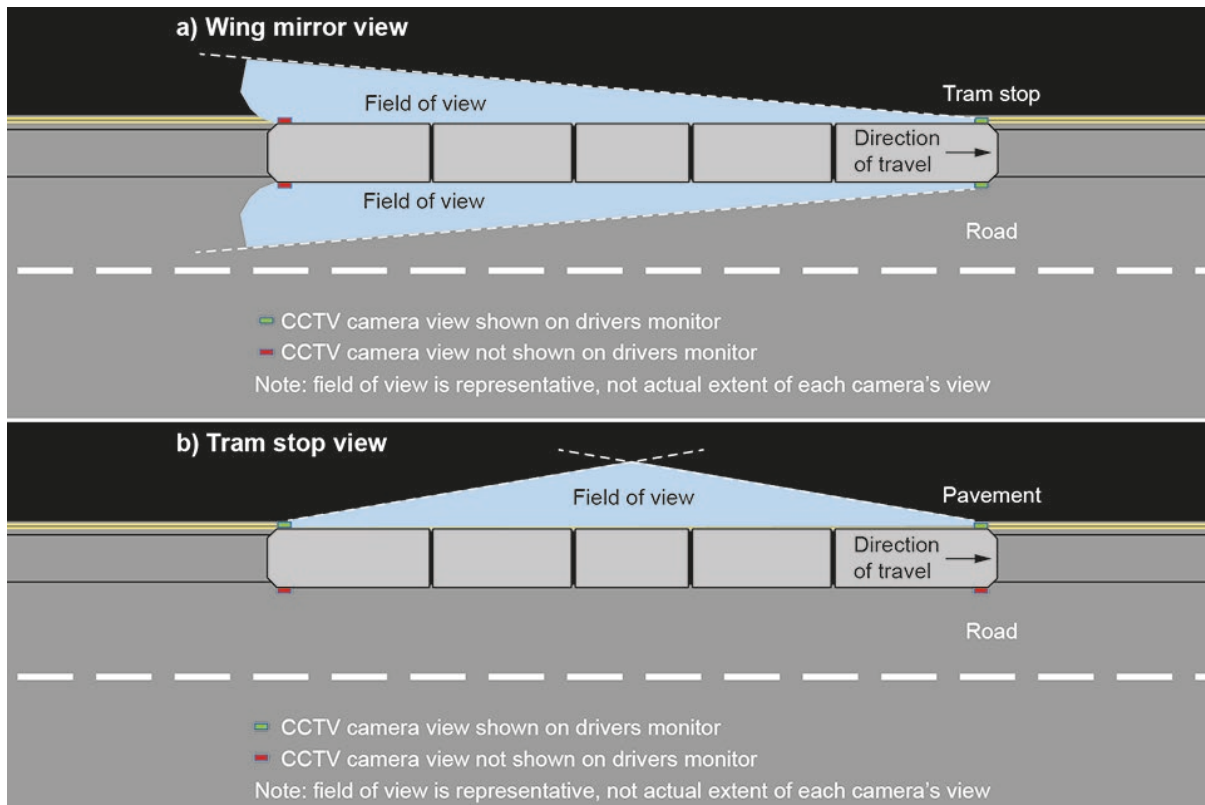
RAIB published its investigation report into this incident in September 2018 ([report 15/2018](#)). This made recommendations intended to reduce the risk of someone being dragged by a tram, including a recommendation to NTL to make 'CCTV modifications to ensure a good view during the final visual door check of all areas where items could be trapped in closed and locked doors'. This recommendation arose because the investigation found that the only view available to the tram driver after the doors had closed was a 'wing mirror' view on their in-cab CCTV screens. This made it difficult to discern what was happening on the platform at the far end of the tram.

In response to this recommendation, modifications were made to NTL trams to provide drivers with a button to press to obtain an alternative 'rear view' once the doors are closed. This gives drivers images from the leading and trailing bodyside cameras which provides them with a better opportunity to carry out an effective final safety check before departure.

Diagram extracted from RAIB report (15/2018) which shows the different camera angles available to a tram driver, when selecting 'wing mirror' or 'rear view' (referred to as 'tram stop view' in the Radford Road investigation) settings. Note that the accident at Beeston Centre occurred to the right-hand side of the tram and that the 'tram stop/rear view' setting was not used by the driver.

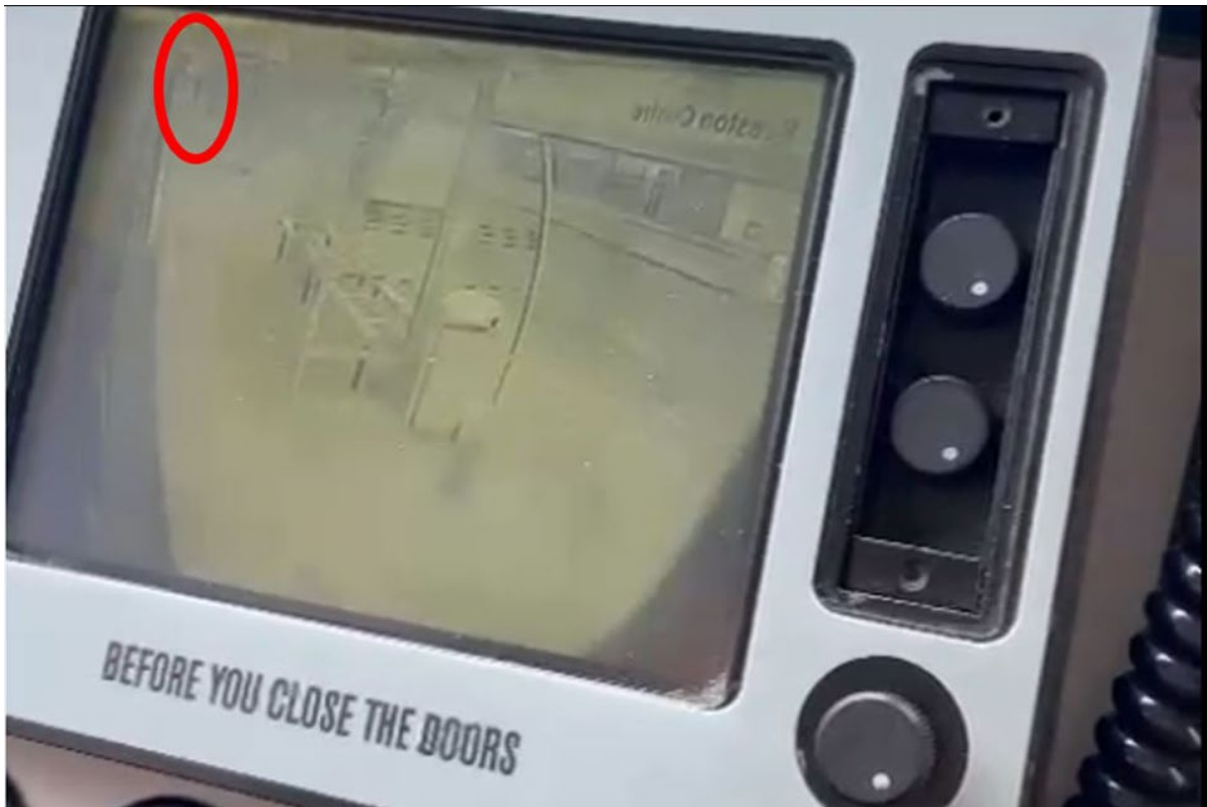
RAIB attended Beeston Centre tram stop in daylight and positioned a person, wearing a high-visibility vest, at the rearmost doors (at which the passenger attempted to board). The conspicuity of the person on the platform, in the most favourable conditions, was poor when the bodyside camera footage was displayed in 'wing mirror' view. When the cameras were commanded to display 'rear view' mode, the person on the platform became more visible.

Wing mirror view image from RAIB reconstruction.

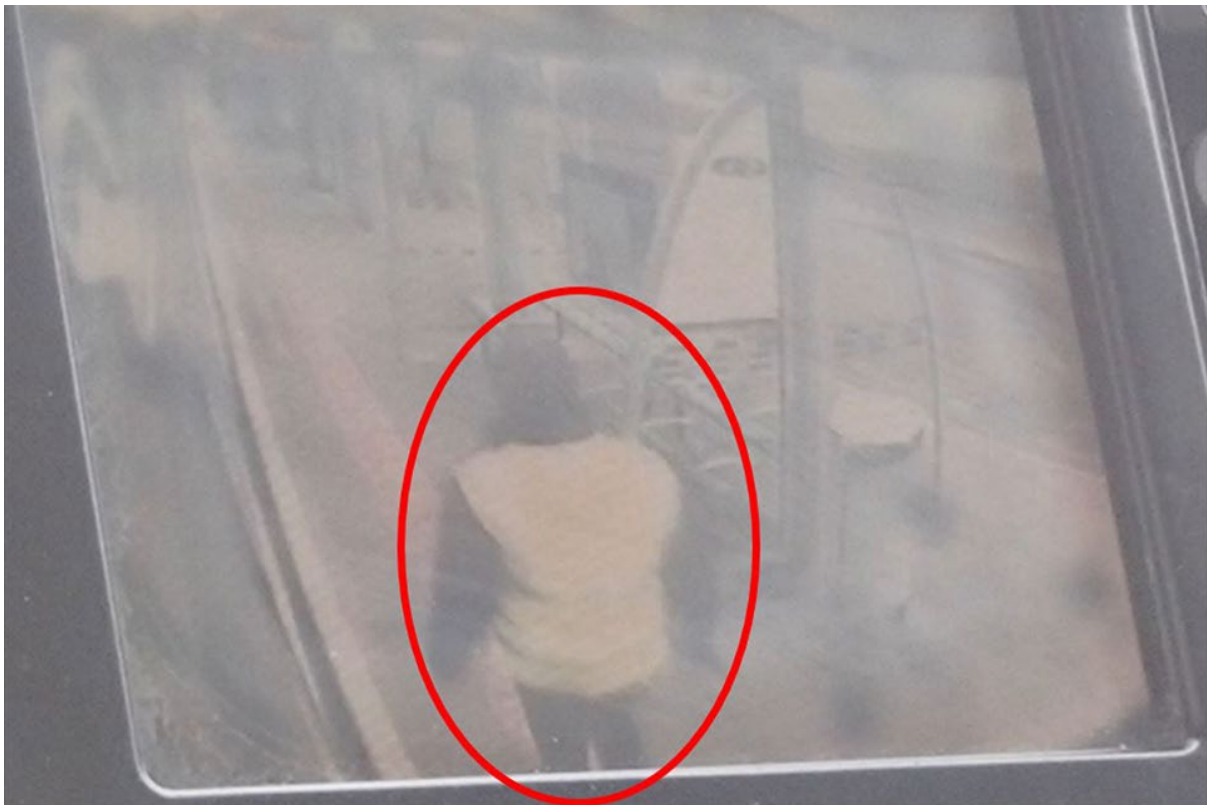
Rear view image from RAIB reconstruction.
