Report on the investigation of  
the man overboard from the stern trawler  
***Copious (LK 985)***  
resulting in one fatality  
approximately 30 nautical miles south-east of the  
Shetland Isles  
on 18 February 2021

VERY SERIOUS MARINE CASUALTY

REPORT NO 3/2023

JUNE 2023

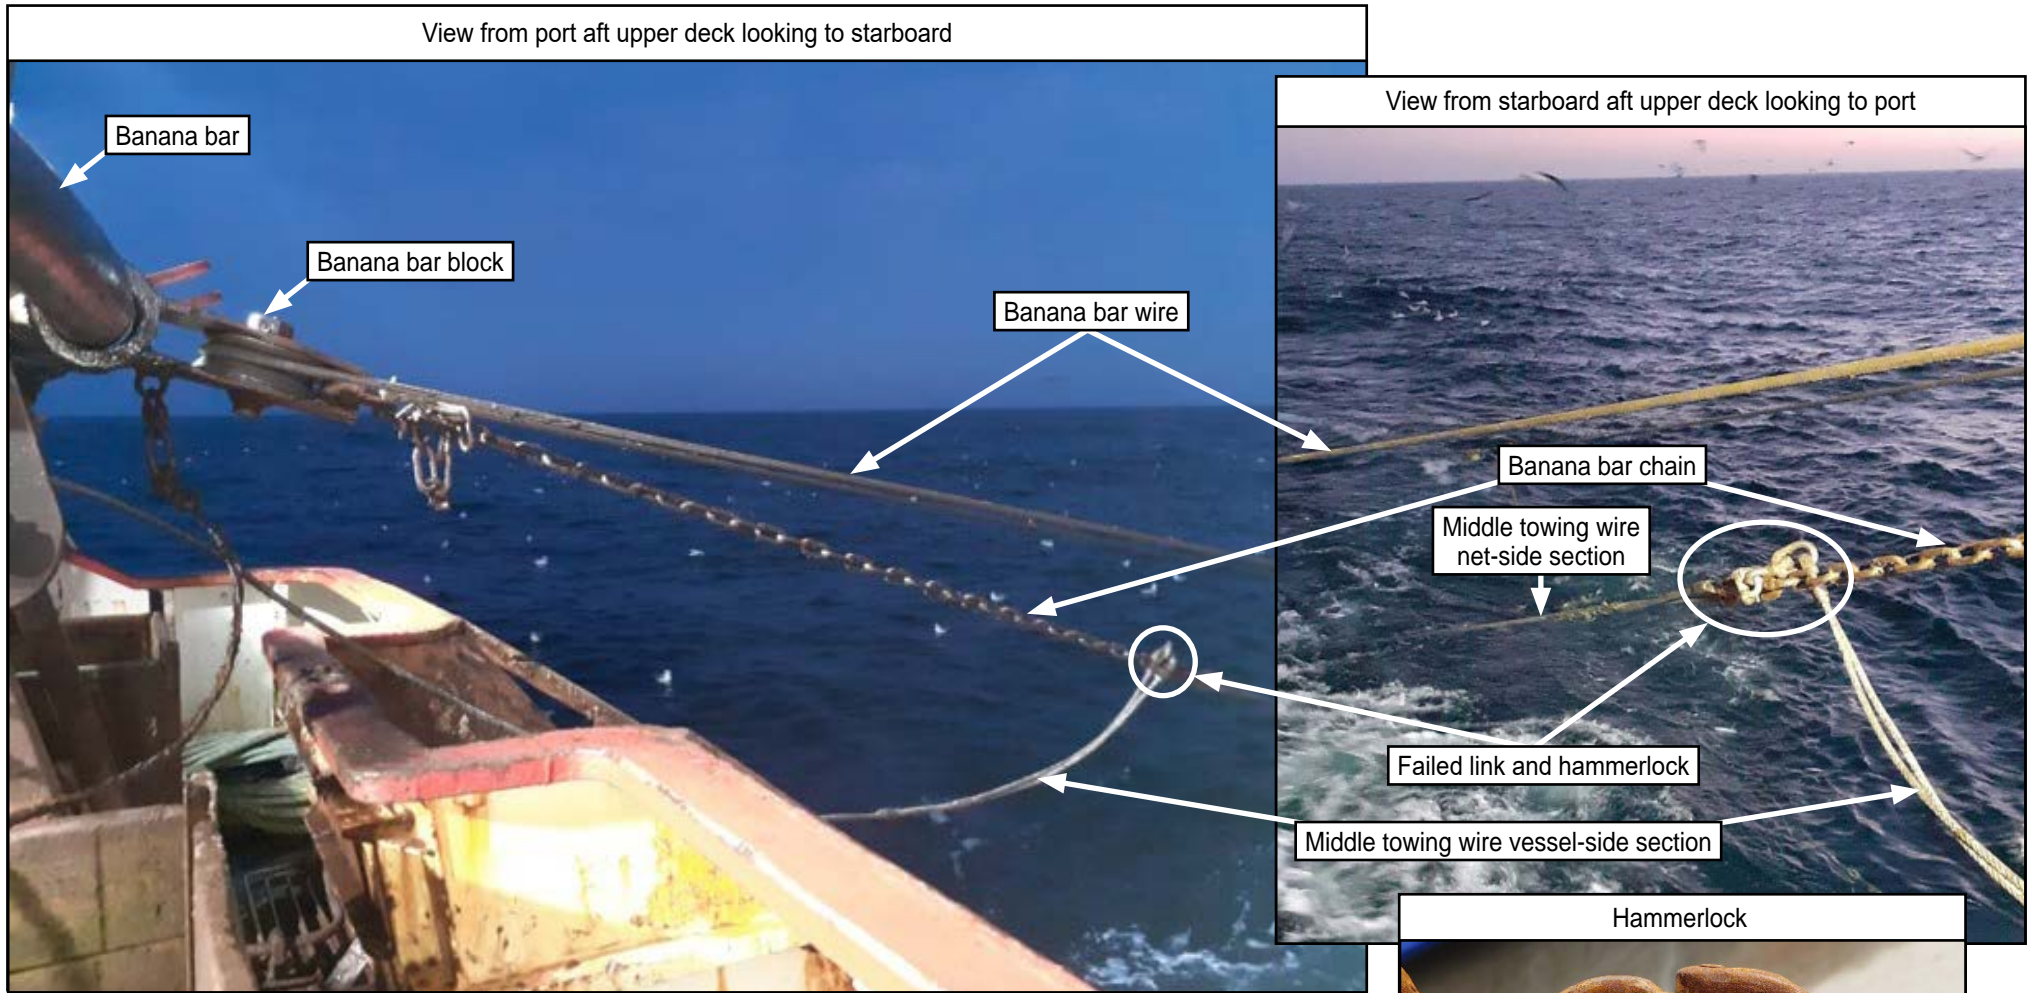
**Figure 4:** Location of gear failure and hammerlock

The deckhand fell overboard while trying to reconnect the vessel-side section of the middle towing wire to the link connecting the banana bar chain to the net-side section of the middle towing wire. A hammerlock in the link connecting the vessel-side and net-side sections of the middle towing wire had failed; this therefore meant that the net-side section of the towing wire was extended astern from the banana bar chain with no connection to the winch.

The deckhand was considered a proactive and helpful member of the crew and it is highly likely that he was attempting to progress the required repair. He recognised that the hammerlock had failed and knew that a shackle was needed to reattach the loose end of the vessel-side section of the middle towing wire. It is likely that he believed he could reach this by stepping up onto the aft bulwark on the main deck; a practice that happened regularly on board when retrieving the trawl door pennant, so far without consequence. He asked the crew member on the main deck to hold the back of his lifejacket as he stepped up onto the bulwark, which was indicative of some appreciation that what he was doing was hazardous. However, with the vessel rising and falling in the large swell, the deckhand lost his balance and fell overboard before the crew member was able to stow the guide pole he was holding and turn round to grab the back of the lifejacket.

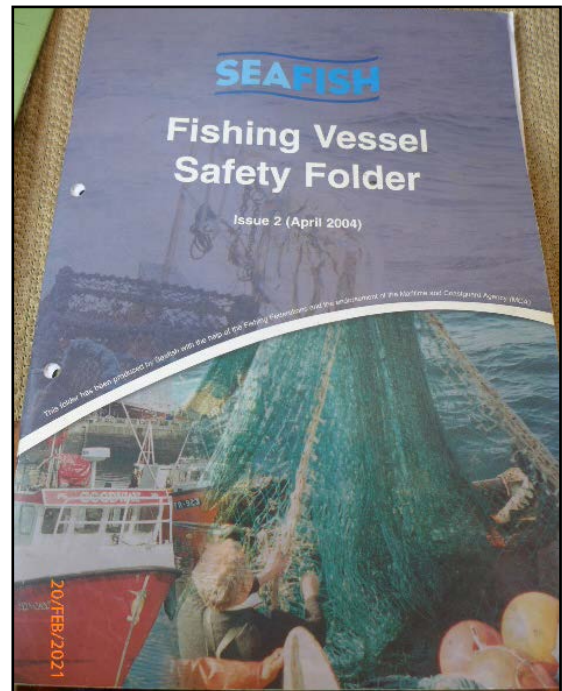
**Figure 9:** Seafish safety folder on board *Copious*

The Seafish safety folder on board *Copious* was completed in March 2013 and reviewed every year. The hazard of leaning over the rail to reach for gear had been identified in the *fouled gear/gear mending* section of the standard risk assessment form. The likelihood of occurrence was rated 1 – very unlikely – and the level of harm was rated 2 – harmful (**Figure 10**). The mitigation was recorded as *lone worker avoided in situation*. There were no risk assessments in place for working at height.

No risk assessments were in place for working at height and the risk factor calculated for the identified hazard of working over the side of the vessel did not represent the actual danger of falling overboard. The only mitigation for this hazard was that lone working would be avoided. However, this was inappropriate and fell short of the guidance that was widely available, for example that safety harnesses and lifelines should be worn when work is carried out where there is any risk of falling overboard, or when work is carried out in an exposed area in adverse weather. The consequences of falling overboard were well documented in MGN 570 (F) and MGN 571 (F); this included specific guidance on how to prevent a fall overboard when crew had to carry out emergency repairs that involved working over the side of the vessel or at height over the water. MSN 1872 (F) required that any hazardous operations were risk assessed and adequate control measures put in place to reduce those risks to an acceptable level.

The standard sections within the Seafish safety folder had been completed; however, the conduct of repairs that involved the hazard of working over the side of the vessel had not been adequately considered prior to the task being undertaken. Therefore, the skipper and crew were unprepared to safely carry out this activity.

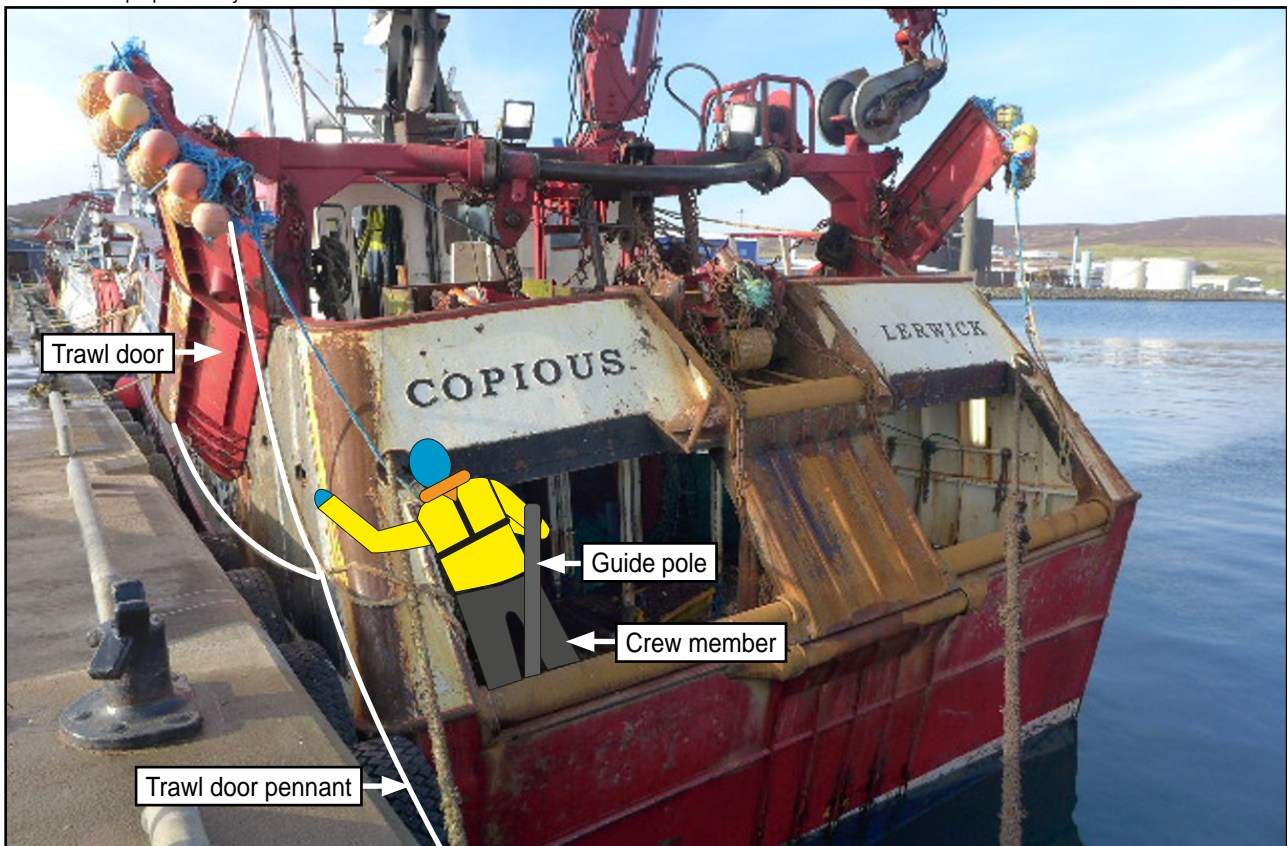
**Figure 11:** Position of crew member when recovering the trawl door pennant

One example of an onboard working practice that required a crew member to work outboard of the transom opening was during the trawl door pennant recovery. Once the towing wires had been heaved in and the trawl doors were stowed alongside the vessel, the trawl door pennant had to be recovered from the main deck in order to pass the sweeps (**Figure 1**) onto the net drum. The normal practice on board *Copious* was for the crew member on the main deck to climb onto the aft bulwark (**Figure 11**) and, using a guide pole (**Figure 7**) for support, lean around the corner, outboard of the vessel, to recover the pennant. Although the deckhand did not always carry out this duty himself, it is almost certain that he would have witnessed it happening.

2. The deckhand's decision-making is likely to have been influenced by the unsafe and common practice of stepping onto the aft bulwark to reach the trawl door pennant and his willingness to help resolve the situation. It is possible that his decision-making was also impaired by sleep disruption and that the task was being undertaken during a window of circadian low. [2.3.1].

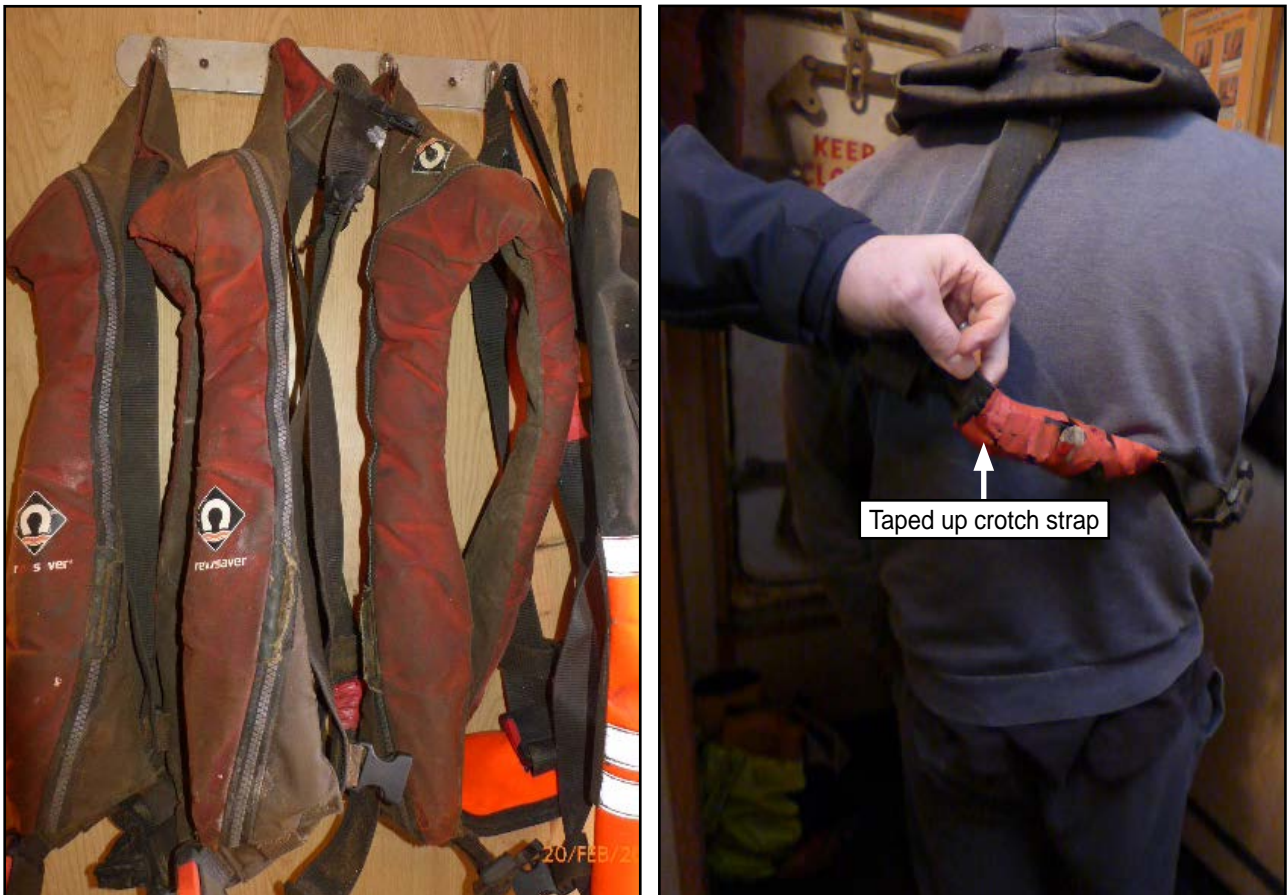
**Figure 12:** Lifejackets on board *Copious* and a taped up crotch strap

Each crew member was issued with a Crewsaver 150N auto-inflate lifejacket for working on deck (**Figure 12**). The lifejackets were purchased new in April 2019 but had not been serviced as required in April 2020 due to the owner's reported confusion surrounding the required service periodicity.

Post-accident examination of the deckhand's lifejacket found that the waist strap was set to 52 inches with no evidence of adjustment on the buckle. The deckhand's waist measurement was recorded as 32 inches during the postmortem examination. The crotch strap had been taped up at the back of the lifejacket, in common with all the working lifejackets found on board *Copious* immediately after the accident.

A properly worn lifejacket is designed to keep the airways of an unconscious person clear of the water and give them and their crewmates more time to carry out a successful rescue. Unfortunately, the waist strap on the deckhand's lifejacket was very loose and the crotch strap, although fitted to the lifejacket, was taped up and unused, which was also the case for the other lifejackets found on board. The incorrectly fitted lifejacket provided essential buoyancy in the early stages of the recovery attempt; however, the combination of the unworn crotch strap and loosely fitted waist strap allowed the lifejacket to ride up around the deckhand's face as he fell unconscious and therefore failed to keep his airways clear of the water.

The deckhand was wearing an auto-inflate lifejacket that provided him with initial buoyancy when he went into the water. The crotch strap provided with the lifejacket, which was new in 2019, was not worn and instead remained taped up at the back of the lifejacket. The combination of the unworn crotch strap and loosely fitted waistbelt allowed the lifejacket to ride up, resulting in the deckhand's airways becoming submerged in the water when he became unconscious.

Owners and skippers need to ensure that crew are fully conversant with the manufacturer's instructions on how to correctly wear PFDs provided to them for use while working on deck, and the risks if they do not.

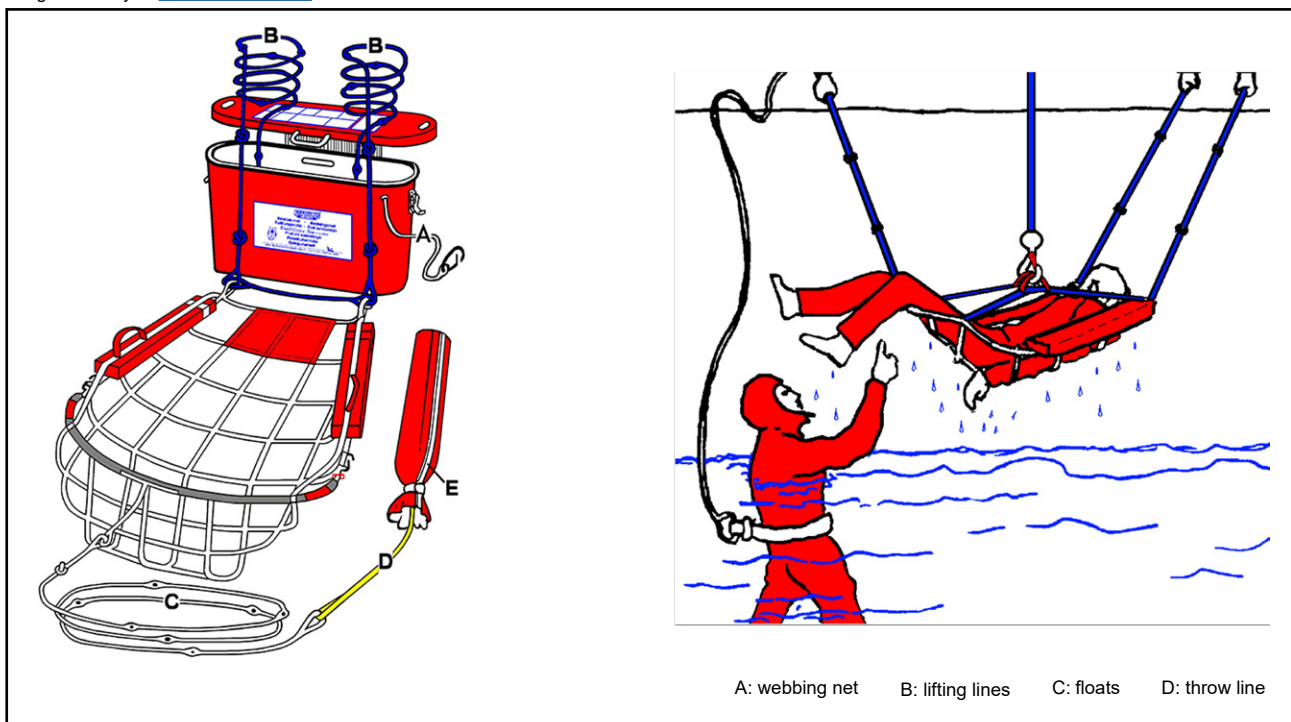
**Figure 13:** The Markusnet, including the use of a rescue swimmer for the recovery of an unconscious casualty

The Markusnet was a Lloyd's Register (LR)<sup>9</sup> approved system that comprised of a webbing net, lifting lines, floats and a throw line with a rescue/safety loop attached. The device was housed in a moveable storage container and was capable of being deployed by one person. If the person in the water was incapable of assisting in their own recovery, then an in-water rescue would need to be carried out by the crew, one of whom would need to enter the water with a safety line attached to the vessel and wearing a survival suit. A survival suit was not carried on board *Copious*, as it was not a mandatory piece of equipment. No safety line was carried on board which was designated for use with the Markusnet.

Although not explicitly required in MSN 1872 (F), MGN 570 (F) stated that fishing vessels should have a plan and a means of recovering an unconscious person from the water. The manufacturer's instructions for the Markusnet MS.10 system on board *Copious* explicitly stated that a rescue swimmer was needed to float an unconscious casualty into the recovery net. To carry out this type of rescue safely the swimmer would need to be wearing a survival suit and designated safety line, neither of which were carried on board *Copious*, noting that fishing vessels of this size were not required to carry immersion suits. The use of the Markusnet to rescue an unconscious casualty had not been fully considered when it was selected for the vessel and the necessary supplementary equipment and training was not provided, leaving *Copious* without an effective means of recovering an unconscious casualty.
