**SERIOUS INCIDENT**

<b>Aircraft Type and Registration:</b>	Piper PA-28-151 (Modified), G-BOTI	
<b>No &amp; Type of Engines:</b>	1 Lycoming O-320-D3G piston engine	
<b>Year of Manufacture:</b>	1975 (Serial no: 28-7515251)	
<b>Date &amp; Time (UTC):</b>	22 October 2022 at 1330 hrs	
<b>Location:</b>	9 nm final approach into Exeter Airport	
<b>Type of Flight:</b>	Private	
<b>Persons on Board:</b>	Crew - 1	Passengers - 1
<b>Injuries:</b>	Crew - None	Passengers - None
<b>Nature of Damage:</b>	None	
<b>Commander's Licence:</b>	Commercial Pilots Licence	
<b>Commander's Age:</b>	33 years	
<b>Commander's Flying Experience:</b>	331 hours (of which 40 were on type) Last 90 days - 21 hours Last 28 days - 16 hours	
<b>Information Source:</b>	AAIB Field Investigation

**Synopsis**

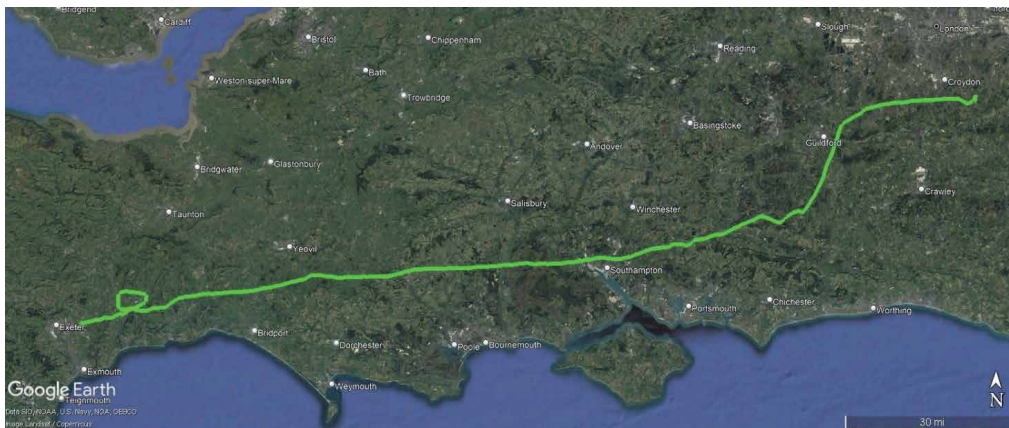
**Figure 1**  
G-BOTI flight path

The flight departed Biggin Hill at 1150 hrs. There was one passenger on board who also held a pilot's licence, although he was not qualified to fly under instrument flight rules (IFR). The pilot flew under IFR outside controlled airspace and navigated enroute between VORs (Figure 1), plotting his position at various points and comparing with navigation software he was using on a tablet device. He was satisfied that the VOR indications on the CDI were correct and the instrument was operating normally.

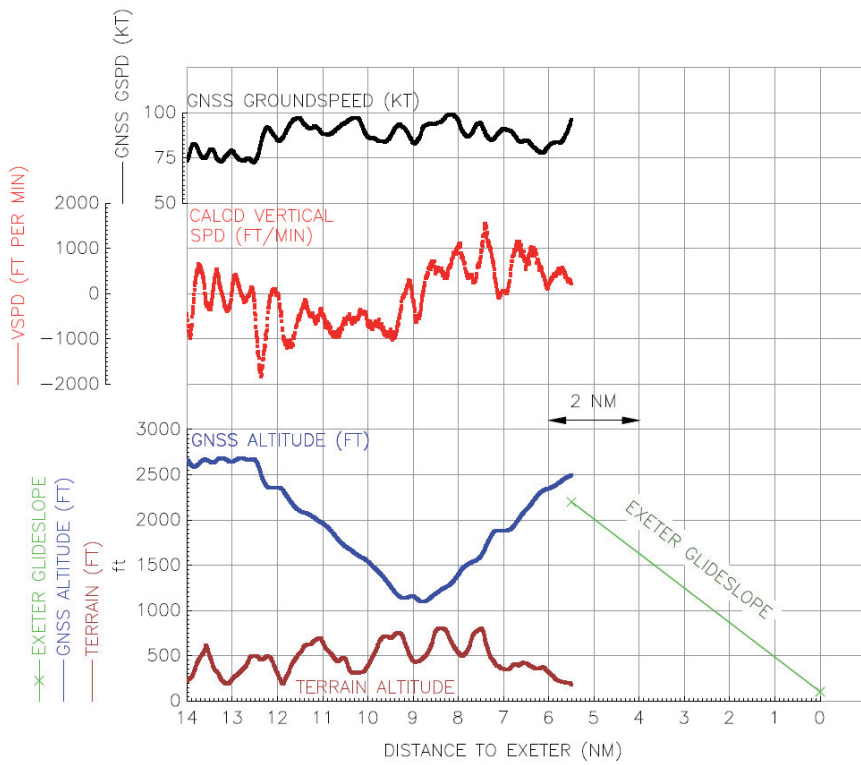
**Figure 2**

The aircraft took off from Biggin Hill at 1150 hrs and climbed to approximately 2,300 ft amsl, tracking towards Exeter. At 1318:11 hrs, while 23 nm from the threshold, the approach controller instructed G-BOTI to descend to 2,600 ft. After this transmission, the approach controller was changed. At 1325:01 hrs, when 12.5 nm from the runway threshold, a descent from 2,600 ft commenced. This initially levelled at 2,300 ft for 10 seconds before continuing (Figure 2).

G-BOTI altitude and track distance from Exeter Airport.  
Green line shows Exeter glideslope

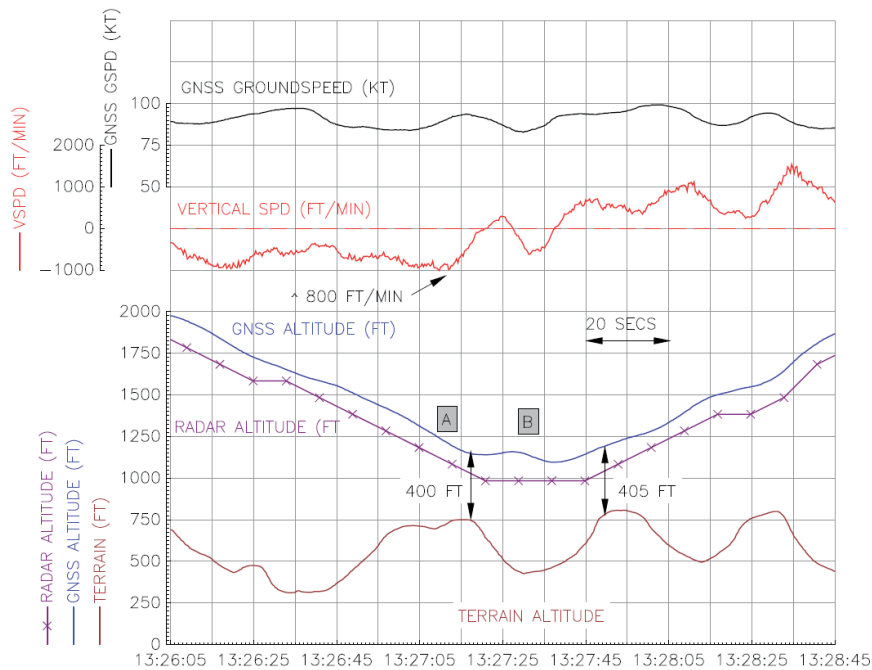
**Figure 3**

At 1327:13 hrs, the aircraft was 9.4 nm from the runway threshold, descending at approximately 800 ft/min (Figure 3, Point A). The approach controller requested the pilot's altitude to which he replied 'ALTITUDE 1,100 DESCENDING'. At this time, the recorded radar altitude was 1,084 ft<sup>2</sup>, the GNSS altitude was 1,155 ft and the terrain was estimated at 751 ft. After this query from the approach controller, the aircraft levelled at approximately 1,150 ft but descended to a minimum GNSS altitude of 1,096 ft. Terrain under the flight path undulated with the minimum clearance, based on GNSS altitude, estimated at 400 ft.

The approach controller asked whether G-BOTI was on the glidepath to which the pilot replied he was. At 1327:29 hrs (Figure 3, Point B), the approach controller stated 'GOLF TANGO INDIA YOU'RE WELL BELOW THE GLIDE PATH LEVEL, CLIMB UP TO ALTITUDE 2,600 FT'. The pilot acknowledged this and commenced a climb. During this, the aircraft's heading became more westerly and the approach controller asked if G-BOTI was established or whether a repositioning was required. The pilot responded with a repositioning request, which the controller facilitated, and the subsequent approach was successful.

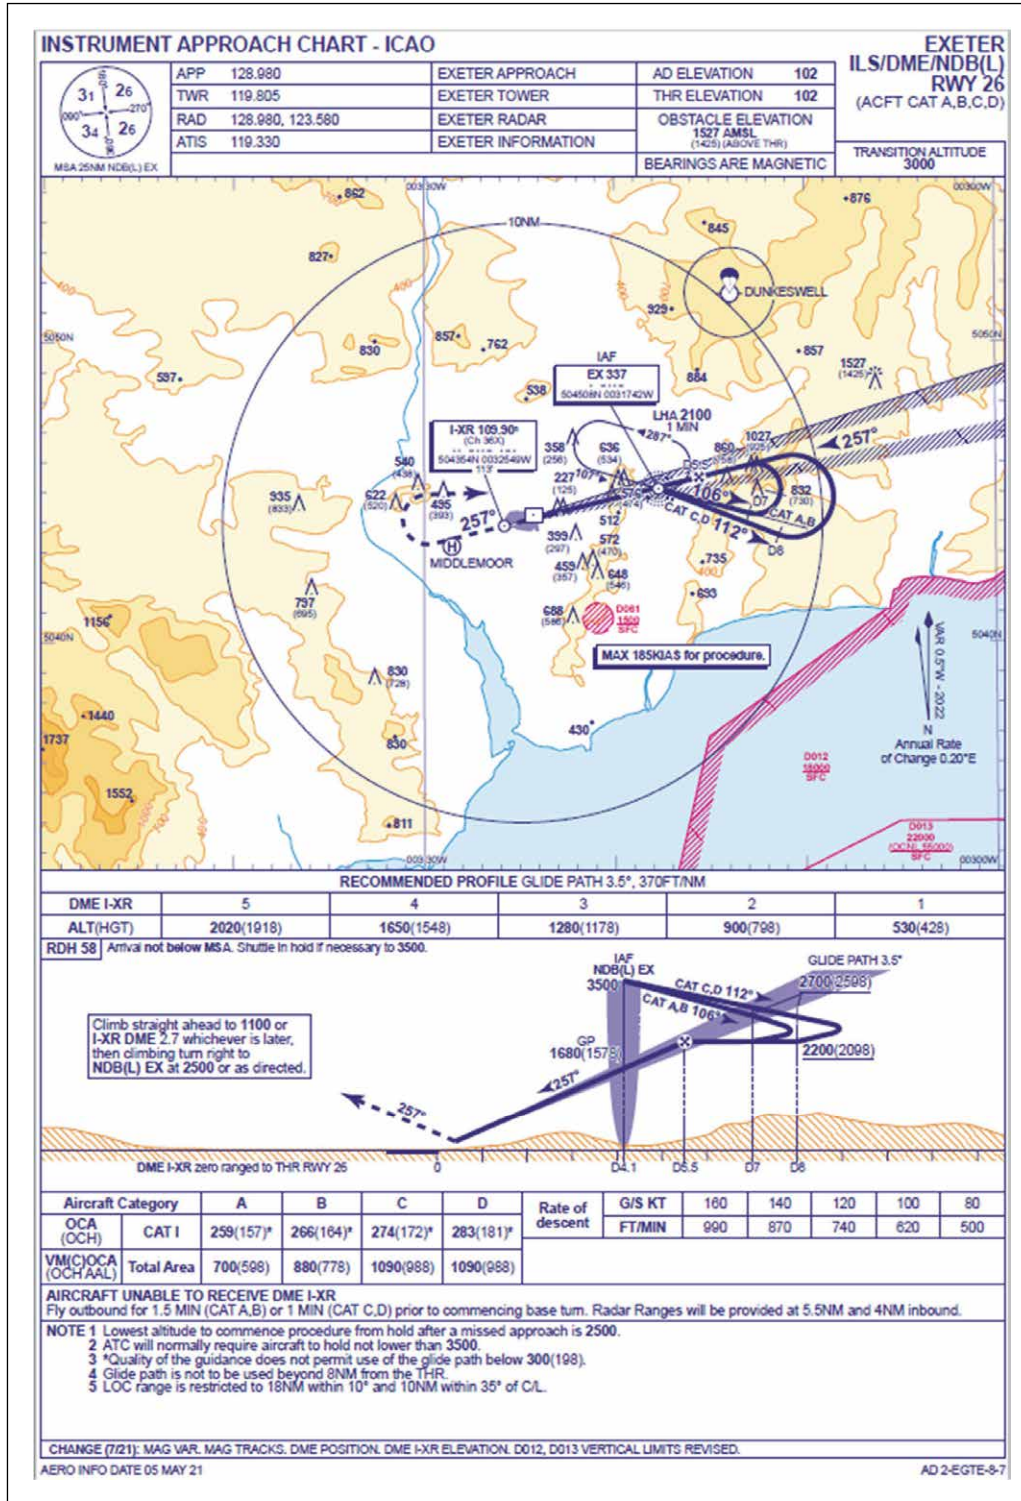
**Figure 4**  
AIP ILS approach chart for Runway 26 at Exeter Airport

The ILS approach to Runway 26 at Exeter has a non-standard 3.5° glidepath<sup>4</sup> due to high terrain to the east of the airport. The published descent point from 2,200 ft is 5.5 nm from the runway threshold. From 2,600ft, which was the altitude from which G-BOTI was cleared to join the glidepath, the nominal descent point would have been at approximately 6.5 nm. This would not have been immediately apparent to the pilot when he received his clearance for the ILS approach.

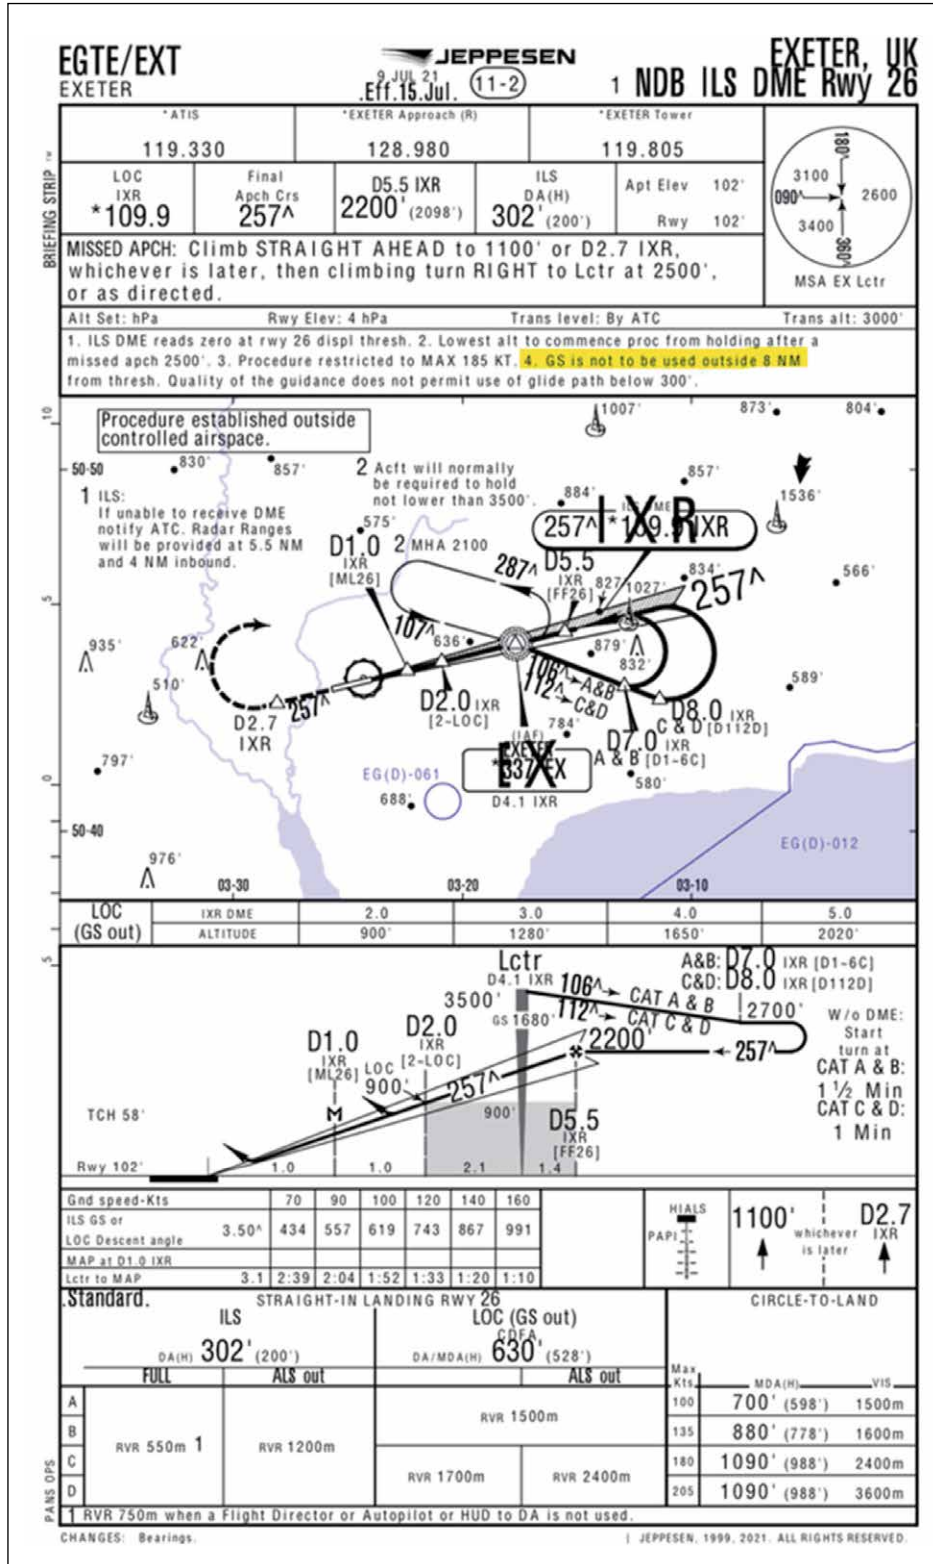
Figure 5 shows the approach plate used by the pilot during the flight. For commencing a straight-in approach from the east, which was the clearance received by the pilot, the descent point is to be determined by DME. For aircraft without DME, there is a published procedural join to the ILS where timings can be used to join the ILS. There is a note which states that the glidepath signal is not to be used beyond 8 nm from the runway threshold<sup>5</sup> (highlighted in Figure 5).

ILS approach chart used by the pilot of G-BOTI

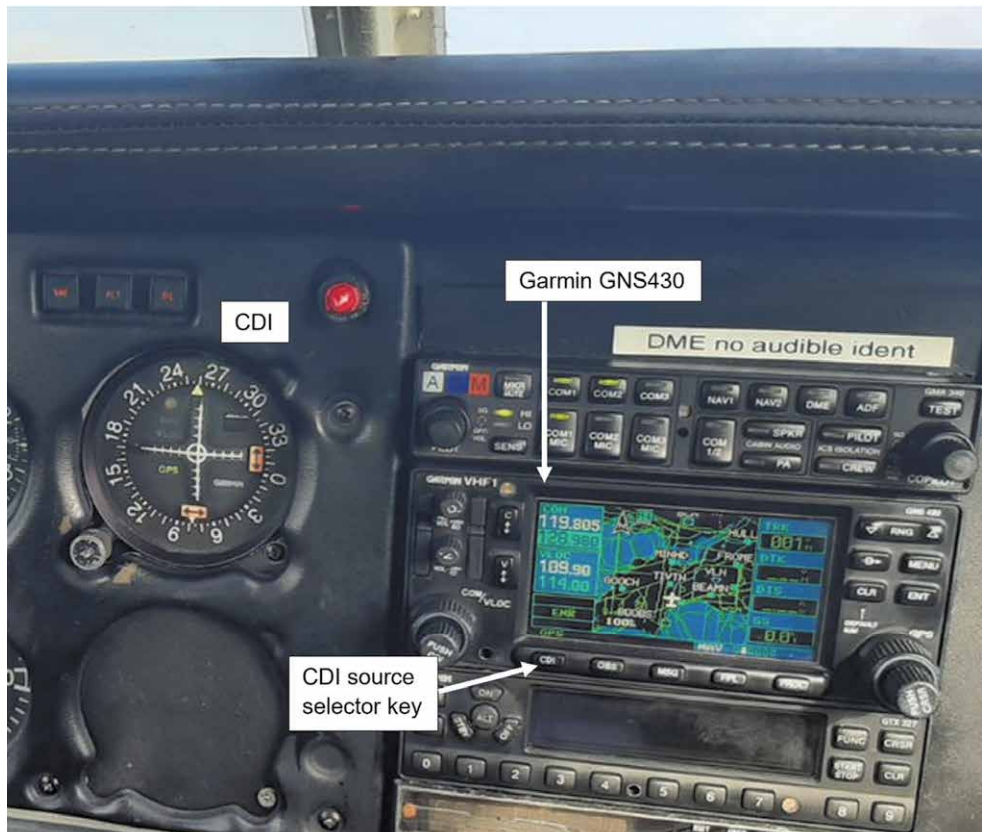
**Figure 6**

GNS 430 and CDI fitted to G-BOTI

To use GPS-derived navigational data, the 'cdi' source selector key must be selected to 'GPS'. Then the GPS-derived navigation data will be displayed on the CDI along with a 'GPS' caption. In Figure 6, as GPS is the selected navigation source, 'GPS' is displayed above the 'cdi' source selector key and as a caption on the CDI. The orange flags next to the vertical and horizontal guidance bars on the CDI show that there is no valid navigational data, and the centred deviation bars should not be used.
