AAIB Bulletin

7/2023

Published 13 July 2023

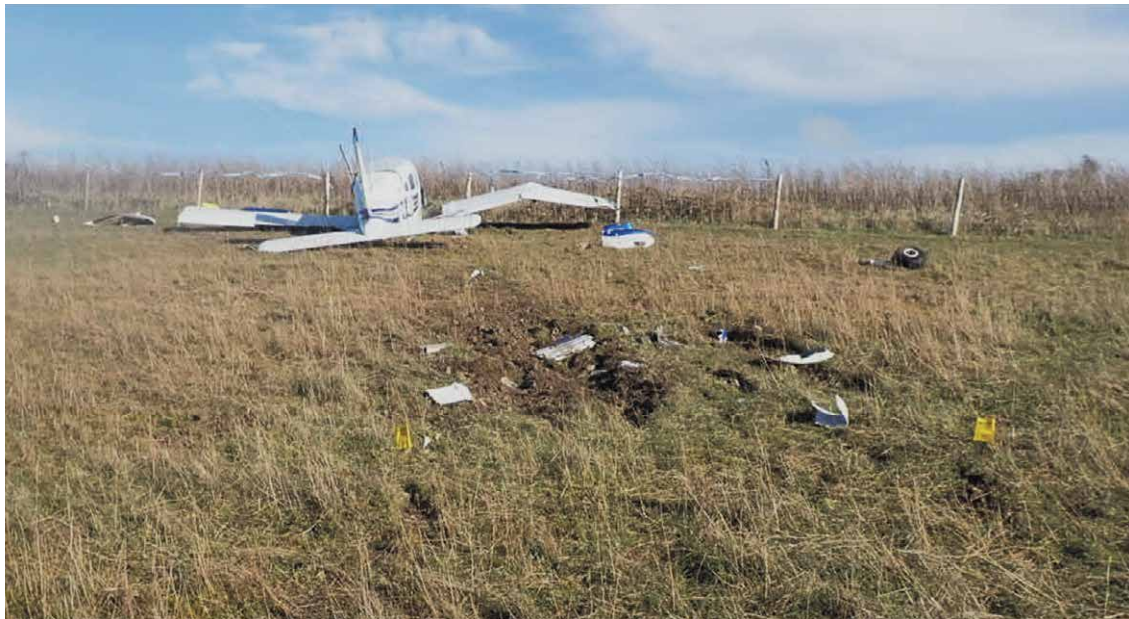
Figure 6

The aircraft force landed on an eastern face of Steyning Valley, on rising ground that varied from approximately 15° gradient, at the first point of impact, to 11°; where the aircraft came to rest. The initial ground impact marks show the left-wing tip hit the ground first. The impact on the left-wing tip was followed by the left main landing gear (MLG) striking the ground causing it to break free and bounce forward and right of the aircraft heading. The aircraft then rolled right resulting in an impact on the right MLG, which struck with such force that it resulted in a downward bend of the right wing at approximately 50% span. The aircraft's lower left front fuselage then struck the ground with sufficient impetus to drive the engine upwards, bend the nose landing gear aft and cause the tail structure to fail and partially separate just aft of the rear cockpit. Damage to the aircraft was consistent with a high sink rate on impact. After the fuselage impact, the aircraft bounced, shedding various pieces of structure including the left tip tank and right MLG. The aircraft came to rest at a fence line, (Figure 6), where the right-wing tip struck a fence post, disrupting the fuel tank.

Ground impact marks, wreckage trail and damaged aircraft

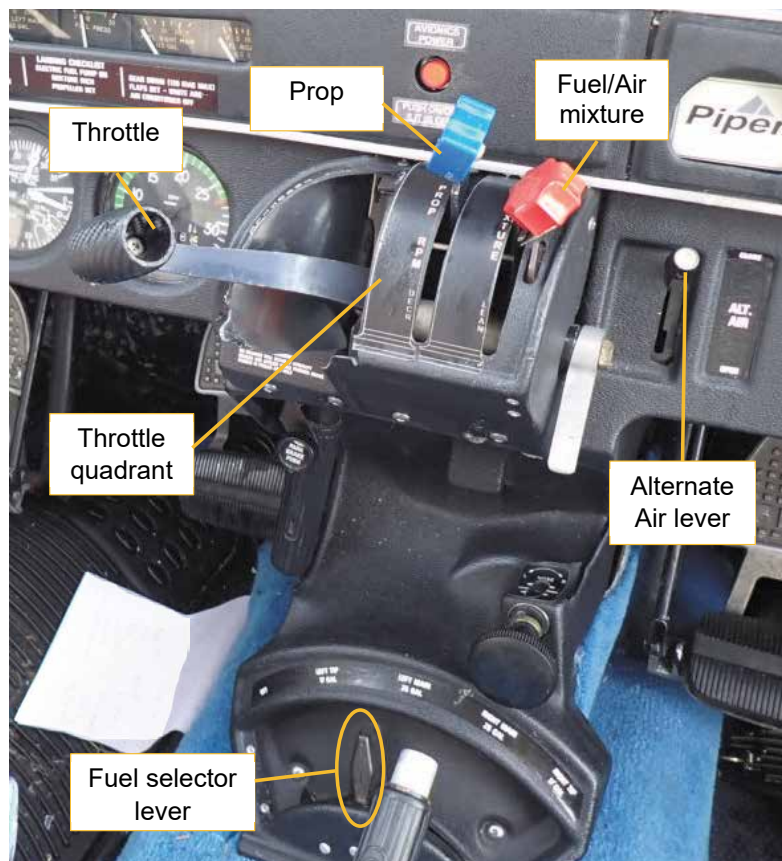
Figure 8

Examination of the cockpit at the accident site revealed the fuel selector lever was positioned between LEFT TIP (left-wing tip fuel tank), and LEFT MAIN (left main fuel tank), (Figure 8). Force was needed to move the lever to OFF, but it would not stay in position and sprang back between LEFT TIP and LEFT MAIN. From this position, moving the lever two 'clicks' to the right selected the RIGHT MAIN fuel tank and the lever remained in position. The switches on the main switch panel to the left of the cockpit and the ignition switches were set to OFF. The flap lever between the front seats was positioned in the first notch of the selection mechanism, indicating 10° flap was selected¹⁷. Although the flaps were selected to 10°, the flap control surfaces were in the up position (0° flap). On the engine control quadrant, the throttle lever was set just above IDLE and was bent and jammed in this position. The throttle housing was also deformed and torn. The fuel mixture lever was positioned just below RICH and the propeller lever was pushed fully forward to INCR (increase). To the right of the quadrant, the Alternate Air (Alt. Air) lever was in the CLOSED position.

Fuel selector lever position, throttle quadrant and Alt. Air lever

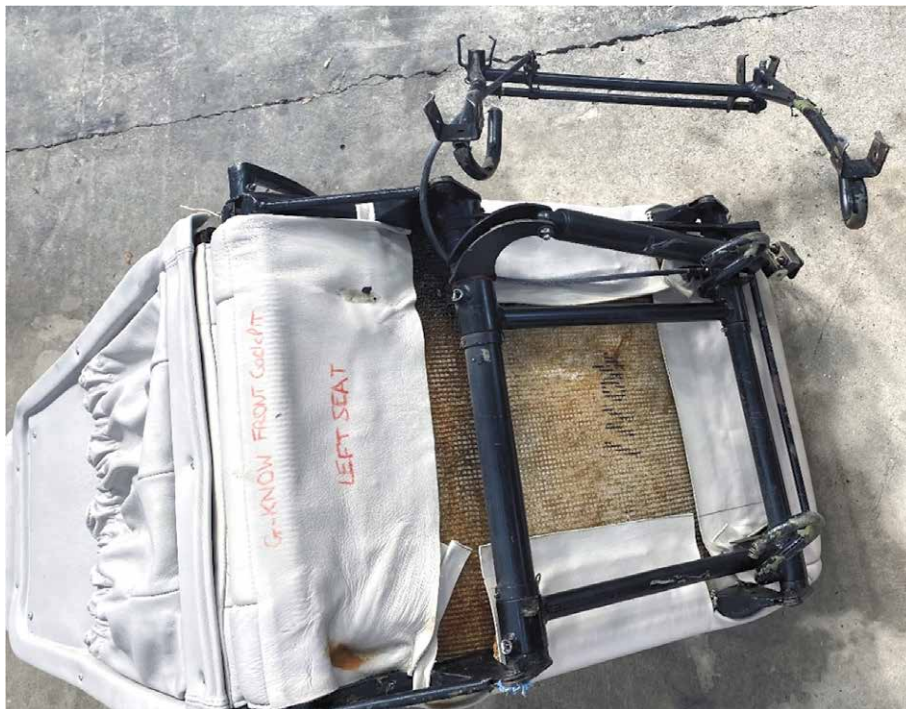
Figure 9

The front left seat's frame lower assembly had deformed and completely collapsed during the accident leaving the upper section of the seat frame resting on the cockpit floor. The lower section of the structure had broken away from the frame assembly and, although still attached to the cockpit floor, was only attached to the seat by the cables for the height adjustment mechanism (Figure 9). The assembly had failed in overload due to the vertical impact force resulting from the aircraft's high sink rate as it struck the ground.

Front left seat showing disrupted frame assembly

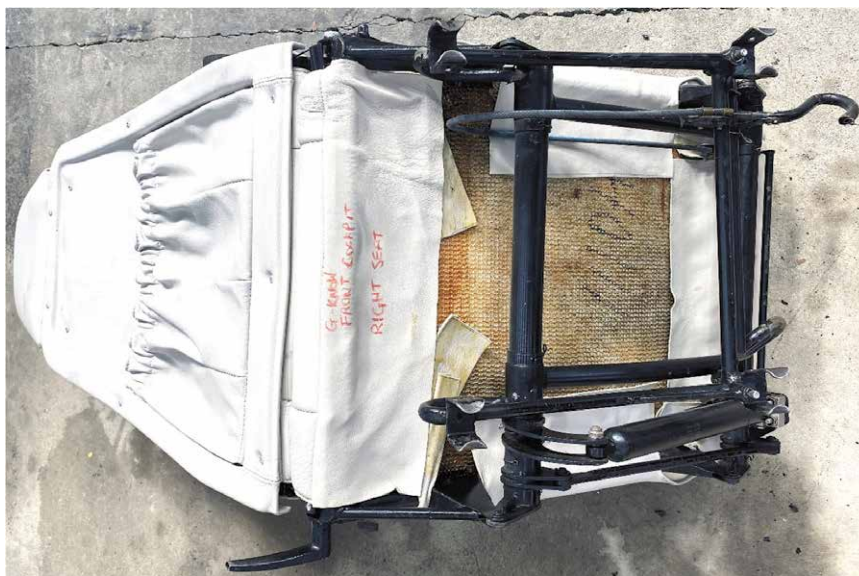
Figure 10

By comparison, the right seat's frame assembly although deformed, remained attached to the cockpit floor on three out of the four floor brackets (Figure 10). The seat was still

elevated above the floor by the brackets but, due to the deformation of the frame assembly, not to its full extent.

Front right seat showing compressed and partially disrupted frame assembly

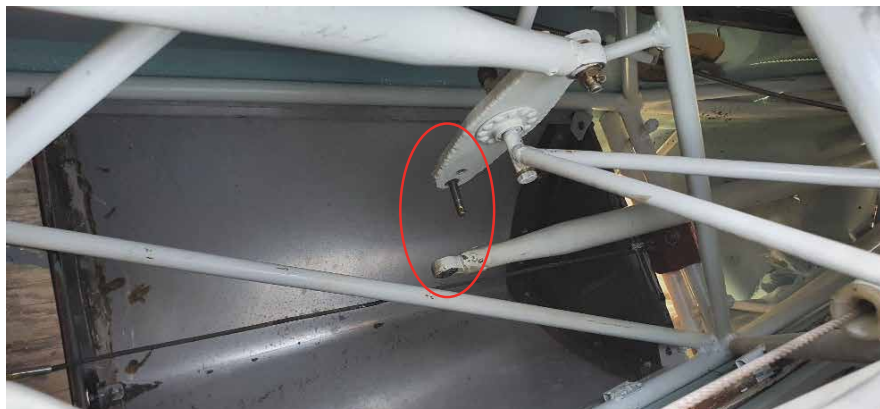
Figure 2

The investigation identified that a pivot joint at the end of an elevator pushrod had become disconnected, most probably due to the lack of a split pin to prevent the securing bolt's castle nut from loosening.

There were no access panels close to a bellcrank in the elevator control linkage, but it could be seen through a hole in the lower fuselage fabric, created during the accident (Figure 2). One of the push rods was no longer connected to the bellcrank which resulted in the loss of elevator control.

Showing bellcrank and disconnected pivot joint after recovery to the hangar, view looking towards top of fuselage, cockpit is to the left
Image used with permission

The disconnected bolt for the pushrod to the elevator was found in the bellcrank hole furthest from the pivot point. It could not be confirmed whether this was the hole it was in at the time of the accident, as damage to the paint around both bolt holes indicated a bolt had been fitted in both positions. The bolt showed signs of a nut having been fitted. Neither the nut nor a split pin was found, but the fuselage is open at the rear. The other push rod connected to the bellcrank was connected to the control column. Its bolt and the bell crank mounting bolt were secured with a nut and split pin as was the central pivot bolt.

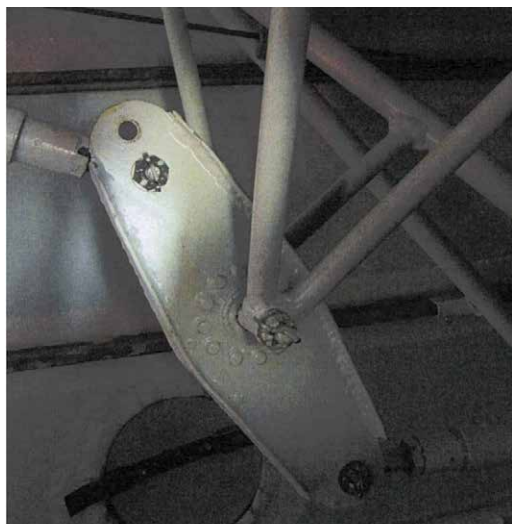
Figure 3

Photographs taken after the previous rebuild, completed in 2014, show at this time the aircraft had access panels next to the bellcrank and that the bellcrank was fitted in the other orientation. The pivot bolt for the control column pushrod was fitted to the inner hole (Figure 3).

Bellcrank arrangement after previous rebuild
Image orientated to be similar to Figure 2 to show different orientation
Image used with permission

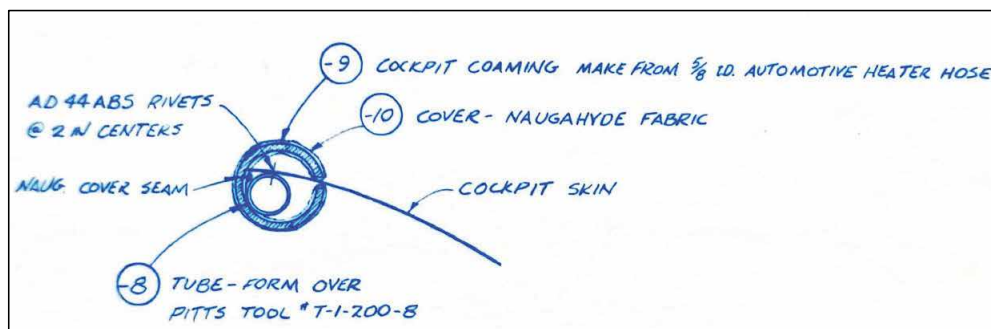
Figure 4

The material of the fuselage skin that formed the coaming above the instrument panel was manufactured from flat sheet. Design drawings for the aircraft specify the resulting sharp edge, in front of the pilot's head, to be thickened with a tube riveted to the panel and then covered with padding. This is to minimise injury to the pilot should they be thrown forward on to it (Figure 4). This had not been installed on G-BTOO.

Drawing of padding arrangement for cockpit skin forming instrument panel coaming

Although the pilot was restrained by the seat and harness, he was not wearing any head protection. His unprotected head struck the sharp edge of the coaming, which had not been padded as required, causing a deep cut to his forehead and scalp.

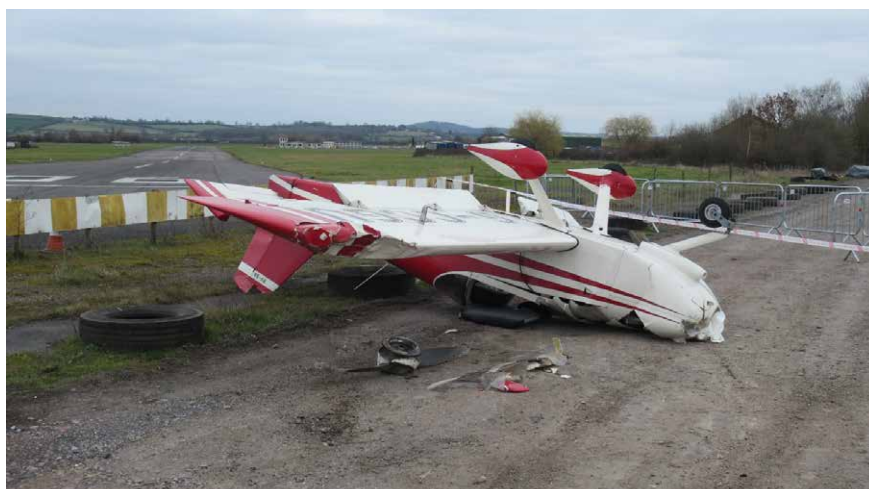
Just before touchdown the pilot saw a heavy goods vehicle (HGV) very close to the right of the aircraft, and the right wingtip struck the rear of the HGV trailer. The vehicle was crossing the undershoot from left to right. The pilot recalled nothing else until he became aware that the aircraft was inverted on the ground with the canopy broken (Figure 2). A roll bar behind the aircraft seats kept the cockpit off the ground protecting the occupants, and the aircraft harnesses successfully restrained both occupants in their seats. A car that had been following the HGV stopped and the occupants assisted the pilot and passenger to escape by breaking away sections of canopy perspex to clear an exit path. Ambulance personnel from the Air Ambulance base at Henstridge were quickly on scene and gave medical assistance, and they were subsequently supported by the local emergency services. There was no fire on the aircraft. Both those on board were taken to hospital by ambulance, and the pilot was released later that evening having sustained only minor injuries. The passenger remained in hospital for three days as he had sustained a broken wrist, which required surgical intervention to correct.

Figure 2
Aircraft inverted on road
