Rail Accident Investigation Branch

Rail Accident Report

Buffer stop collision at Enfield Town station 12 October 2021

Report 13/2022
November 2022

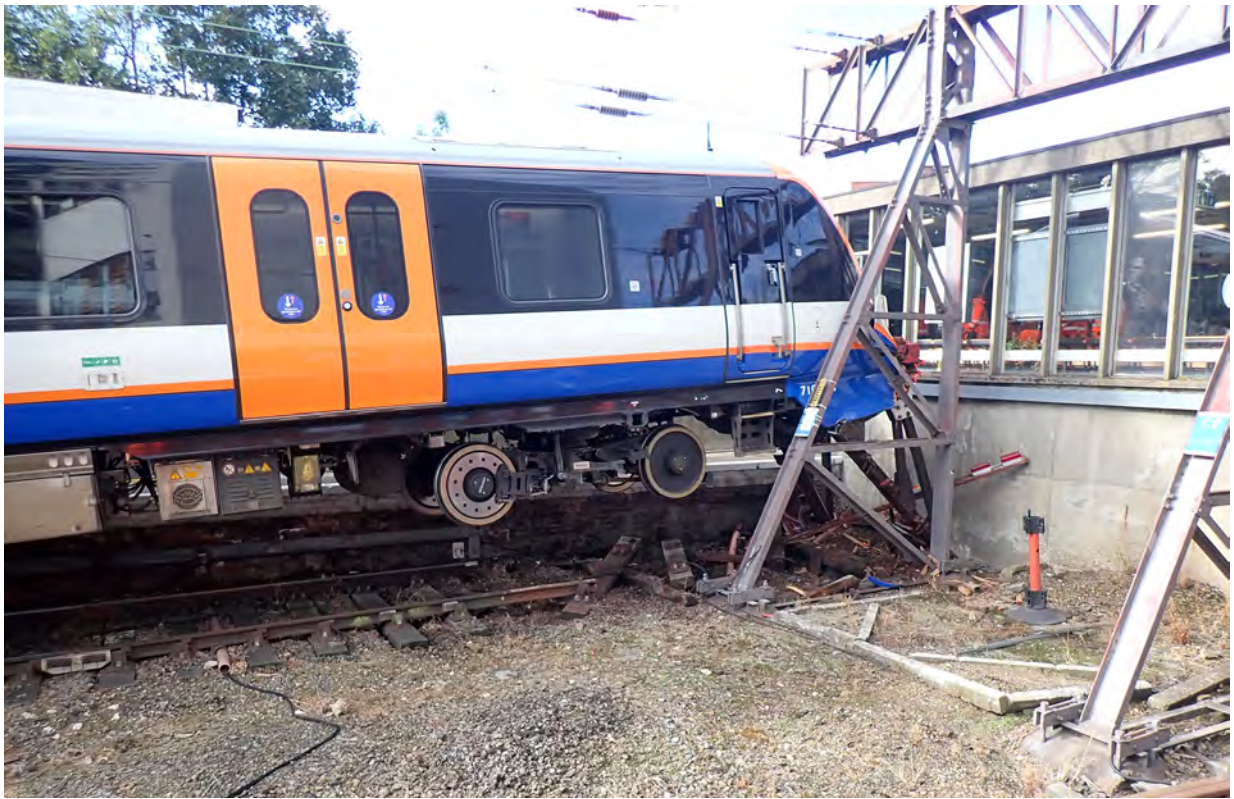
Figure 2: Position of the train after the collision

- 27 The buffer stop detached from its fixings and became trapped under the leading end of the train. The remains of the buffer stop then pivoted backwards due to the force of the collision and lifted the front of the train into the air. The train stopped with its leading wheels about 800 mm above the rails, and with its front end about one metre from the station concourse wall.

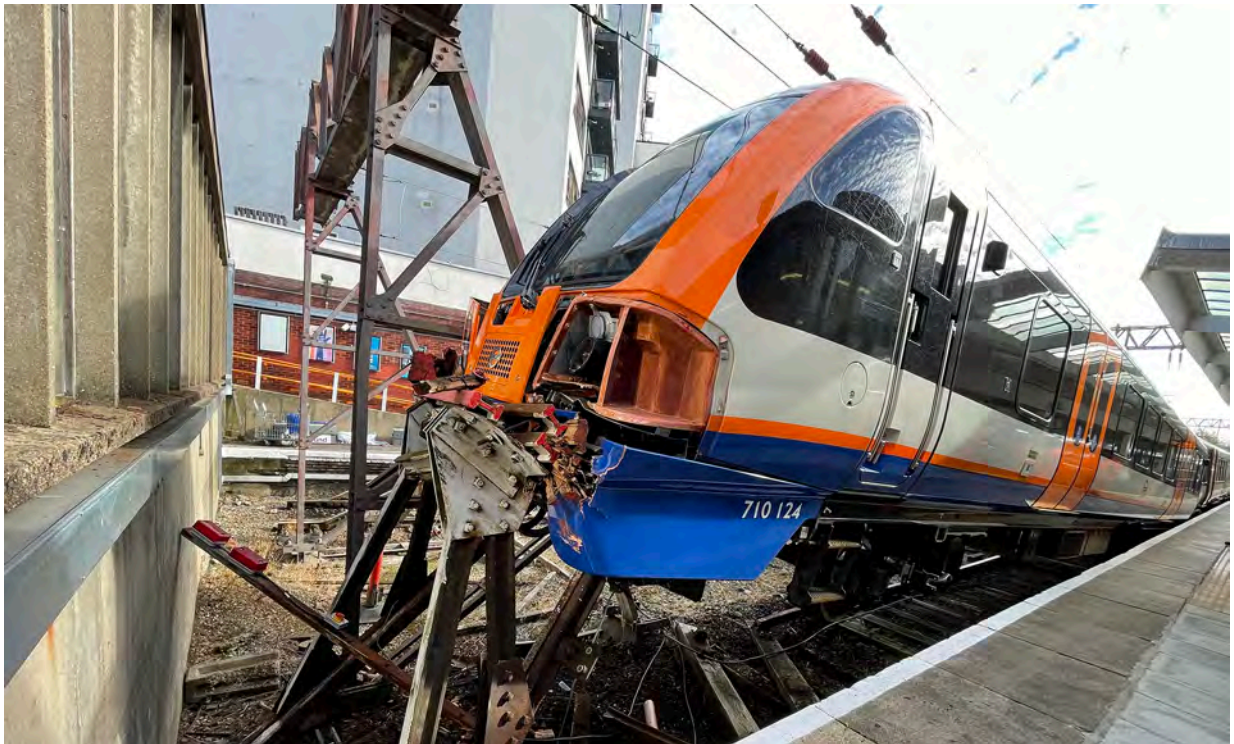
- 6 The train's front end was damaged, but this was largely confined to the replaceable front nose assembly (figure 3). There was no structural damage to the train's body that required major repair. The buffer stop was destroyed in the collision.

Figure 3: Damage to the front of the train

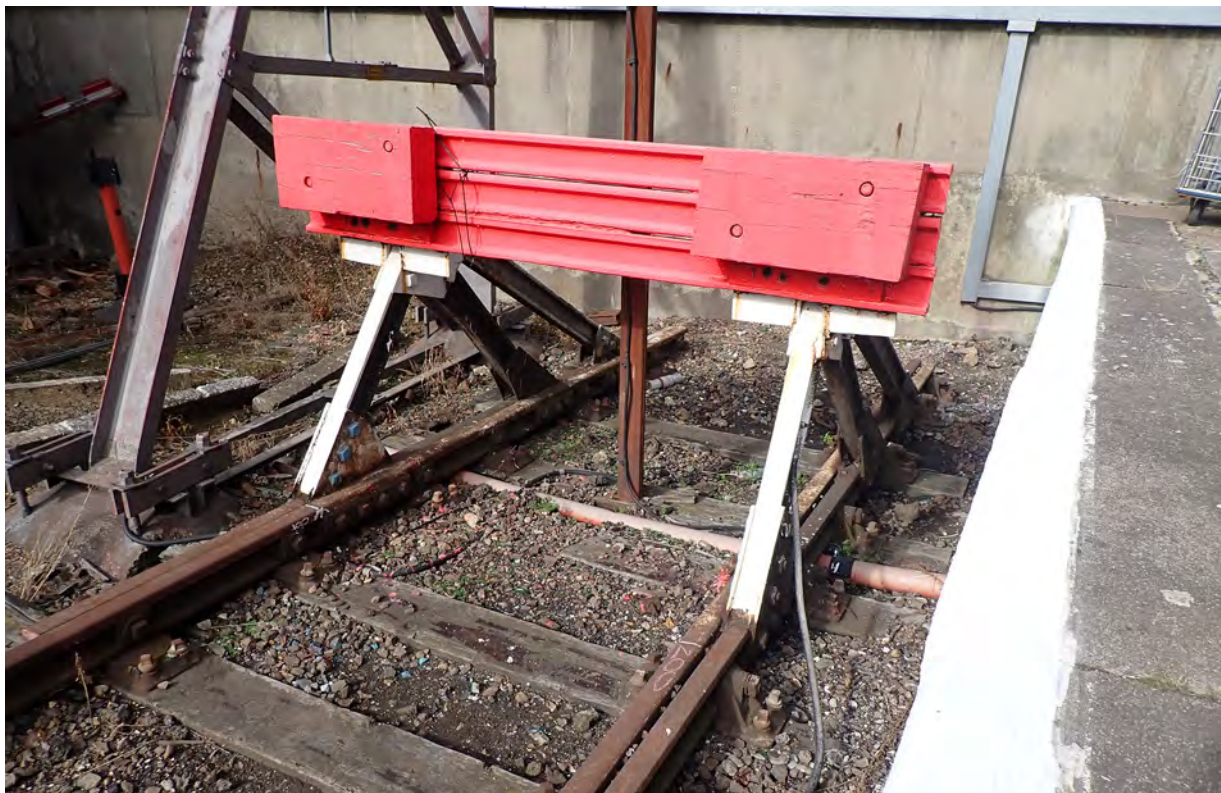
- 7 The accident occurred at the buffer stop at the end of platform 2 at Enfield Town station (figure 4). The buffer stop was a fixed, non-energy-absorbing type.

Figure 4: Type of buffer stop at Enfield Town station (platform 3 shown)

- 119 Network Rail has replaced all the platform buffer stops at Enfield Town with an energy absorbing type that is compatible with the class 710 rolling stock and that fits in the limited platform space currently available. It has also reduced the maximum allowable speed for trains approaching the platforms to 10 mph (16 km/h). Network Rail has assessed that these measures will reduce the calculated risk value to less than 1 FWI per 100 years.

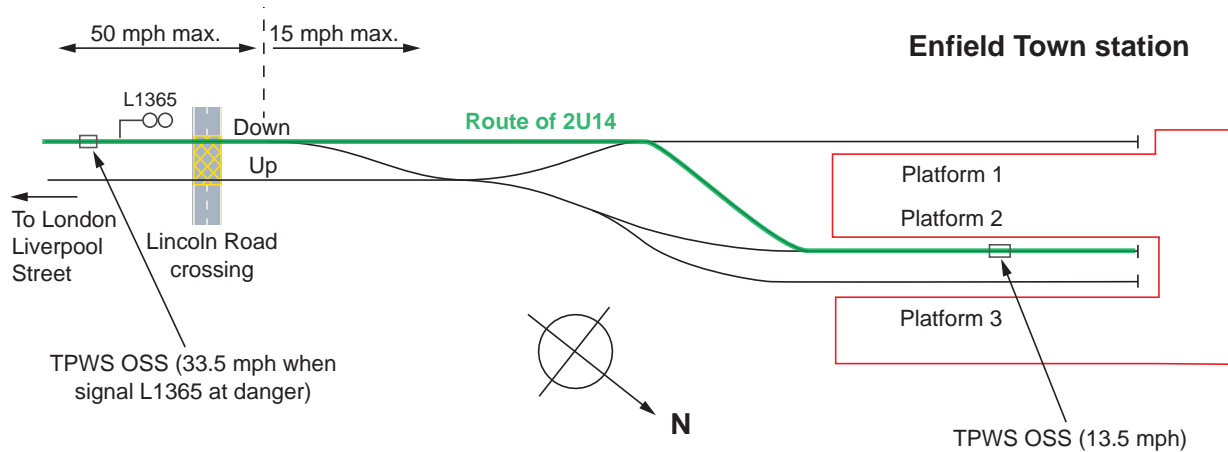
- 8 Enfield Town station is at the end of a two-track branch line, and consists of three terminal platforms (figure 5). Signalling is controlled from London Liverpool Street Signalling Centre. The line is electrified using 25 kV overhead line controlled from Romford Rail Operating Centre. The maximum permitted speed on the approach to the station is 50 mph (80 km/h), reducing to 15 mph (24 km/h) in the station area. Trains enter the station on an uphill gradient of 1 in 121 before running into level platforms.

Figure 5: Track layout at Enfield Town station, showing the route of train 2U14

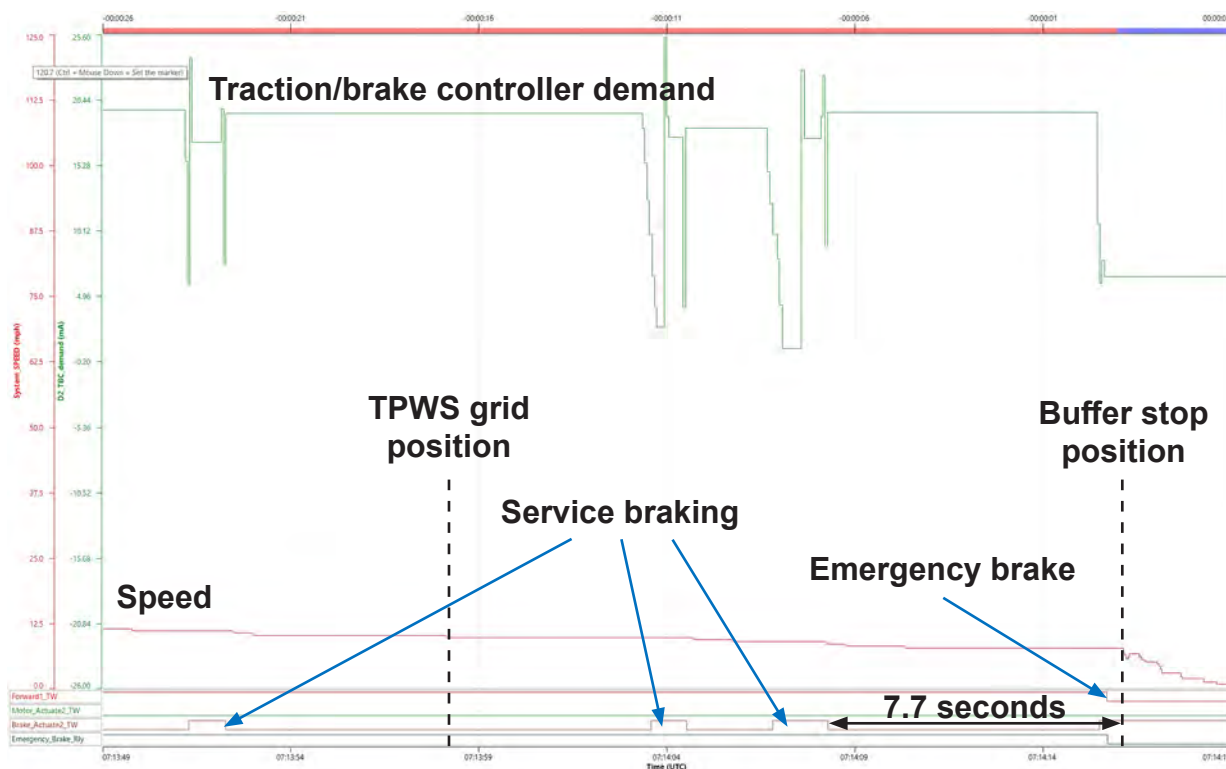
- 33 OTDR data shows that the driver applied the emergency brake about 0.5 seconds (approximately two metres) before the train collided with the buffer stop. No control actions were recorded in the seven seconds before the driver applied the emergency brake (figure 7).

- 34 Before this emergency brake application, the last recorded actions by the driver were two brake applications starting about 12.5 seconds before the collision (about 46 metres from the buffer stop), and ending 7.7 seconds before the collision (about 27 metres from the buffer stop).

Figure 7: Train data showing driver control actions before the collision

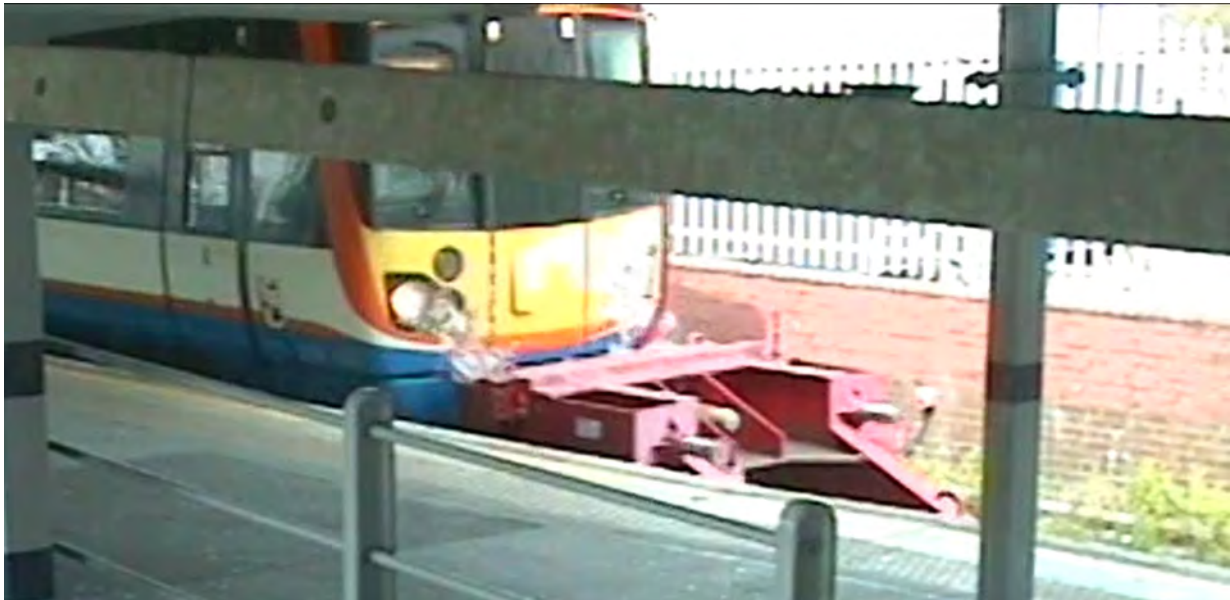
105 RAIB is also aware of a collision that occurred at New Cross station on 10 April 2022, involving a different type of train operated by ARL. The train collided with a buffer stop at a similar speed to the accident at Enfield Town. This buffer stop was of a more modern design than that at Enfield Town. It was intended to be compatible with the coupler of trains using the platform and to absorb energy by sliding along the rails in a collision (figure 8). In this collision, the train's kinetic energy was absorbed in a controlled fashion by the buffer stop, rather than by the buffer stop collapsing and lifting the train into the air. The result was that the train suffered no damage and was able to return to service the next day, demonstrating the benefits of an energy absorbing buffer stop that is designed to be compatible with the rolling stock.

Figure 8: Collision at New Cross on 10 April 2022, showing energy absorbing buffer stop (image courtesy of Arriva Rail London)
