Maritime &  
Coastguard  
Agency

# SS Richard Montgomery: Survey Report 2022

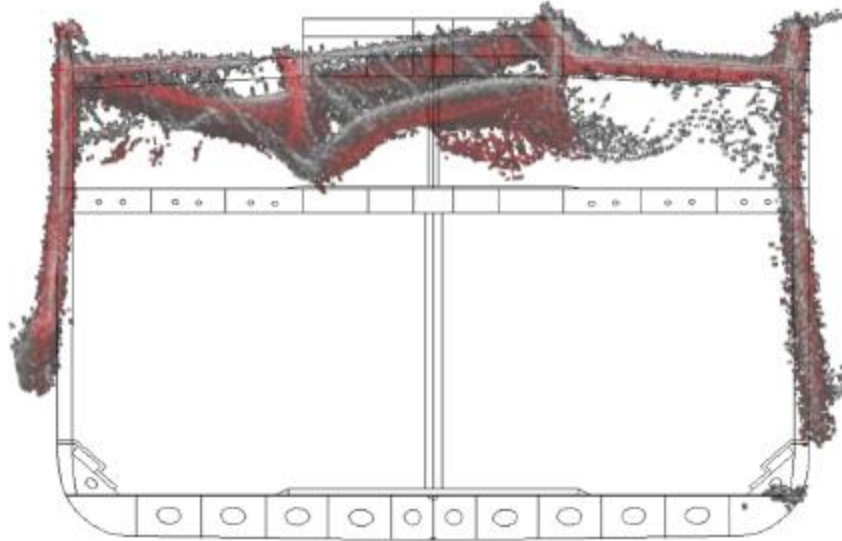
Figure 5: Crack in the hull (port side, forward section) and collapse of cargo Hold 2 deck (port side, forward section).

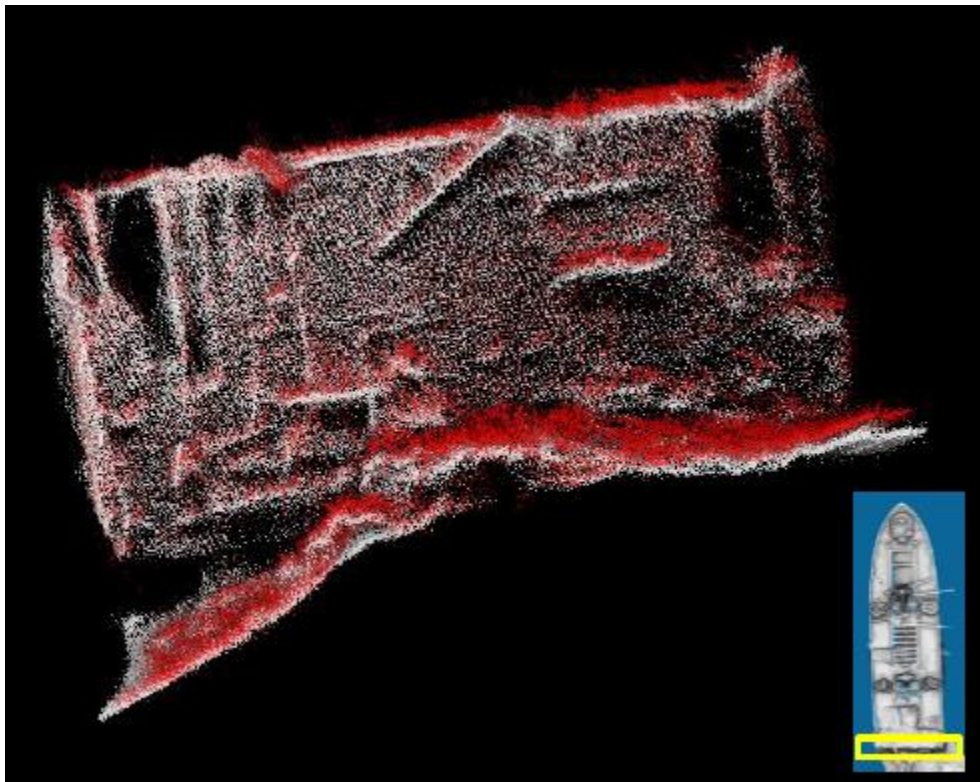
**4.1.5** Key area 3, Aperture (Aft end, forward section).

Figure 6: Aperture (Aft end, forward section).

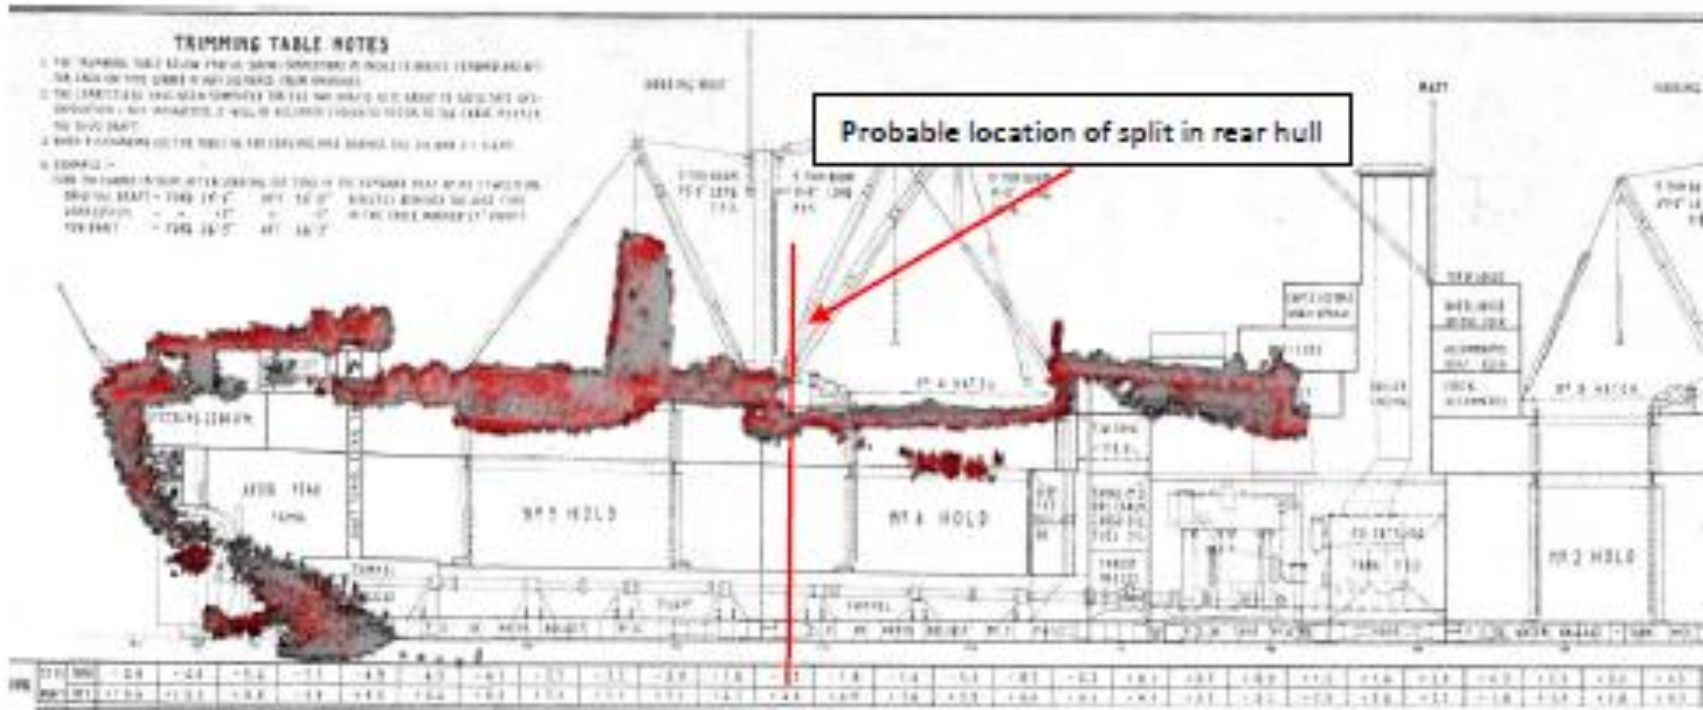
**4.1.6** Key Area 4, Split in the hull (Starboard side, aft section near the aft mast house).

Figure 7: Longitudinal profile through the stern section.

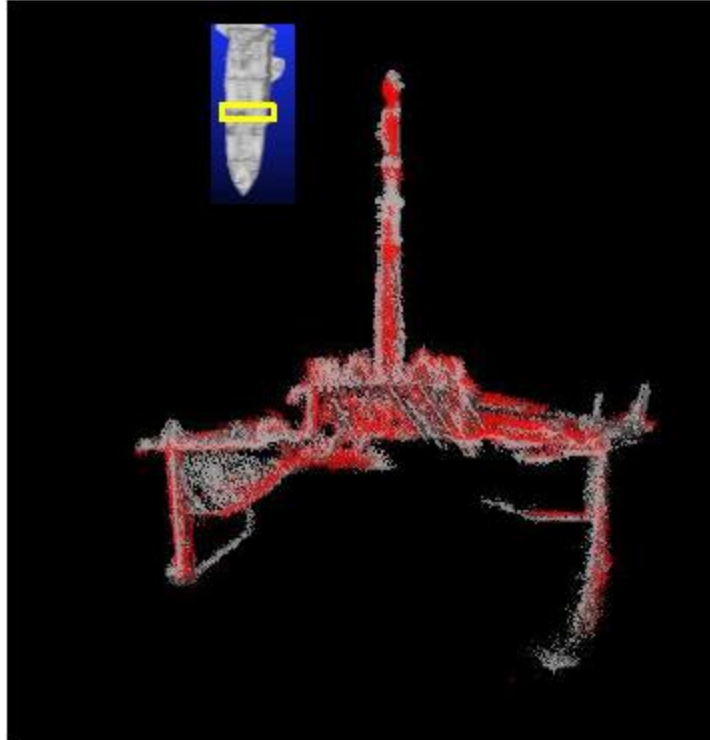
4.1.7 Key Area 5, Split in deck and split in the hull (Aft section, port side)

*Figure 8: Split in deck and split in the hull (Aft section, port side).*

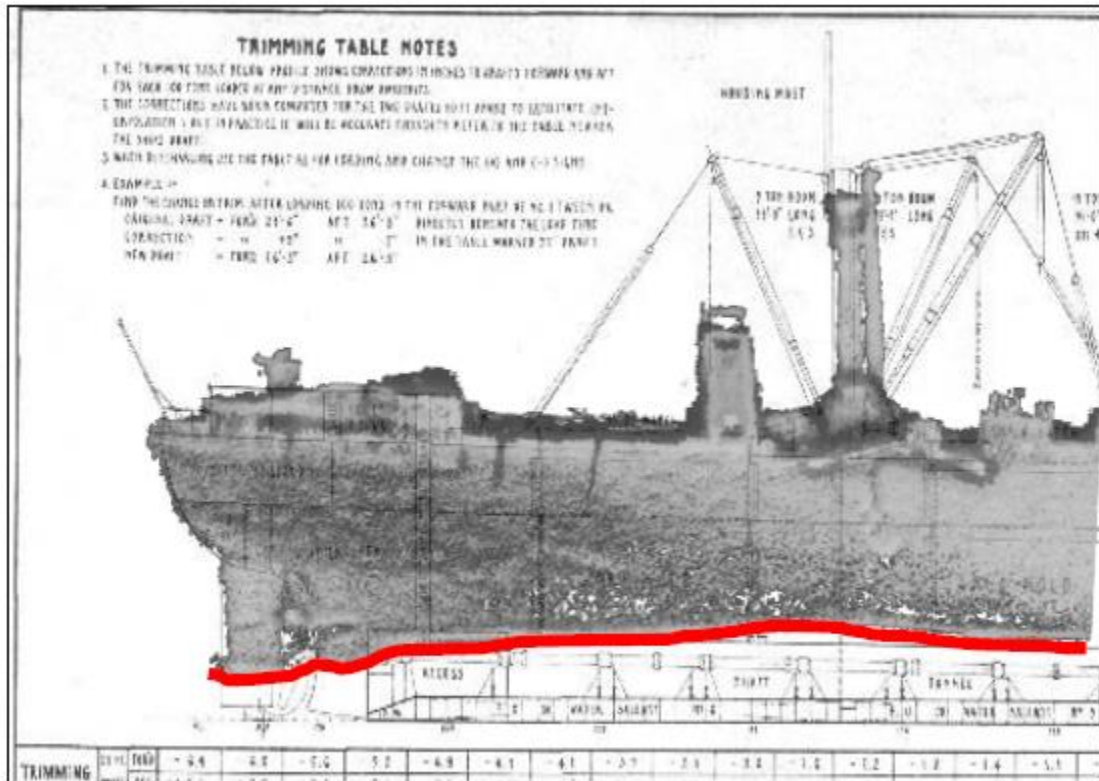
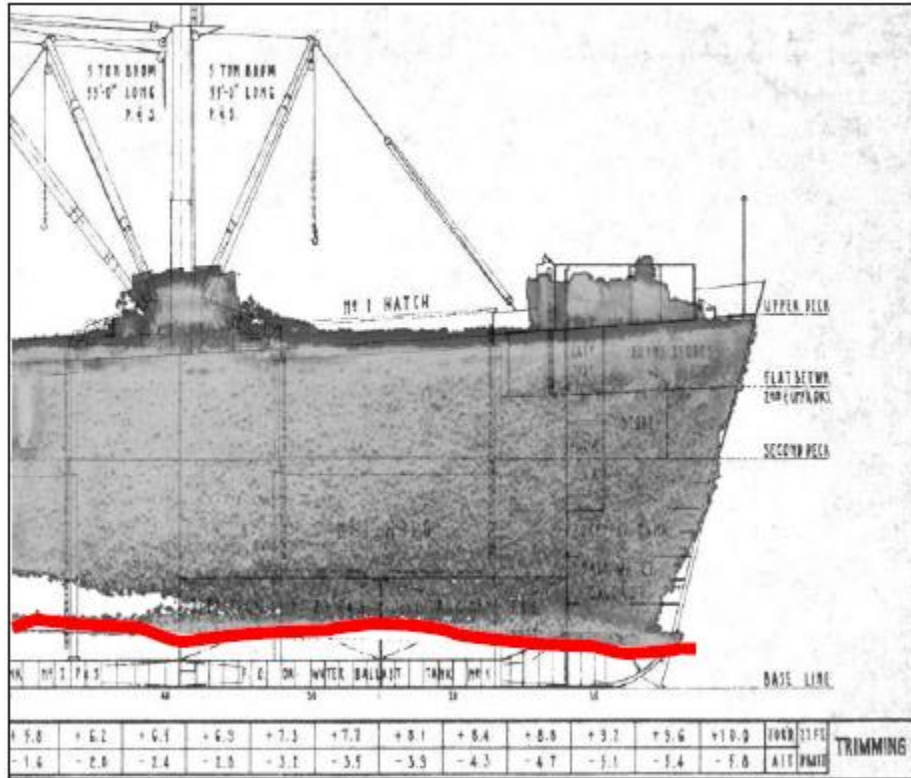
The degree to which the bow and stern may be undercut as the supporting sediment is eroded away is a potential concern. For information on the seafloor please refer to 5.1. Figure 11 and Figure 12 below show profiles from the October 2022 survey overlaid on a Liberty Ship Plan. Although the data on the seafloor has been removed from the profiles, it can be seen in both cases that the bow and stern are both still resting on, or are slightly embedded in, the sediment so remain supported.

4.2.4 The stern generally shows less than 10cm change although there is evidence of some deposition at the rudder of potentially up to 1m. These small depositions/erosions of sediment at the bow and stern appear to be cyclical with sediment being eroded then deposited potentially in a short time period but leaving the overall depths essentially unchanged from year to year.

Figure 11: Profiles of the starboard Stern taken from October 2022 Survey data overlaid on a Liberty Ship's plan.

Figure 12: Profiles of the starboard bow taken from October 2022 survey data over laid on a Liberty ship's plan.

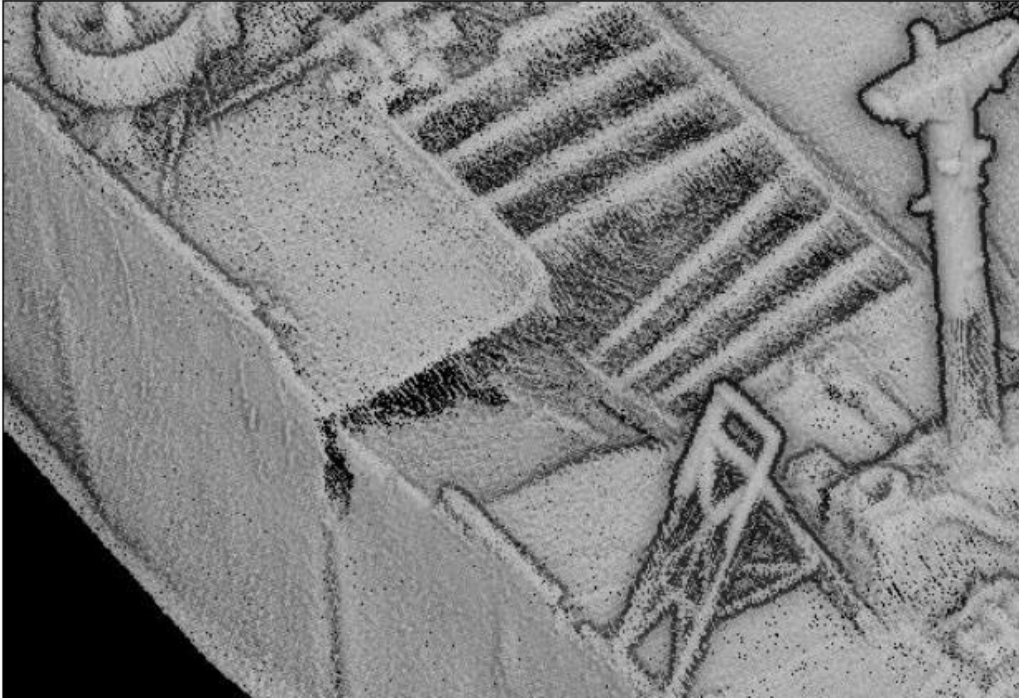
The forward section of the Richard Montgomery is seriously hogging around frame 53 almost exactly halfway along the No. 2 Hold Hatch. This hogging has resulted in a crack appearing on the upper part of the port side while the lower part of the starboard side is significantly buckled giving the appearance that the forward part of the wreck is splitting in two and pivoting about the starboard rim of Hold 2. The flexing of the upper deck has caused a portion of the upper deck and half of the No. 2 hatch cover supports to collapse through into the 'tween deck space.

Figure 13: Crack in Hull (ID04) and Collapsed Upper Deck (ID 08) overview from the October 2022 dataset.

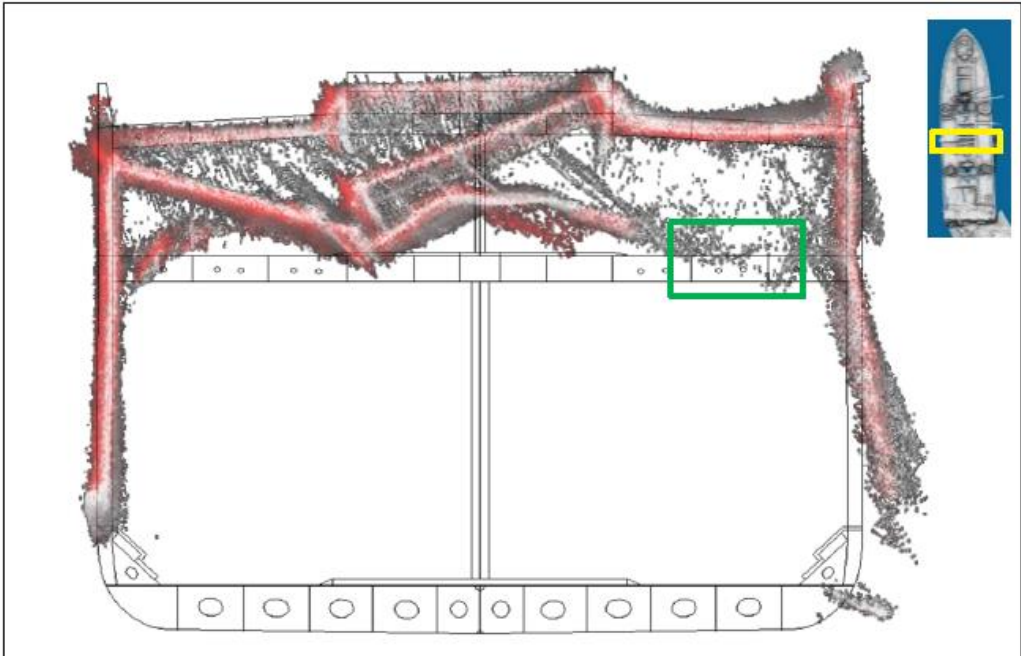
Figure 14: September 2022 (grey) and September 2021 (red) data overlaid on a Liberty Ship section.

- 4.2.6** Overlaying the 2022 and 2021 survey data on a section plan through a Liberty Ship shows the extent of the upper deck collapse as seen in Figure 14. The figure shows the location of the split and deck collapse with, on the left, both the non-collapsed deck and the collapsed deck. The collapsed upper deck and coaming to Hold 2's hatch have not quite fallen to the level of the second deck although it appears that the deck has collapsed until being supported by the sediment within the 'tween deck space.

- 4.2.8** Also of note is the fact that the sediment in the 'tween deck space does not fill the space to the height of the starboard coaming of the hatch. In all other holds the sediment does fill the starboard side to the height of the hatch coaming. Why this has not happened here is not known but may be related to the crack in the hull on the starboard side allowing the sediment to wash out of this space rather than being trapped in it.

**4.2.9** There is evidence, in Figure 14, for a breach/buckling of the lower deck (green box), however due to the lack of change to the rest of the deck plates and sediment level within the hold it is highly unlikely that this is recent and more likely down to this survey having ensonified the area better. Note the extreme bulging outward of the hull plates on the starboard side as seen in Figure 14. The bulge is limited to Hold 2 and the form of the hull returns to normal at the bulkheads at either end – potentially due to the greater strength afforded to the hull by the presence of the bulkheads. This bulging seems to have remained stable over the last few surveys.

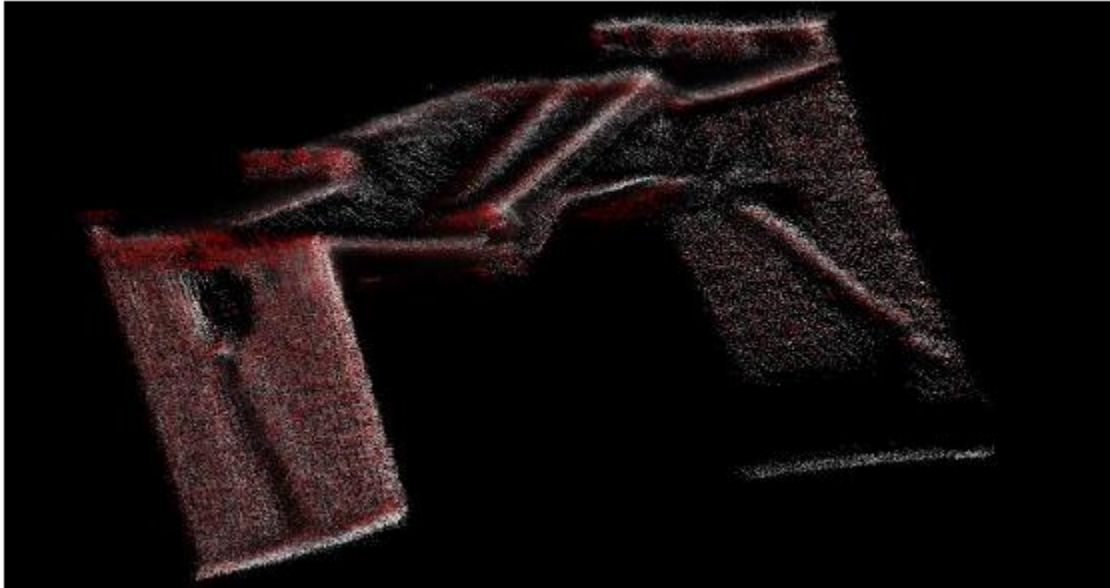
Figure 15: Buckling of the Hull port side inward starboard outward. Red 2021 and Grey 2022 data.

- 4.2.7** The crack in the hull is at the location shown above in Figure 14 and enhanced in Figure 15. Of note is the sediment to the left (port side) that appears to extend deeper in the hull than the second deck level indicating that the second deck has been breached in this area – not surprisingly since the hull has split here and hence a tear in the second deck would be expected. How much sediment has entered the lower hold cannot be determined from this image though.

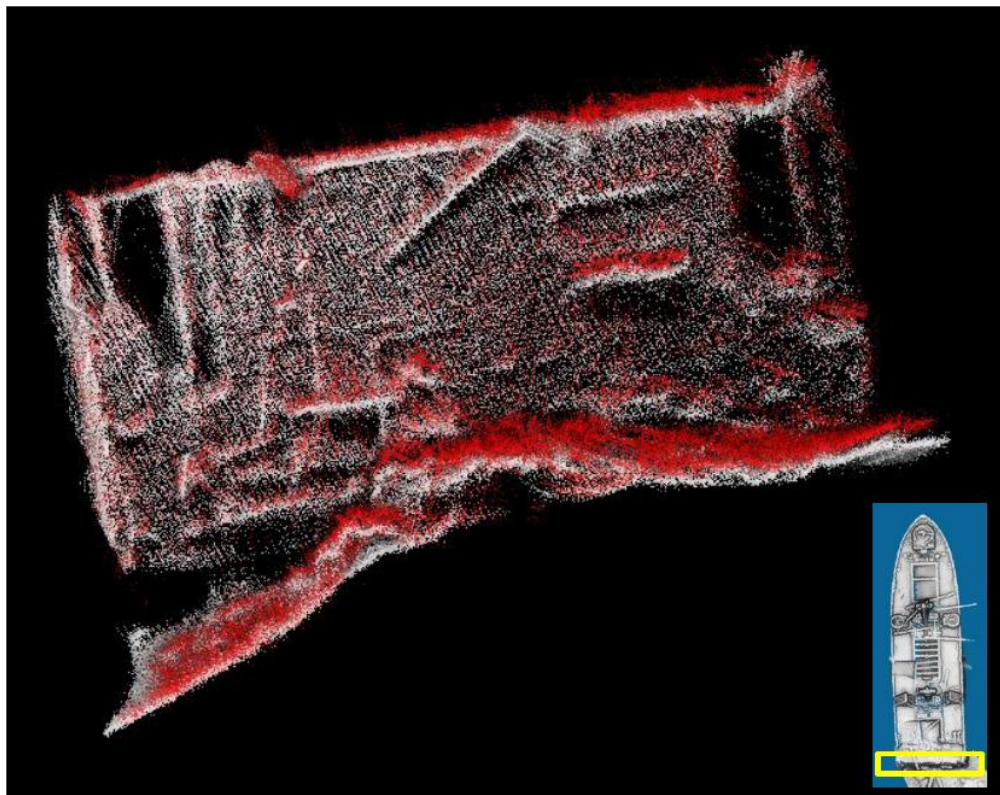
Figure 16 shows the apertures on the bulkhead at frame 88 at the aft end of the forward section, which are clearly visible in the 2022 dataset although there is no appreciable difference between this survey and that from September 2021.

Figure 16: Aperture in the Bulkhead to rear of Hold 3. Grey October 2022, Red September 2021.

**4.2.11** The poor quality of returns of objects obtained through the aperture mean it is not possible to identify them. The data collected during this survey shows very similar dimensions to what was gathered during the survey of September 2021. However, whether the returns are from cargo in the hold or sediment surrounding them cannot be ascertained.

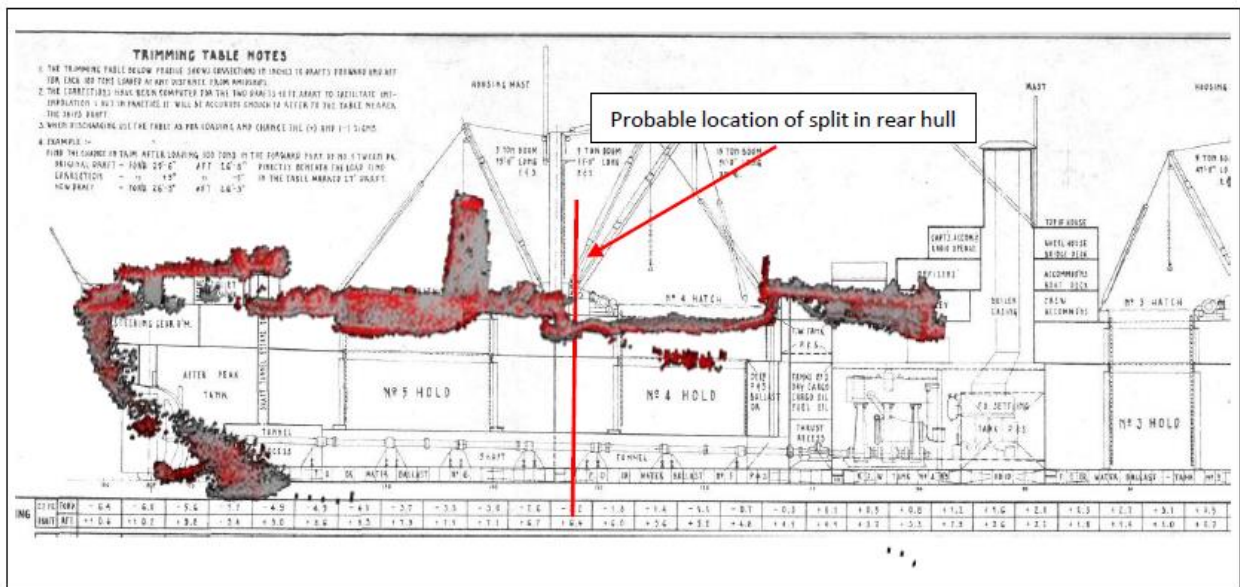
Areas 4 and 5 represent the two ends of the same feature, namely a transverse crack across the rear hull section at about frame 134, the bulkhead between holds 4 and 5. Like the forward section, the rear section is hogging and potentially breaking in two about halfway along its length. The split appears to be occurring just forward of the mast with the mast remaining upright with respect to the stern part as it drops away from the forward part.

Figure 17: Longitudinal profile through the stern section. Grey October 2022, Red 2021.

**4.2.13** No noticeable change has occurred to the angles or orientation of the wreck between the September 2021 and October 2022 surveys although some variation is apparent to the sediment in Hold 4 and the collapsing Bridge deck. In Figure 17 above, the ship's plan has been positioned and orientated so the forward part of the stern aligns with the survey data showing how far below the plan the rear of the data lies.

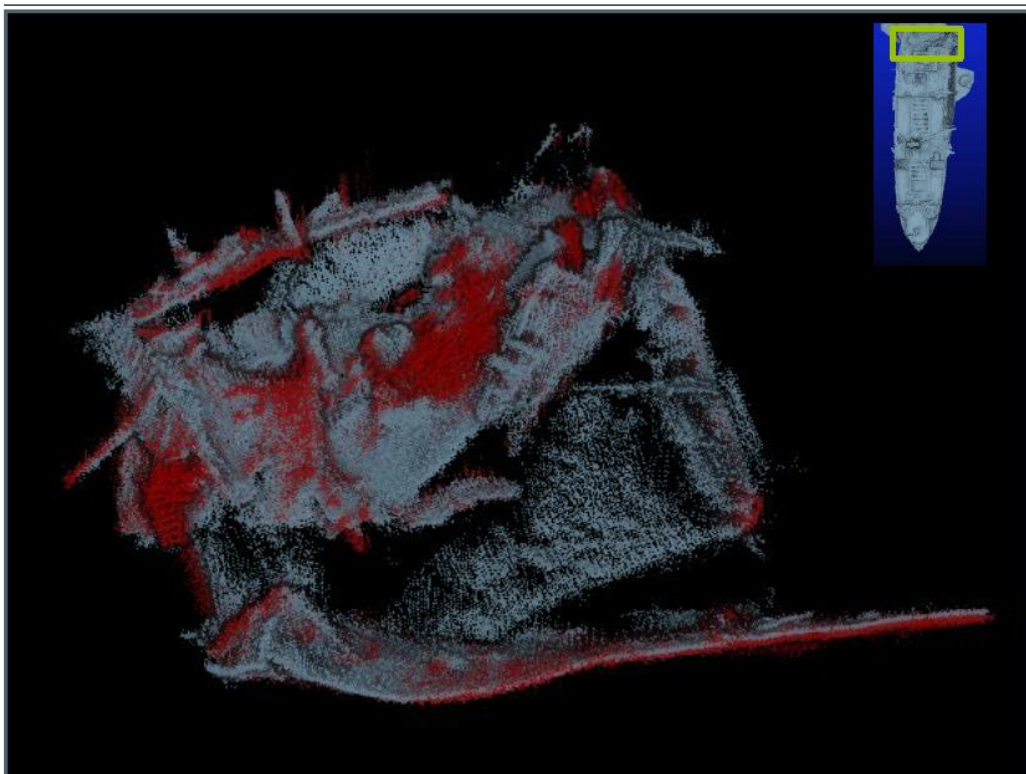
This area was left unsupported when the ship broke in two back in 1944. Consequently, it has been badly affected by wave and current action and is steadily collapsing and falling into the gap between the two halves of the vessel. This area has showed significant degradation in earlier surveys but there is only minor change between the 2021 and 2022 surveys although there appears to be some evidence of degradation and a slip of debris.

- 4.2.15** The area is difficult to survey accurately as the large number of angular protrusions create numerous echoes and multi path returns, creating a large amount of noise which makes picking out the real features hard. For this reason, the presence, or absence, of a given feature, especially internal structures within the void, are not conclusive of the actual feature existing or not. The main upper surface is more robust, and it is this area that has been used to assess the amount of change in this region.
- 4.2.16** In Figure 18 the change on the wreck is evident from the red areas indicating a higher spot in the 2021 survey whereas the pile on the sea floor is grey indicating a rise over the year.

*Figure 18: Profile through Bridge Deck Area. Grey 2022, Red 2021.*

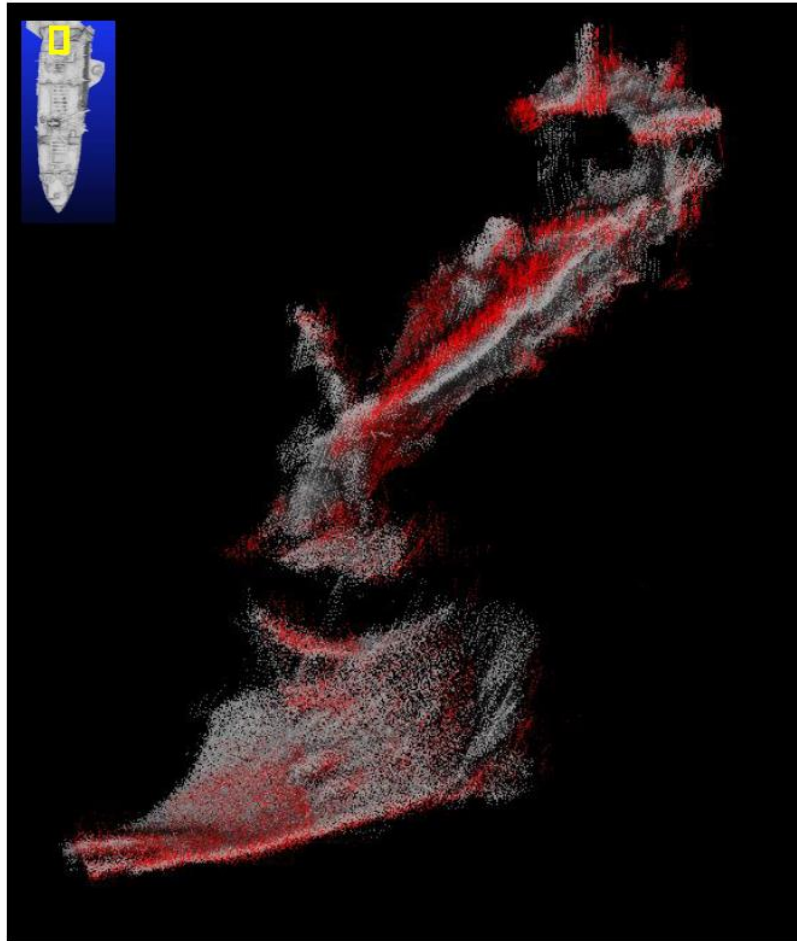
- 4.2.17** Figure 19 below shows a longitudinal cross section through the collapsing Bridge Deck area. The grey (2022) and red (2021) points along the long

unsupported section of deck agree very well at the top but vary significantly towards the left where it appears that the deck has collapsed to the lower floor level. This does not seem to have altered the general level of that section of wreckage, but it is possible that this structure may fail completely in the future and fall into the gap between the two halves of the ship.

*Figure 19: Longitudinal cross section through forward end of rear section showing area of continued change.*

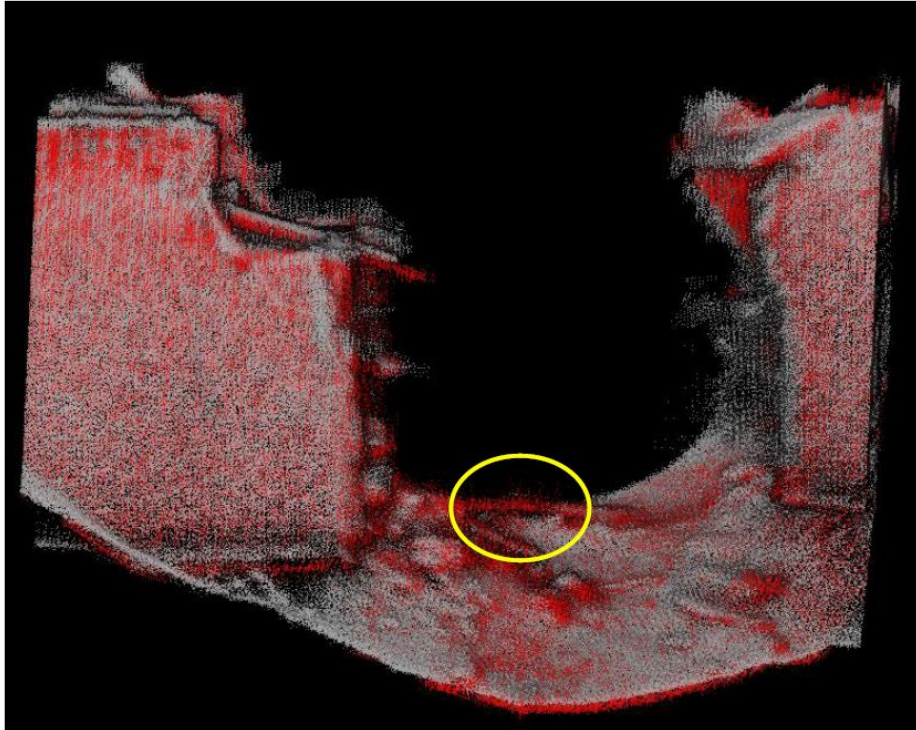
- 4.3.1** There has been very limited appreciable difference in the debris between the bow and stern section. In Figure 20 below the only appreciable difference is that the pipe (or similar structure) sticking out from the debris pile at the base of the front section has rotated so that its free end is now no longer in the image. The pipe is identified in the image below by a yellow circle with the 2021 position in red.

*Figure 20: Longitudinal cross section through forward end of rear section showing area of continued change.*

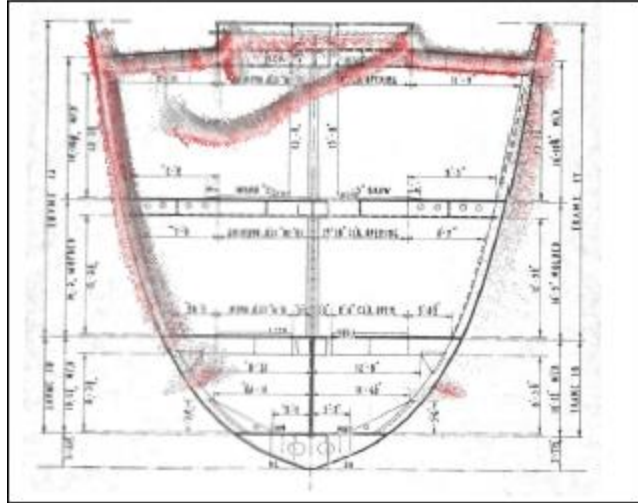
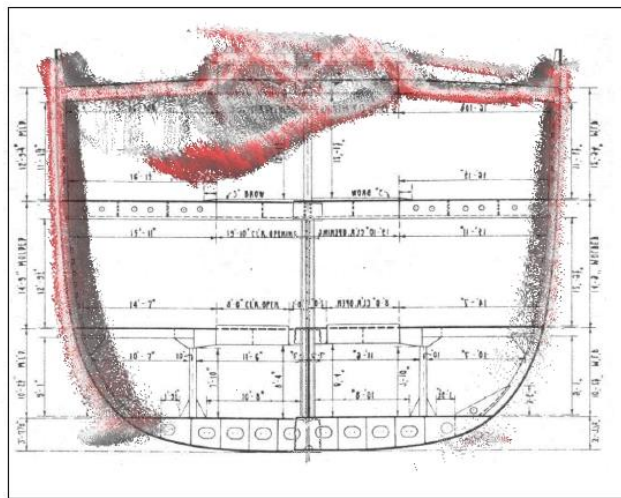
**4.4.6** The Hatch Cover is missing as are all but one of the Hatch Cover Supports. Sediment has settled in the 'tween deck space to a considerable depth, filling the starboard side to the top of the starboard side hatch coaming. The port side remains clear above the horizontal from the starboard hatch coaming. Apart from some undulations in the sediment surface there is no difference between the level identified by the September 2021 and this survey. This is indicative of all the sediment visible in the data as imaged through the open hatch.

**4.4.7** Notably there is no indication that the Second Deck nor the Second Deck hatch covers have collapsed. However, it is possible, but is very unlikely, that the sediment has filled both the 'tween deck area and the Lower Hold. There has been a slight erosion of the sediment in the rear of the hatch area. However, this is likely to be cyclical event with sediment being washed in and out of the open hatch area possibly on a daily basis.

Figure 21: Cross section through the Hull at frames 17-18 at the forward end of No. 1 Hatch. Red September 2021, Grey October 2022.

Figure 22: Cross section through the Hull at frame 32, the aft end of No. 1 Hatch. Red September 2021, Grey October 2022.

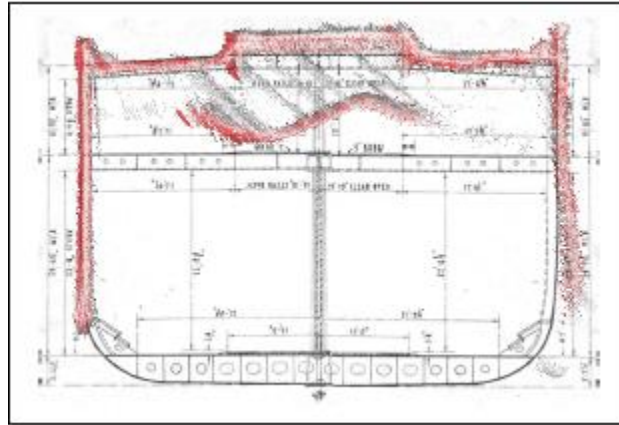
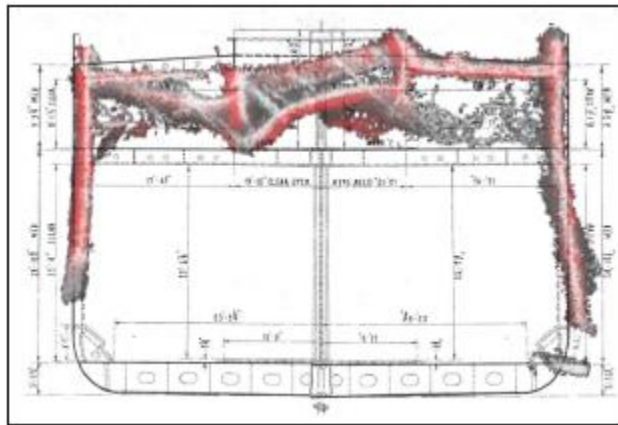
- 4.4.8** The second from forward hold. As with Hold 1, the outer hatch cover is missing although all the cover supports are in place. The forward section of the wreck is splitting at frame 54, nearly mid-way along No.2 hatch, and this has resulted in part of the Upper Deck collapsing into the 'tween deck space bringing the connected hatch cover supports with it. Sediment is visible through the open No. 2 Hatch and similarly to Hold 1, the sediment has filled the 'tween deck space to a considerable depth although, unlike Hold 1, it appears that the sediment has not reached the port side hatch coaming and

the starboard side is not completely filled. Again, there is no indication that the second deck or the lower hatch covers have failed as there is no indicative slump in the sediment.

Figure 23: Cross section through the Hull at frame 46, the forward end of No. 2 Hatch. Red September 2021, Grey October 2022.

Figure 24: Cross section through the Hull at frame 60, the aft end of No. 2 Hatch. Red September 2021, Grey October 2022.

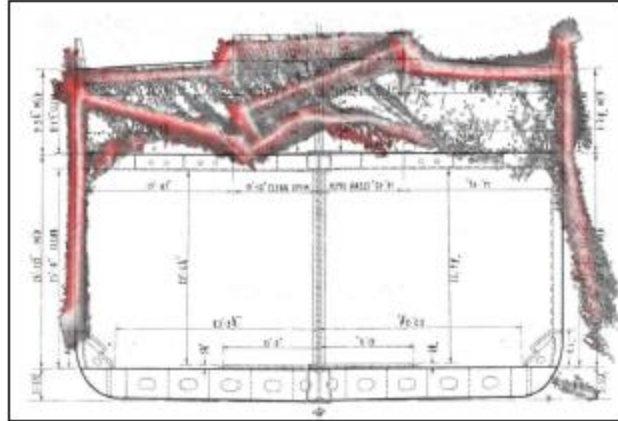
Figure 25: Cross section through the Hull at about frame 54, where the forward section is breaking in two. Red September 2021, Grey October 2022.

**4.4.9** In Figure 25 above, the sediment in the ‘tween deck space of Hold 2 is visible. In this area, unlike the fore and aft ends of No. 2 Hatch, the sediment does not fill the ‘tween deck space. This may be due to the cracks in the hull sides at this location which could allow water to flush through and so remove the upper most sediment layers. It is also possible that the Second Deck has partially collapsed where it joins the port and starboard hull – see the data as collected through the split in the hull in Figure 25 above, although this could also be the result of poor acoustic properties caused by the sound passing through the narrow gap.

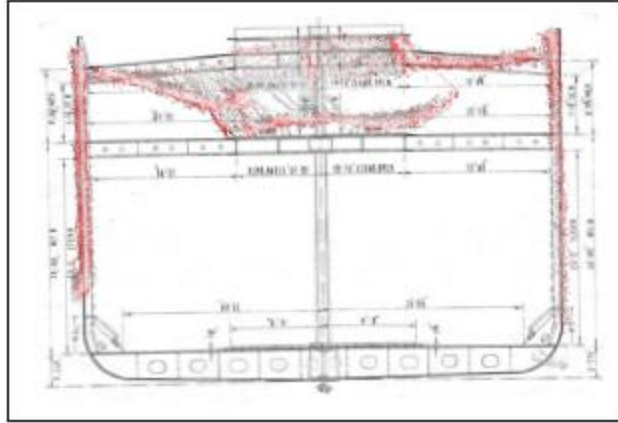
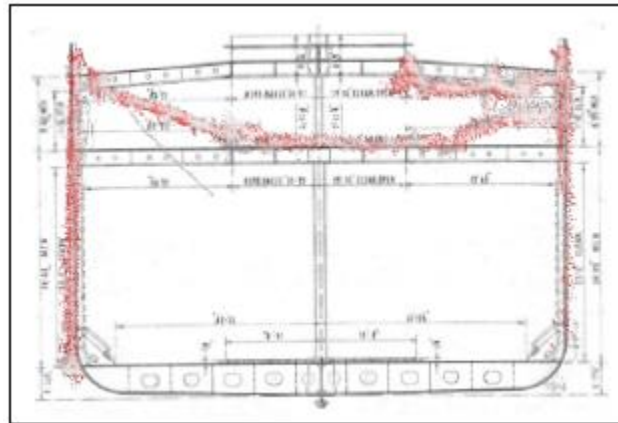
**4.4.10** The rearmost hold of the forward section. The rear bulkhead of this hold forms the rear of the forward section, the vessel having broken in two immediately aft. Although the Lower Hold remained with the forward section, the bulkhead at the rear of the ‘tween deck space and the section of the upper deck above it were carried away leaving this area open. The outer hatch cover has gone as have all the cover supports although there is a beam – possibly a cover support or part of the coaming lying on the starboard side.

**4.4.11** Sediment accumulation is largely limited to the forward part that still retains the protection of the Upper Deck and, in common with all the forward holds there is no evidence that the Second Deck or the cover leading to the Lower Hold have collapsed. All sediment layers are higher than the second deck with no indicative slumps.

Figure 26: Cross section through the Hull at frame 73, the forward edge of No. 3 Hatch. Red September 2021, Grey October 2022.

Figure 27: Cross section through the Hull at frame 82, the aft end of No. 3 Hatch. Red September 2021, Grey October 2022.

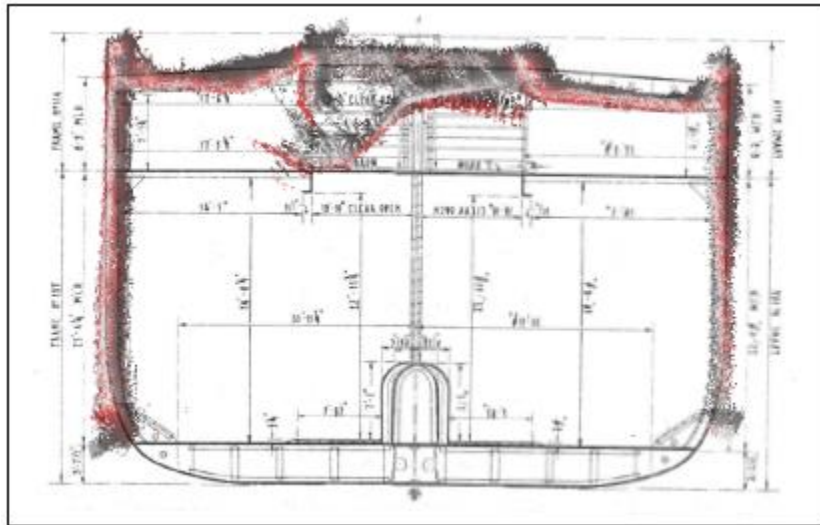
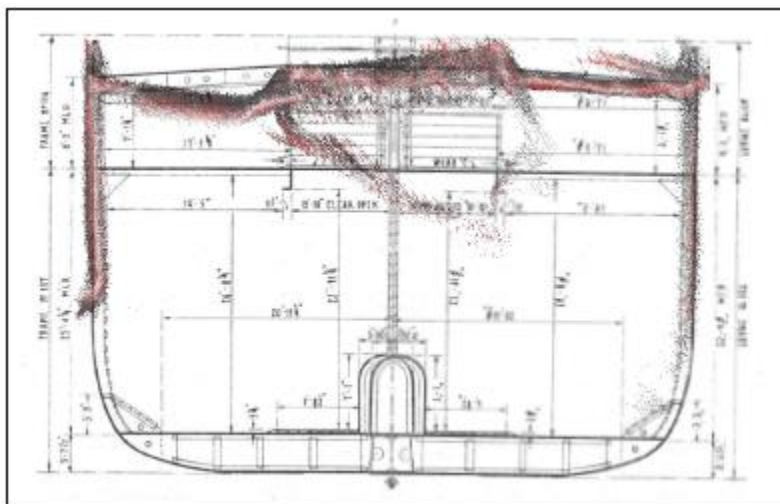
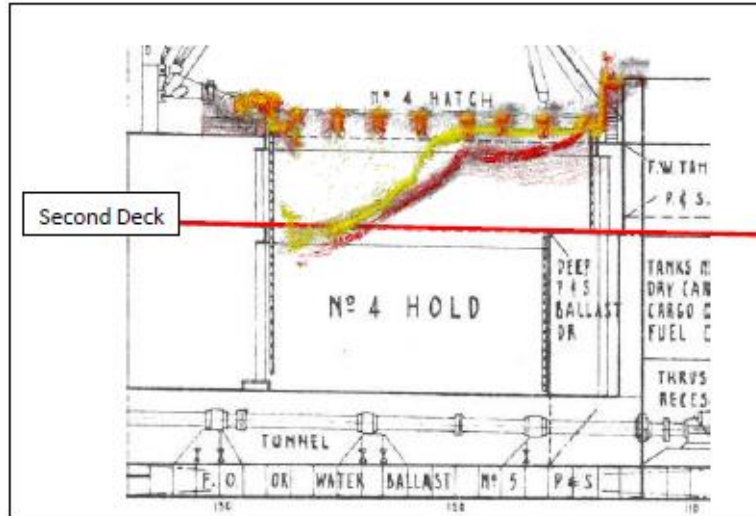
- 4.4.12 The most forward of the two holds in the stern section. Since the two stern holds are reported to have been emptied during salvage operation conducted soon after the grounding it is not known if the lower hatch covers were replaced. However, since the upper Hatch supports are in place it seems likely that the salvors did replace the covers once they were finished.
- 4.4.13 The sediment in the forward part of No. 4 Hatch shows distinct similarities with that in No 1 hatch with the starboard side of the 'tween deck space being completely filled and the port side remaining clear above the horizontal to the top of the hatch coaming.
- 4.4.14 The rear of the hatch area shows the sediment layer descending below the level of the Second Deck due to some form of collapse, probably a partial

collapse of the lower hatch cover which occurred between 2010 (where the survey showed the sediment above the Second Deck) and the 2017 survey where the sediment was just below the Second Deck, this has been included in profile. There has been a reduction in the slope of the sediment below the tween deck which indicates there has been some settling/ current distribution occurring.

- 4.4.15 Overall, there has been little change in the overall volume of sediment but rather a redistribution due to currents within the Hold between September 2021 and October 2022.

Figure 28: Cross section through the Hull at frame 114, the forward end of No. 4 Hatch. Red September 2021, Grey October 2022.

Figure 29: Cross section through the Hull at frame 114, the rear of No. 4 Hatch. Red September 2021, Grey October 2022.

Figure 30: Longitudinal cross section through Hold 4. Yellow September 2020, Red September 2021, Grey October 2022.

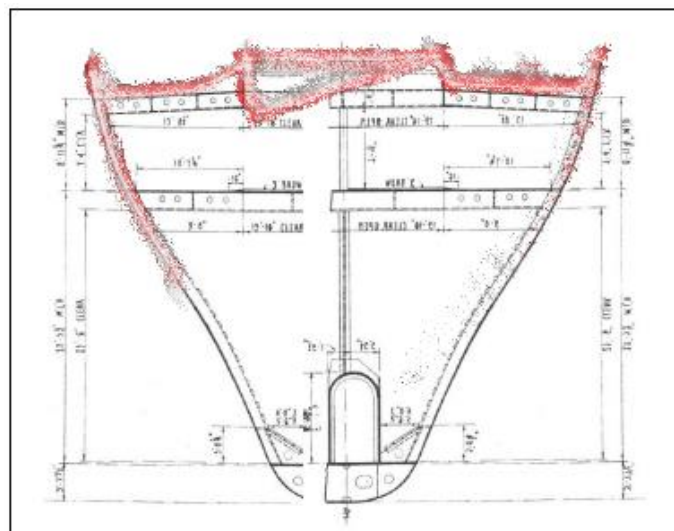
**4.4.16** The rear most hold. The forward four of the six hatch cover supports remain in place. Sediment levels in the 'tween deck space again follow the pattern of the other mainly intact holds in that the starboard side is filled while the port side remains clear above the level of the horizontal from the top of the hatch coaming. As with the other holds (apart from Hold 4), there is no indication that the second deck or the lower hatch cover have collapsed.

Figure 31: Cross section through the Hull at frame 154, the aft of No. 5 Hatch. Red September 2021, Grey October 2022.

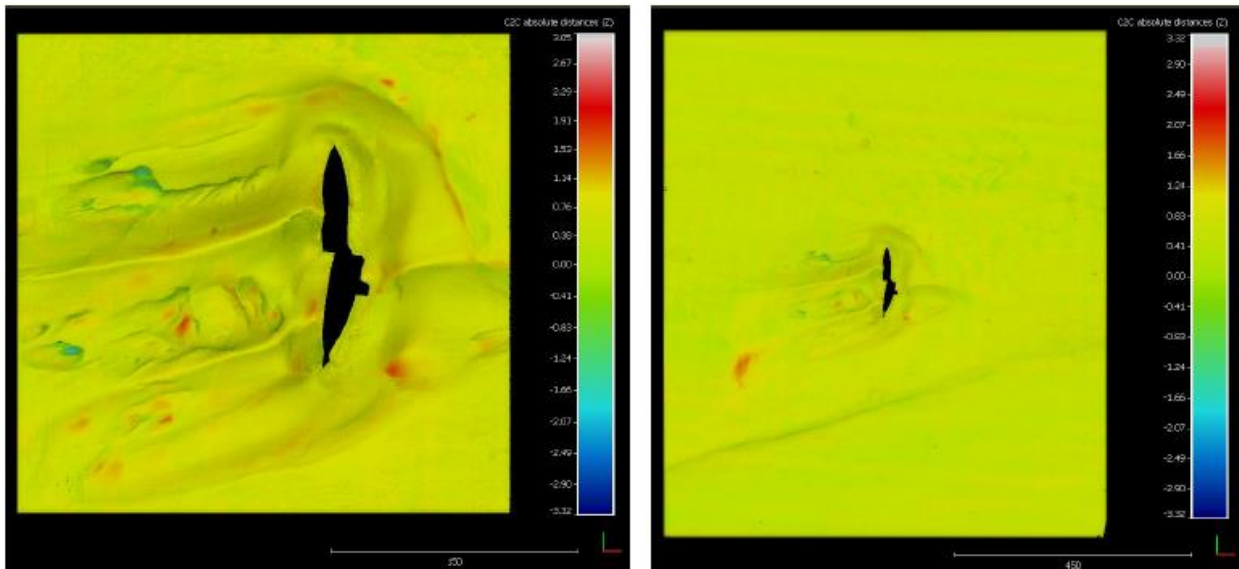
**5.1.3** Figure 33 shows the elevation displacement of the seafloor around the wreck has seen a general increase of around 0.4m between the 2021 and 2022 surveys with areas of greater accretion outside the scour basin with relative height differences in excess of 2m. There is some evidence of scouring in the valleys and ridges heading westward from the wreck with losses ranging from approximately 0.3m in the valleys to the west and the outer face of the scour pit to 1.25m on the north-eastern faces of the large dunes.

*Figure 33: Shaded relief plan showing the wider seafloor around the survey area.*

**5.1.4** Changes to the wider seafloor are shown in Figure 33, the most significant of which being the accumulation of 2m of sediment at the end of the scour channels as a result of net sediment transport running east to west sediment accretion over the wider site is on average 0.4m. Other changes to the wider survey area include minor changes in the level of sediment in the sand waves to the north and west of the site and the erosion of the southern side of the channel by approximately 0.8m.

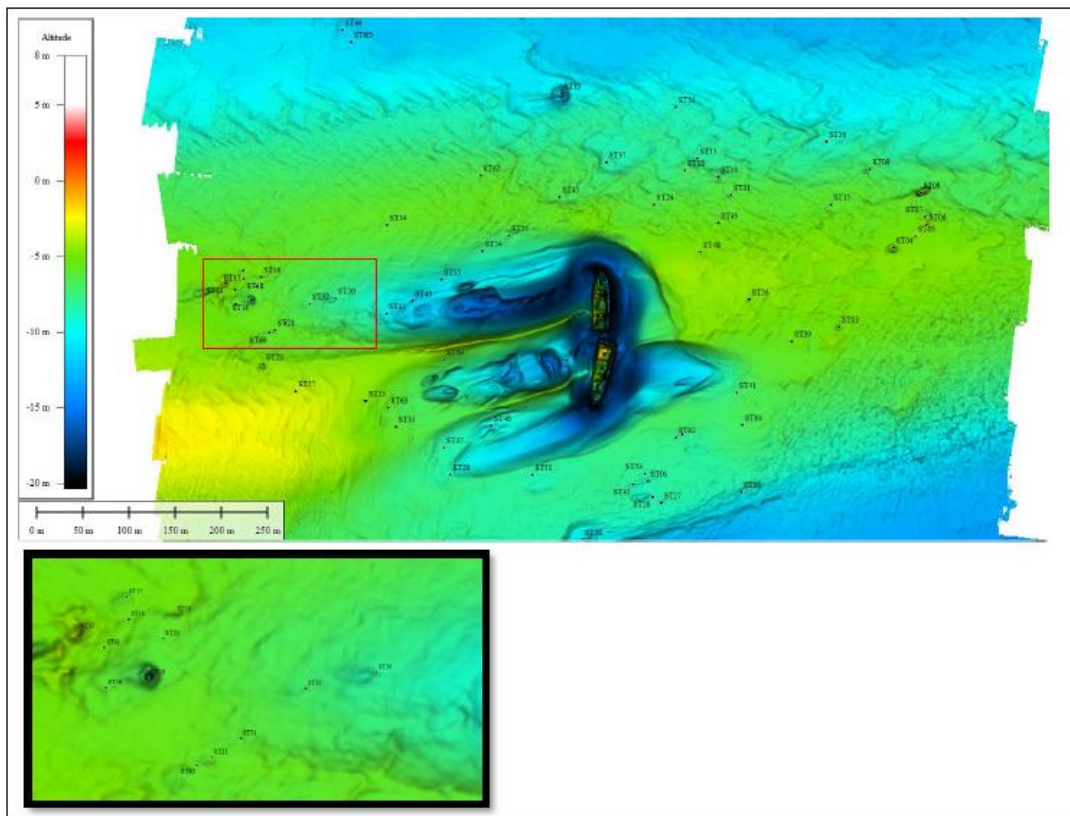
**5.2.1** The seabed contact list from 2017, with a total of 66 contacts, was compared against this year's bathymetry. Analysis of the 2022 dataset has added no further targets to the contact list, while 12 items from the 2017 contact list are not apparent on the 2022 data. The seabed contacts, especially the smaller or lower lying ones, are subject to a pattern of being buried and uncovered by moving sediments. Consequently, their presence or not in any particular year's data set is largely a function of the movement of sediment around and over them.

Figure 34: Seabed reference points.
