Maritime &
Coastguard
Agency

SS Richard Montgomery: Survey Report 2020

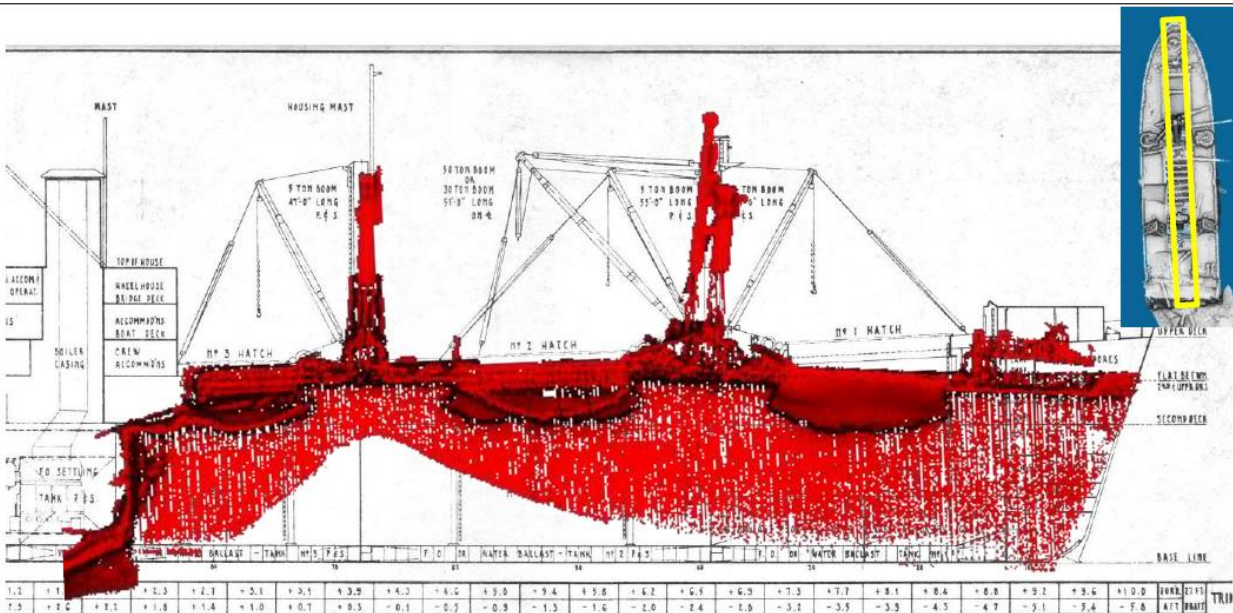
- 4.2.3 **Bow Section**
- 4.2.4 In Figure 8 a cross section through the SSRM wreck overlaid on a sectional plan shows the extreme bulging outward of the hull plates on the starboard side of the bow section. Although this bulging does seem to have remained stable over the last few surveys, its extent is a cause for possible concern, and it is recommended that this area is included in all future reports as an area for particular study. Note that the starboard side is distorted in as well as out and the port side is also distorted in this area.

- 4.2.7 It is likely that the crack, bulge and distortion to the ship's upper deck all happened some time ago and no new movement has been apparent. As there is no indication of subsidence at the bow or stern it can be concluded that the split in the hull is not getting larger and the wreck seems to be stable.

Figure 8 September 2020 Data overlain on ship's plan and oriented – rear alignment.

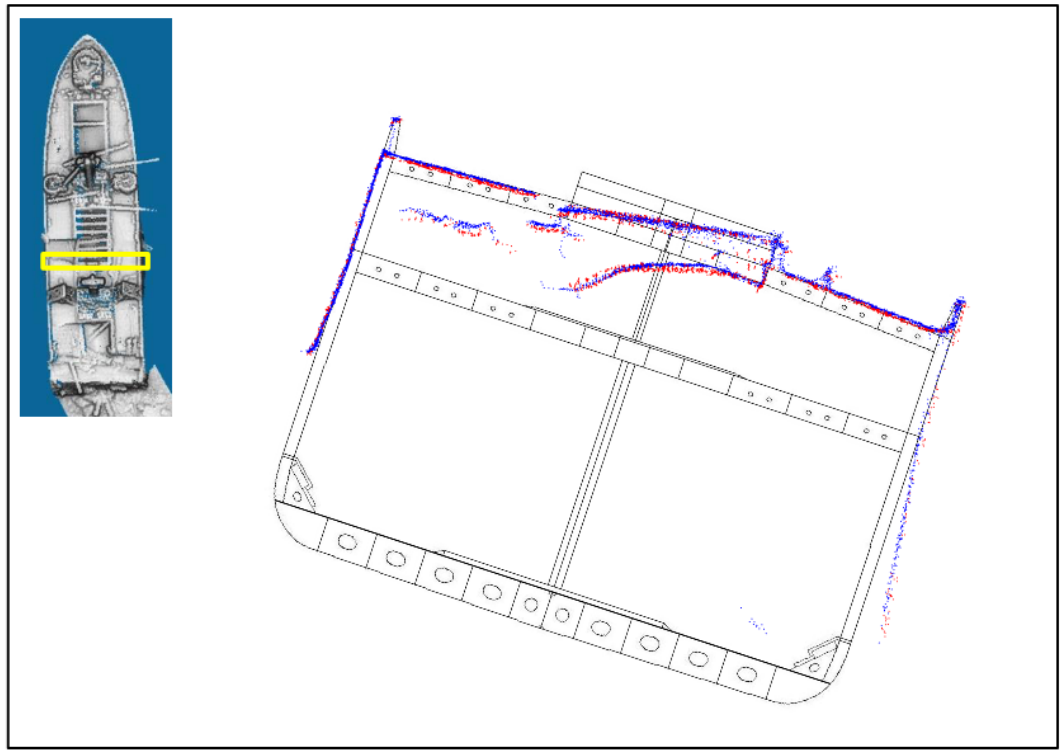
- 4.2.6 The forward hull appears to be buckling at the crack in No. 2 Hold with two distinct levels to the forward hull. Firstly, the rear part from the bulkhead at Frame 88 (the rear of No. 3 Hold) to the crack mid-way along No. 2 Hold (see Figure 9 below). Secondly, from the crack forward (see Figure 10).

Figure 9 Cross section through the hull at frame 60, the aft end of No. 2 hatch. Blue 2017, red 2020.

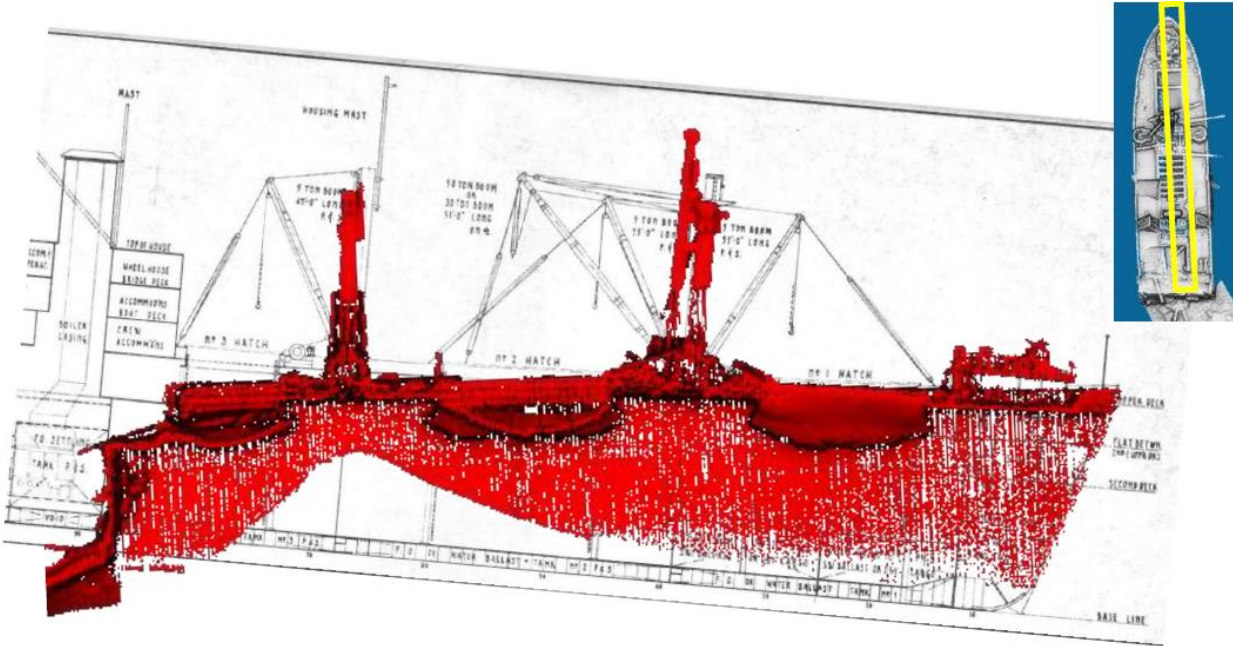
Figure 10 September 2020 Data overlain on ship's plan and oriented – front alignment.

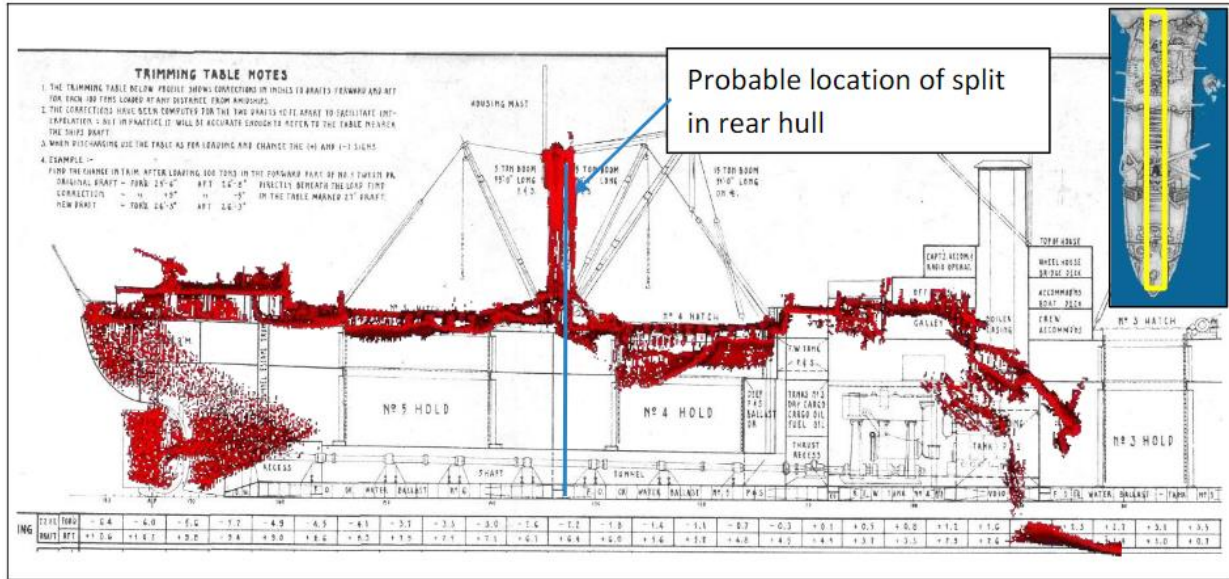
Figure 12 Image of Key Areas 4 and 5: severe splitting of hull showing a slight dip of the stern and the mast.

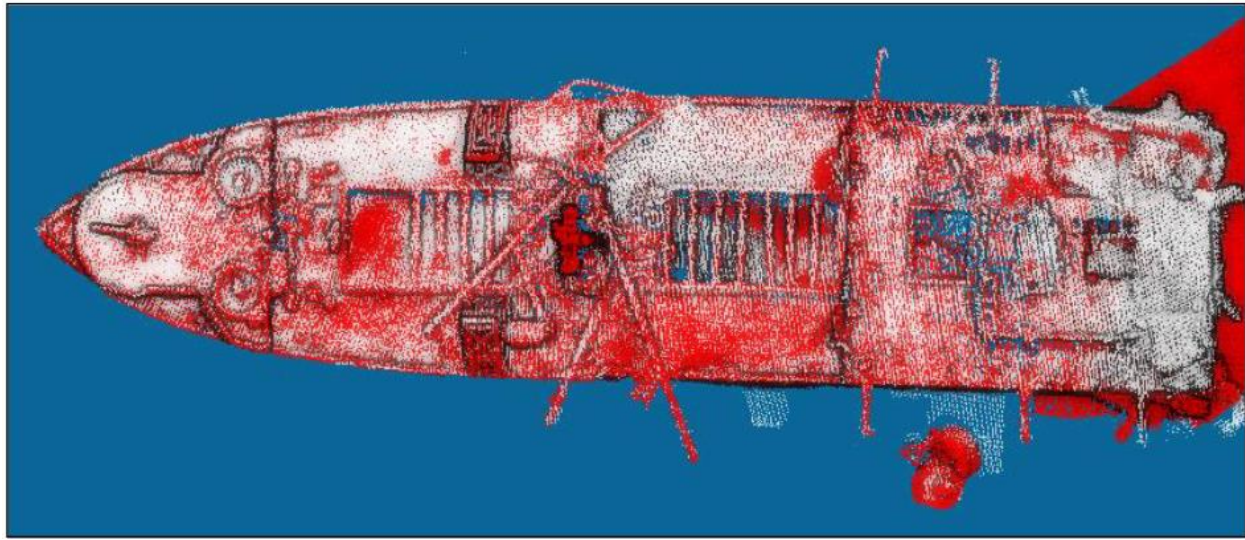
4.2.10 In Figure 13 below, the 2020 survey data is presented with the 2010 survey data. The speckled red/white indicates that the two data sets agree, and that no movement has occurred. Areas of movement are the forward section of the superstructure (to the right of the image) which has collapsed quite a bit over the 10-year gap. Also, the section of decking adjacent to No. 4 Hold. This indicates that this section of decking has subsided over the 10 years probably related to the crack in the hull just forward of the mizzen mast. The crack in the hull was present in 2010 and seems not to have altered much.

Figure 13 2020 data (red), 2010 data (white) of the stern part of the wreck.

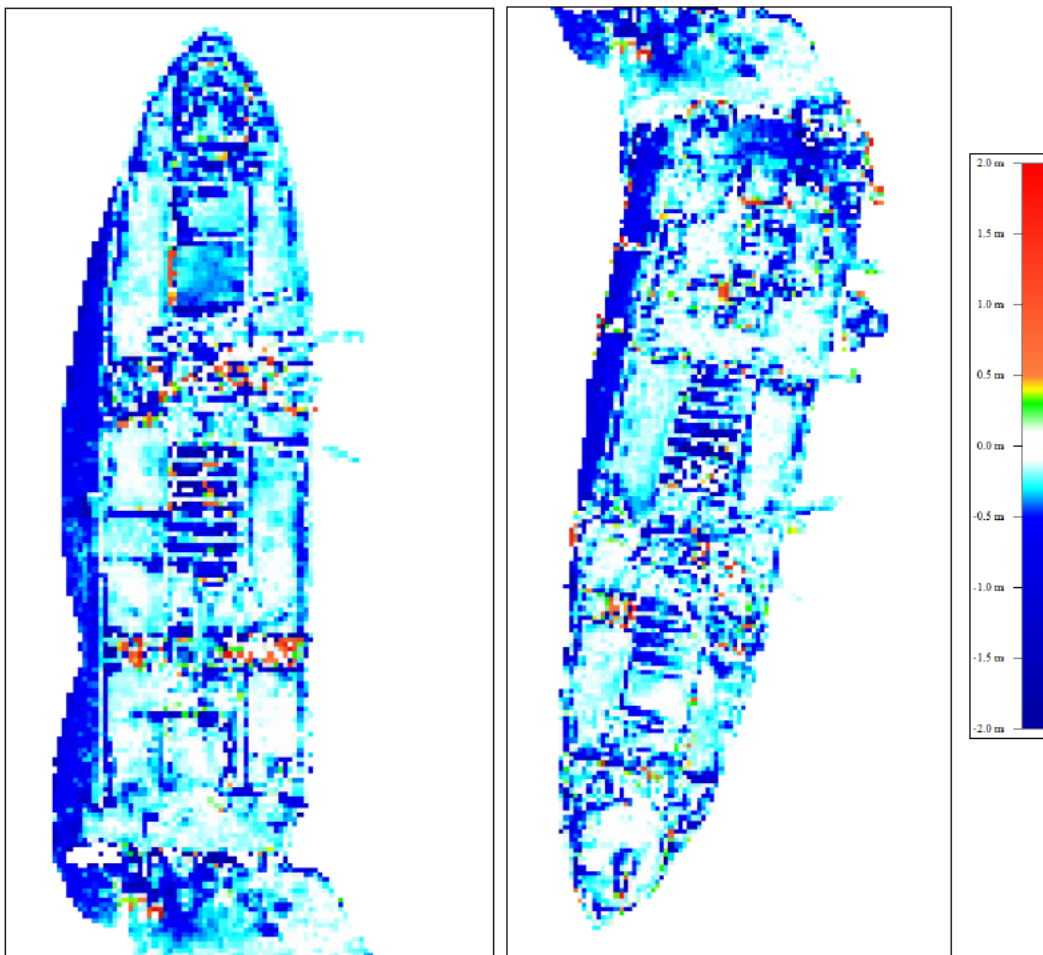
- 4.3.1 Surface differencing provides a useful tool in quickly assessing the general deterioration of the wreck. As described in Section 8.1, the accuracy of final processed data sets has been considered and the scale is graduated to reflect this by discounting any values less than $\pm 0.05\text{m}$. No major areas are assessed to have undergone change between the August 2019 and September 2020 surveys.
- 4.3.2 The red and dark blue areas (indicating significant changes) occur only in areas of great height difference (e.g., the masts, ships sides and life raft support). These areas yield a large vertical difference due to small horizontal changes or the existence of noise in the data, not actual vertical change.

Figure 14 Forward section (L) and stern section (R) surface difference results September 2020 - August 2019.

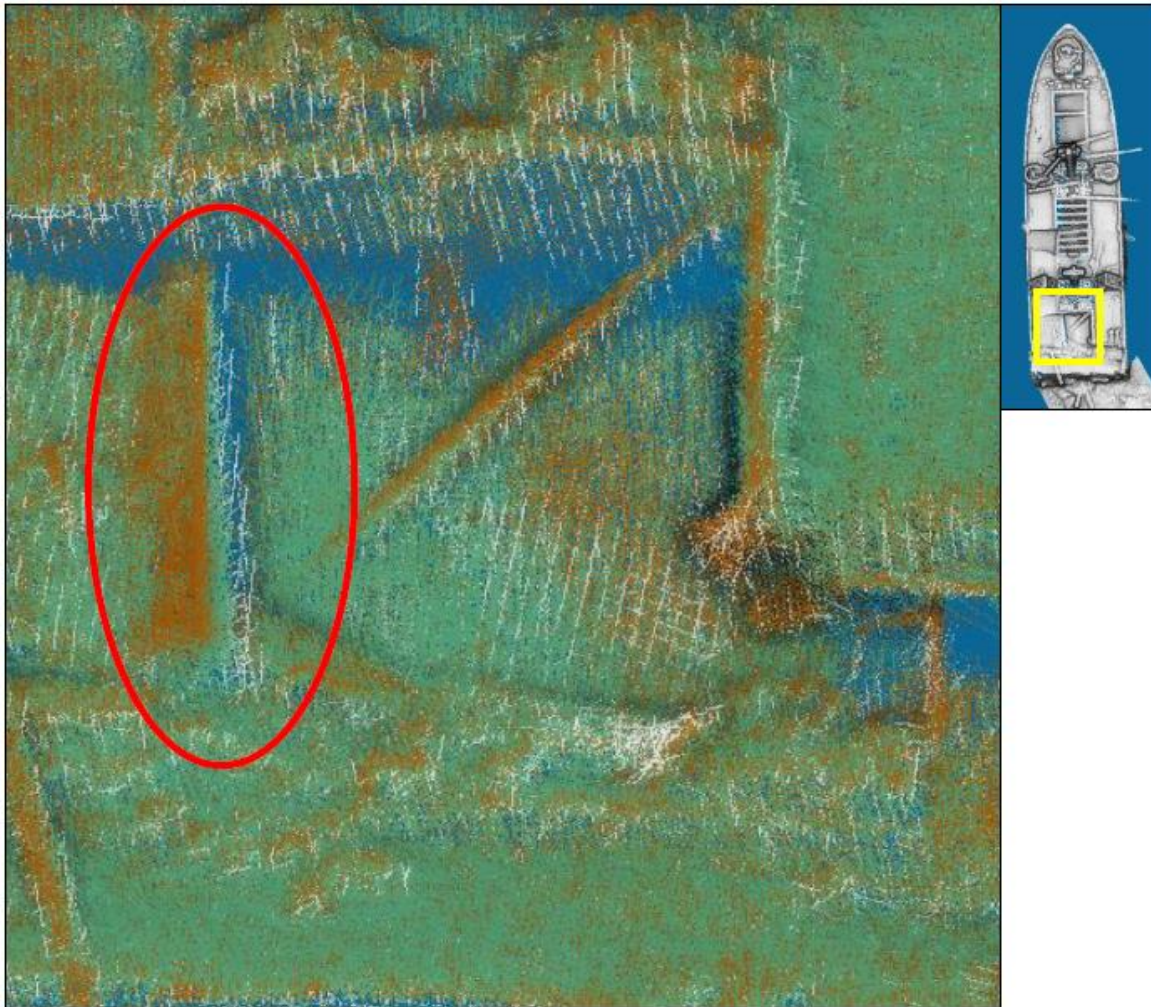
- 4.4.4 The port side coaming of the No. 3 hold hatch has collapsed a short way, the movement is shown in Figure 17 below and indicated by the red oval. The collapse is approximately 0.6m between the 2017 and 2020 surveys and seems to be caused by the coaming rotating clockwise (when viewed from the stern).

Figure 17 No.3 hatch showing movement of hatch coaming. Brown 2017, green 2019, white 2020.

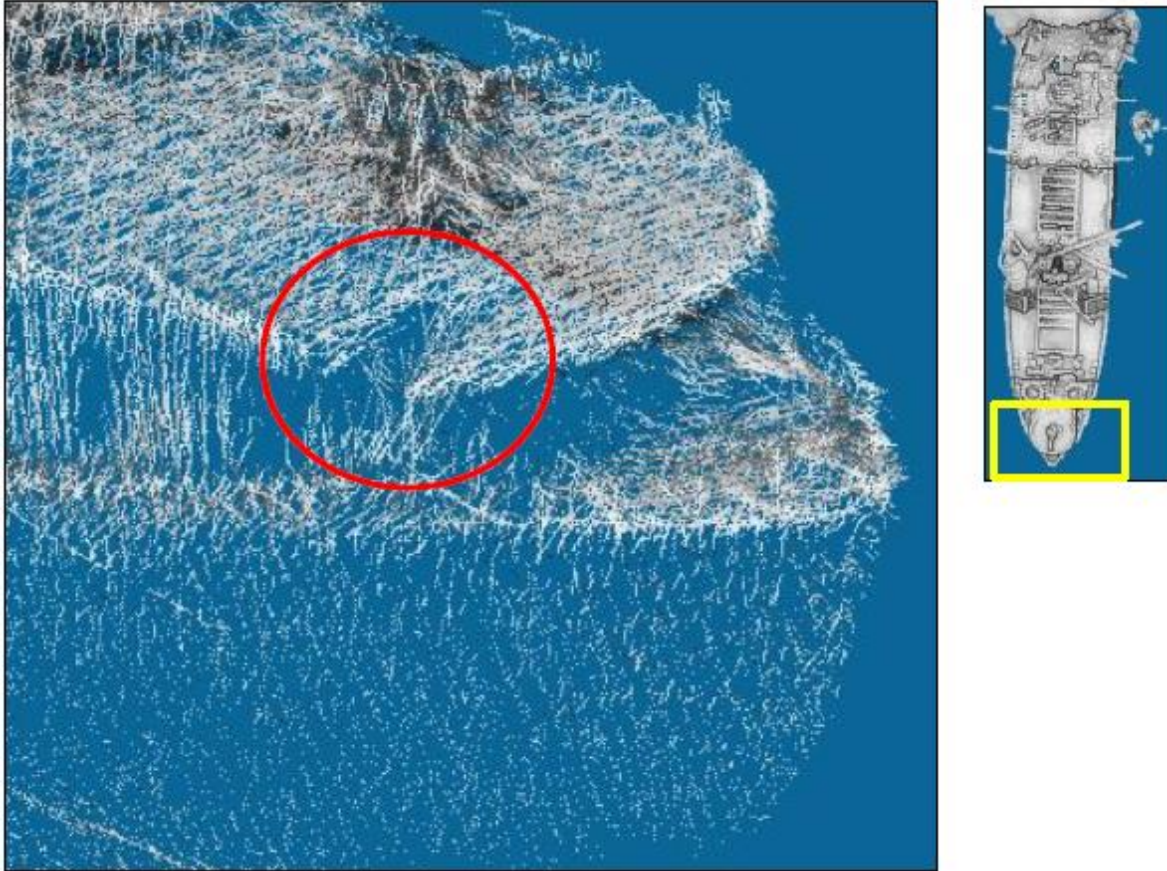
- 4.4.6 A small section of the rear gun deck has collapsed. The section is approximately 0.9m wide by 2.5m long. This is a new change from the 2019 survey. The 2019 and 2017 surveys showed no change. The small section that has dropped remains attached at its inboard edge, but the outboard edge has dropped so it rests on the lower deck and now forms a ramp up to the rear gun deck. It is indicated by the red oval in Figure 18 below.

Figure 18 Small collapse on the rear gun deck. 2020 data.

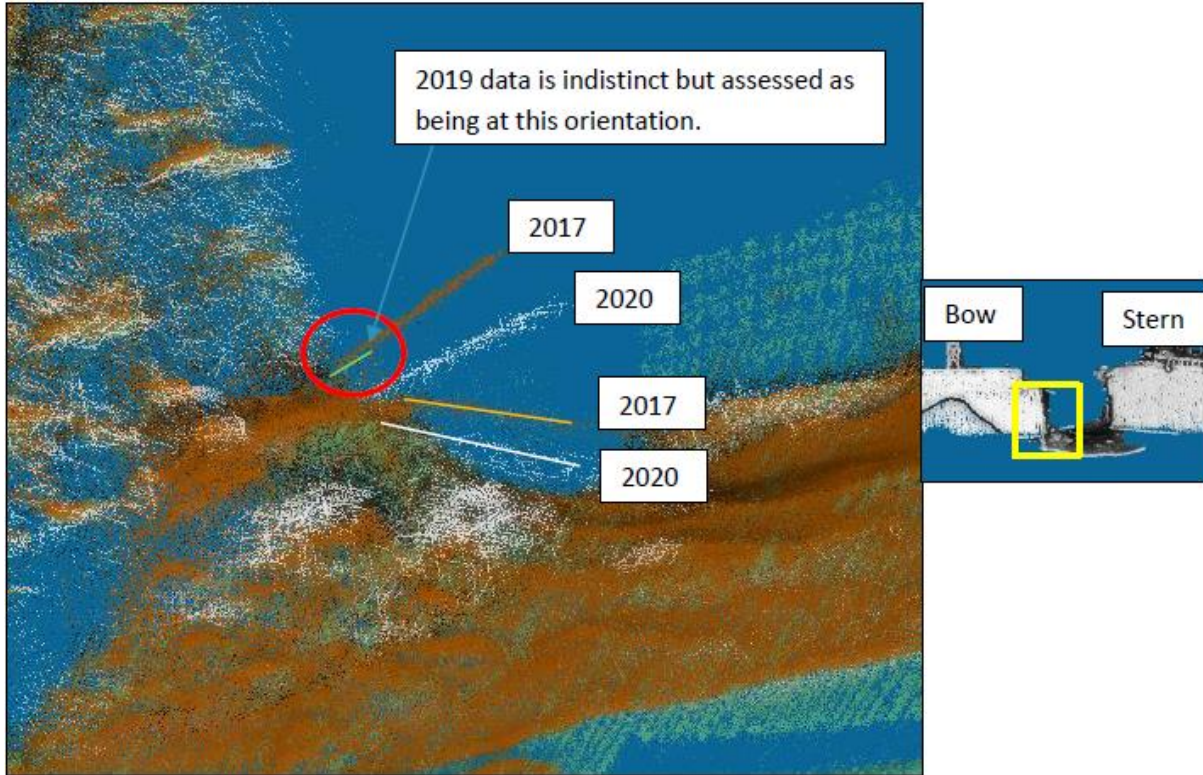
4.4.10 The lower pipe, which is of similar dimensions, has also apparently rotated about its forward end so the unsupported rear end has dropped by approximately 0.5m. Both of these measurements are between the 2017 and 2020 surveys.

Figure 19 The 'pipes' in the gap between bow and stern sections. Brown 2017, green 2019, white 2020.

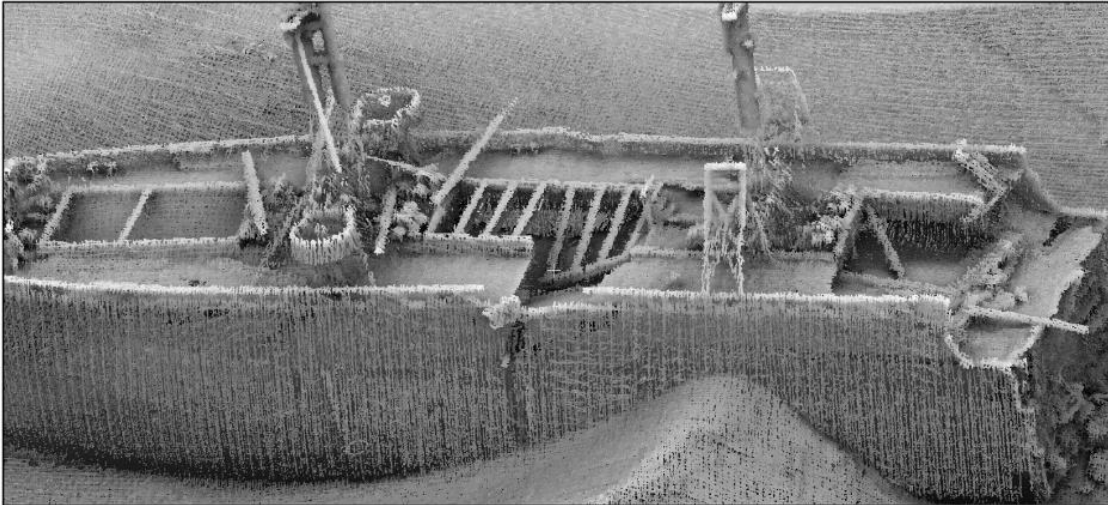
4.5.4 The forward section of the SSRM is hogging around frame 53 almost exactly halfway along the No. 2 Hold Hatch. This hogging has resulted in a crack appearing on the upper part of the port side while the lower part of the starboard side is significantly buckled giving the appearance that the forward

part of the wreck is splitting in two and pivoting about the starboard rim of Hold 2 on both the port and starboard sides as well as significant deformation of the hull sides, particularly on the starboard side. The flexing of the upper deck has caused a portion of the upper deck and half of the No. 2 hatch cover supports to collapse through into the 'tween deck space. (Figure 21 and Figure 22)

4.5.5 There is no change in these areas between the 2019 and 2020 datasets.

Figure 21 Crack in Hull (ID04) and collapsed upper deck (ID08) overview in the 2020 dataset.

- 6.1.4 It is recommended that Key Areas 1 and 2 are combined and joined by all IDs across the hull to the gap in the port hull at ID 20 and the bulge on the port side adjacent to this. This collection of IDs will then represent the significant split in the hull at approximately frame 53, which should be monitored as a single entity.

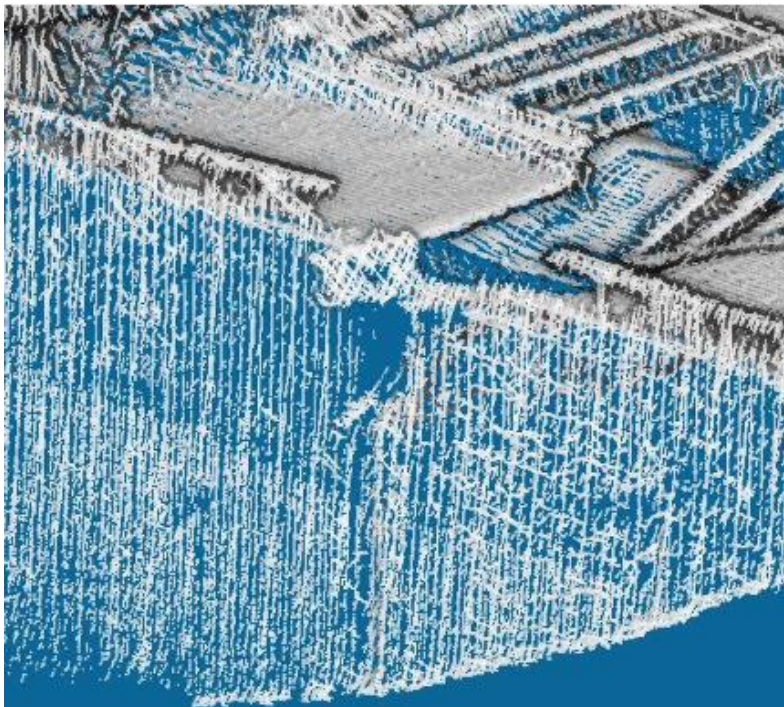
Figure 22 Image of Key Area 1, crack in hull.

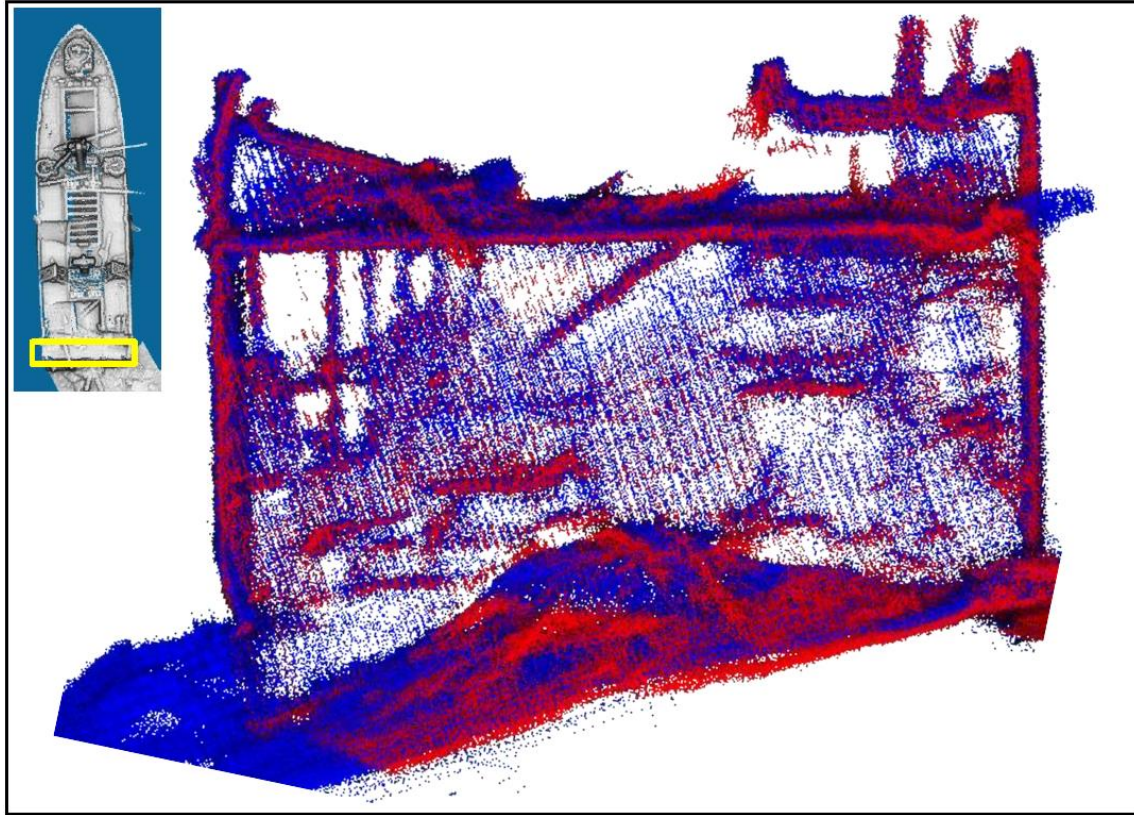
Figure 23 Aperture in the bulkhead to rear of No. 3 Hold. Blue 2017, red 2020.

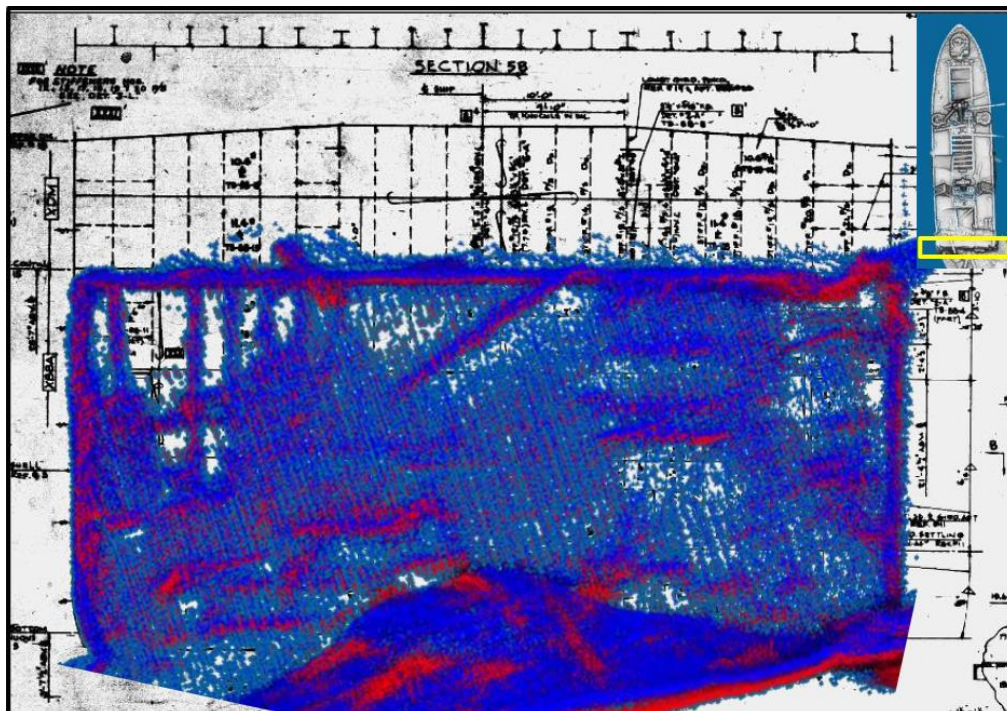
- 4.5.8 A Cloud Compare profile, illustrated in Figure 24, shows the September 2020 and August 2019 data overlaid on a plan of the oil and watertight bulkhead at frame 88 (the rear of No. 3 Hold). The apertures in the bulkhead occur where the plates have corroded away but frequently leaving the stringers in place (the dashed vertical lines in the plan). Note that the second stringer from the left has fallen away. Also note the absence of the upper part of the bulkhead that would have formed the rear end of the No. 3 Hold 'tween deck storage area. This was carried away with the stern section of the wreck when the two halves separated.

Figure 24 2019 and 2020 data on plan of the bulkhead at frame 88 (rear of No. 3 Hold) blue 2017, red 2020.

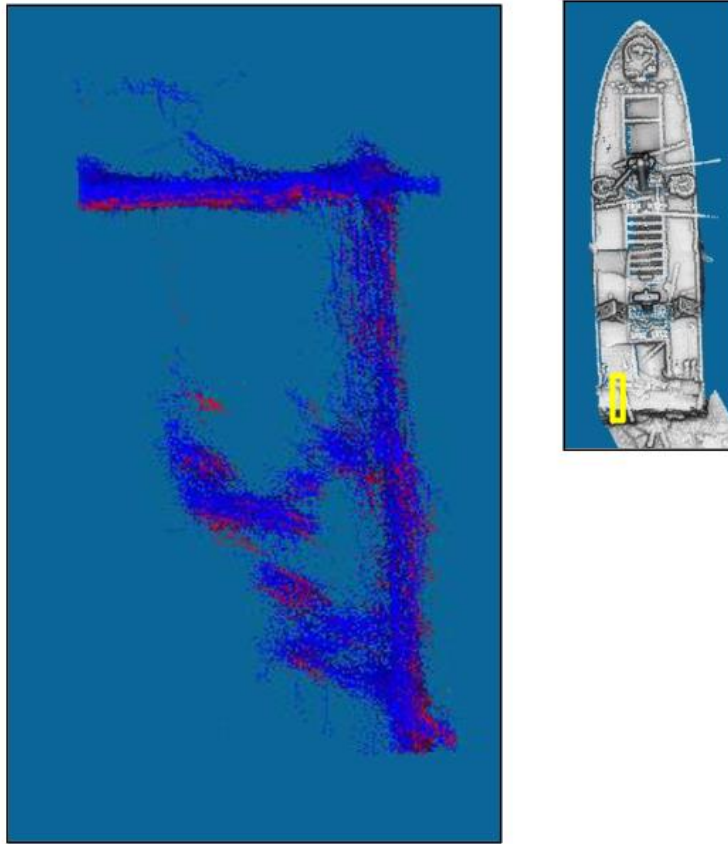
- 4.5.9 Whilst returns were obtained from objects through the aperture the quality of the returns is poor, so it is not possible to identify what the objects are. The data collected during September 2020 shows very similar dimensions to what was gathered during 2019. However, whether the returns are from cargo in the hold or sediment surrounding them cannot be ascertained.

Figure 25 Returns of content through hold aperture, blue 2017 red 2020.

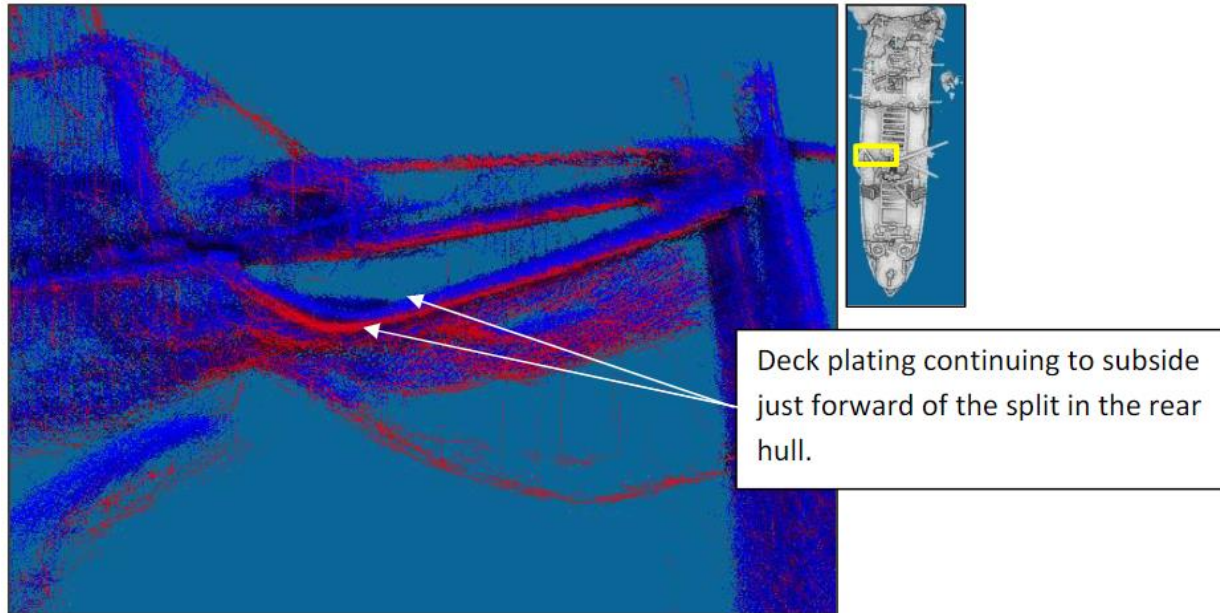
- 4.5.10 **Key Areas 4 & 5 (ID22 and ID24 & ID25) – Splitting of hull, and split in deck and hull.**
- 4.5.11 Key Areas 4 and 5 represent the two ends of the same feature, namely a transverse crack across the rear hull section at about frame 134, the bulkhead between Nos. 4 and 5 holds.
- 4.5.12 The crack just forward of the mizzen mast has resulted in a large part of the deck plating subsiding into the ‘tween deck space over time. This subsidence appears to be continuing slowly with a small difference noted between the August 2017 survey and the September 2020 survey as can be seen in Figure 26 below. However, no change has occurred between the August 2019 and September 2020 survey.

Figure 26 Looking rearward at the crack, 2020 (red), 2019 (blue).

- 6.1.5 Secondly, it is recommended that the split on the rear hull is also monitored as a single entity by combining Key Areas 4 and 5 as well as all IDs between.

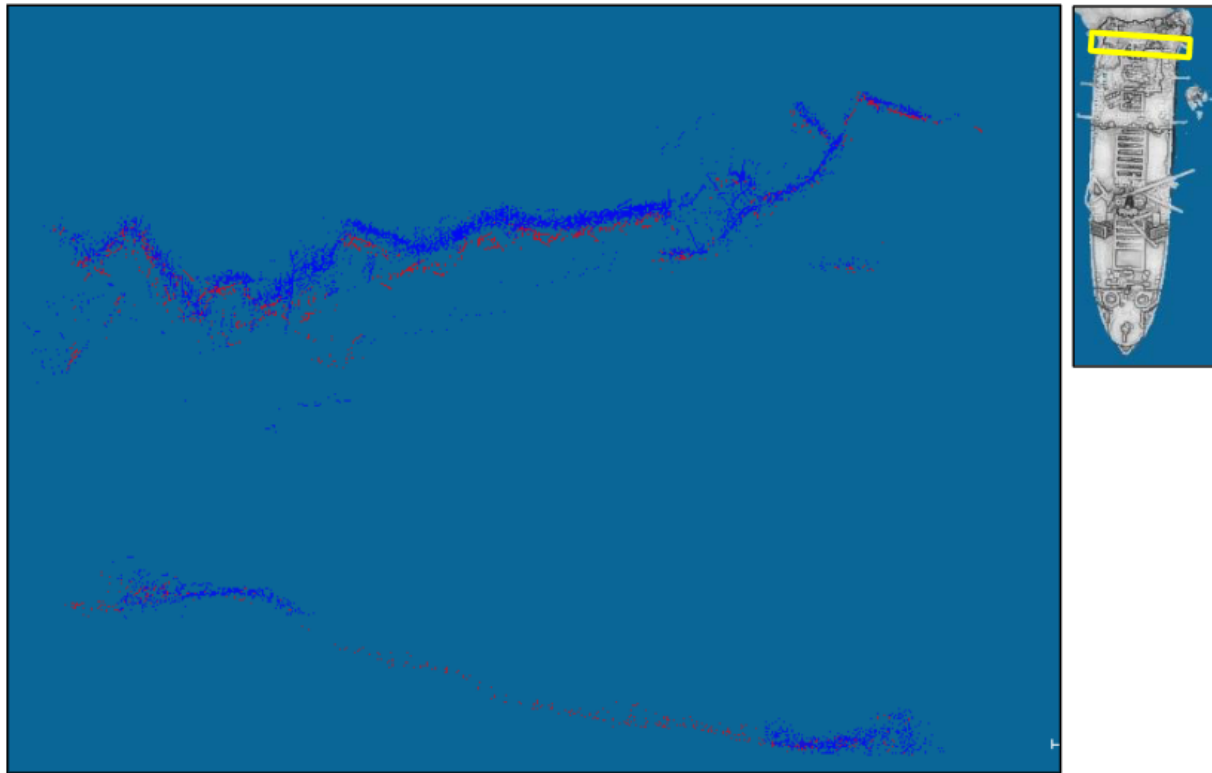
4.5.14 The collapsing bridge deck area. This area was left unsupported when the ship broke in two back in 1944. Consequently, it has been badly affected by wave and current action and is steadily collapsing and falling into the gap between the two halves of the vessel. This area has showed significant degradation in earlier surveys. However, although there is some evidence of continued collapse, the difference between the September 2020 data and the August 2019 data is only very minor.

Figure 27 Key Area 6: collapsing bridge deck area. 2020 (red) 2019 (blue).

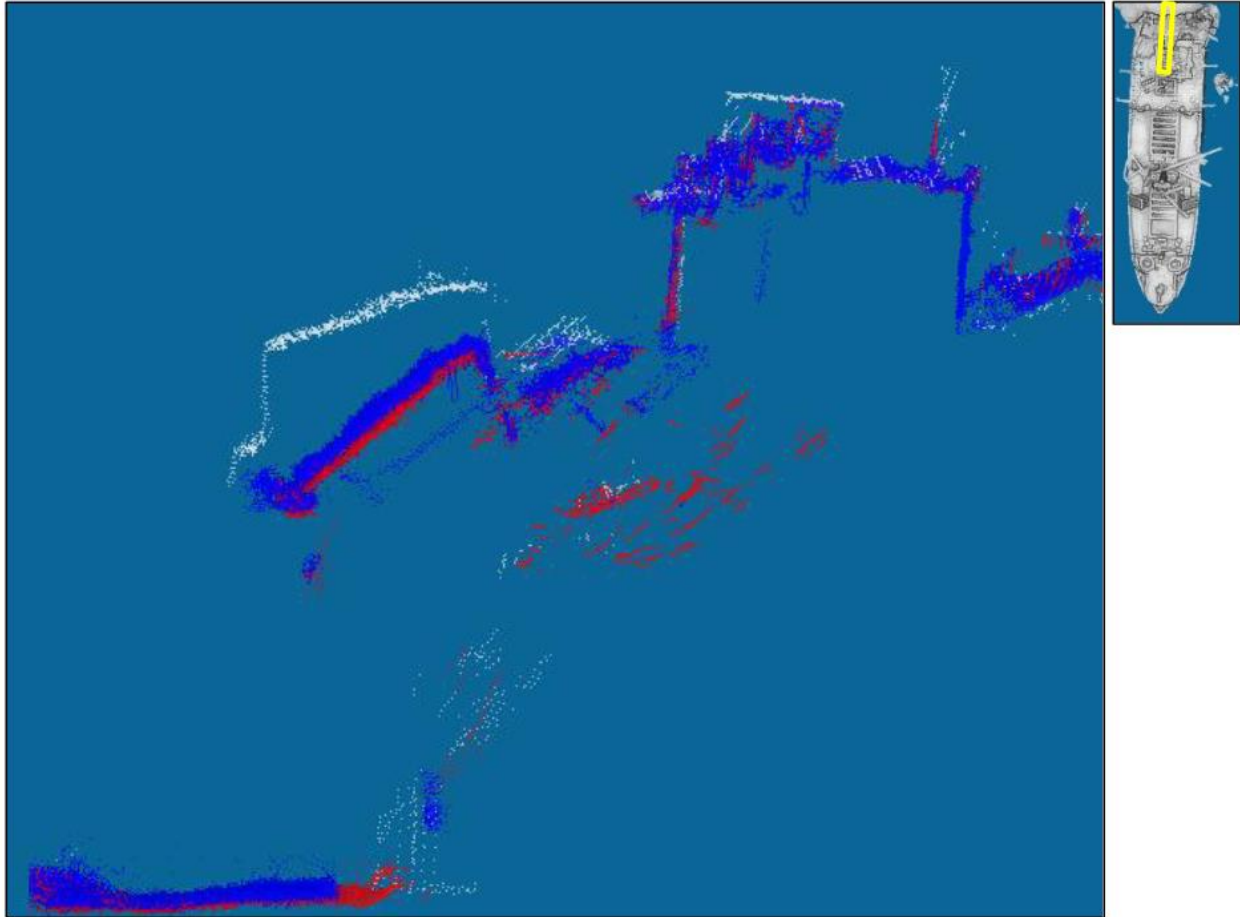
the long unsupported section of deck show how this section has collapsed over the 10 years. The variations within the void may be artefacts created by the very complex environment in this area for MBES data acquisition.

Figure 28 Longitudinal cross section through forward end of rear section. White 2010, blue 2019, red 2020.

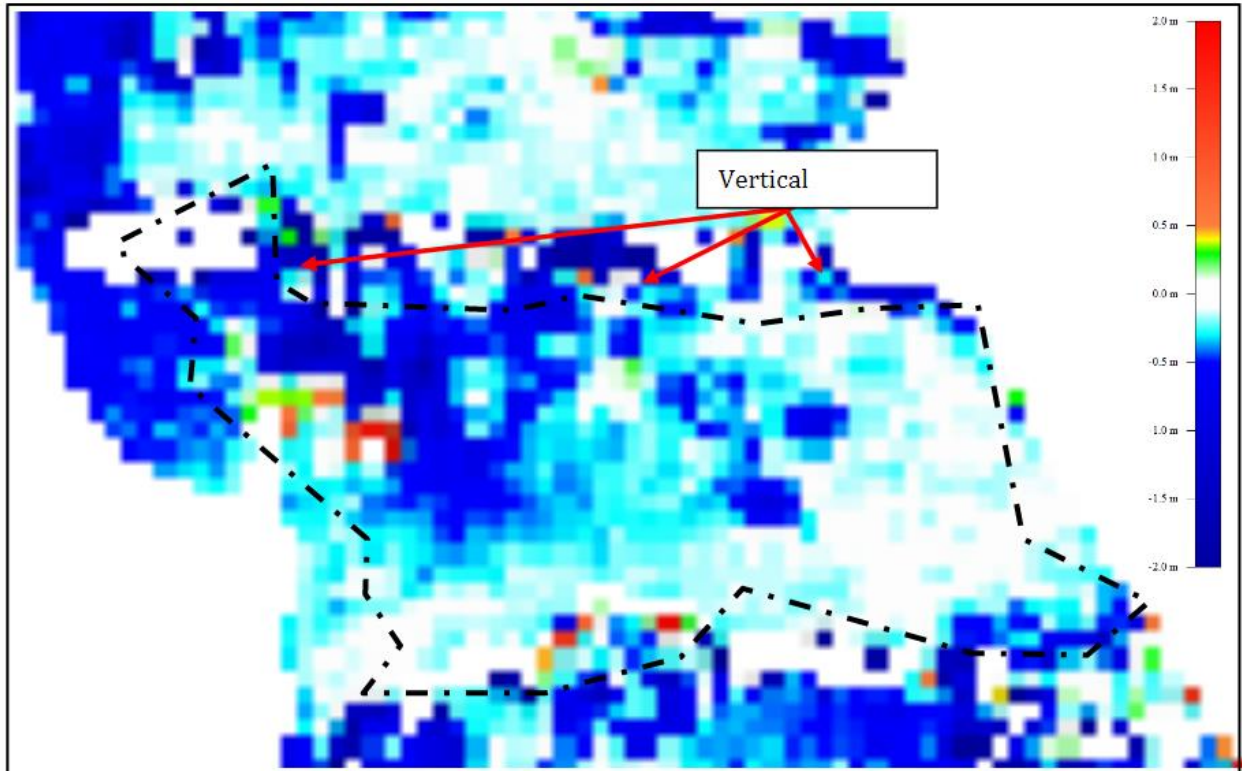
- 4.6.1 Apart from the changes to the two pipes sticking out from the bulkhead at the back of No. 3 Hold there are no appreciable differences between the August 2019 and September 2020 data sets in this area.

Figure 29 - Surface difference between September 2020 survey and August 2019 data.

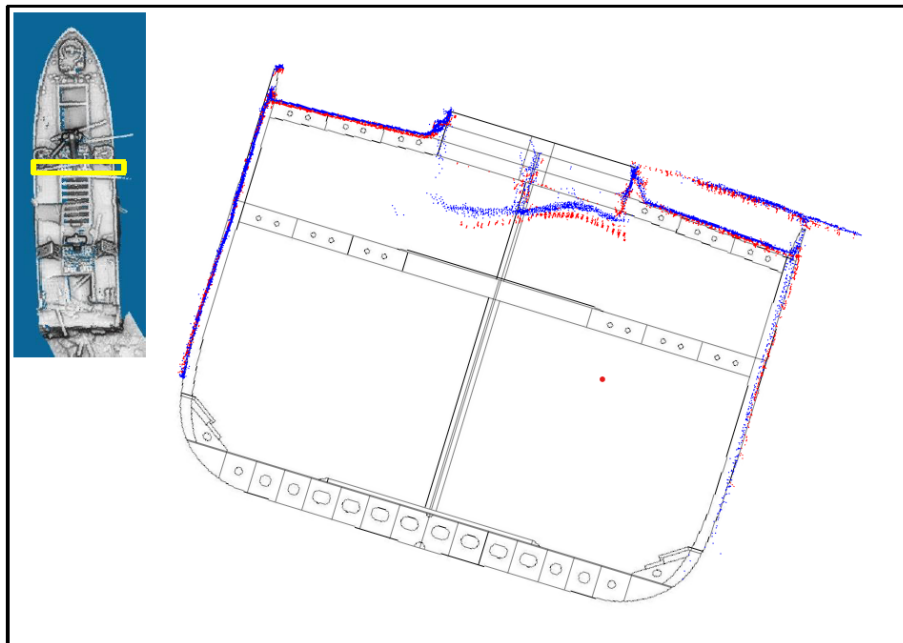
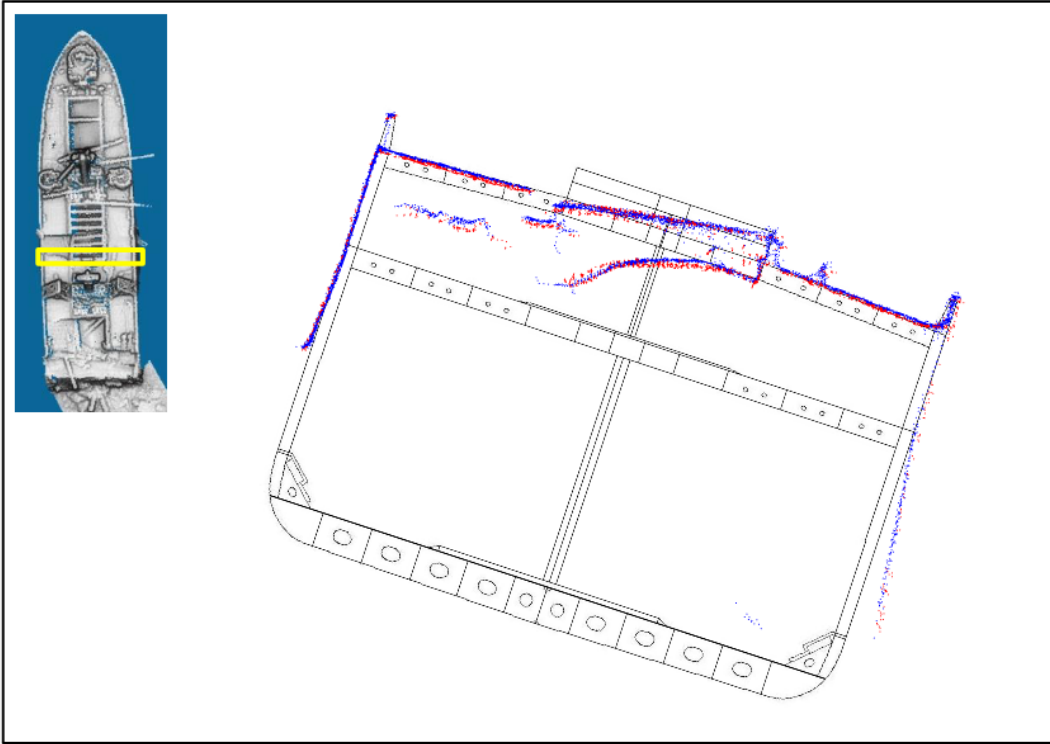
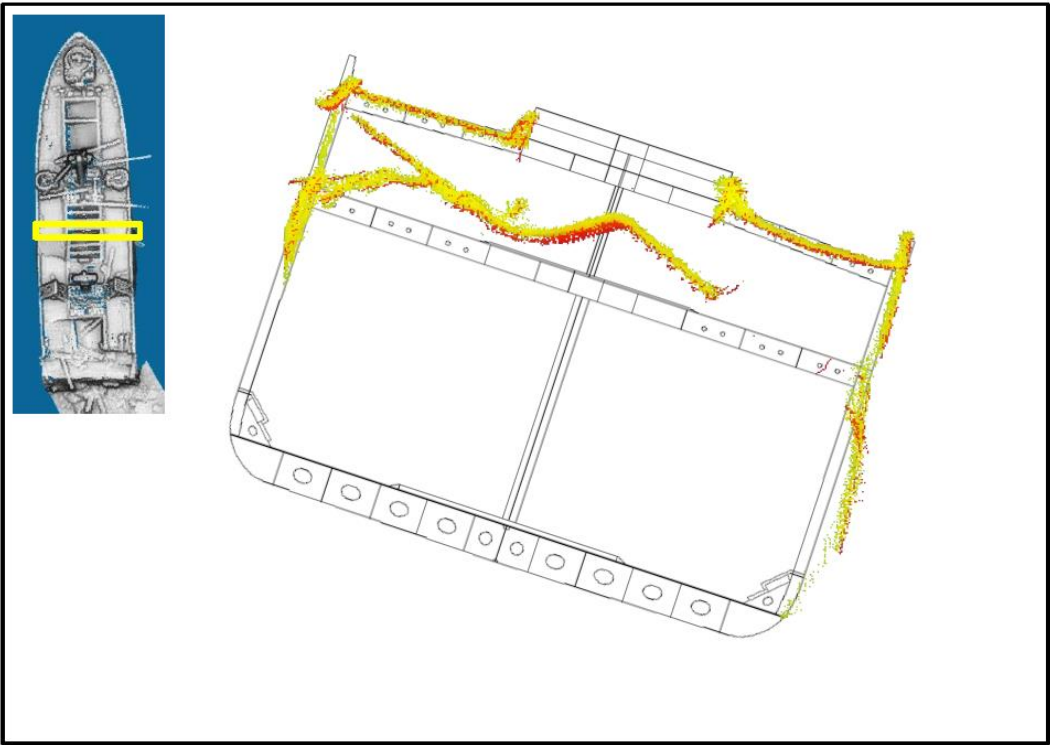
- 4.7.9 The second from forward hold. As with Hold 1, the outer hatch cover is missing although all the cover supports are in place. The forward section of the wreck is splitting at frame 54, nearly mid-way along No. 2 Hatch, and this has resulted in part of the Upper Deck collapsing into the 'tween deck space bringing the connected hatch coaming and hatch cover supports with it. Sediment is visible through the open No. 2 Hatch and similarly to hold 1, the sediment has filled the 'tween deck space to a considerable depth. Again, there is no indication that the second deck or the lower hatch covers have failed as there is no indicative slump in the sediment. (Figures 32, 33 and 34).

- 4.7.10 There is a large bulge in the lower hull of the ship's side around frame 54.
- 4.7.11 The sediment in the holds has remained relatively stable over the last several years. Small fluctuation in the depth occurs but essentially the 'tween deck space is filled to the same extent, seemingly limited by the sediment reaching the height of the lower hatch coaming after which, presumably, it is washed away. Note the deformation of the hull side to the right of Figure 34. This is part of the bulge mentioned earlier that extends for the entire length of hold 2. This is also the location of the maximum hull deformation on the starboard side. However, this deformation currently seems to be stable, not having increased over the last several years.

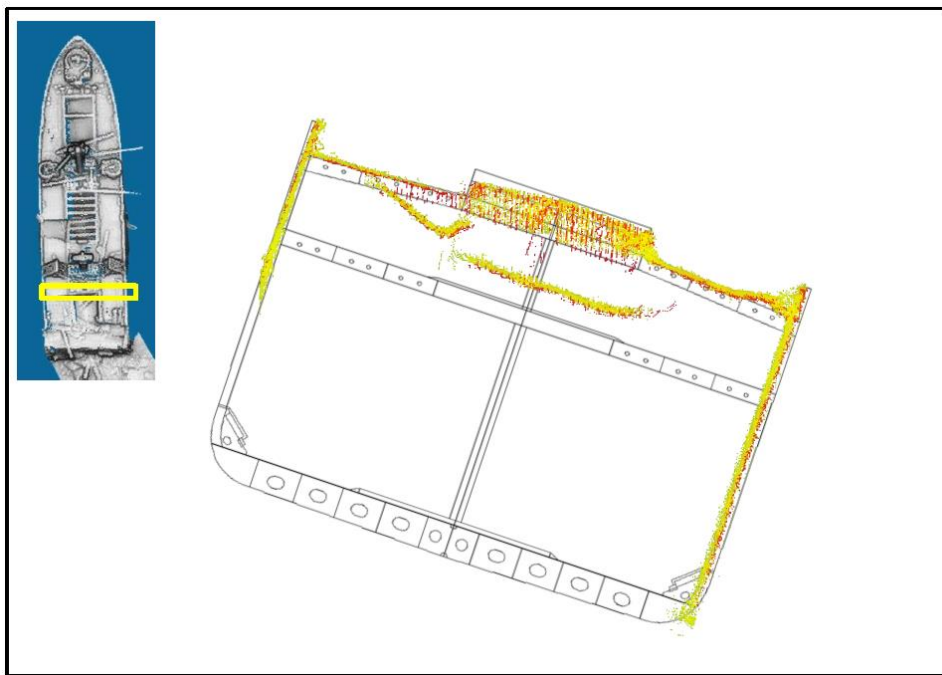
- 4.7.12 The rearmost hold of the forward section. The rear bulkhead of this hold forms the rear of the forward section, the vessel having broken in two immediately aft of that bulkhead. Although the lower hold remained with the forward section, the bulkhead at the rear of the 'tween deck space and the section of the upper deck above it were carried away leaving this area open. The outer hatch cover has gone as have all the cover supports although there is a beam – possibly a cover support or part of the coaming lying on the starboard side. (Figure 35).

Figure 35 Cross section through the hull at frame 73, the forward edge of No. 3 Hatch. Yellow 2019, red 2020.

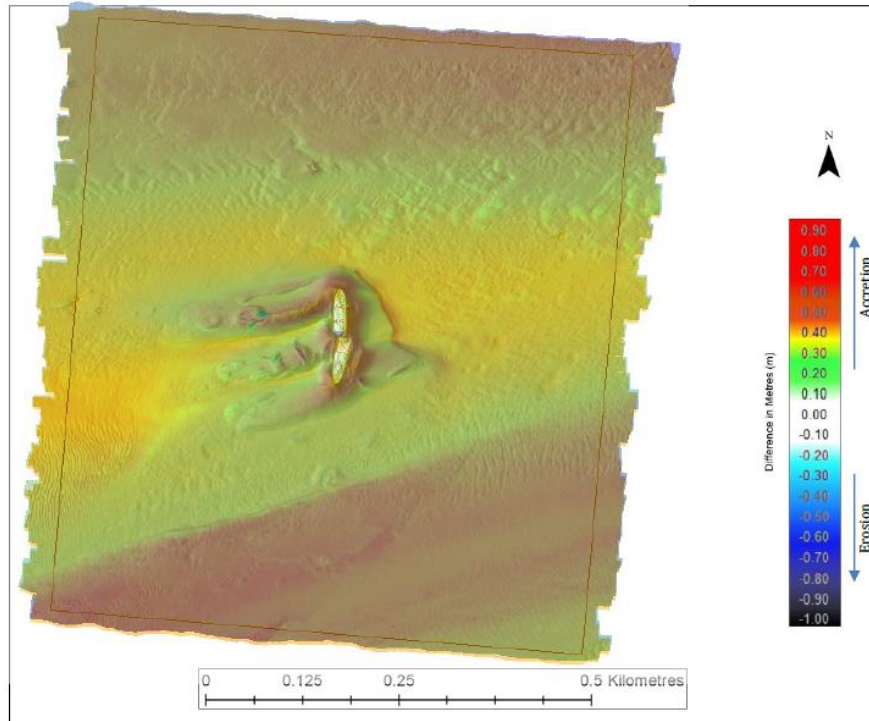
- 5.1.3 Overlaying the difference plot on the bathymetry (Figure 51) shows the relative location of the sediment loss to the latest bathymetry.

Figure 51 Overlay of difference plot on the bathymetry.
