Maritime &
Coastguard
Agency

SS Richard Montgomery: Survey Report 2019

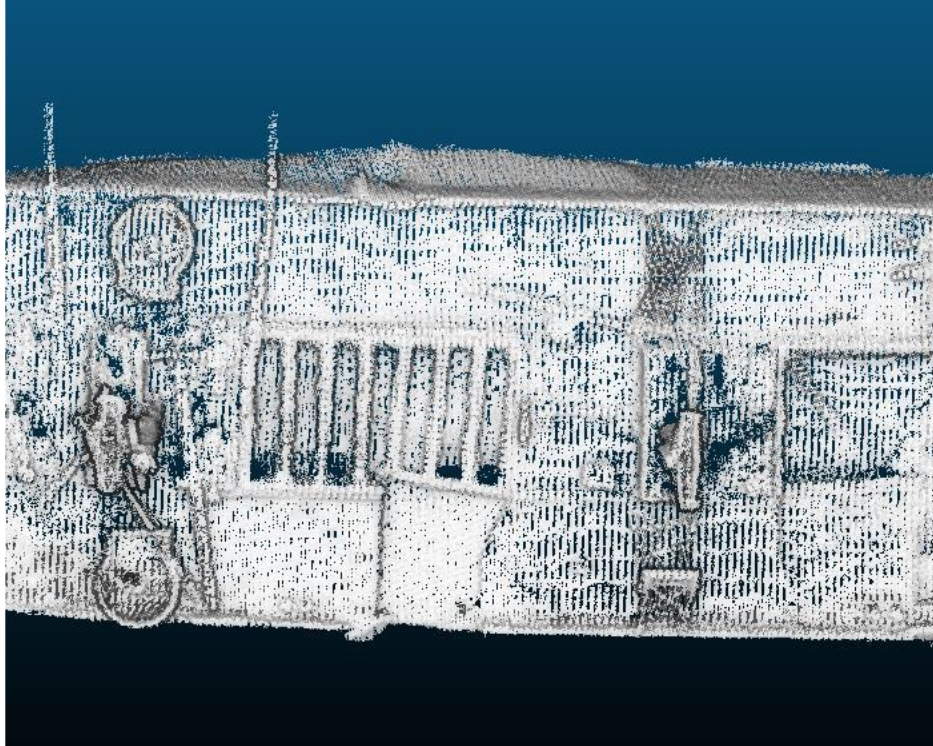
4.2.4 In Figure 8 a cross section through the Richard Montgomery overlaid on a sectional plan shows the extreme bulging outward of the hull plates on the starboard side of the bow section. Although this bulging does seem to have remained stable over the last few surveys, its extent is a cause for possible concern, and it is recommended that this area is included in all future reports as an area for particular study. Note that the starboard side is distorted in as well as out and the port side is also distorted in this area.

4.2.5 The bulge is limited to Hold 2 and the form of the hull returns to normal at the bulkheads at either end – potentially due to the greater strength afforded to the hull by the presence of the bulkheads (Figure 9).

Figure 9 Overview of bulge in hull plating on starboard side from August 2019 data.

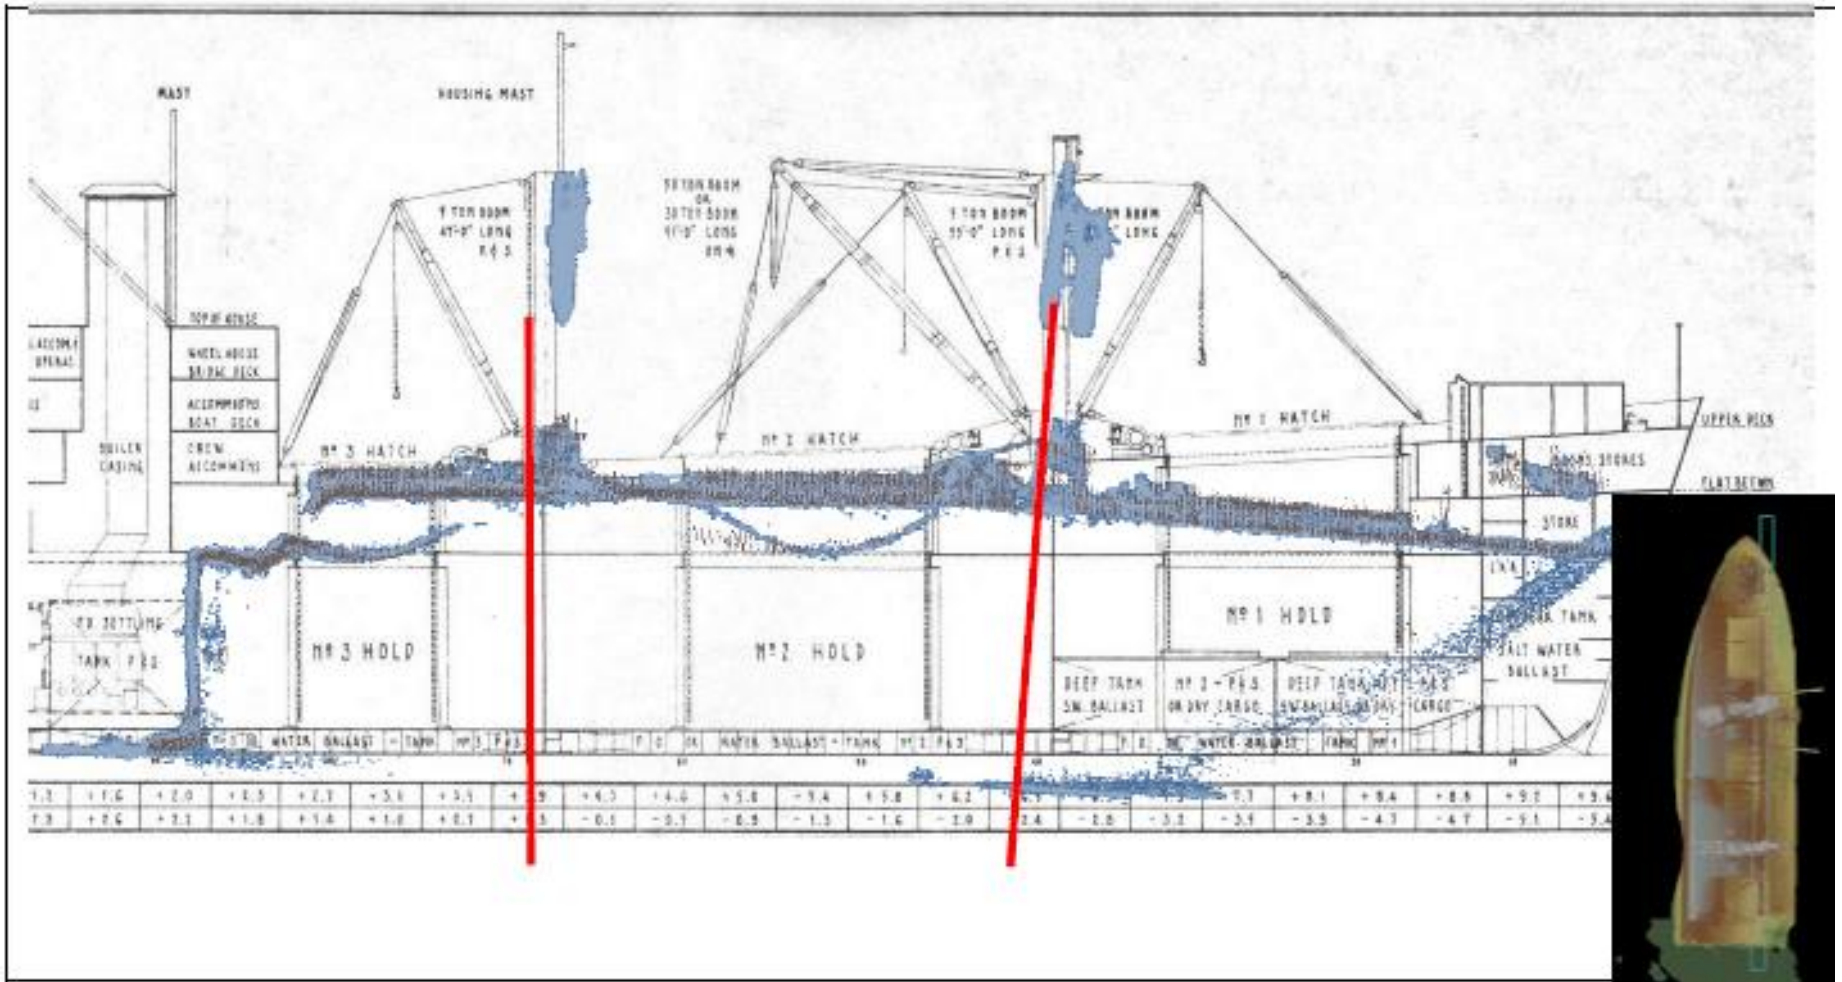
- 4.2.6 The forward hull appears to be buckling in two places resulting in there being three different levels to the deck. Firstly, the rear part from the bulkhead at Frame 88 (the rear of Hold 3) to just rear of the main mast (see Figure 10 below). Secondly, the main mast and Hold 2 area up to the fore mast (see Figure 11). This section also contains the large crack at the centre of Hold 2. Finally, at the forward section from the foremast forward (see Figure 12).

Figure 10 2010 (brown) and August 2019 (blue) survey data overlain on the ships plan – rear alignment.

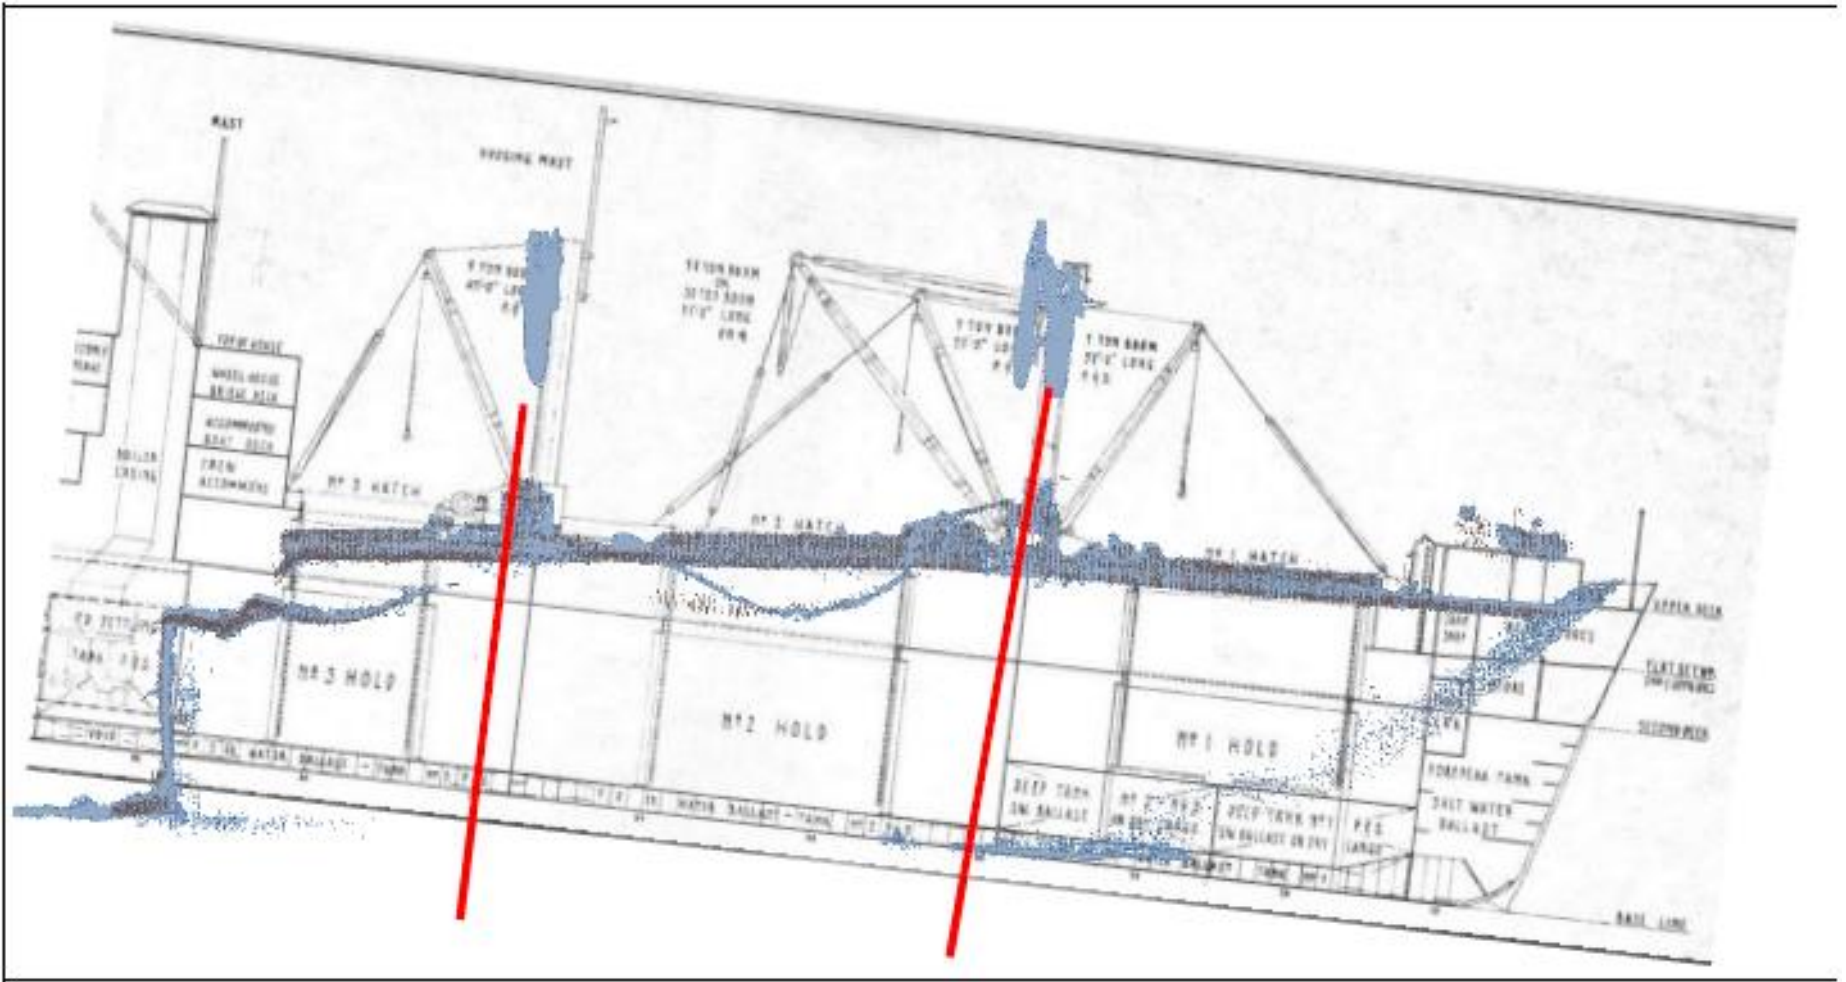
Figure 12 2010 (brown) and August 2019 (blue) survey data overlain on the ships plan - front alignment.

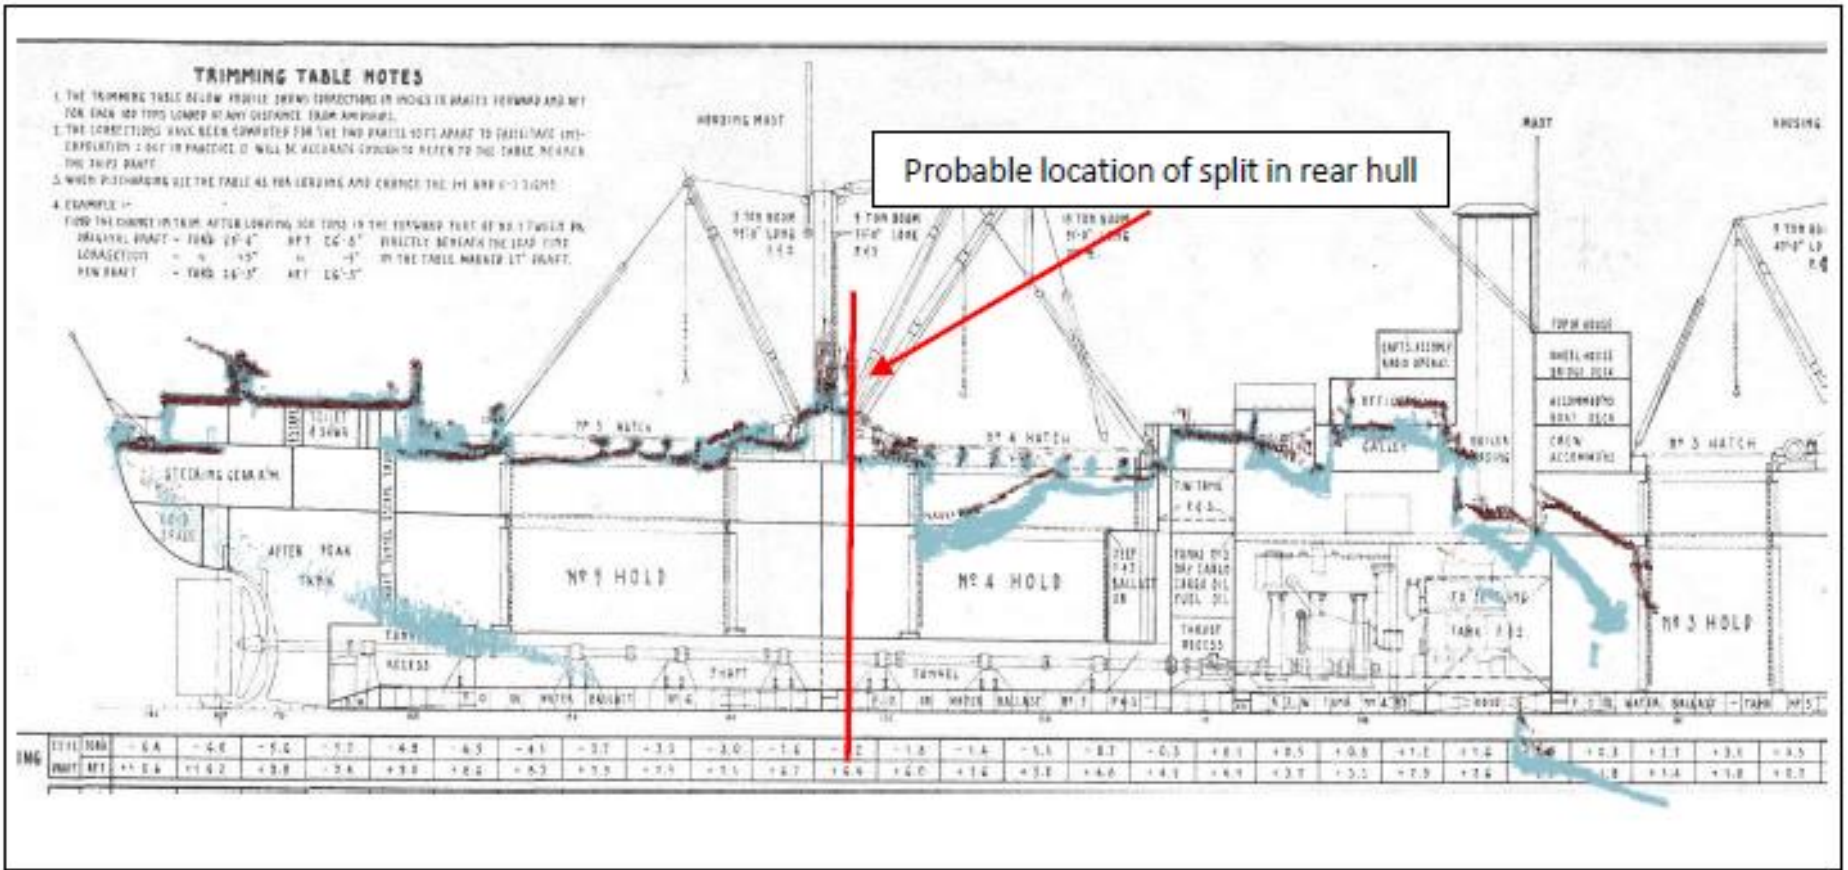
- 4.2.11 The forward end of the stern section was left unsupported when the two halves of the vessel separated soon after it went aground in 1944. This area has steadily subsided although the subsidence seems to have stopped over the last few years – no significant changes have occurred since 2017. It is possible that this has been caused because the collapsing decks are now resting on the ship's boiler which provides a stable base.

Figure 13 Longitudinal profile through the stern section showing the slight dip of the stern and the mast.

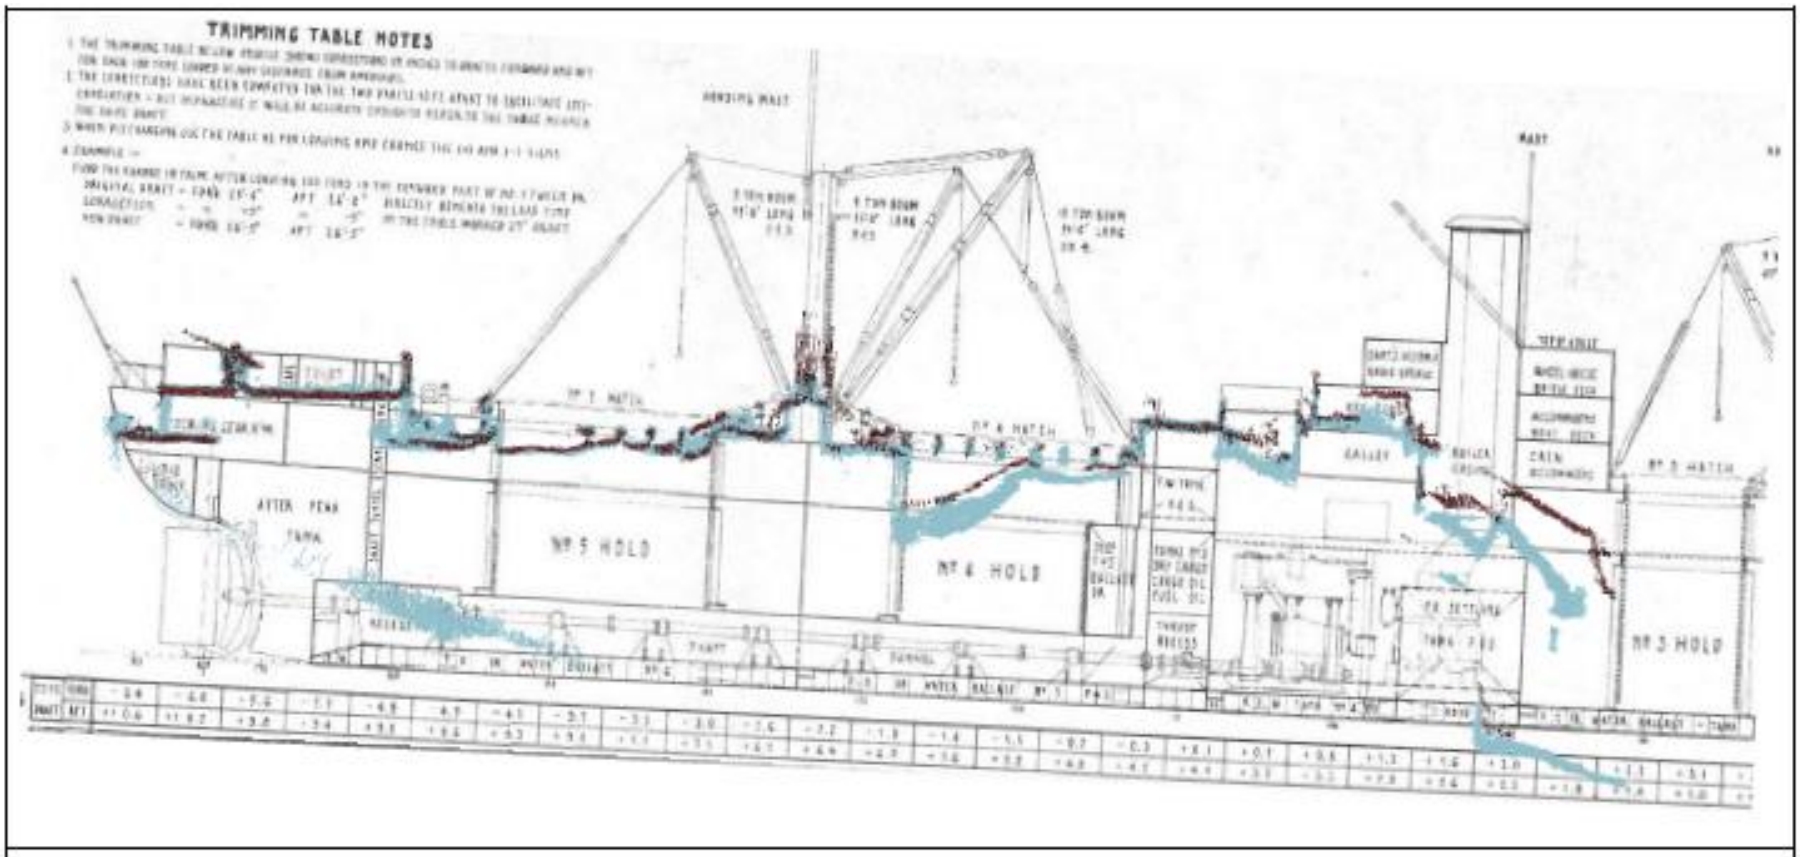
Figure 14 Longitudinal profile through the stern section oriented so that the wreck's hull aligns with the forward part of the survey data.

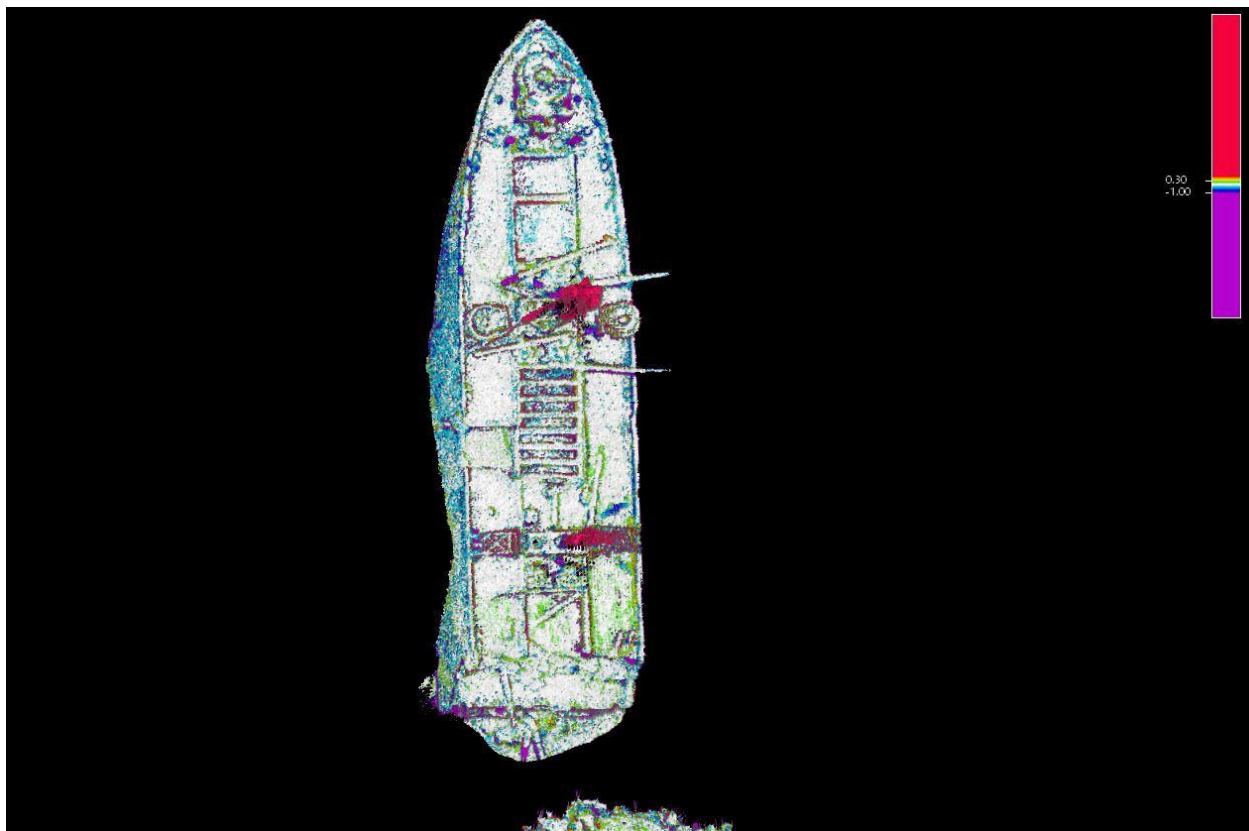
Figure 15 Forward section surface difference results August 2019-January 2019 MBES survey.

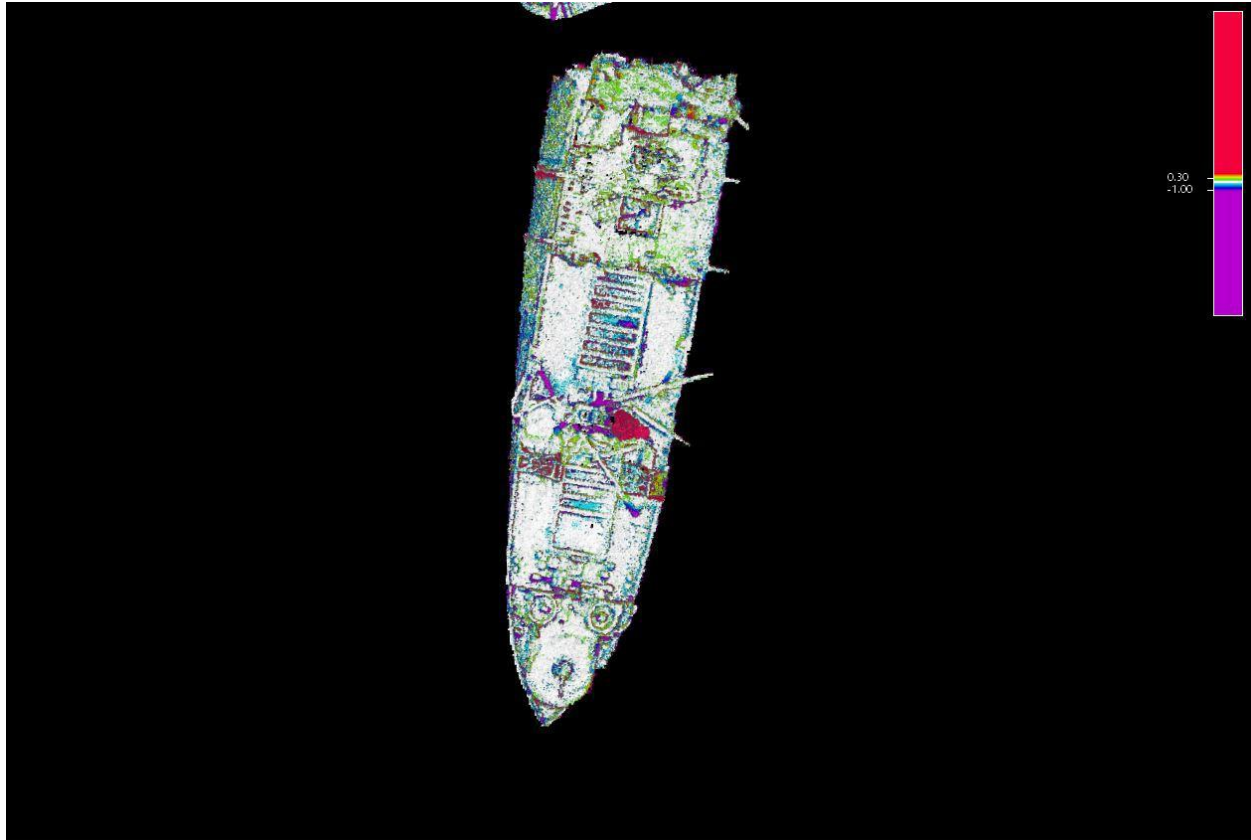
Figure 16 Aft section surface difference results August 2019 - January 2019 MBES.

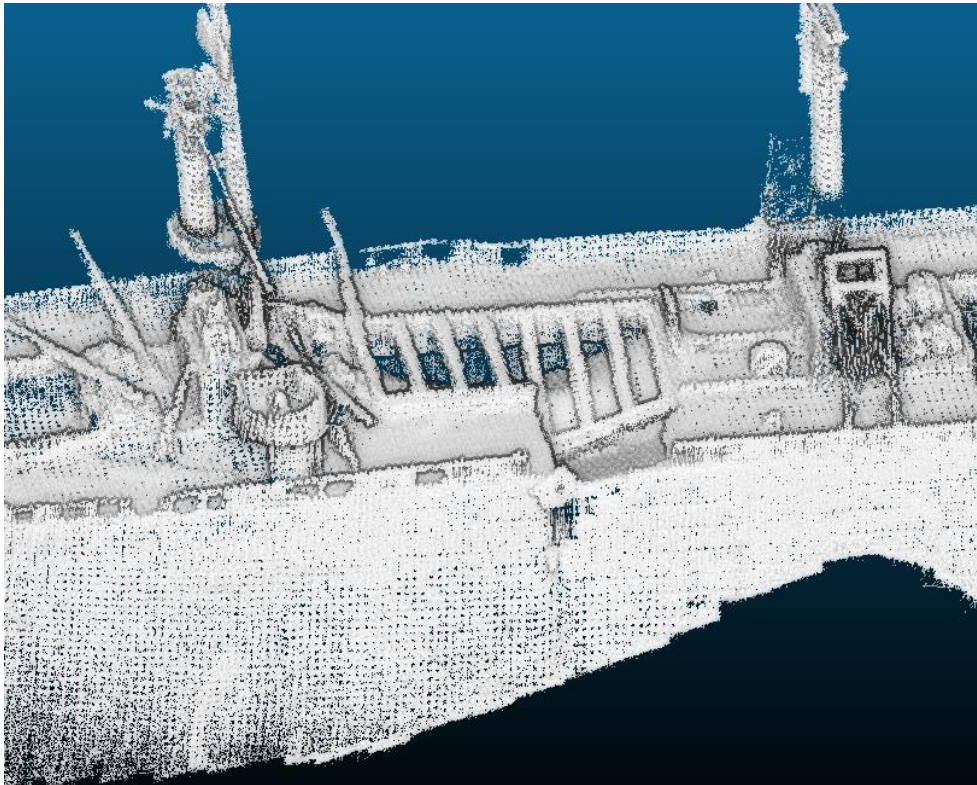
4.5.3 The forward section of the Richard Montgomery is hogging around frame 53 almost exactly halfway along the No. 2 Hold Hatch. This hogging has resulted in a crack appearing on the upper part of the port side while the lower part of the starboard side is significantly buckled giving the appearance that the forward part of the wreck is splitting in two and pivoting about the starboard rim of Hold 2 on both the port and starboard sides as well as significant deformation of the hull sides, particularly on the starboard side. The flexing of the upper deck has caused a portion of the upper deck and half of the No. 2 Hatch cover supports to collapse through into the 'tween deck space. (Figure 20)

Figure 20 Crack in hull (ID04) and collapsed upper deck (ID08) from the August 2019 dataset.

- 6.1.4 It is recommended that Key Areas 1 and 2 are combined and joined by all IDs across the hull to the gap in the port hull at ID 20 and the bulge on the port side adjacent to this. This collection of IDs will then represent the significant split in the hull at approximately frame 53 which should be monitored as a single entity.

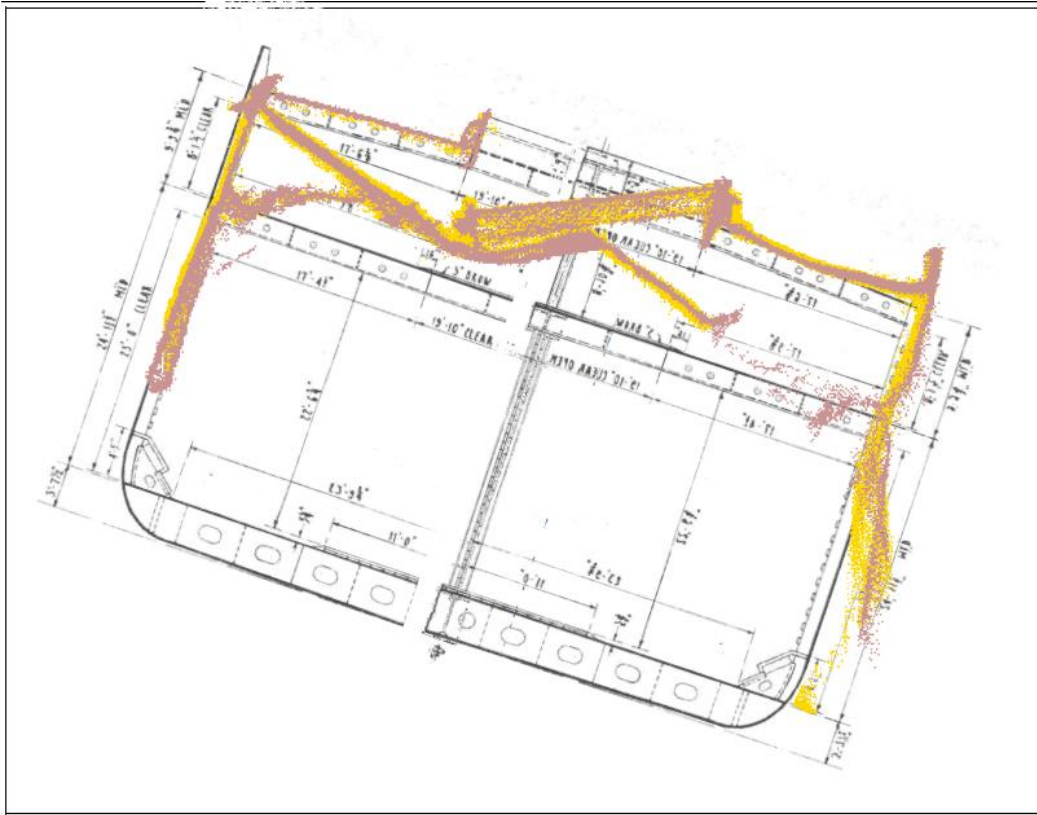
4.5.4 Overlaying the 2019 survey data on a section through a Liberty Ship at Frame 60 (looking aft at the aft end of No. 2 Hold Hatch) shows the extent of the upper deck collapse - Figure 21. The collapsed upper deck and coaming to No. 2 Hold Hatch have not fallen to the level of the second deck. Whether this is the result of the collapsing deck supporting itself or whether it is resting on sediment is not known.

Figure 21 August 2019 (Yellow) and 2017 (Red) data overlaid on a section plan.

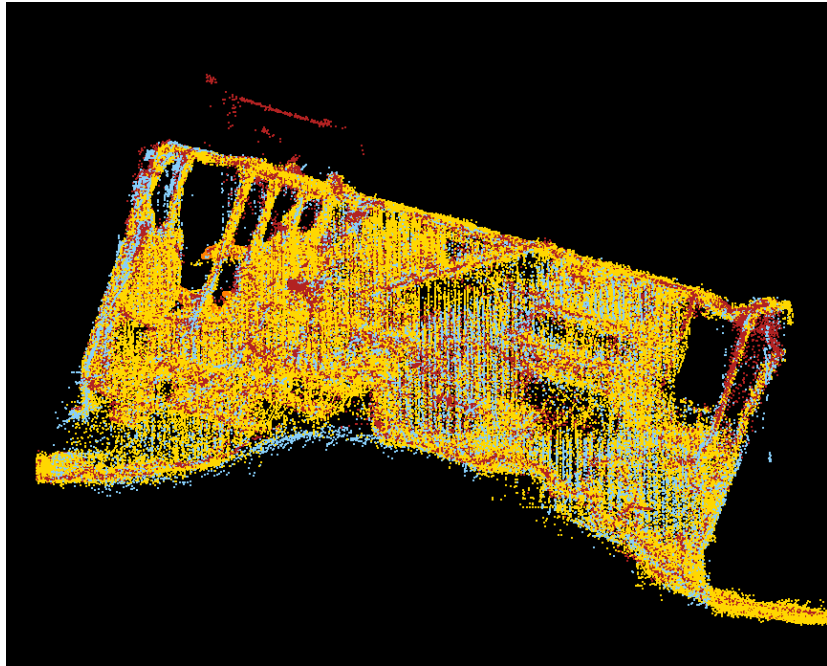
Figure 22 Aperture in the bulkhead to the rear of Hold 3. Yellow August 2019, blue January 2019, red 2017.

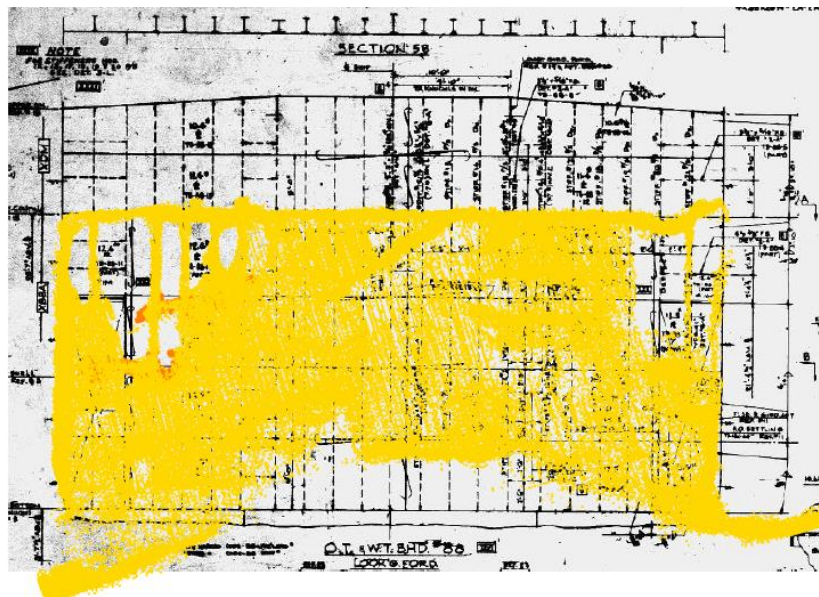
4.5.7 A CARIS profile, illustrated in Figure 23, shows the August 2019 data (as shown in Figure 22) overlaid on a plan of the oil and watertight bulkhead at frame 88 (the rear of Hold 3). The apertures in the bulkhead occur where the plates have corroded away but frequently leaving the stringers in place (the dashed vertical lines in the plan). Note that the second stringer from the left and the second stringer from the right have also fallen away. Also note the absence of the upper part of the bulkhead that would have formed the rear end of the No. 3 Hold 'tween deck storage area. This was carried away with the stern section of the wreck when the two halves separated.

Figure 23 August 2019 data overlaid on sectional plan of the bulkhead at frame 88 (rear of Hold 3).

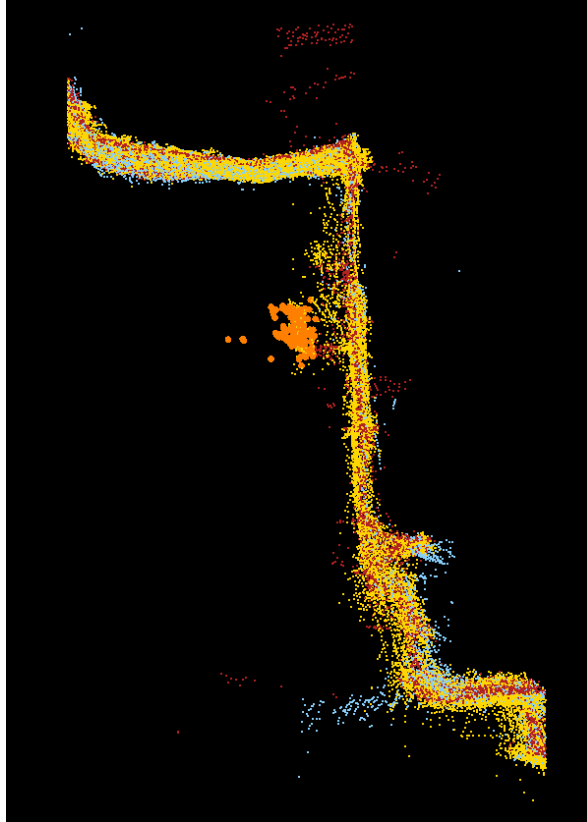
data collected during August shows very similar dimensions to what was gathered during January and in 2017 (Figure 24). However, whether the returns are from cargo in the hold or sediment surrounding them cannot be ascertained.

Figure 24 Section showing returns from contents of hold through aperture. Yellow August 2019, blue January 2019, red 2017. Orange dots highlighted in the 2017 survey as potential cargo.

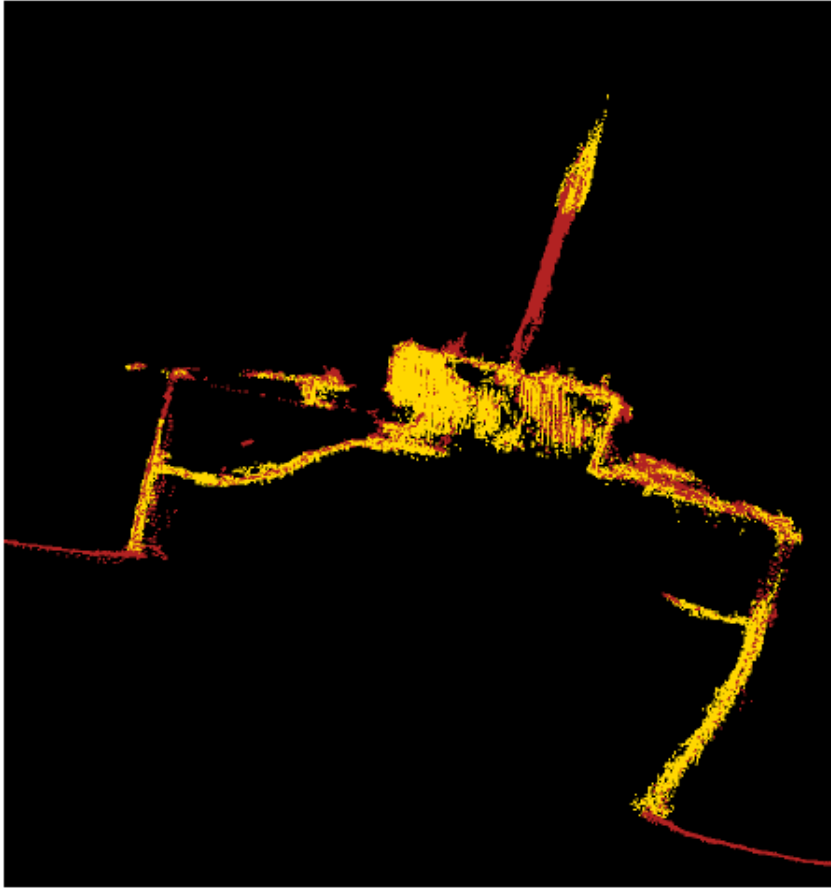
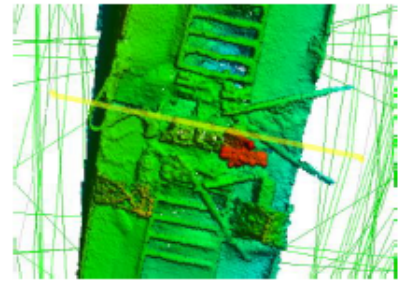
4.5.10 Areas 4 and 5 represent the two ends of the same feature, namely a transverse crack across the rear hull section at about frame 134, the bulkhead between Holds 4 and 5.

4.5.11 Figure 25 below shows the August 2019 survey data and the 2017 survey data and clearly shows that no changes have occurred in the angle of the hull and that no changes have occurred to the sediment levels within the hull.

Figure 25 Cross section through the crack in the rear section of the hull. Yellow August 2019, red 2017.

- 6.1.5 Secondly it is recommended that the split on the rear hull is also monitored as a single entity by combining Key Areas 4 and 5 as well as all IDs between.

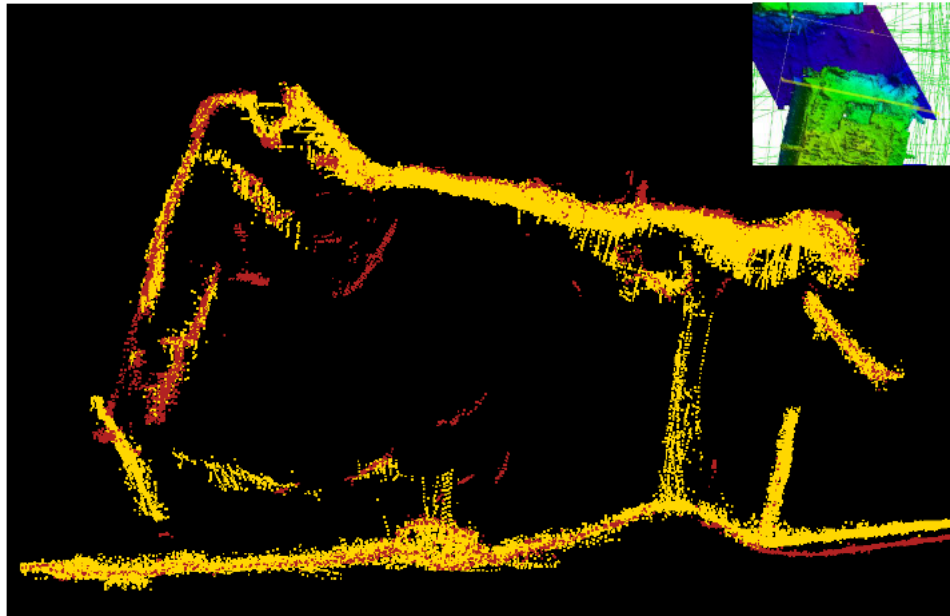
4.5.13 This area was left unsupported when the ship broke in two back in 1944. Consequently, it has been adversely affected by wave and current action and is steadily collapsing and falling into the gap between the two halves of the vessel. This area has showed significant degradation in earlier surveys but there is no noticeable change between the August 2019 survey and the 2017 survey.

4.5.16 The long unsupported section of deck is part of the upper deck that formed the top of Hold 3's 'tween deck space. The lump at its end is probably the rear coaming of No. 3 Hatch. This portion of the upper deck and section of coaming were carried away with the stern when the two halves separated.

Figure 26 CARIS subset profile through bridge deck area. Yellow 2019, red 2017.

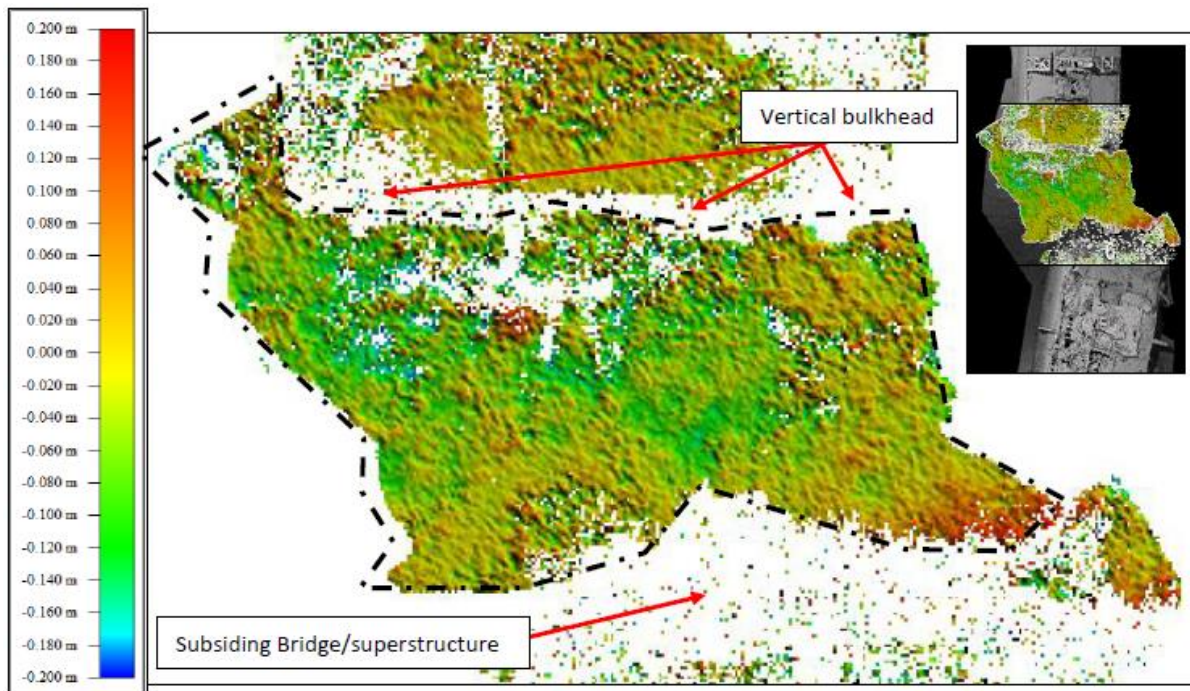
4.6.3 The area within the dotted black line is the seafloor between the front and rear sections of the wreck and predominantly shows changes of less than +/- 0.2m depending on the direction of change. The larger portion of white near top centre is again caused by overhanging debris giving large height differences for small lateral movements.

Figure 27 Difference surface of 2017 survey - August 2019 data.

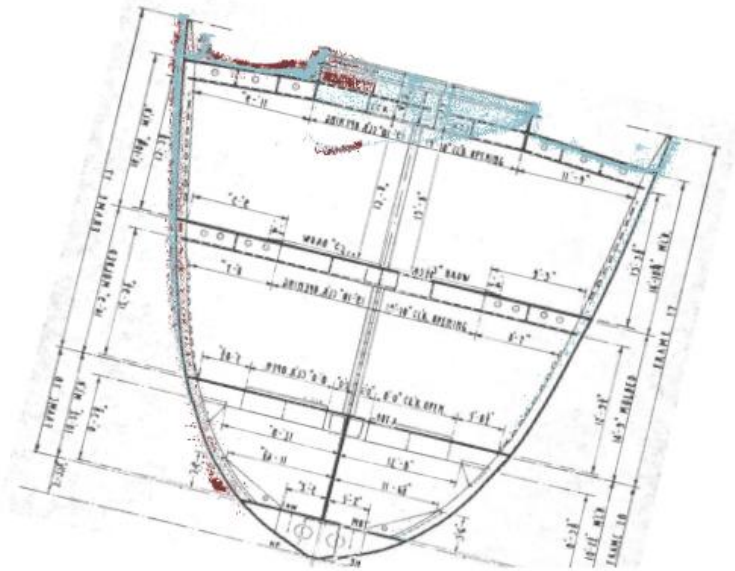
- 4.7.5 The hatch cover is missing as are all but one of the hatch cover supports. Sediment has settled in the 'tween deck space to a considerable depth, filling the starboard side to the top of the starboard side hatch coaming. The port side remains clear above the horizontal from the starboard hatch coaming. Apart from some undulations in the sediment surface this is indicative of all the sediment visible in the data as imaged through the open hatch. (Figure 28 & Figure 29).

Figure 28 Cross-section at frame 17-18, forward of No 1. Hatch (red August 2019, blue 2017 survey).

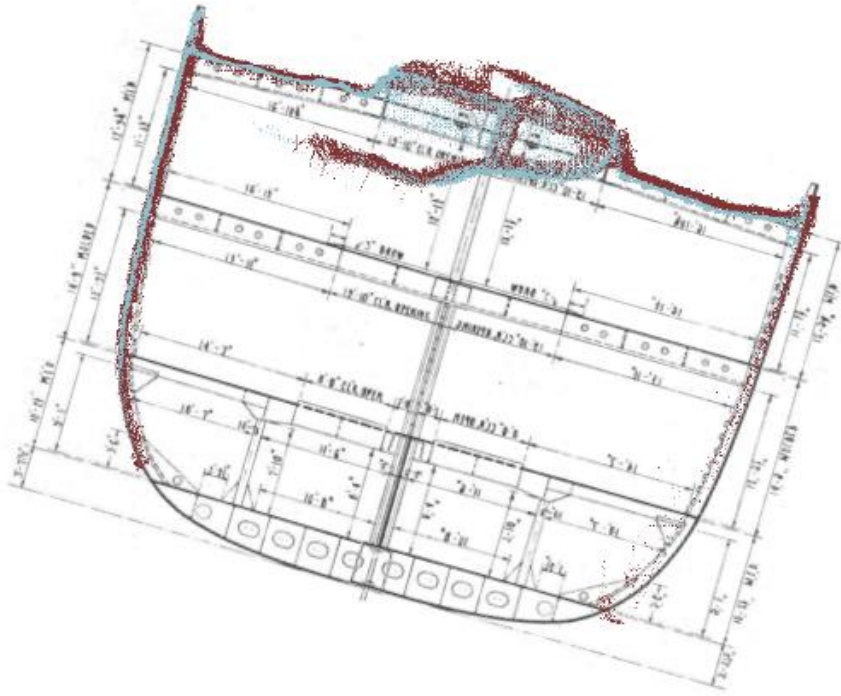
Figure 29 Cross-section through frame 32, aft end of No. 1 Hatch (red August 2019, blue 2017 survey).

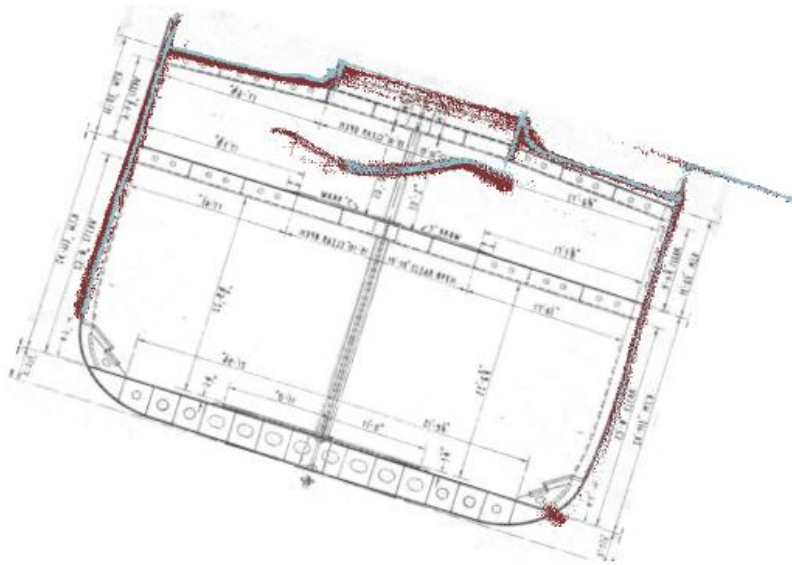
- 4.7.7 As with Hold 1, the outer hatch cover of Hold 2 is missing although all the cover supports are in place. The forward section of the wreck is splitting at frame 54, nearly mid-way along No. 2 Hatch, and this has resulted in part of the Upper Deck collapsing into the 'tween deck space. Sediment is visible through the open No. 2 Hatch and similarly to Hold 1, the sediment has filled the 'tween deck space to a considerable depth although, unlike Hold 1, it appears that the starboard side is not filled. Again, there is no indication that the second deck or the lower hatch covers have failed as there is no slump in the sediment. (Figure 30 & Figure 31).

Figure 30 Cross-section of hull at frame 46, forward end of No. 2 Hatch (Red August 2019, Blue 2017).

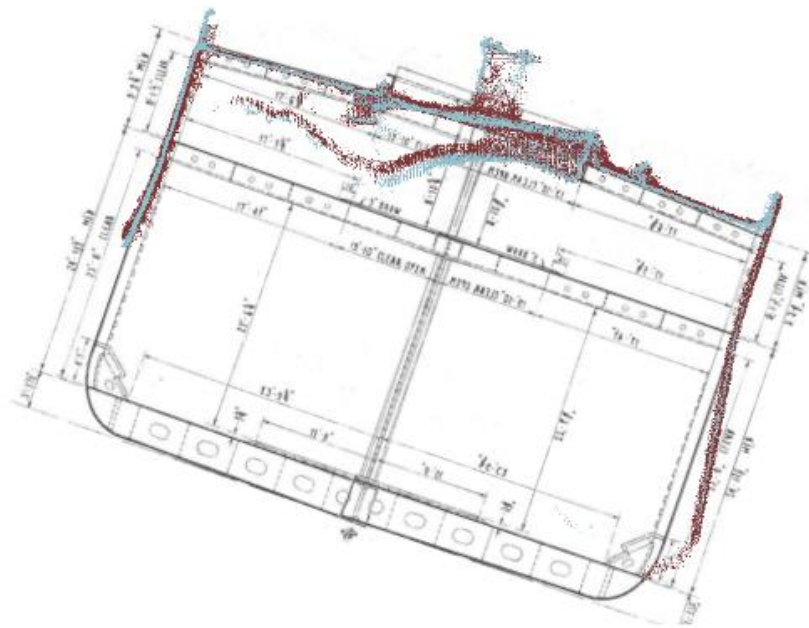
Figure 31 Cross-section of hull at frame 60, aft end of No. 2 Hatch (red August 2019, blue 2017).

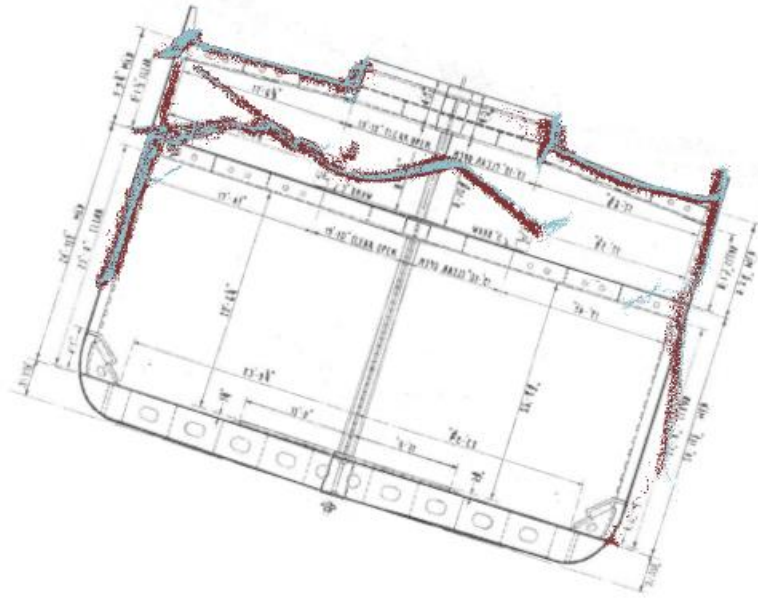
- 4.7.8 In Figure 32 the sediment in the 'tween deck space of Hold 2 is visible. In this area, unlike the forward and aft ends of No. 2 Hatch, the sediment does not fill the 'tween deck space. This may be due to the cracks in the hull sides at this location, which could allow water to flush through and so remove the upper most sediment layers. It is also possible that the Second Deck has partially collapsed where it joins the port hull – see the data as collected through the split in the hull in Figure 32, although this could also be the result of data inaccuracies caused by poor acoustic properties of the sound passing through the narrow gap.

Figure 32 Cross-section of hull at frame 54 where forward section of hull is breaking in two (red August 2019, blue 2017).

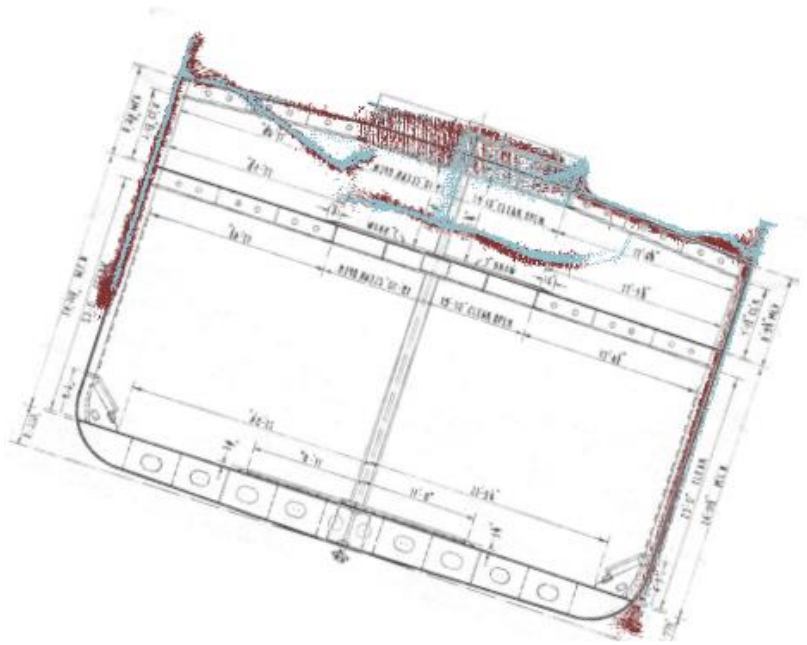
- 4.7.9 The rearmost hold of the forward section. The rear bulkhead of this hold forms the rearmost part of the forward section, the vessel having broken in two immediately aft of that bulkhead. Although the lower hold remained with the forward section, the bulkhead at the rear of the 'tween deck space and the section of the upper deck above it were carried away leaving this area open. The outer hatch cover has gone as have all the cover supports although there is a beam – possibly a cover support or part of the coaming lying on the starboard side (Figure 33 & Figure 34).

Figure 33 Cross-section of hull at frame 73, forward edge of No. 3 Hatch (red August 2019, blue 2017).

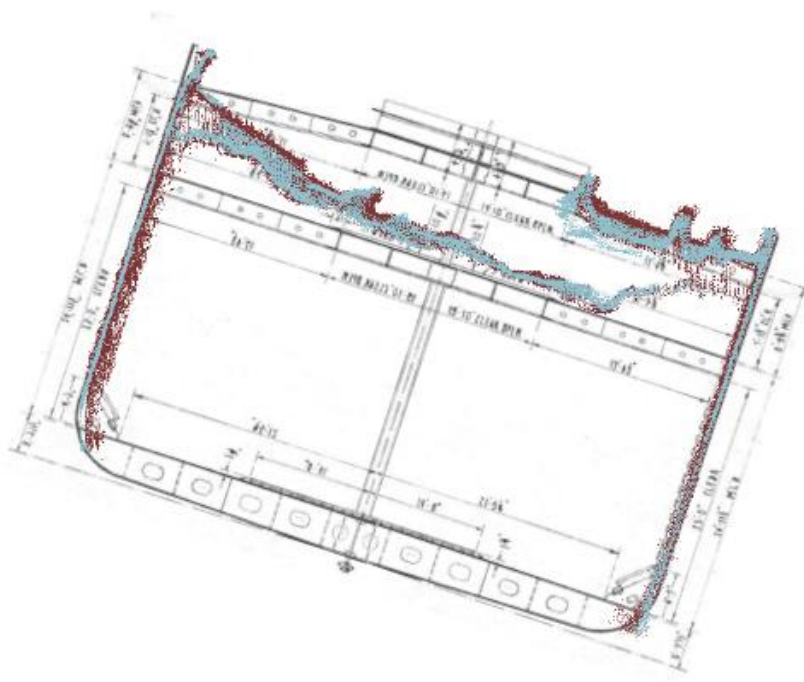
Figure 34 Cross-section of hull at frame 82, aft of No. 3 Hatch (red August 2019, blue 2017).

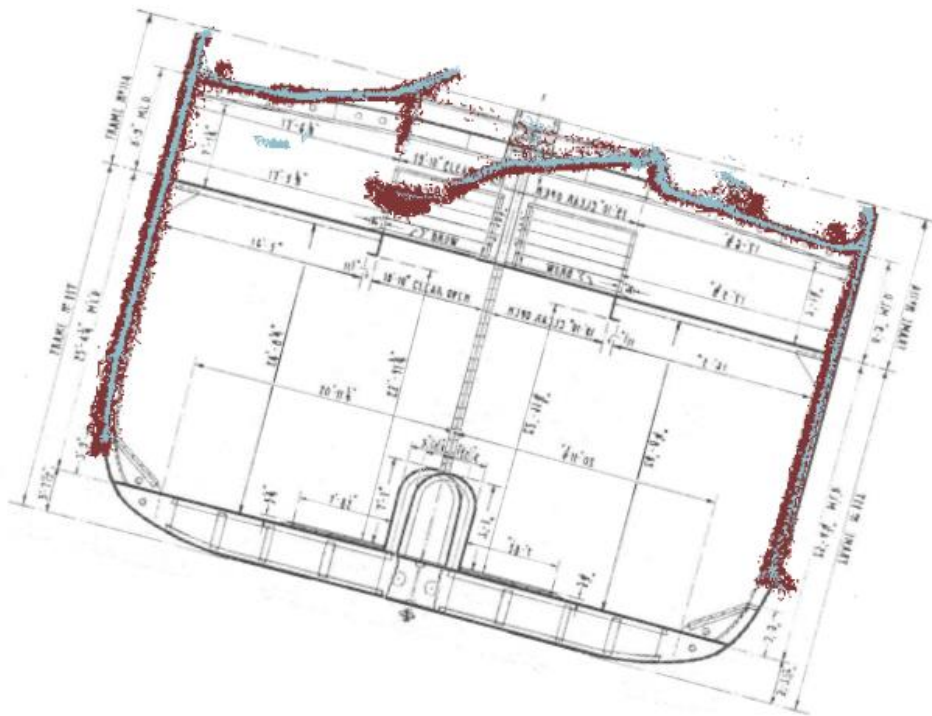
4.7.11 The most forward of the two holds in the aft section. Since the two stern holds are reported to have been emptied during salvage operations conducted soon after the grounding it is not known if the lower hatch covers were replaced. However, since the upper hatch supports are in place, it seems likely that the salvors did replace the covers once they were finished (Figures 35, 36 and 37).

Figure 35 Cross-section through frame 114 at the forward edge of No. 4 Hatch (red August 2019, blue 2017).

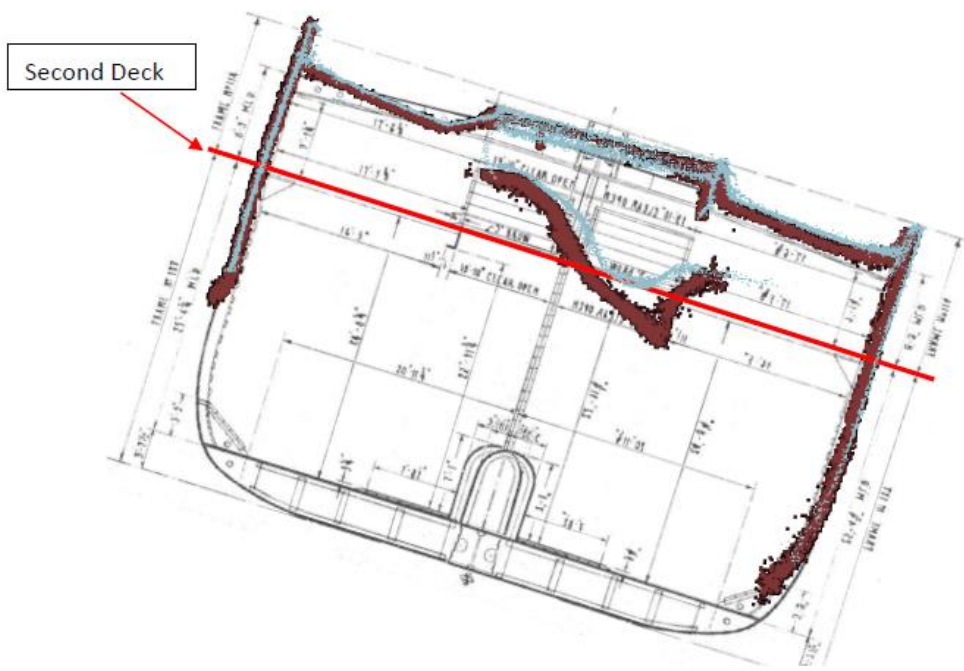
Figure 36 Cross-section through frame 114 at the forward edge of No. 4 Hatch (red August 2019, blue 2017).
