Maritime &
Coastguard
Agency

SS Richard Montgomery: Survey Report 2019

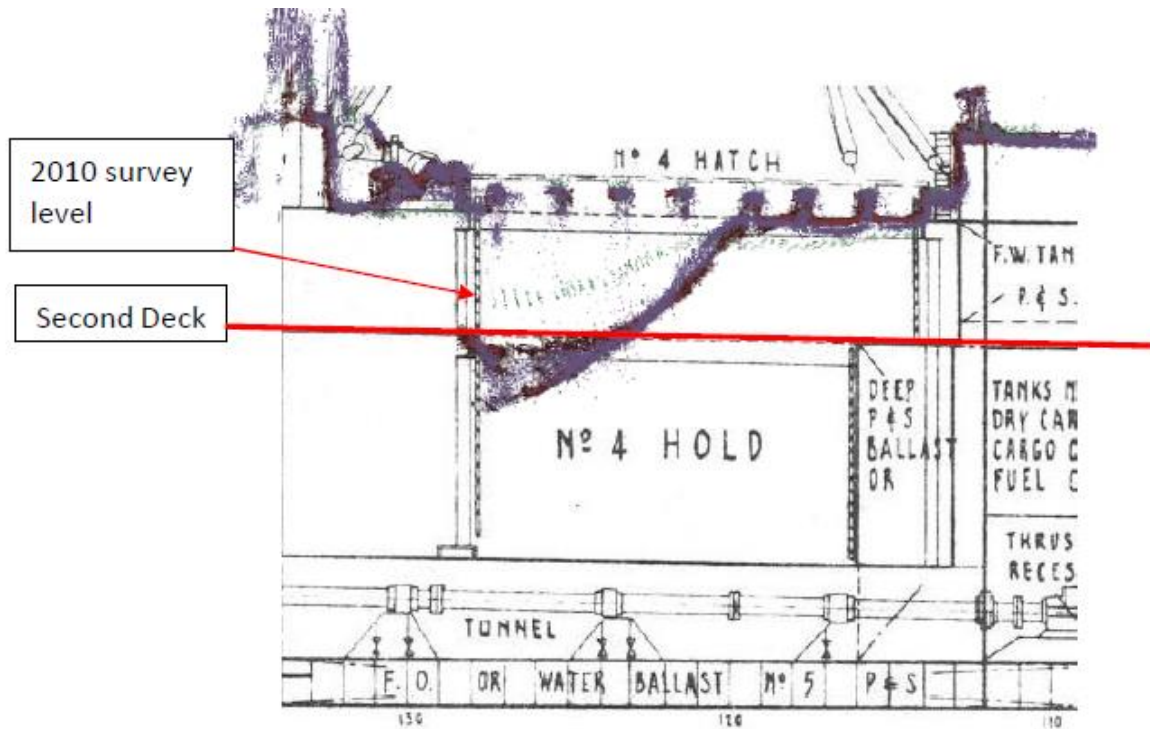
4.7.12 The sediment in the forward part of No. 4 Hatch shows distinct similarities with that in Nos 1 and 2 hatches with the starboard side of the 'tween deck space being completely filled and the port side remaining clear above the horizontal to the top of the hatch coaming (Figure 35). However, the rear of the hatch area shows a different story with the first (and only) indication that the second deck or the lower hatch covers have failed. Here the sediment layer descends below the level of the second deck (Figure 36) confirming some form of collapse, probably a partial collapse of the lower hatch cover. This has happened at some time between 2010 (where the survey showed the sediment above the Second Deck) and the 2017 survey where the sediment is just below the second deck – see Figure 37 below. The sediment has deepened slightly between 2017 and the August 2019 survey.

Figure 37 Longitudinal section through No. 4 Hold (red August 2019, blue 2017).

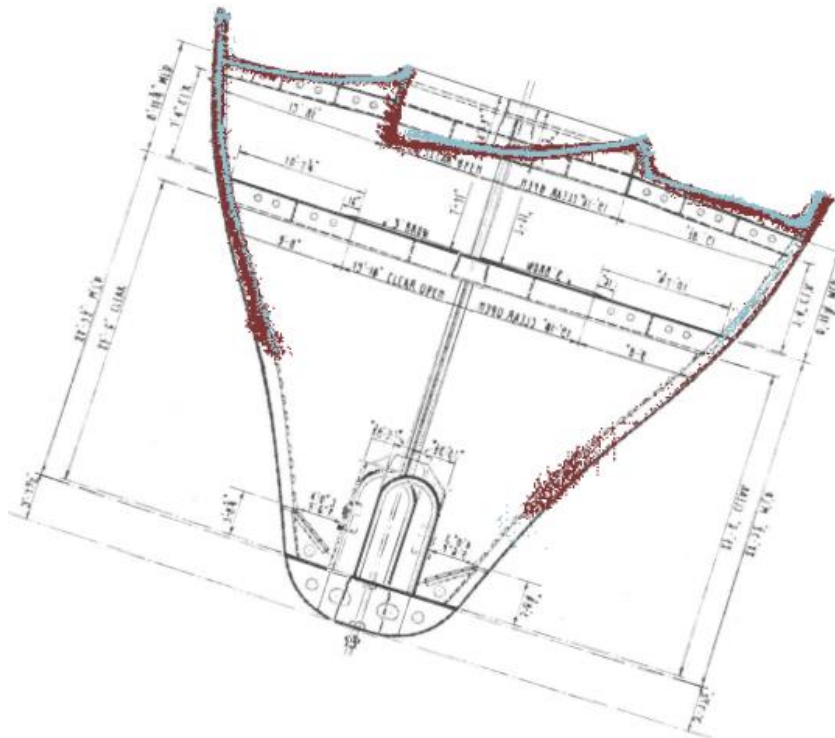
4.7.13 The rear most hold. The forward four of the six hatch cover supports remain in place. Sediment levels in the 'tween deck space again follow the pattern of the other mainly intact holds, in that the starboard side is filled while the port side remains clear above the level of the horizontal from the top of the hatch coaming. As with the other holds, except No. 4 Hold, there is no indication that the second deck or the lower hatch cover have collapsed.

Figure 38 Cross-section through hull at frame 154 (red August 2019, blue 2017).

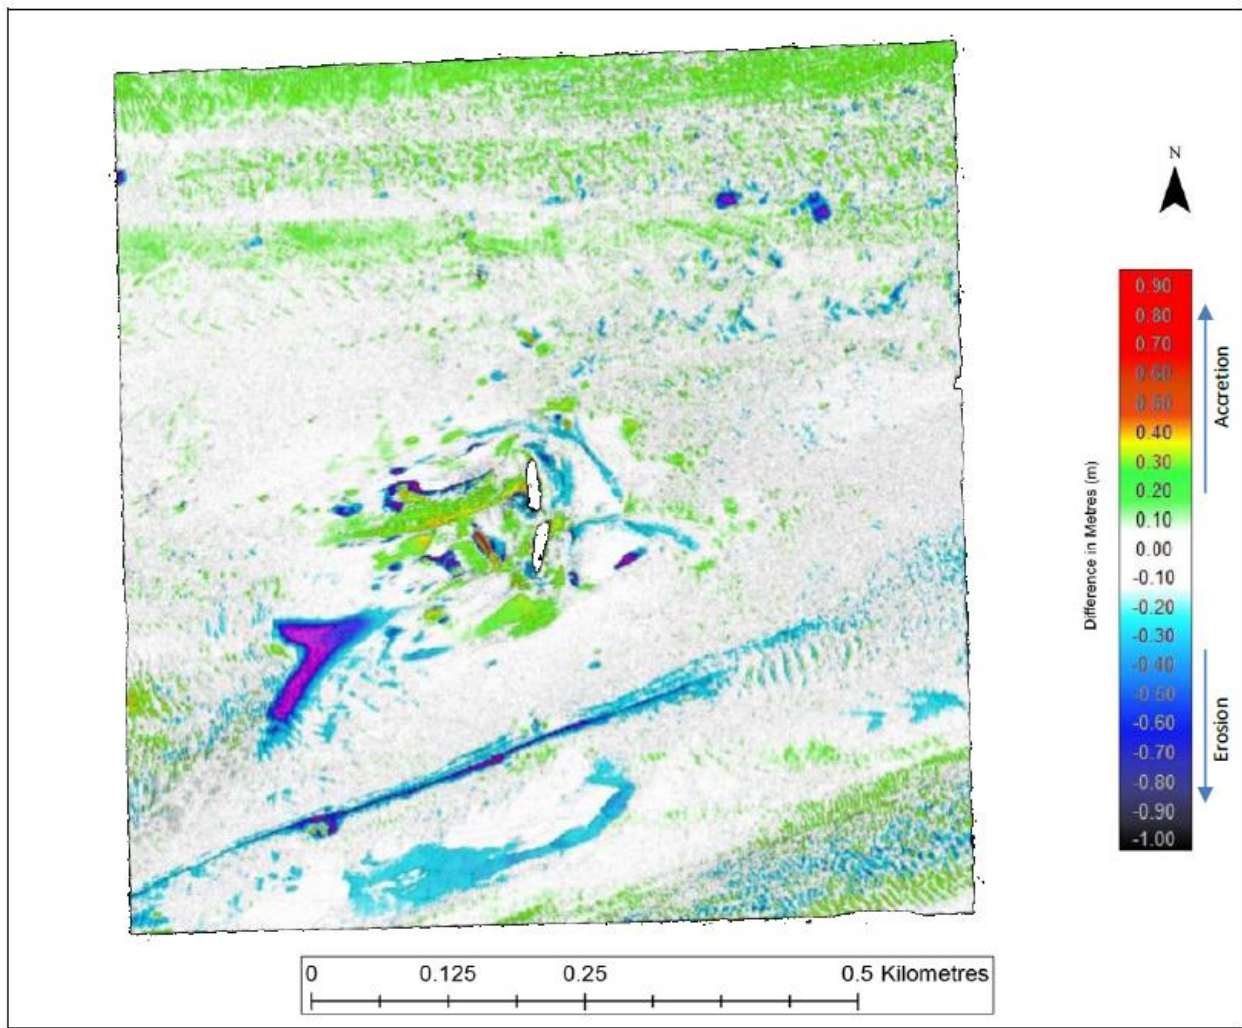
5.1.3 A difference plot was made between the 2017 and 2019 surveys. Changes to the seafloor are fairly limited with the majority remaining stable (± 0.1 m) between the 2017 and 2019 surveys (Figure 44).

5.1.4 The sand bank to the west of the SSRM has been scoured away leaving the seabed some 80 – 90cm deeper in this region. This may show the westerly migration of the sand bank but, with the western depositional end not being covered by the survey, this cannot be confirmed. It could possibly be the erosion of the sand bank with no accretion at the far end. It is of note that a similar pattern of deepening seabed was noted in the 2017 report where the difference surface was between the 2017 survey and the 2014 survey.

Figure 44 Comparison of seabed surveys between 2017 and 2019.

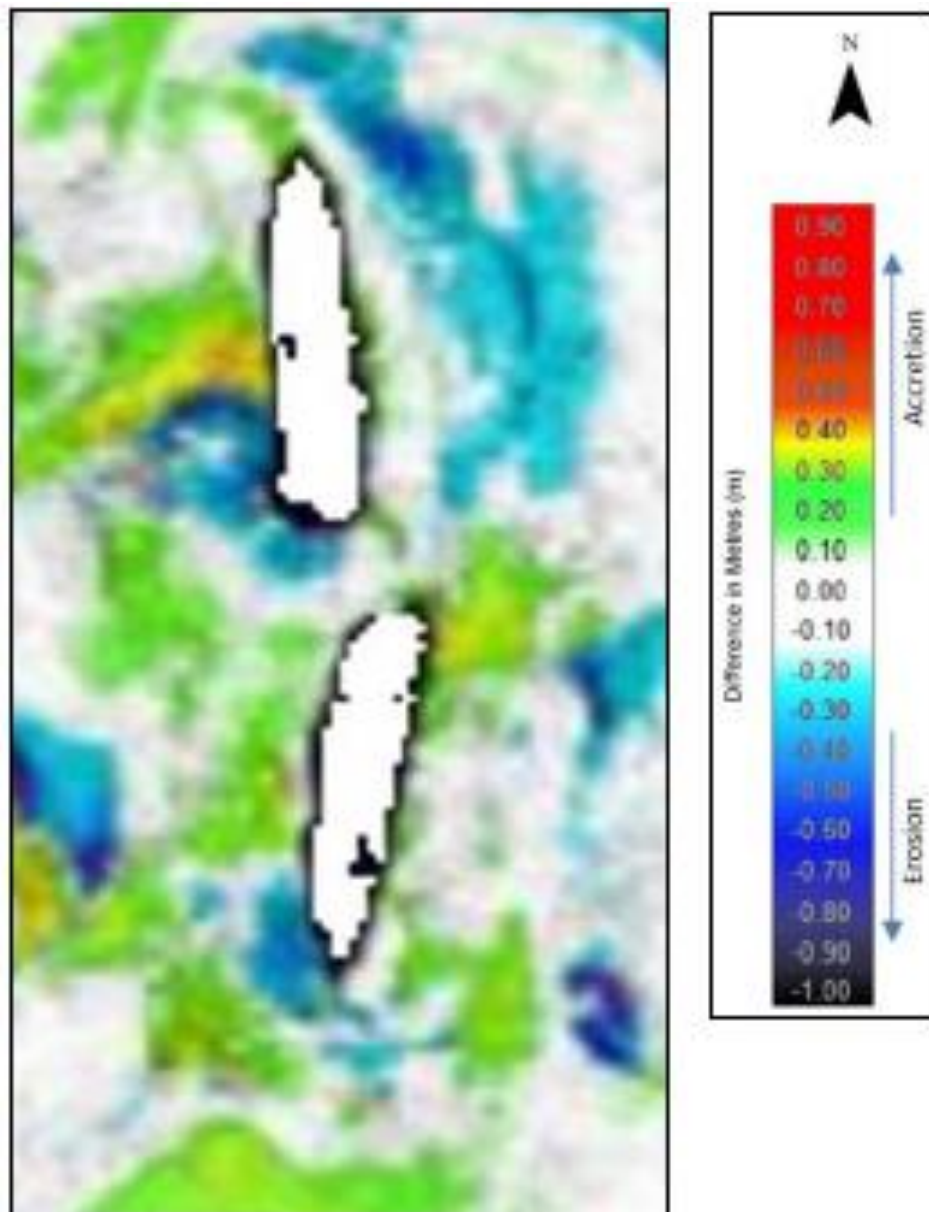
5.2.4 The stern shows less than 10cm change to the east while the western side has suffered from 20 – 30cm of erosion between the two surveys. However, the rudder is still resting on the sea floor and forward of the propeller the hull is quite deeply embedded in the sediment.

Figure 46 Seafloor difference plot around the wreck.
