Maritime &
Coastguard
Agency

SS Richard Montgomery: Survey Report 2018

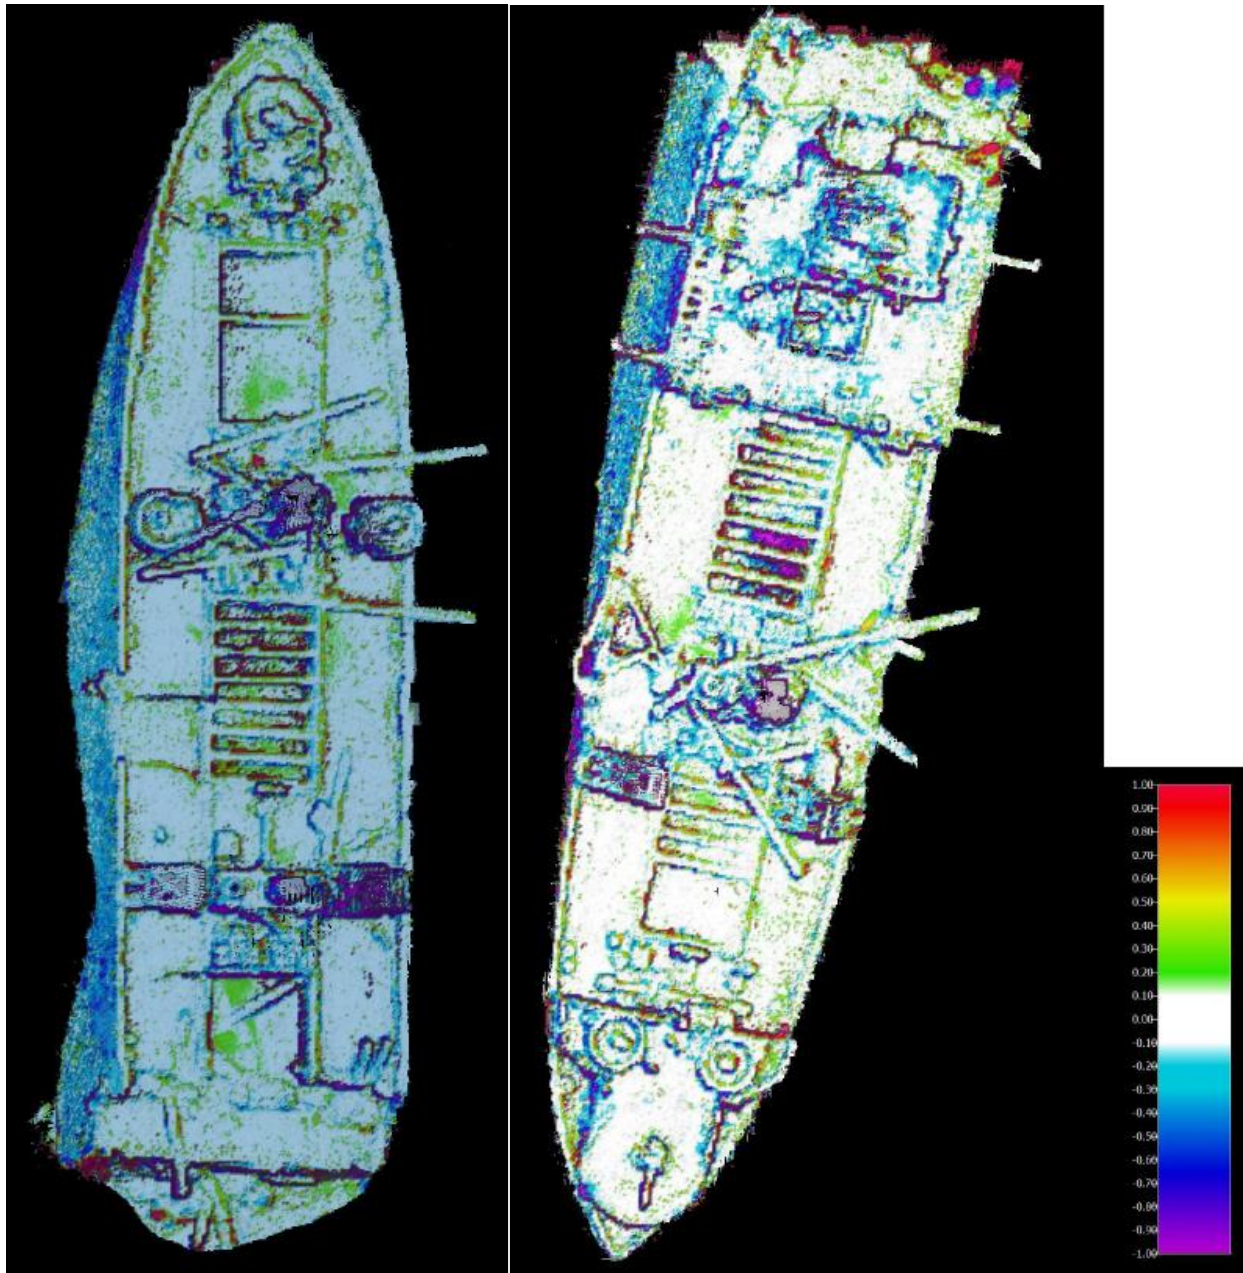
- 1.3.7 Surface difference results showed that the seabed area around the wreck has generally remained stable during the period between the 2017 and 2018 surveys. Deposition has occurred on the starboard side of the of the aft section the wreck, with an increase in sediment of up 0.5m.

Figure 6 Surface difference between 2017-2018 survey data on forward (left) and aft (right) sections.

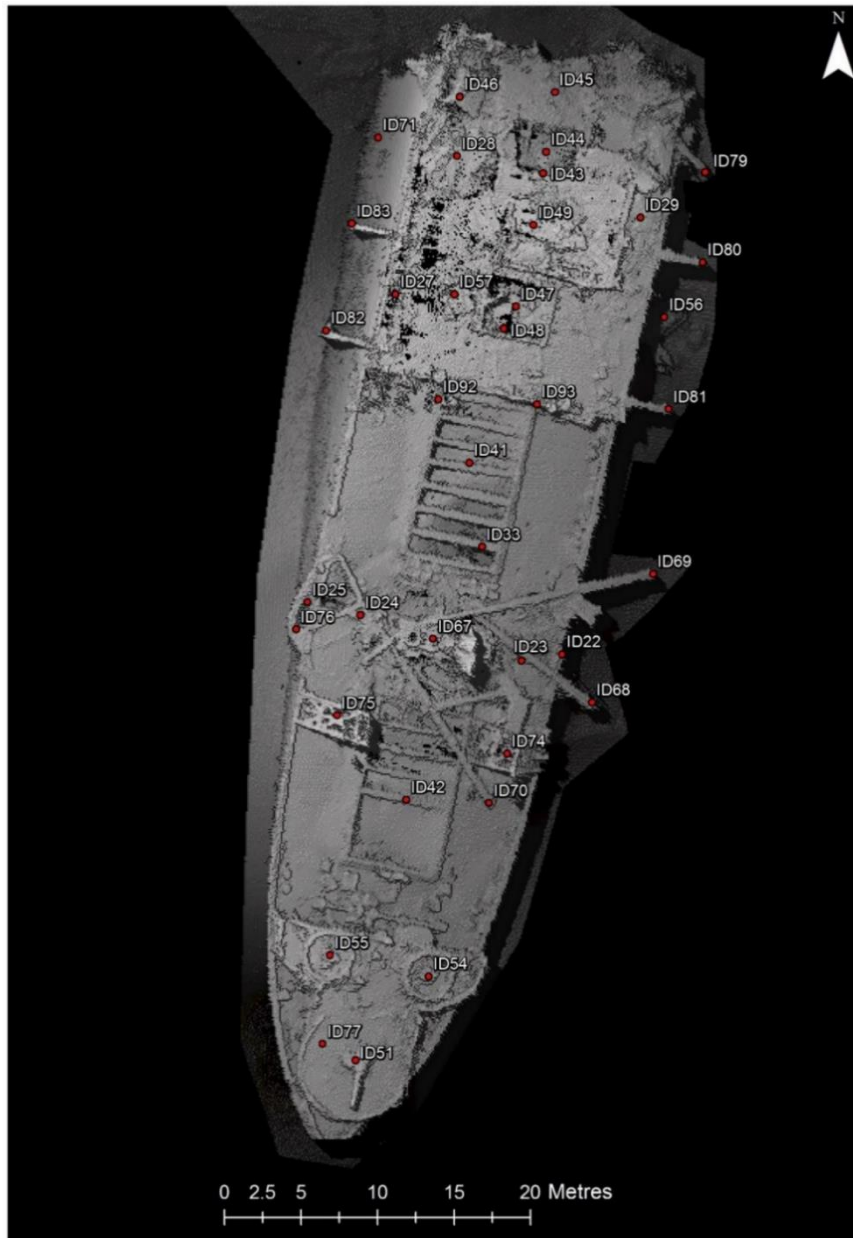
4.2.7 Small changes can be seen in the collapsing bridge deck at the forward end of the aft section of the vessel (feature ID43, ID45 and ID46) and at the accommodation block/bridge wing area (Figure 8). This area experienced significant changes prior to the 2015 survey and has again shown change, albeit of a smaller magnitude. The changes seen here are in the region of 0.5m difference due to the subsidence of deck plating at the NE edge of the bridge deck.

Figure 8 ID features on rear section.

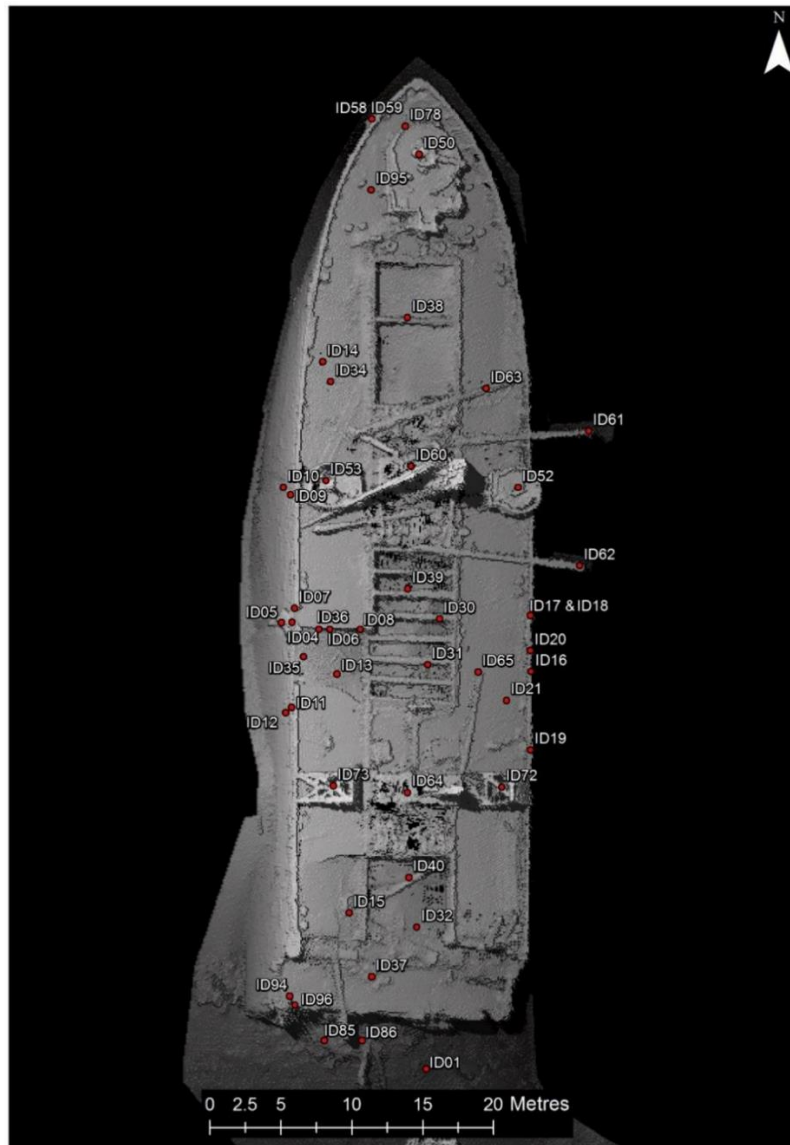
4.2.8 The deck plate on the port side of hold 2 (feature ID08) has remained stable (Figure 9). Interrogation of the data using the CARIS profile shows no changes on this section of collapsed deck.

Figure 9 ID features on forward section.

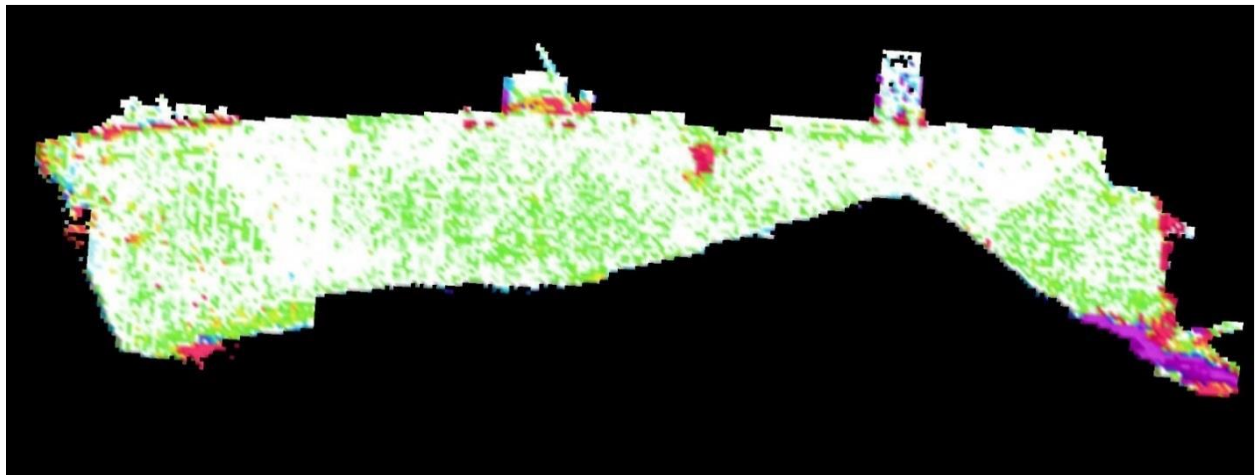
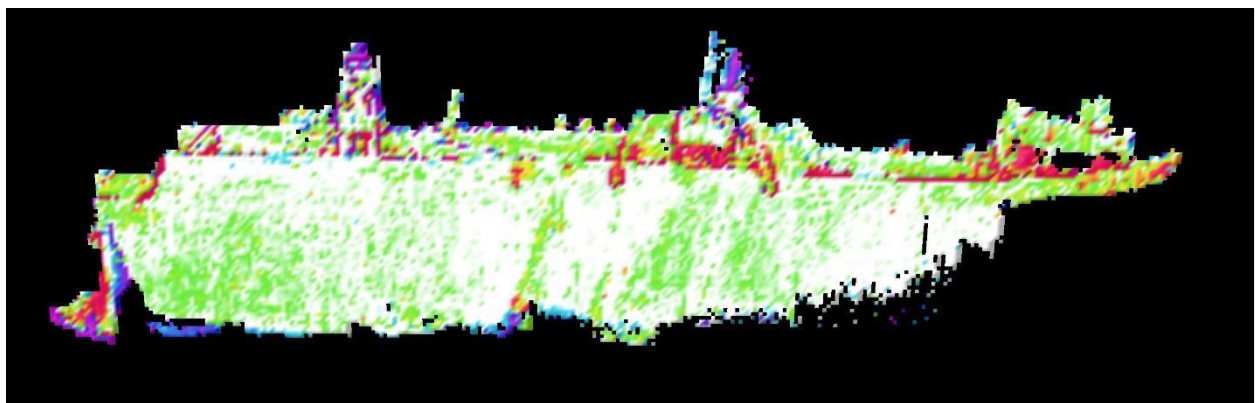
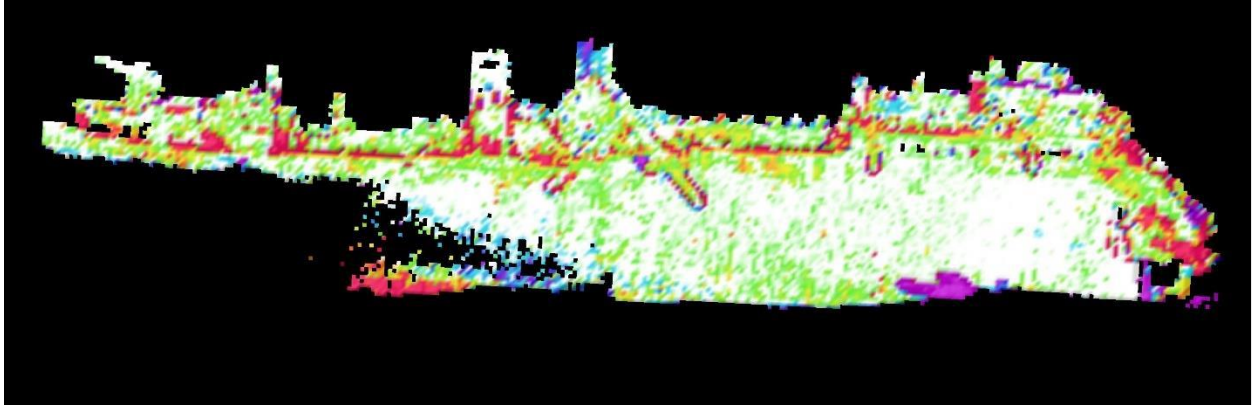
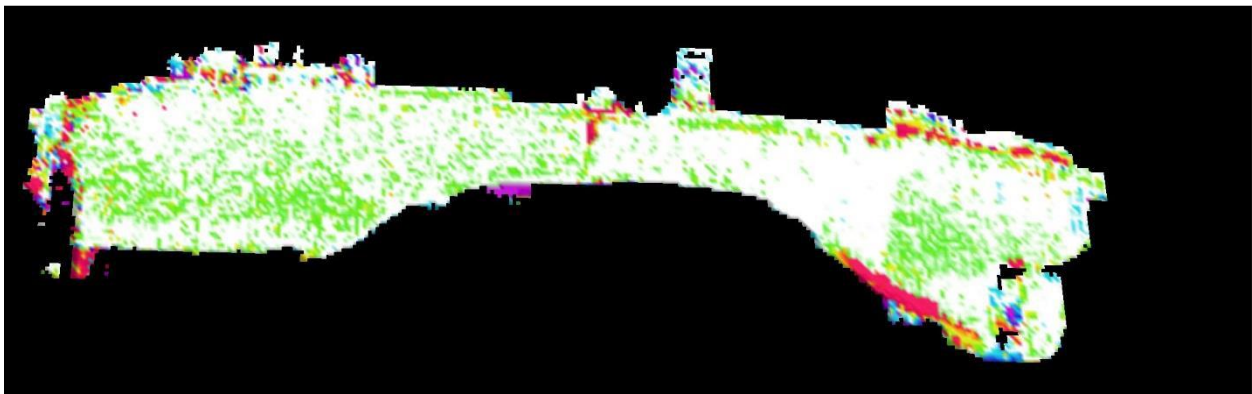
4.2.12 No new deformities have been found and the differences shown are most likely due to comparison of differing data densities and marine growth. The red areas approximately mid-way along both the forward and rear hulls are the cracks. The differences here result from the fact that the inside of the hull is being surveyed rather than a change in the hull plates around the cracks (Figures 10-13).

Figure 10 Port forward hull surface difference plot between 2017 and 2018 surveys.

Figure 11 Starboard forward hull surface difference plot between 2017 and 2018 surveys.

Figure 12 Starboard aft hull surface difference plot between 2017 and 2018 surveys.

Figure 13 Starboard forward hull surface difference plot between 2017 and 2018 surveys.

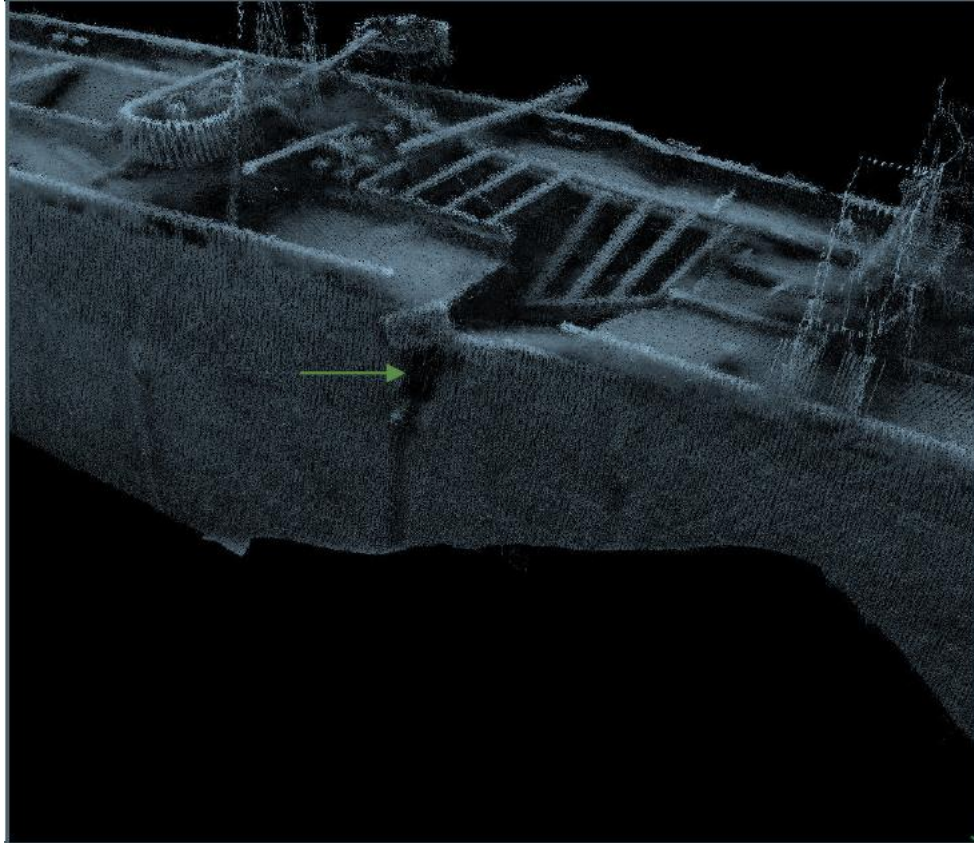
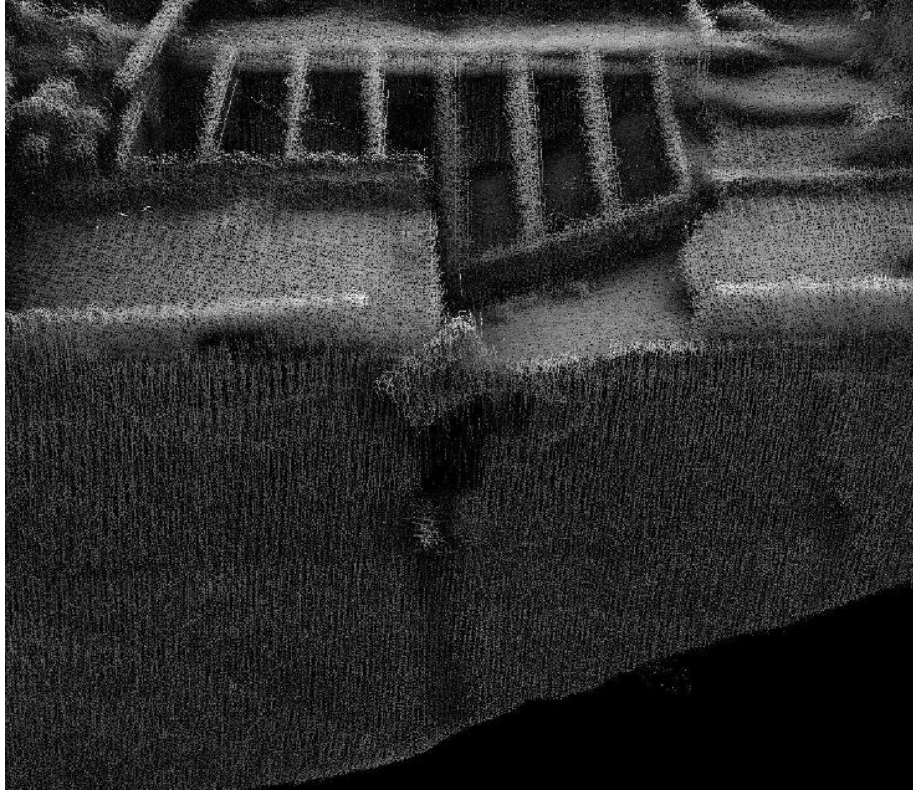
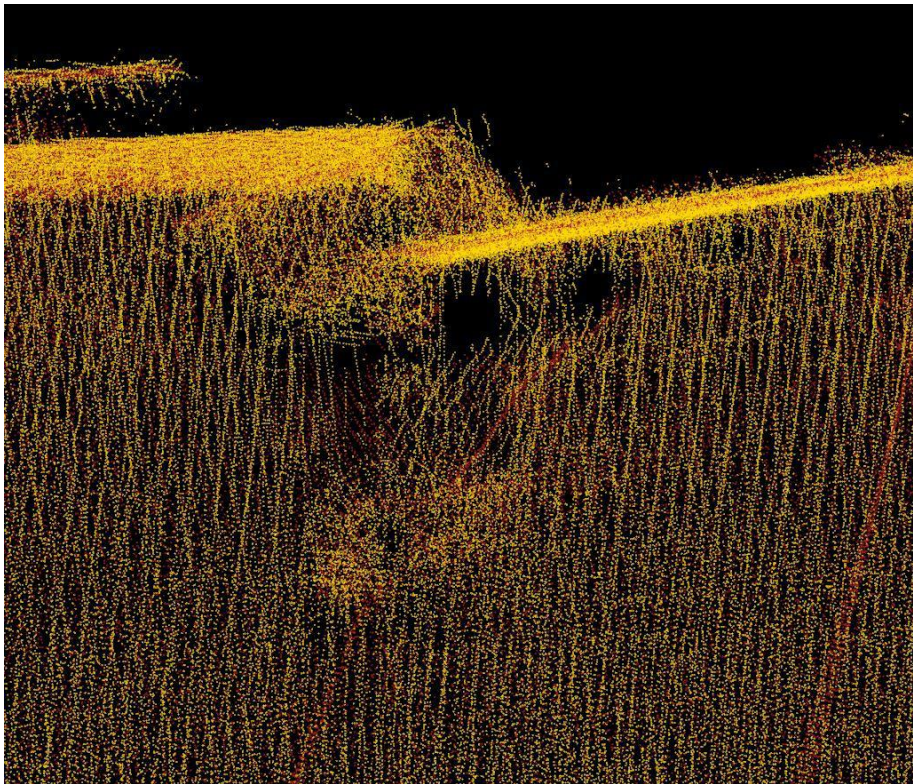
4.3.3 Key Area 1 – Crack in hull (ID04)

4.3.4 Feature ID04, crack in the hull, is located on the port side of the forward section of the wreck adjacent to hold 2. In comparison to the point cloud datasets from 2018 and 2017, no changes have occurred in this location (Figures 15-17).

Figure 15 Crack in hull ID04 in 2017 survey data.

Figure 16 Crack in hull (ID04) in 2018 survey data.

Figure 17 Crack in hull (ID04) 2018 survey data yellow, 2017 survey data red.

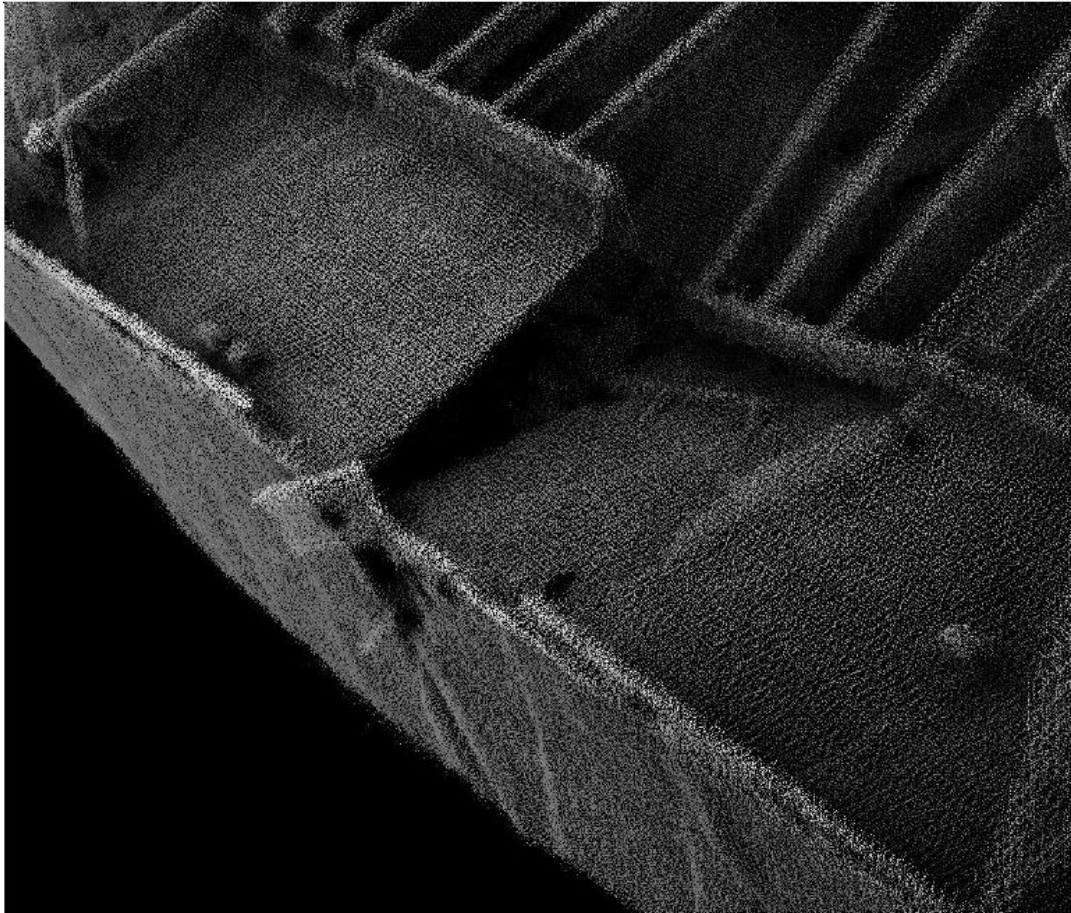
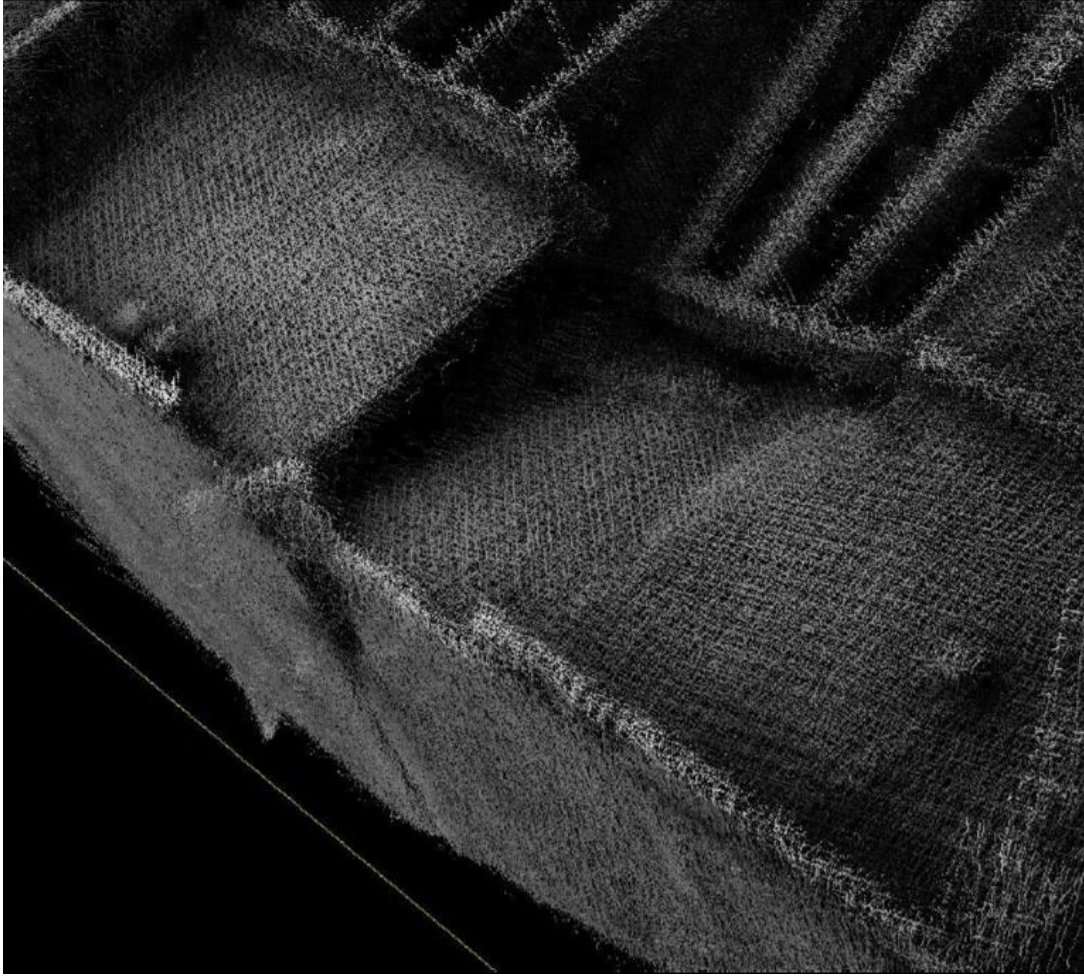
4.3.5 Key Area 2 – Collapse of hold deck 2 (ID08).

4.3.6 The collapsed hold deck 2 is situated on the port side of hold 2 and consists of an area of deck that has undergone subsidence. This area is part of the key areas as it has shown change over the previous surveys. No change has been observed between the 2017 and 2018 surveys (Figures 18 and 19).

Figure 18 2017 survey collapse of hold deck 2.

Figure 19 2018 survey collapse of hold deck 2.

- 6.1.6 The fractured deck plate at the Key Area 2- ID 08, (collapse of the hold 2 cargo deck) has remained stable over the past year. Subsidence was noted between 2016 and 2017.

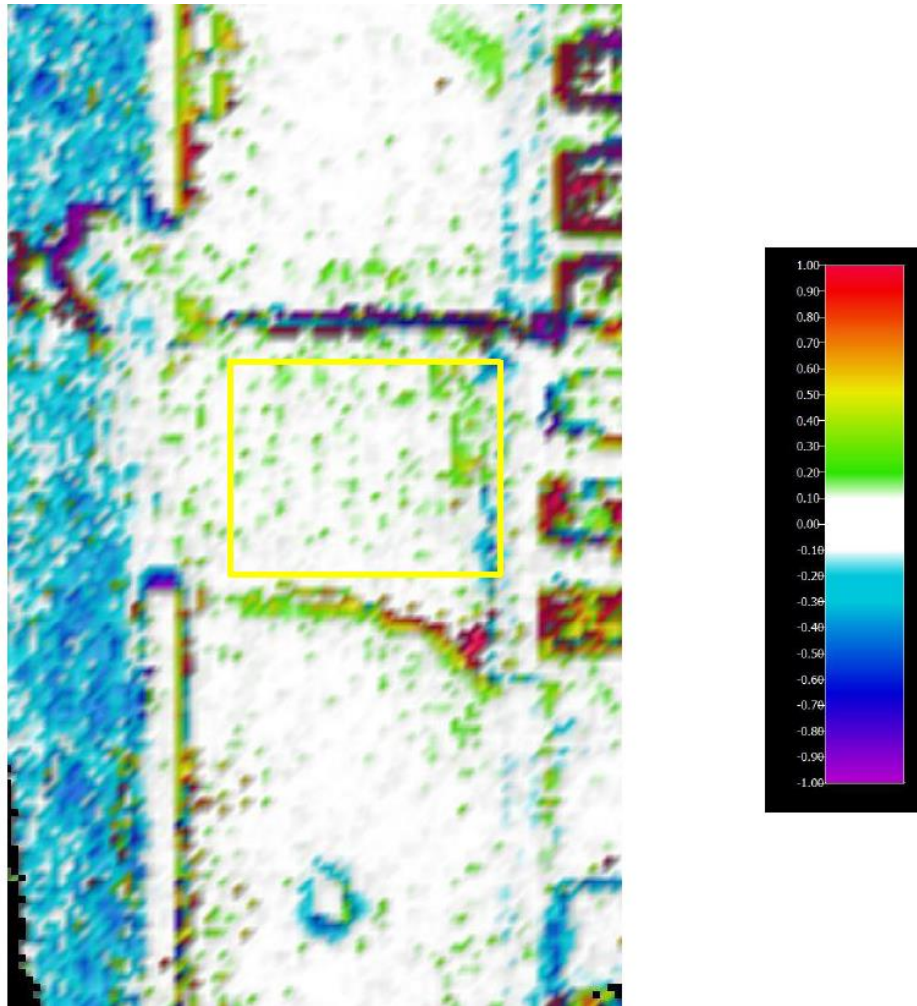
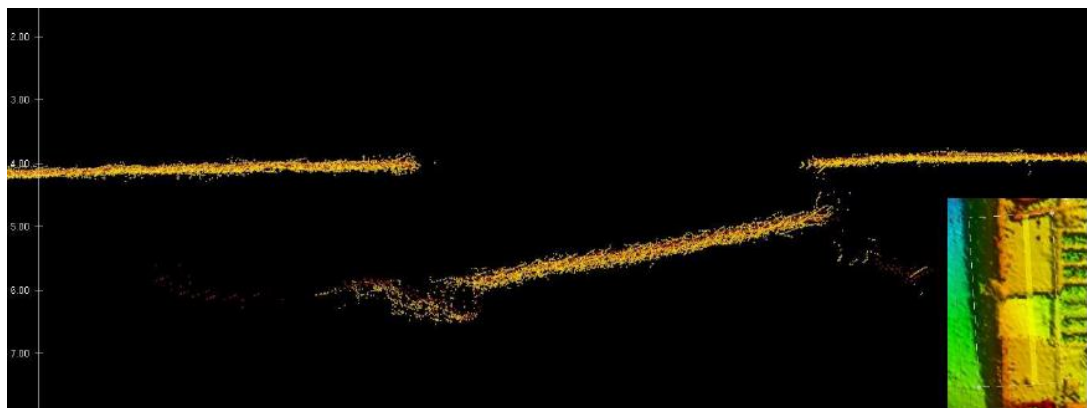
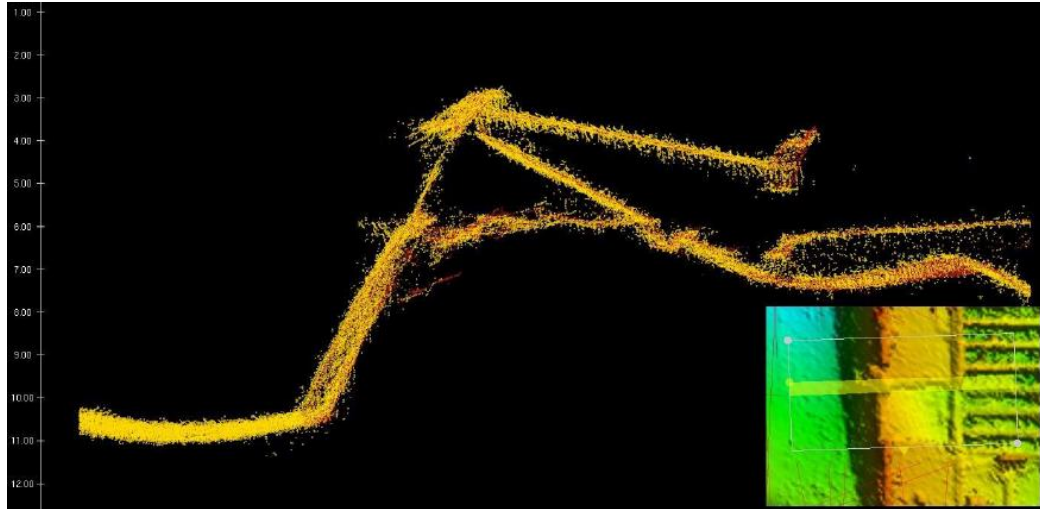
- 4.3.7 Changes in the level of the collapsing deck were noted in the 2017 report although the comparison of the 2017 survey data against the 2018 survey data, as illustrated in Figure 20, shows that no further changes have occurred in this area. Surface difference analysis shows that the deck plate has remained stable within this timeframe (see also Figures 21 and 22).

Figure 20 Key Area 2 - surface difference between 2017 and 2018 surveys.

Figure 21 Profile across deck hold plate. 2018 survey (yellow), 2017 survey (red). No change noted.

Figure 22 Profile through collapsed deck. 2018 survey (yellow), 2017 survey (red). No change noted.

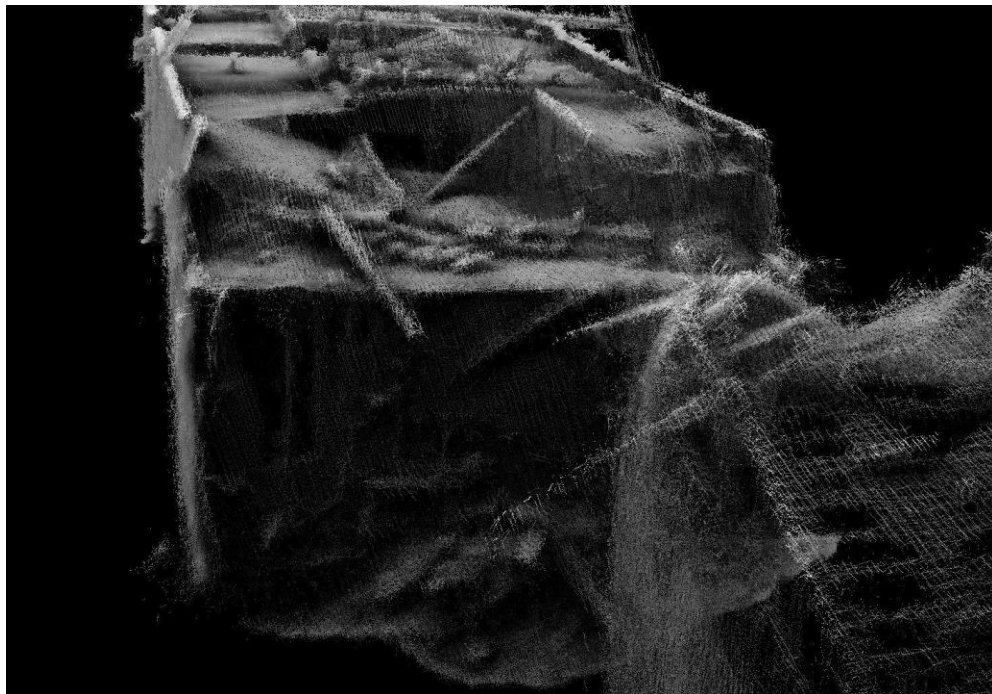
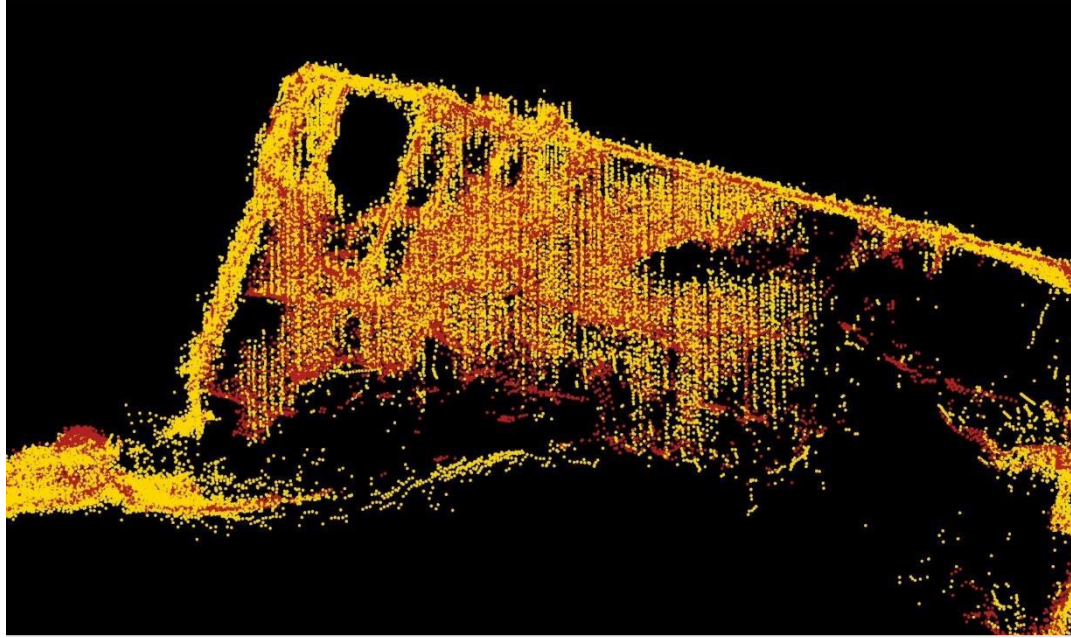
4.3.8 Key Area 3 – Aperture (ID90) and hold contents (ID94)

4.3.9 The aperture on the aft end of the forward section is clearly visible in the 2018 survey dataset (Figure 23). A CARIS profile, illustrated in Figure 24, shows very good correlation between the data sets. The dimensions of the aperture have remained consistent across the datasets from the previous two years.

Figure 23 Aperture at aft end of forward section denoted by red dot. Internal cargo can be viewed through the aperture.

Figure 24 Aperture profile at aft end of forward section, 2019 (yellow), 2017 survey (red). Aperture denoted by red dot.

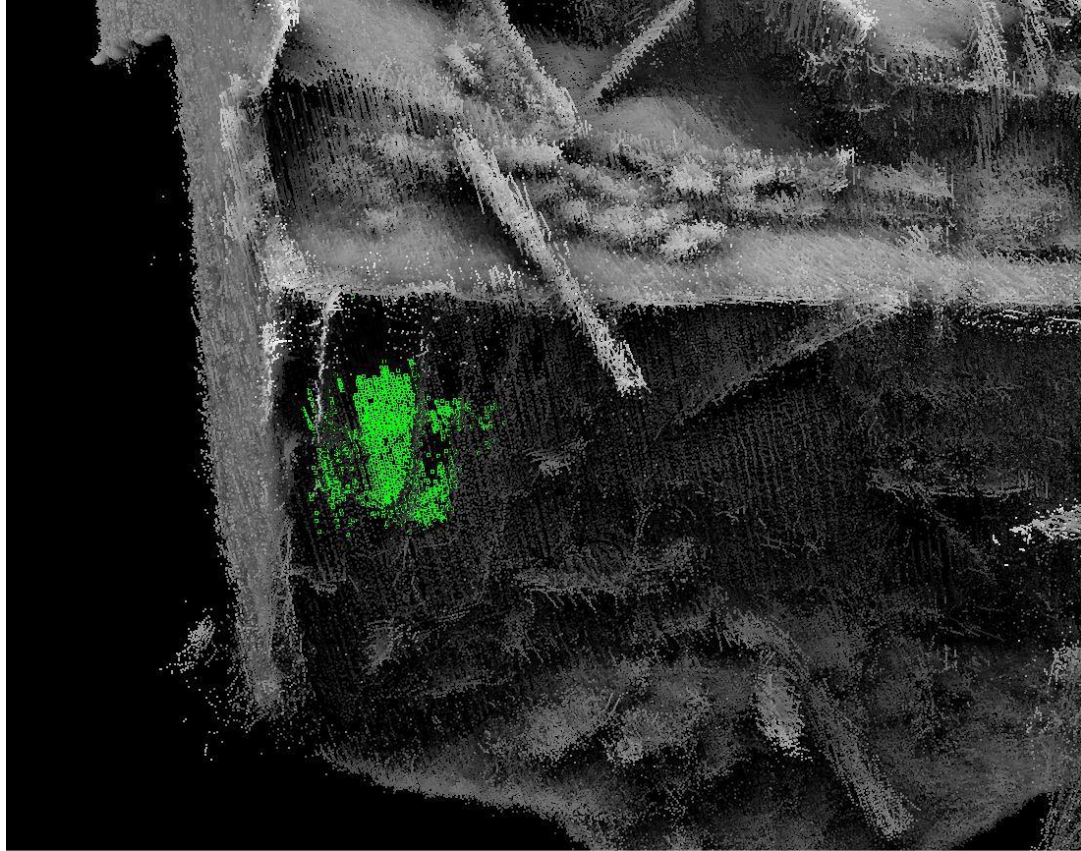
- 4.3.10 Whilst the hold cargo can be seen (Figure 25), the exact oblique sonar angle required for good internal ensonification was not achieved. This may be because of the state of tide or beam sector angle during that pass. The shoalest depth recorded of the internal cargo was 8m below Chart Datum (CD) compared to 7.15m in 2017 - from the data it is not possible to ascertain whether this represents a decrease in the amount of cargo visible or whether the area was not fully ensonified.

Figure 25 Hold cargo data points in green from 2018 survey.

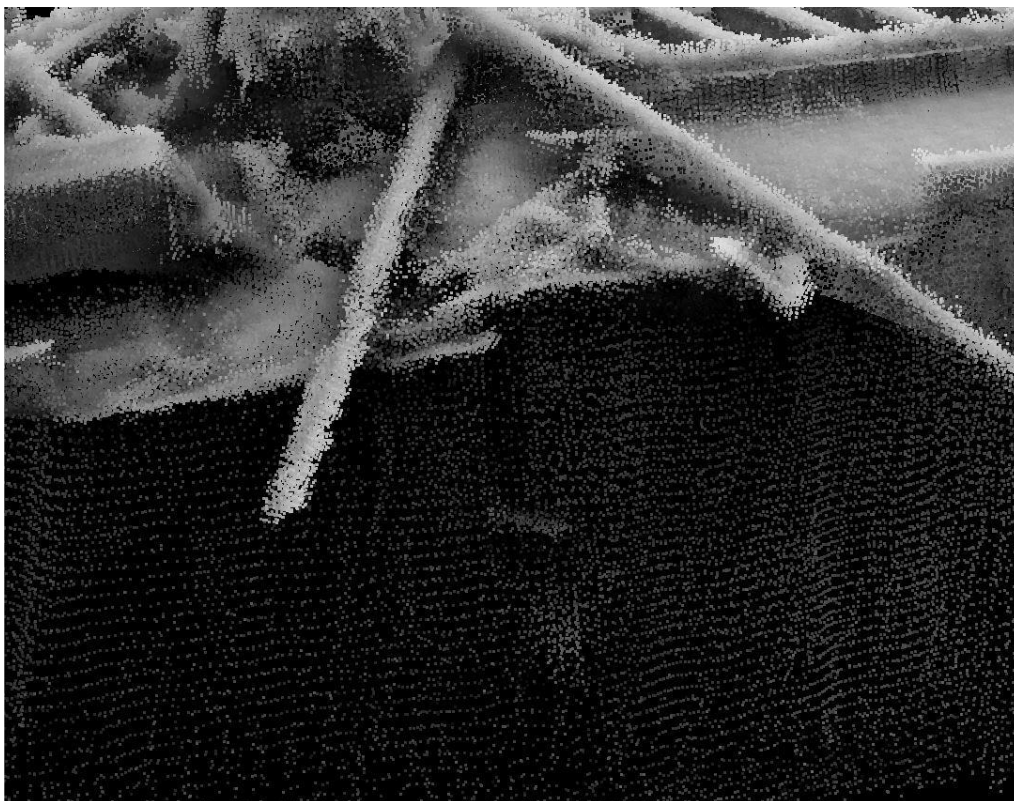
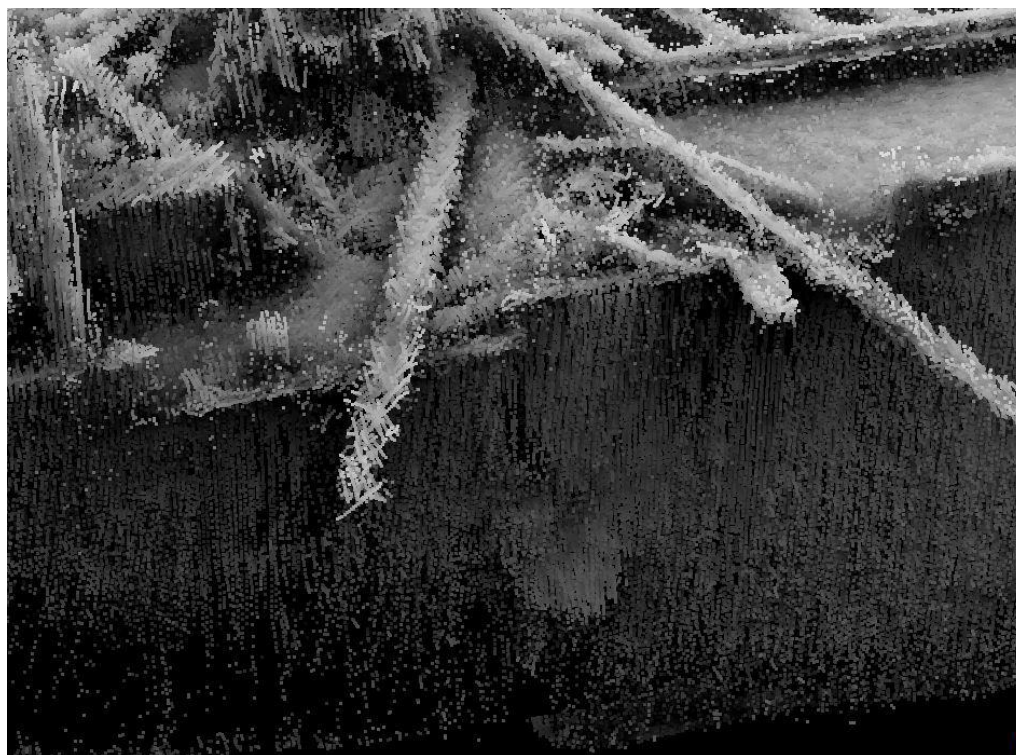
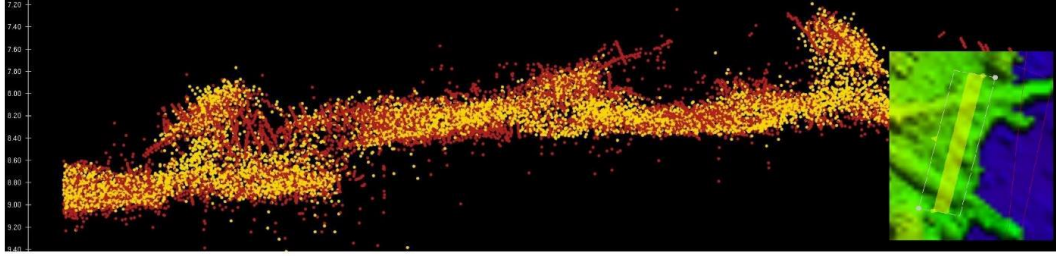
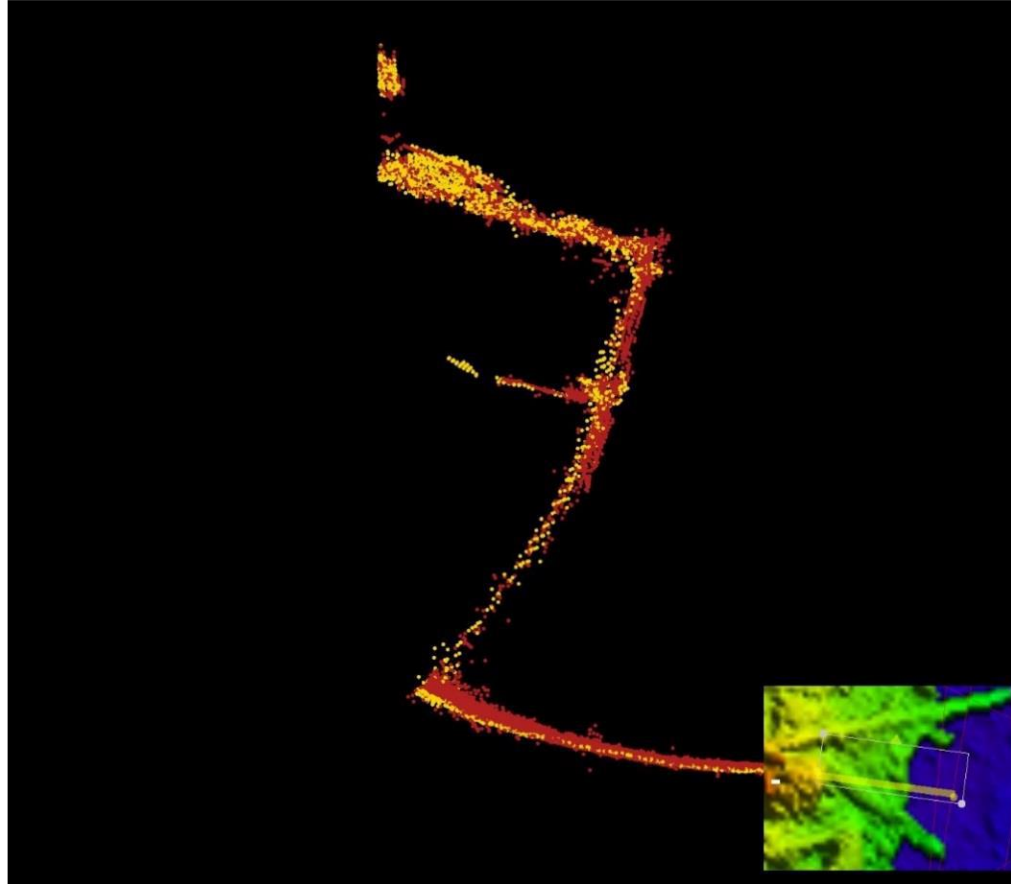
4.3.11 Key Area 4 – Splitting of Hull (ID 22)

4.3.13 Initial visual inspection of the point cloud data shows little change of the split in the hull over the last two years of survey (Figures 26 and 27). Using a surface difference plot and CARIS along and across profiles, no significant change has occurred. The split in the hull appears to be the same with data points inside the hull visible in Figure 29.

4.3.14 Surface differencing shows no change has occurred since the 2017 survey.

Figure 26 2017 survey - Key Area 4 split in hull.

Figure 27 2018 survey - Key Area 4 split in hull.

Figure 28 Profile across deck, location inset. 2018 survey (red), 2017 survey (yellow).

Figure 29 Profile - internal ensonification seen through hull. 2017 (yellow), 2018 survey (red). No change noted.

- 6.1.8 Key Area 4 - the splitting of the hull has not shown any evidence of deterioration when compared with previous datasets.
- 6.1.9 Key Area 3 - the aperture at the aft of the forward section was surveyed with good clarity and no changes have been noted to the opening. The cargo inside was ensonified to a height of 8m CD.
