Maritime &
Coastguard
Agency

SS Richard Montgomery: Survey Report 2018

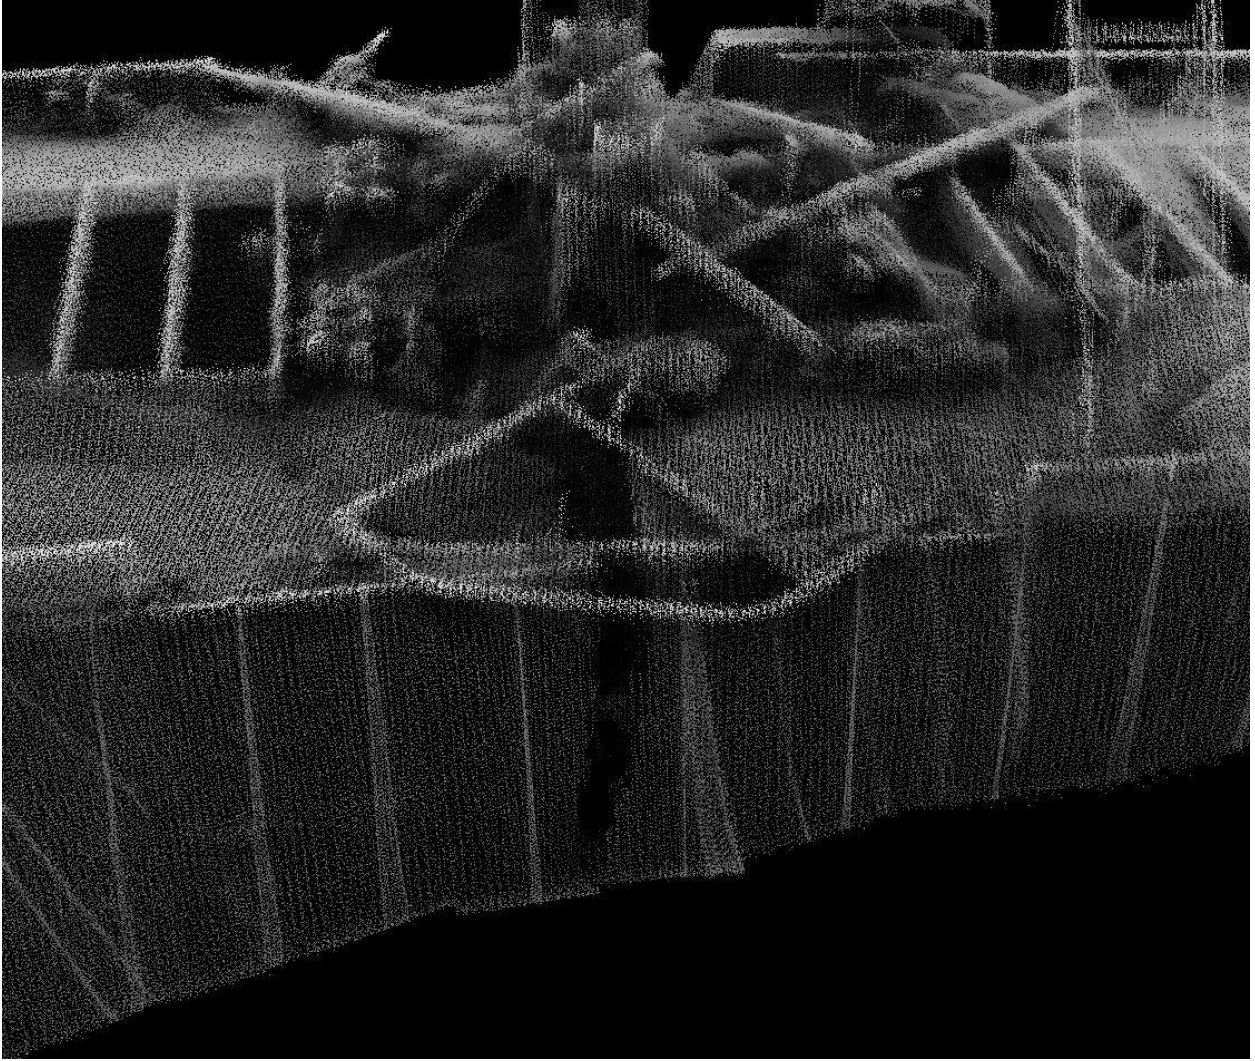
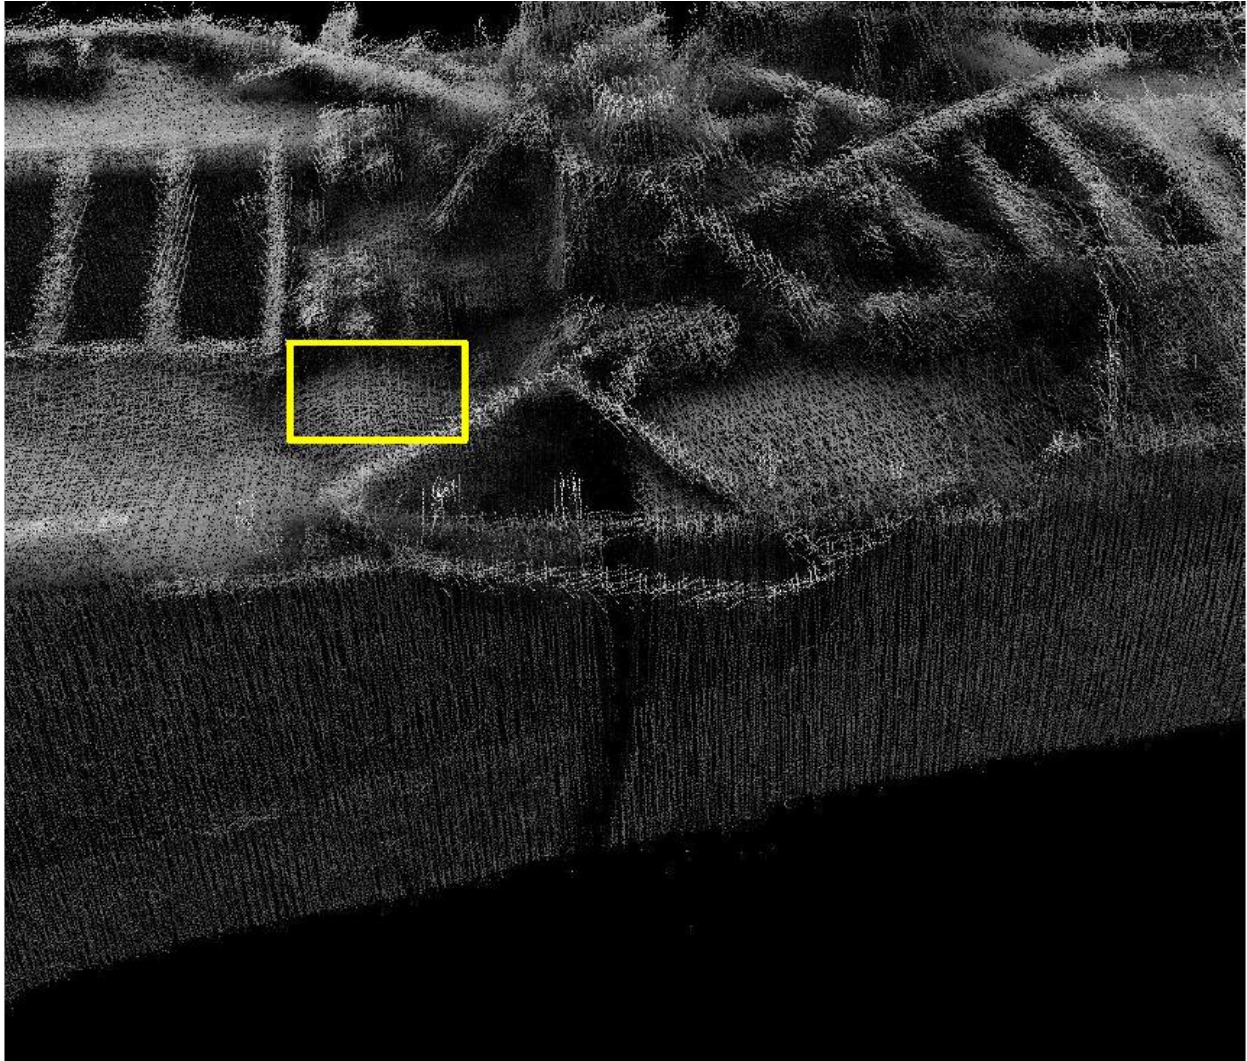
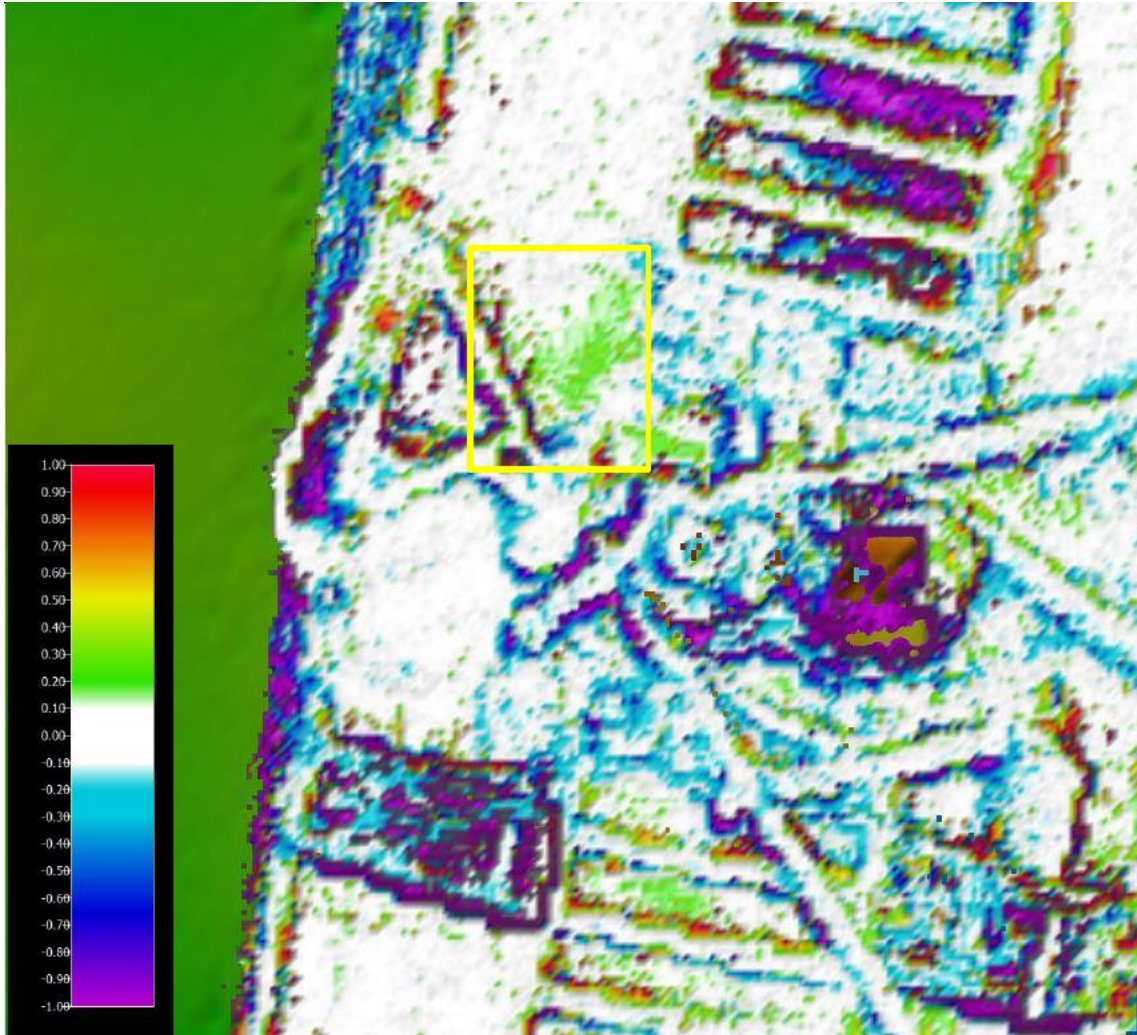
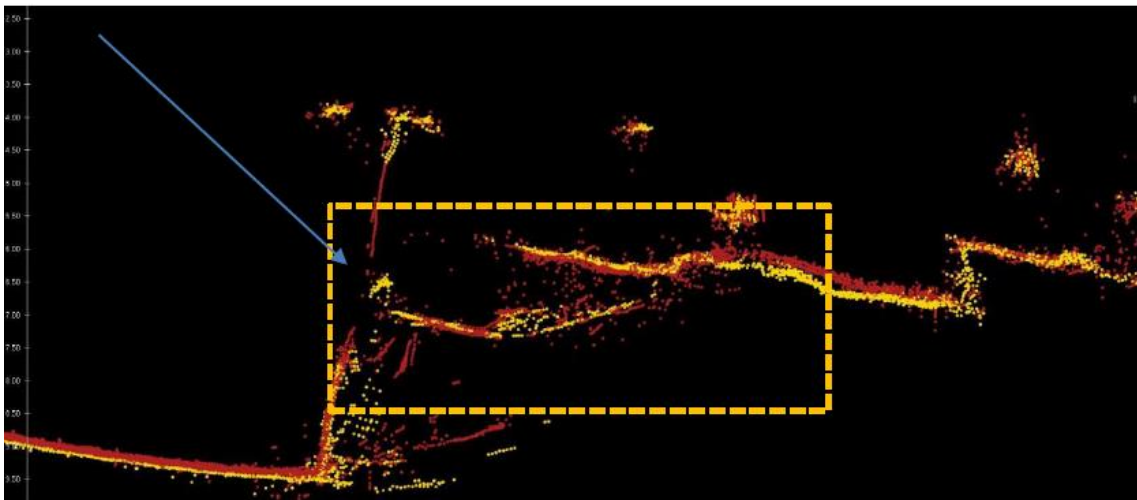
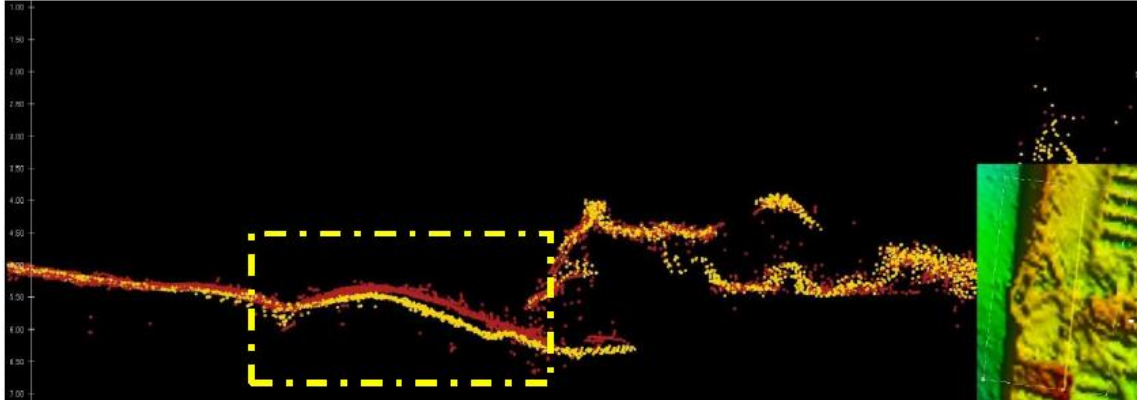
4.3.15 Key Area 5 – Split in Deck & Hull (ID24 & ID25)

- 1.3.3 In Key Area 5 the deck plate appears to be buckling upwards up to 0.2m on the forward side of the crack on the deck. Key Area 6 is the collapsing bridge deck of the aft section where it has split from the fore section of the wreck. This area shows changes of less than 0.5m to the protruding deck plates.

4.3.16 Key Area 5, split in deck and hull (ID24 and ID25) on the aft section port side appears to have remained stable throughout the past two years of survey, however the deck plate appears to be buckling upwards up to 0.2m on the forward side of the crack on the deck (Figures 28 and 30-34). Cross profiles through the hull show the assumed sediment within the hold, which has been ensonified through the crack in the deck above.

Figure 30 2017 Split in deck/crack in hull.

Figure 31 2018 survey split in deck/crack in hull. A buckling of the deck of 0.20m has been identified since the 2017 survey.

Figure 32 Surface difference plot. Yellow box indicating where buckling is seen on deck plate.

Figure 33 Profile through hull 2017 survey (yellow), 2018 survey (red).

Figure 34 Along deck profile showing buckling of deck plate. 2017 survey (yellow), 2018 survey (red).

- 6.1.7 Key Area 5 - Split in deck and hull (ID24 & ID25). The split in hull remains in the same state of deterioration and the contents inside the crack have been

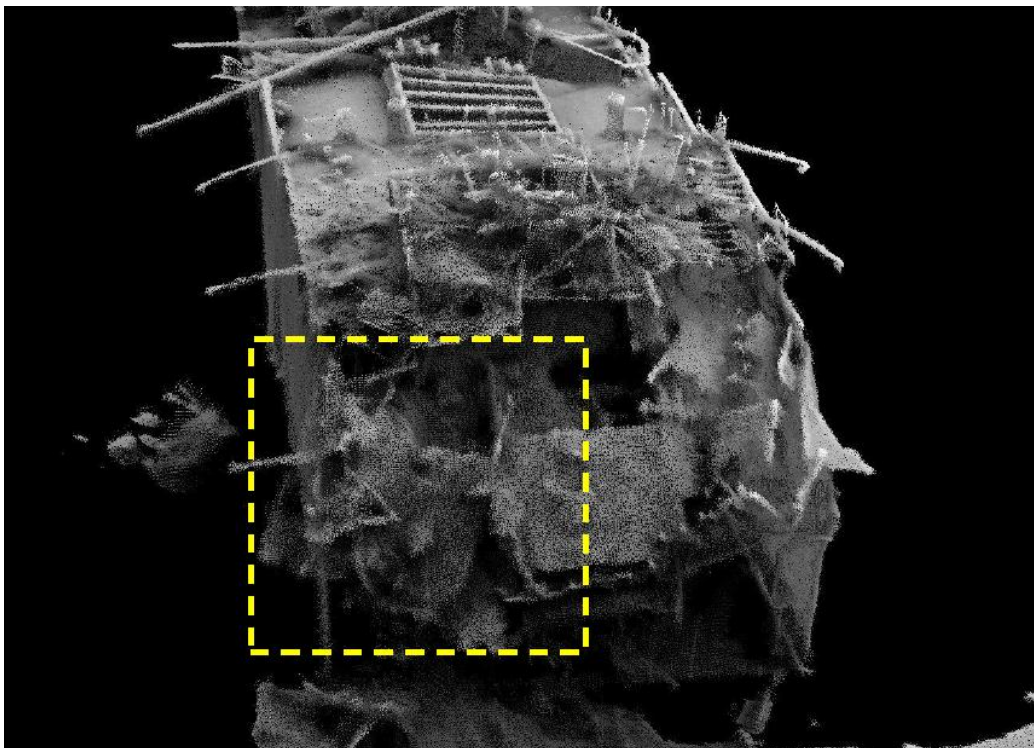
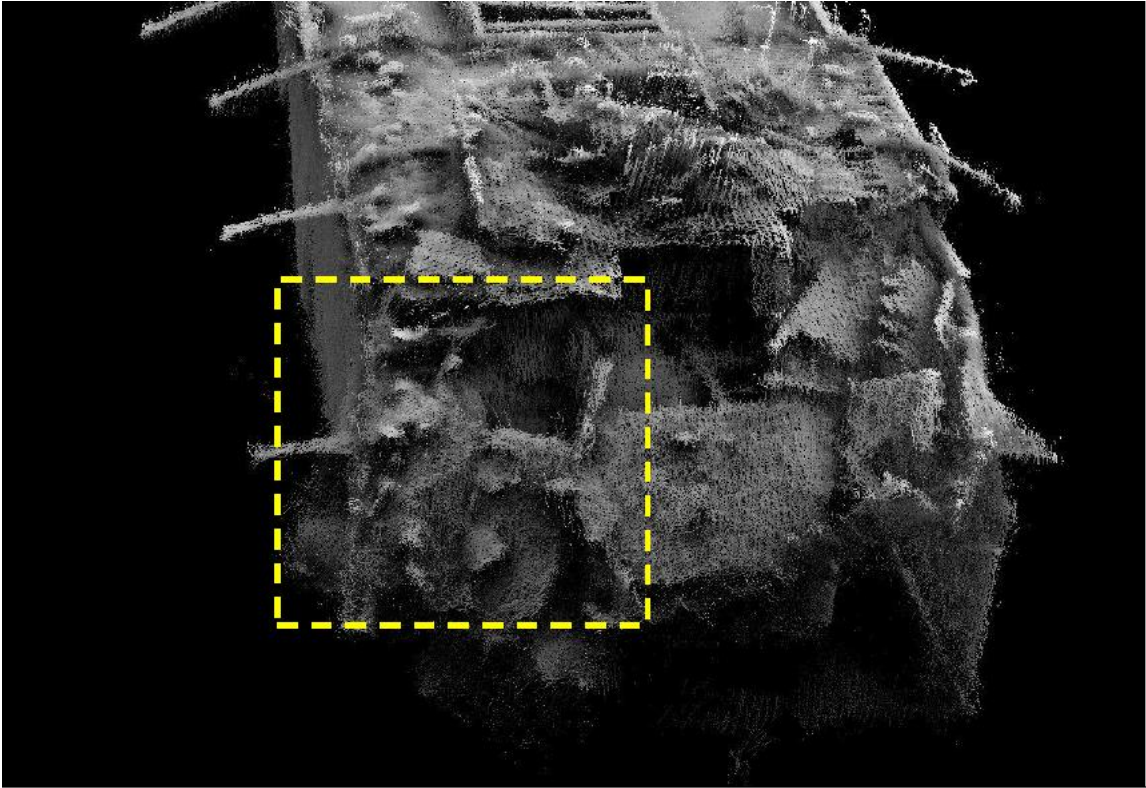
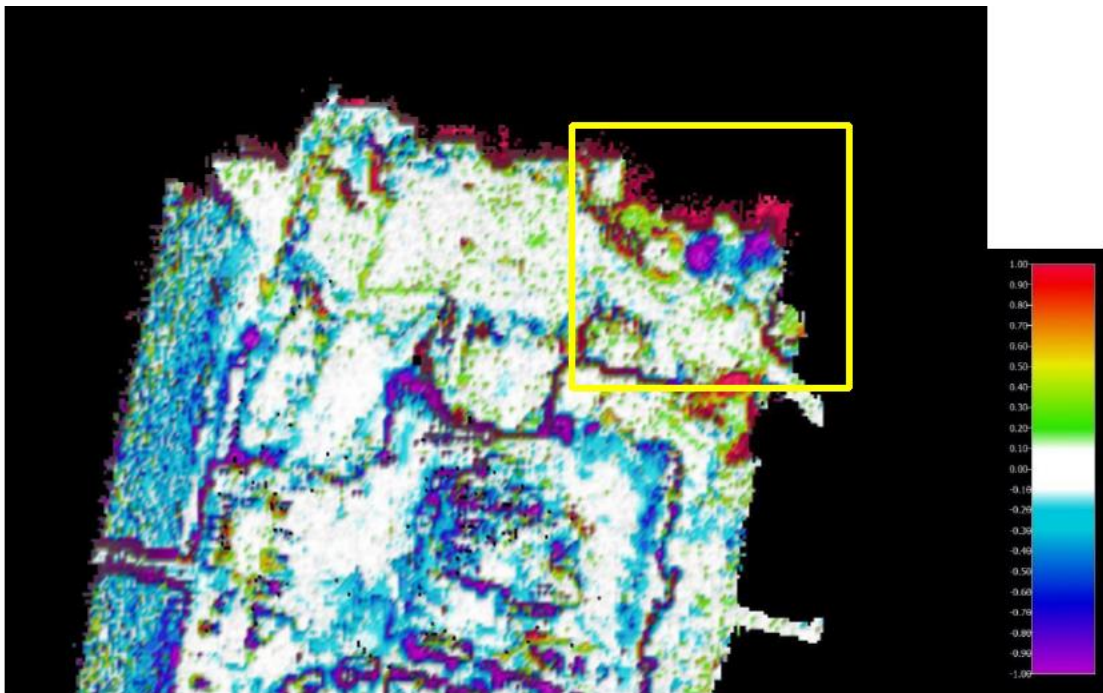
2.11 Key Area 6 – Collapsing bridge deck area (ID43, ID45 & ID46)

4.3.17 Key Area 6 encompasses the collapsing bridge deck at the forward end of the aft section. This area showed significant degradation in the previous surveys between 2014 and 2015. The 2017 survey data indicates that further changes occurred however, the most recent survey shows that degradation has stabilised and smaller changes of less than 0.5m are noted to some of the previously protruding deck plates in the 2018 survey (Figures 35-37).

Figure 35 2017 survey Key Area 6.

Figure 36 2018 survey Key Area 6.

Figure 37 Surface difference showing changes to the aft section starboard upper deck level between 2017 and 2018 surveys.

- 6.1.5 Deterioration of the wreck was shown to be lower than previous surveys with fewer areas of changes noted. The key finding in the analysis of the 2018 survey data was the forward edge of the aft wreck section (Key Area 6, ID43, 45 & 46) and encompasses the boiler room casing, the collapsed boat deck, the remains of the bridge deck, and accommodation block. Following its collapse between 2014 and 2015, this area has remained reasonably stable with one further area of subsidence noted on the starboard boat deck with several of the previous hanging sheets of metal breaking free and now residing on the seabed. Differences of less than 1m are noted on the difference plot and consist of smaller sheets of decking subsiding.

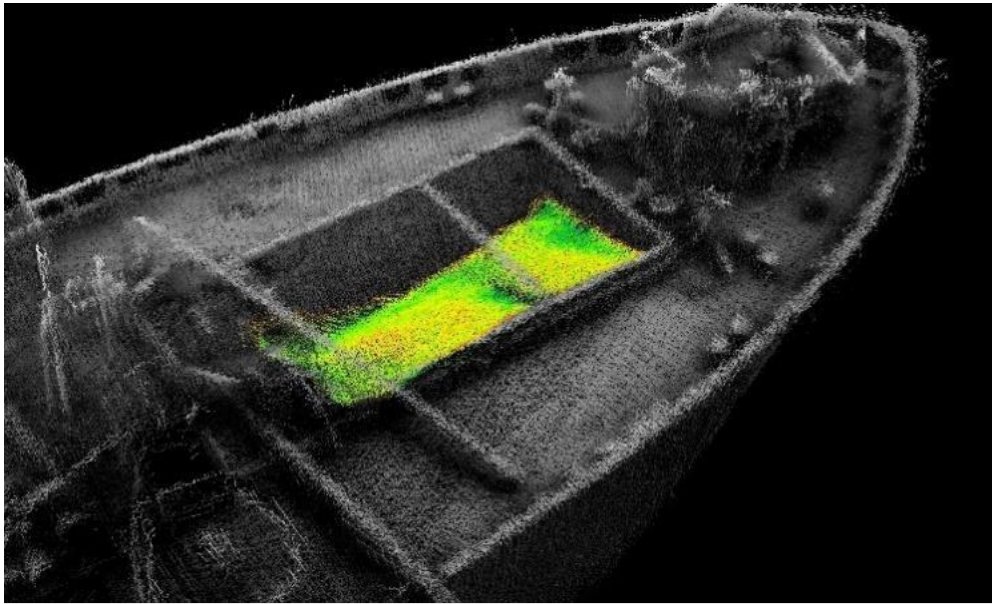
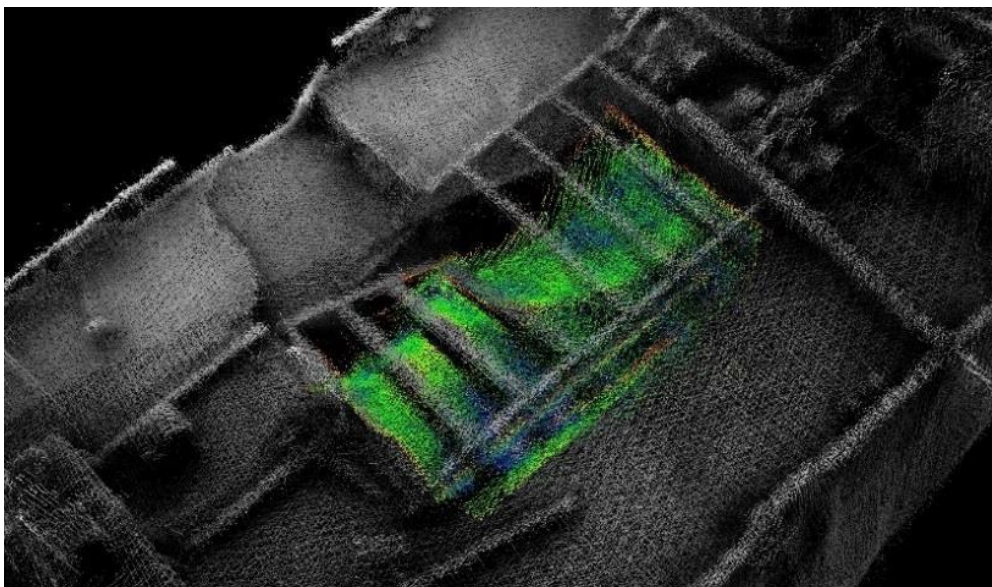
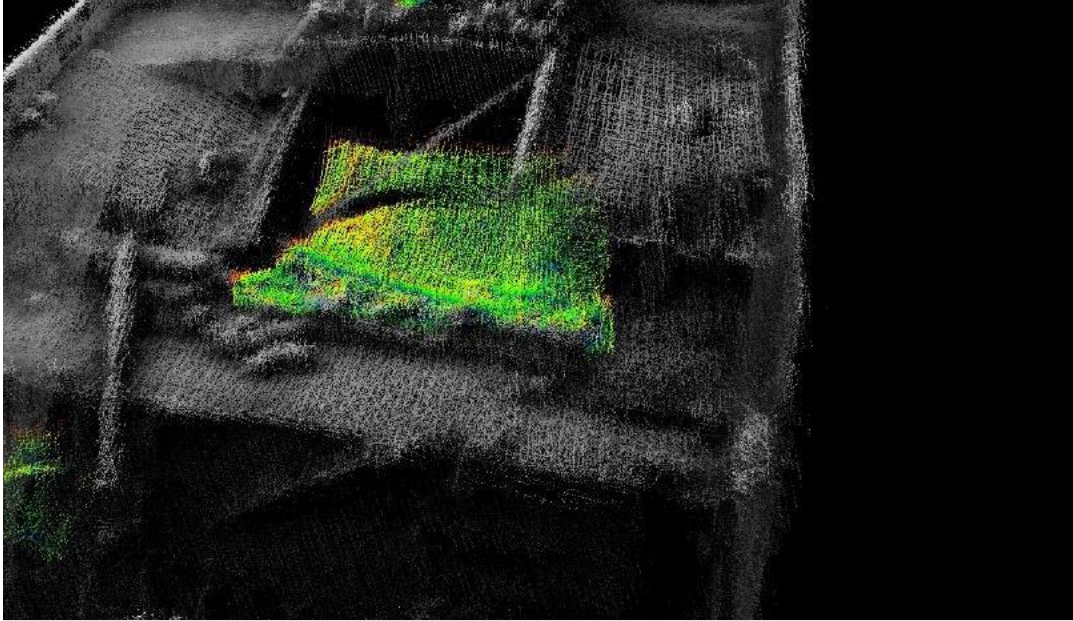
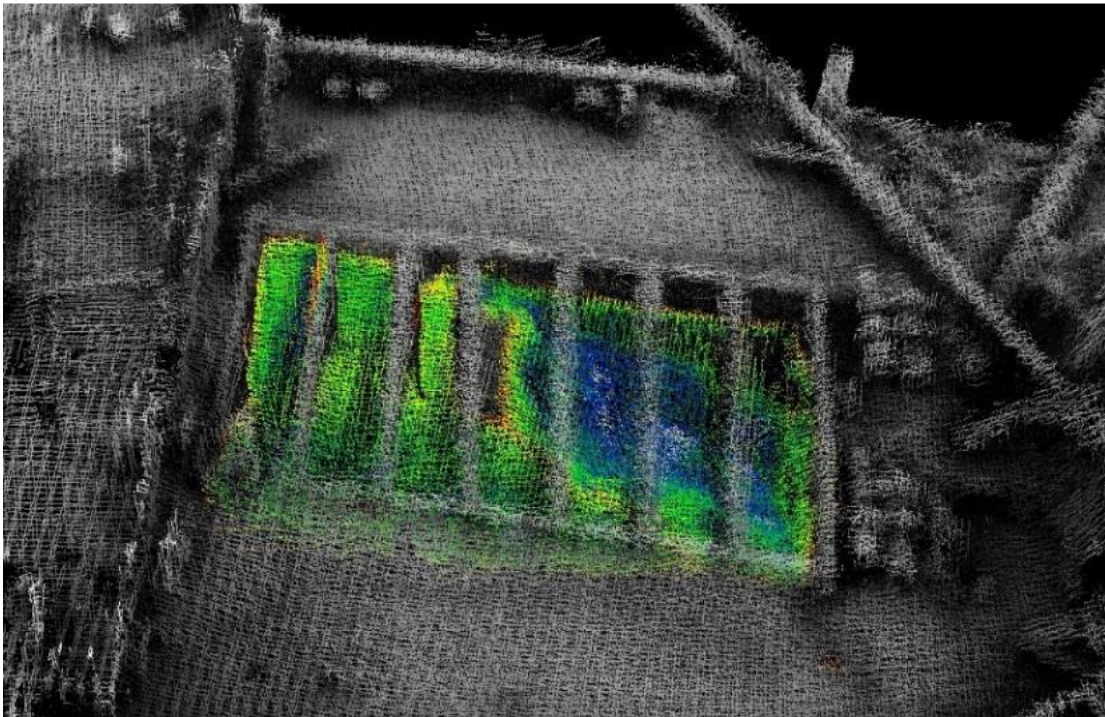
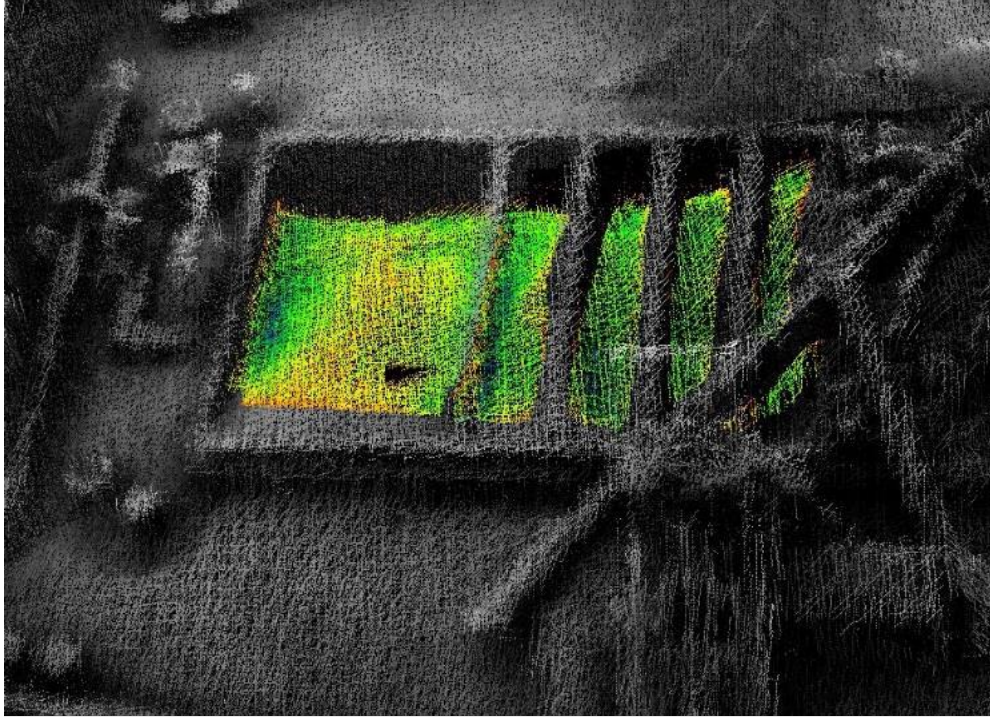
- 4.5.1 The content of each of the five hold areas are highlighted within the point clouds below (Figures 38-42). Holds 1, 2, 3, and 5 all show sediment accretion of up to approximately 0.25m. Hold 4 shows the greatest loss of approximately 0.8m in the southern half of the hold when compared with the 2017 survey.

Figure 38 Hold 1 sediment content.

Figure 39 Hold 2 sediment content.

Figure 40 Hold 3 sediment content.

Figure 41 Hold 4 sediment content.

Figure 42 Hold 5 sediment content.

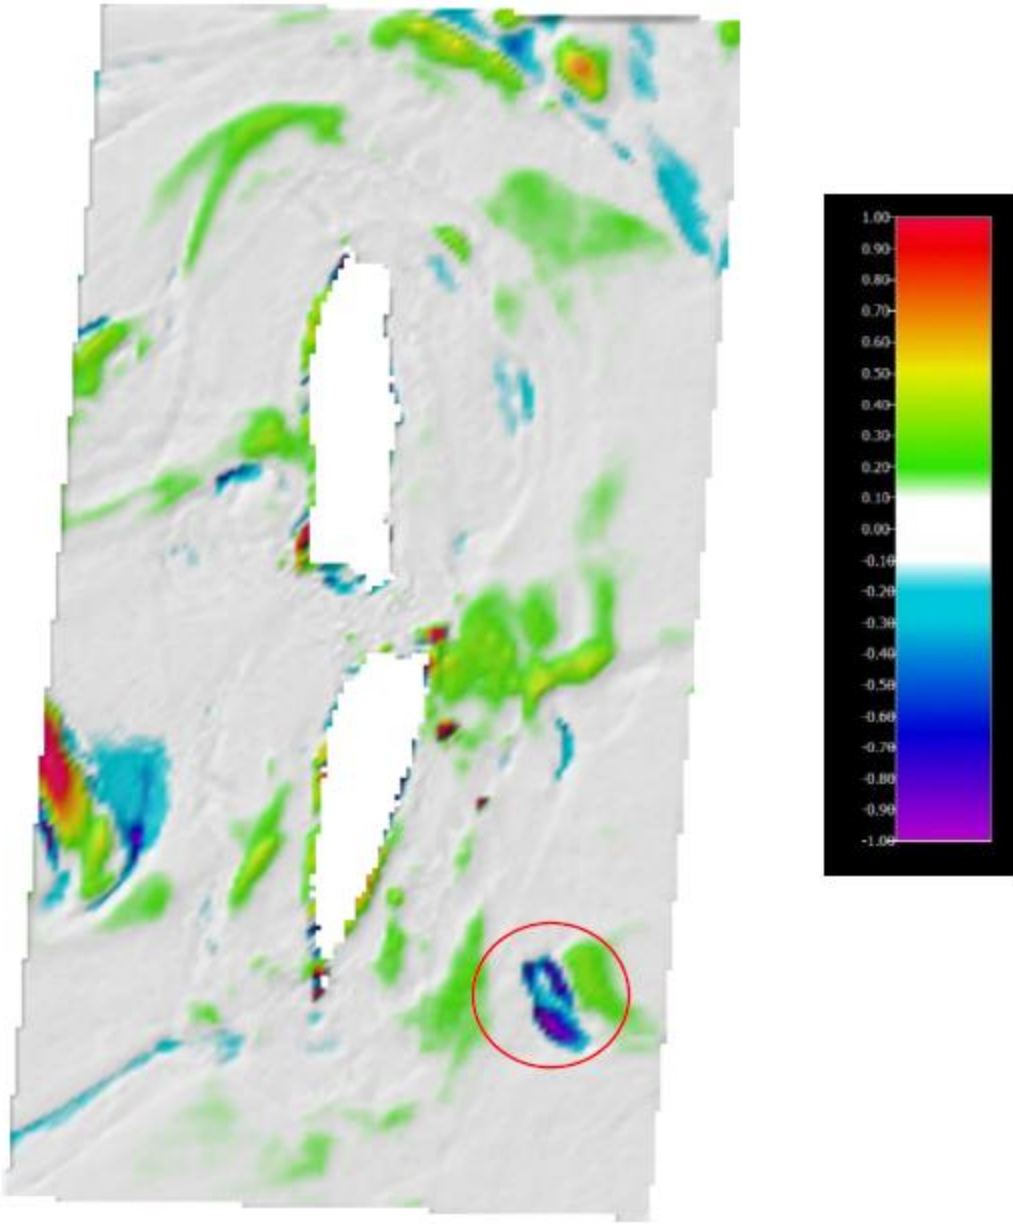
- 5.1.3 Examination of the surface difference plot between the 2017 and 2018 surveys shows that for the most part, the site has remained stable (Figure 46).

- 5.1.4 Deposition has occurred on the starboard side of the of the aft section the wreck, with an increase in sediment of up 0.5m.
- 5.1.5 Small patches of scouring occur around the survey area with the deepest scouring located approximately 35m southeast of the aft section where localised scouring has occurred. The shape of this localised scouring can be seen in Figure 46 (red circle) and appears to be angular in nature. To the west of the wreck there is also evidence of sand wave migration in a north westerly direction (Figure 47).

Figure 46 Surface difference results between the 2017 and 2018 surveys.

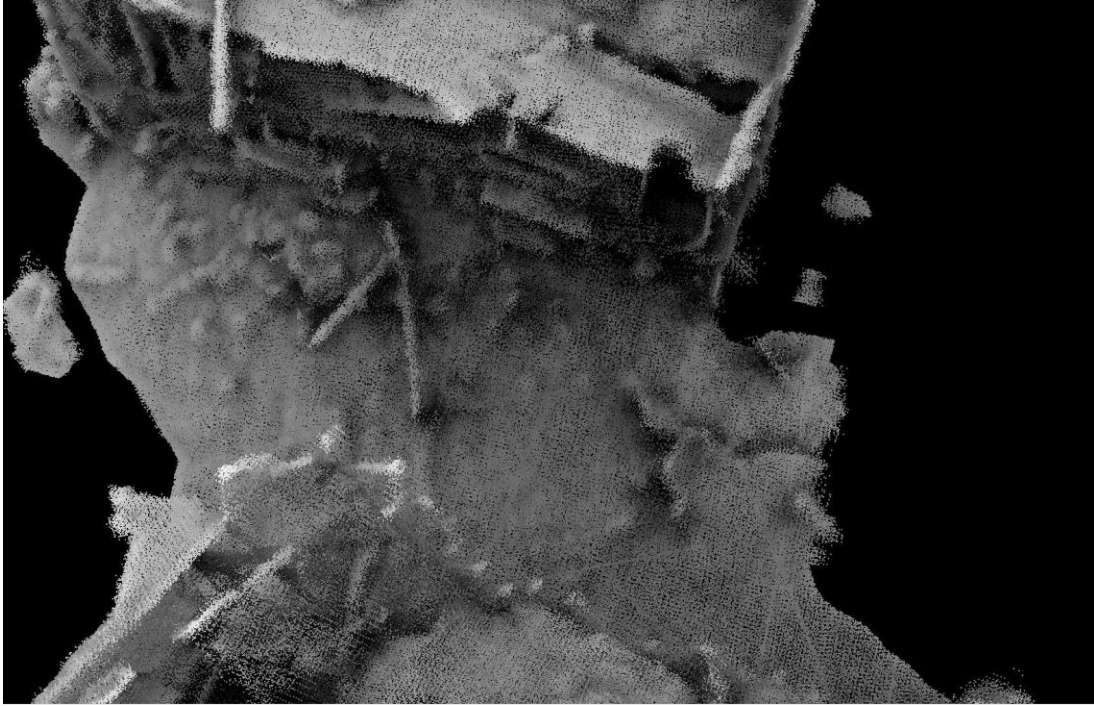
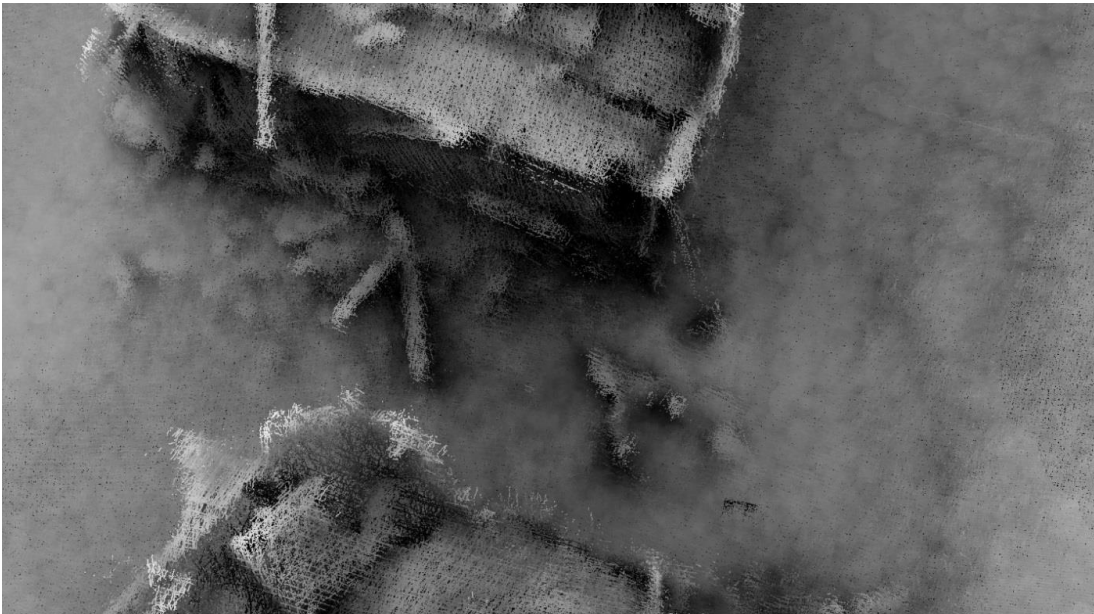
- 5.2.1 A surface difference plot shows evidence of a minor loss of material in the gap between the two sections. Whilst not immediately clear in the 3D point cloud data, a profile view in CARIS shows elevated debris that was previously overhanging but now has now broken off leading to a loss of elevation (Figures 48 and 49).

Figure 48 2017 Survey between the fore and aft hull sections.

Figure 49 2018 Survey between the fore and aft hull sections.
