## ACCIDENT

<b>Aircraft Type and Registration:</b>	Alpi Pioneer 300, G-IPKA	
<b>No &amp; Type of Engines:</b>	1 Rotax 912ULS piston engine	
<b>Year of Manufacture:</b>	2005 (Serial no: PFA 330-14355)	
<b>Date &amp; Time (UTC):</b>	20 August 2022 at 1600 hrs	
<b>Location:</b>	Fenland Airfield, Lincolnshire	
<b>Type of Flight:</b>	Private	
<b>Persons on Board:</b>	Crew - 1	Passengers - None
<b>Injuries:</b>	Crew - None	Passengers - N/A
<b>Nature of Damage:</b>	Left landing gear failure and damage to left wing	
<b>Commander's Licence:</b>	National Private Pilot's Licence	
<b>Commander's Age:</b>	76 years	
<b>Commander's Flying Experience:</b>	2,840 hours (of which 877 were on type) Last 90 days - 17 hours Last 28 days - 6 hours	
<b>Information Source:</b>	Aircraft Accident Report Form submitted by the pilot and AAIB visual examination of the landing gear

## Synopsis

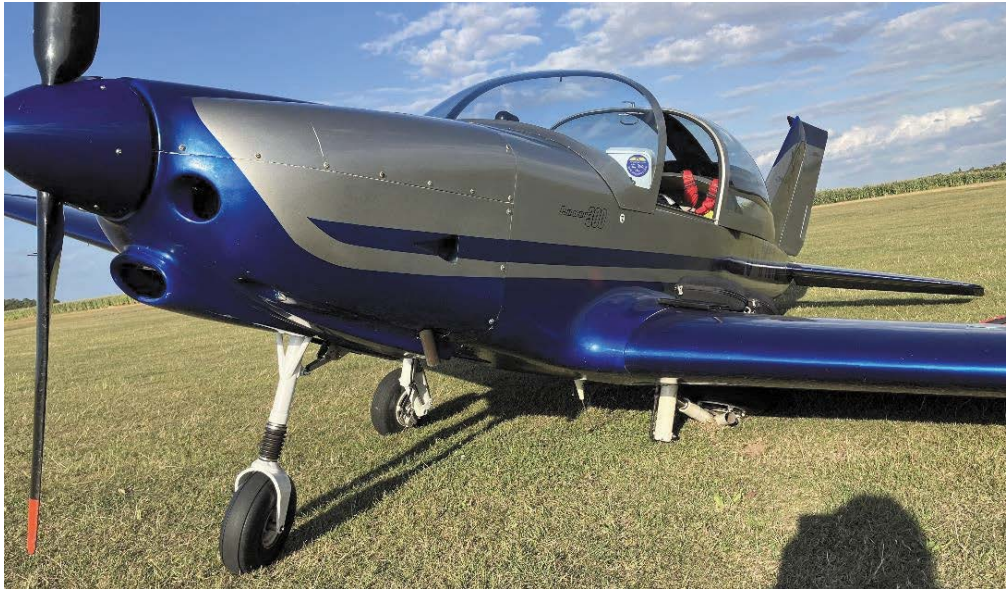
The aircraft landed on Runway 26 at Fenland Airfield. As the aircraft taxied, its left main gear collapsed causing the left wing to contact the ground (Figure 1).

**Figure 1**  
G-IPKA once it had come to rest

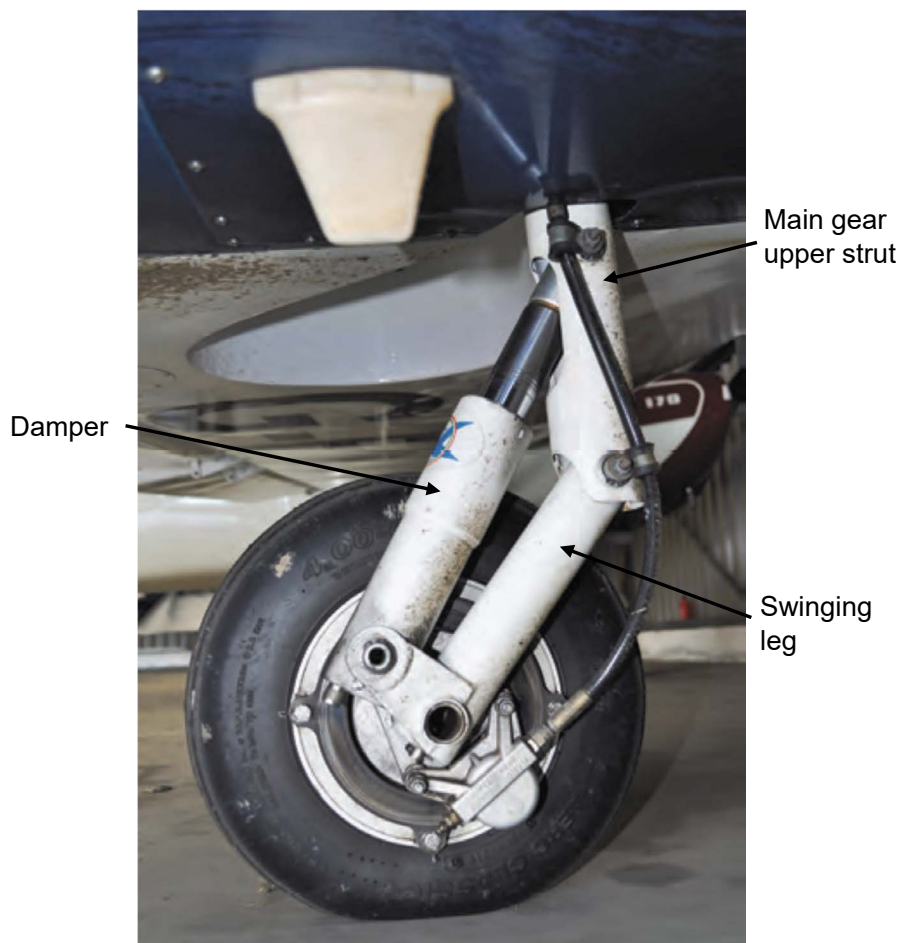
**Figure 2**  
Alpi Pioneer left main landing gear

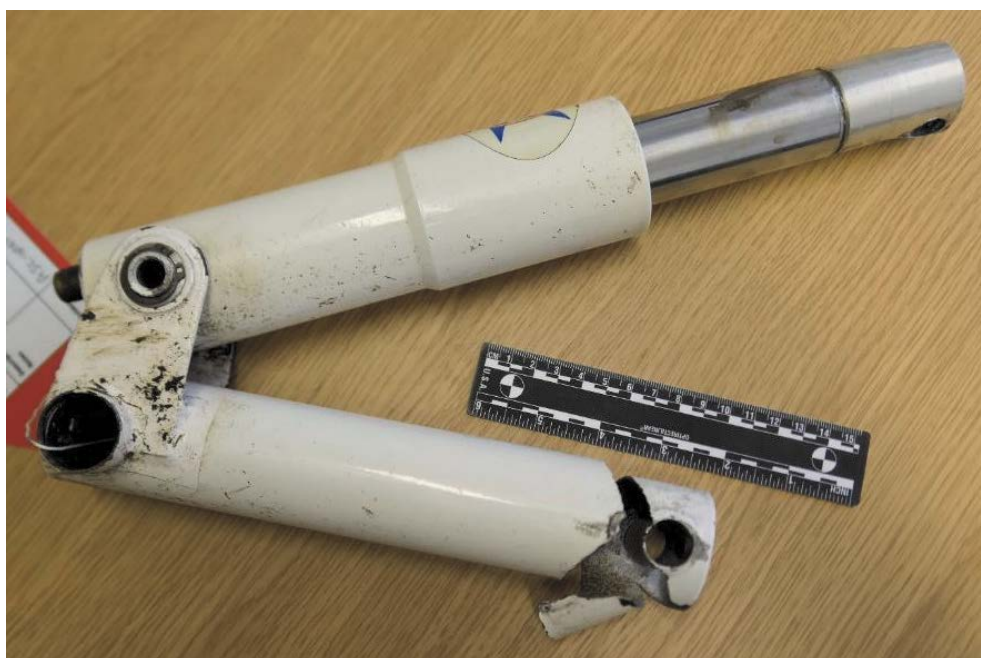
**Figure 3**

G-IPKA left main swinging arm and damper

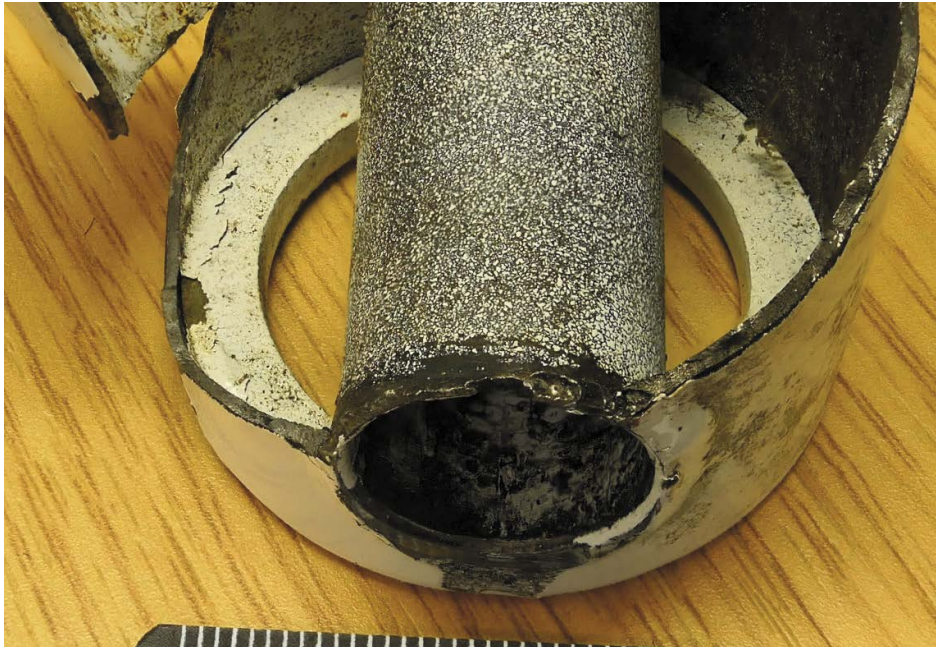
The swinging leg had failed around its full circumference, the crack initiating adjacent to the weld between the swinging leg tube and the upper pivot tube (Figure 4).

The fracture in the wall of the tube was indicative of overload, suggesting that the fracture had occurred rapidly. The inside of the tube, which is uncoated and had evidence of overspray on some of the inner surfaces, was lightly corroded.

The condition of the interface between the swinging leg tube and the pivot tube suggested the weld had not fully penetrated the parent material and is a possible factor in the initiation of the crack.

**Figure 4**  
Swinging tube upper end

The crack initiated from the interface of pivot tube to swinging leg tube. Poor weld quality between two components can act as a stress raiser at the interface and could serve to locate a crack. If the landing gear was subjected to a heavy landing or an element of lateral loading during a crosswind landing, this could increase the stress at the interface between the swinging tube and the pivot tube and cause a crack to initiate and propagate rapidly.

Although the owner had inspected the landing gear components recently it would be difficult to inspect as the downtube of the main landing gear strut partially covers the location of the crack initiation.

As a result of this investigation the LAA are reviewing the design and manufacturing aspects of the Alpi Pioneer 300 landing gear, including whether on-going maintenance action is required.
