Rail Accident Investigation Branch

Rail Accident Report

**Near miss with two track workers at Penkridge,
Staffordshire
10 July 2022**

Report 09/2023
August 2023

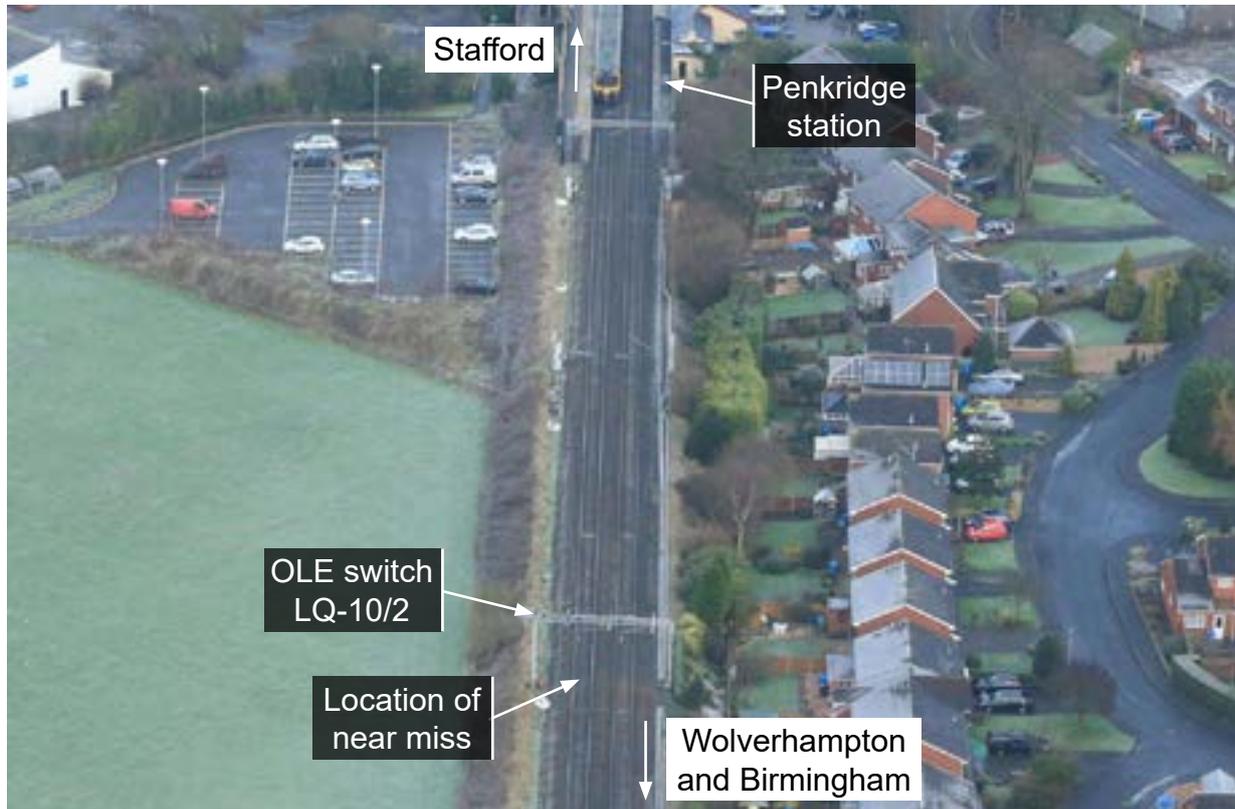
Figure 2: Aerial photograph showing Penkrigde station and the overhead line equipment structure and switch LQ-10/2 where the near miss occurred (courtesy of Network Rail).

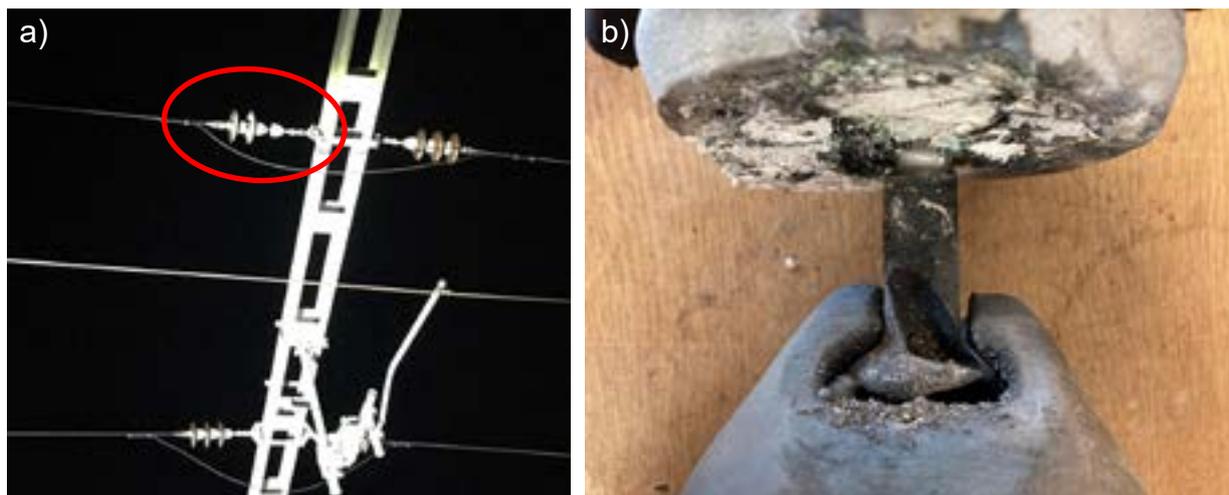
- 59 The PIC, TW3, TW4 and two further OLE technicians carried on with the OLE inspections and eventually found the fault midway between Swan Lane access point and Penkridge Viaduct, roughly halfway between where the various flashes had been seen. The fault related to a damaged cap and pin insulator (figure 6), which had allowed enough current to leak to earth to register as an earth fault, tripping the OLE section. The damaged component was at the height of the OLE wires, and not easily visible from ground level, appearing intact during the initial visual inspection (paragraphs 37 to 39) undertaken by the PIC and TW2. The final re-energisation attempt caused part of the insulator to fracture fully, dropping to the ground, so it was now visible to the staff. The insulator was replaced with a polymeric equivalent in an emergency possession later that morning. The line was fully reopened at 12:18 hrs on 11 July.

Figure 6: Picture showing a) the missing section of the cap and pin insulator and b) close up of the damaged insulator (courtesy of Network Rail).

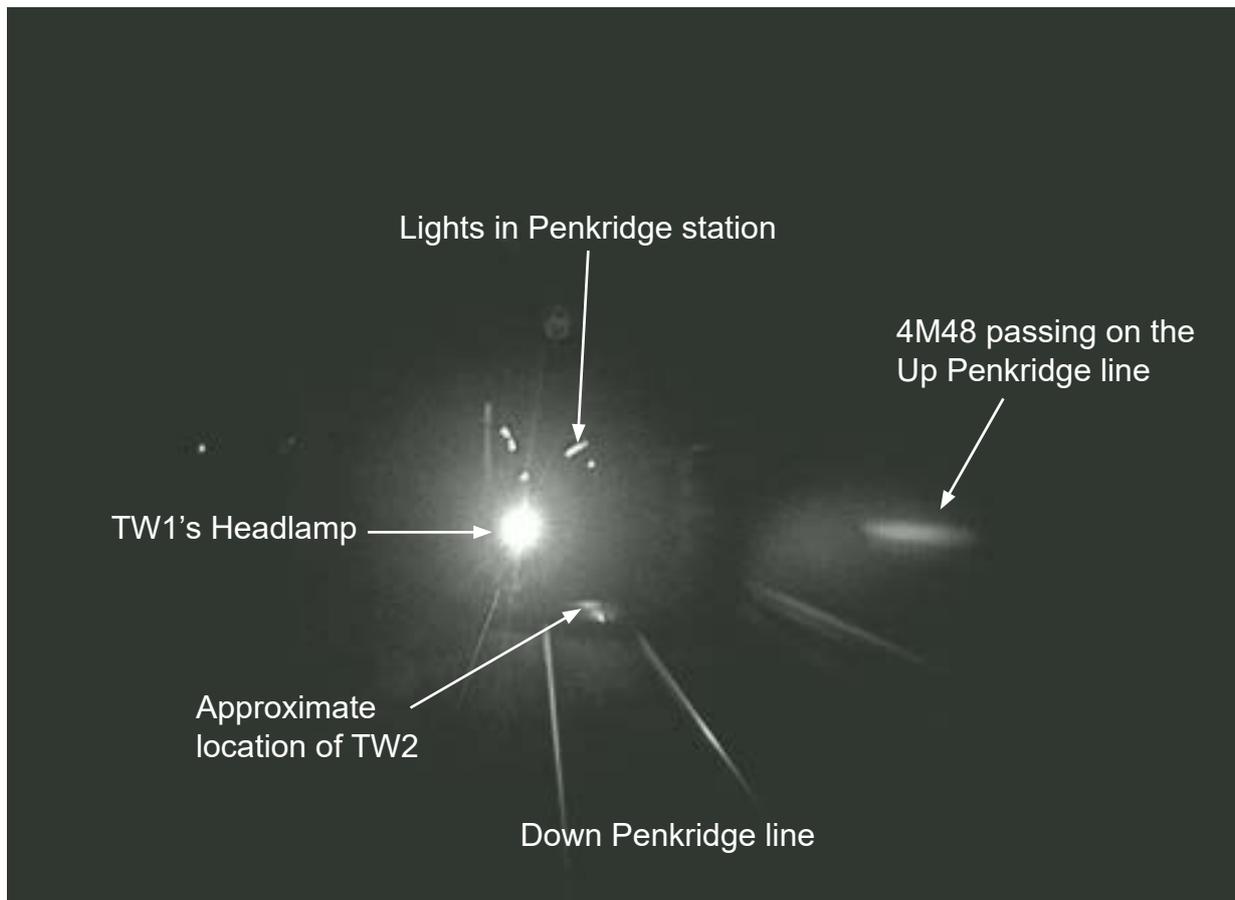
62 FFCCTV footage from train 4H98 clearly shows at least one track worker in its path (figure 7). Witness evidence confirms that the second track worker was also in the path of the train as it approached. Both staff jumped clear of the track, less than a second before the train reached their location. The track workers were in the approaching train's path because there was no recognised SSoW in place to protect them from it.

Figure 7: FFCCTV still from train 4H98 showing the headlamp of TW1 and train 4M48 passing on the adjacent line (courtesy of GB Railfreight Ltd).

- 97 By the time the incident train approached the team, FFCCTV showed that it had split into two distinct groups which were approximately 55 to 60 metres apart. Given the splitting of the team, the curvature of the track and the dark conditions, the site warden, who was in the group furthest away from the approaching train, could no longer adequately monitor the position of staff working very close to the boundary. This meant that the COSS received no warning from the site warden to step back when he moved over the boundary and towards the open line on which the train was approaching.
