Accident

Aircraft Type and Registration:	Piper PA-28-161, G-EKIR	
No & Type of Engines:	1 Lycoming O-320-D3G piston engine	
Year of Manufacture:	1989 (Serial no: 2841157)	
Date & Time (UTC):	22 March 2023 at 1300 hrs	
Location:	Sandtoft Airfield, Belton, North Lincolnshire	
Type of Flight:	Private	
Persons on Board:	Crew - 1	Passengers - None
Injuries:	Crew - None	Passengers - N/A
Nature of Damage:	Left navigation and position lights, casing damaged. Scuffs to paint work on wing tip area	
Commander's Licence:	Private Pilot's Licence	
Commander's Age:	32 years	
Commander's Flying Experience:	105 hours (of which 98 were on type) Last 90 days - 16 hours Last 28 days - 7 hours	
Information Source:	Aircraft Accident Report Form submitted by the pilot

Synopsis

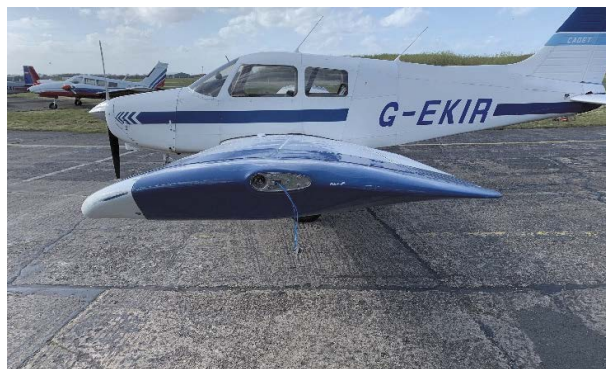
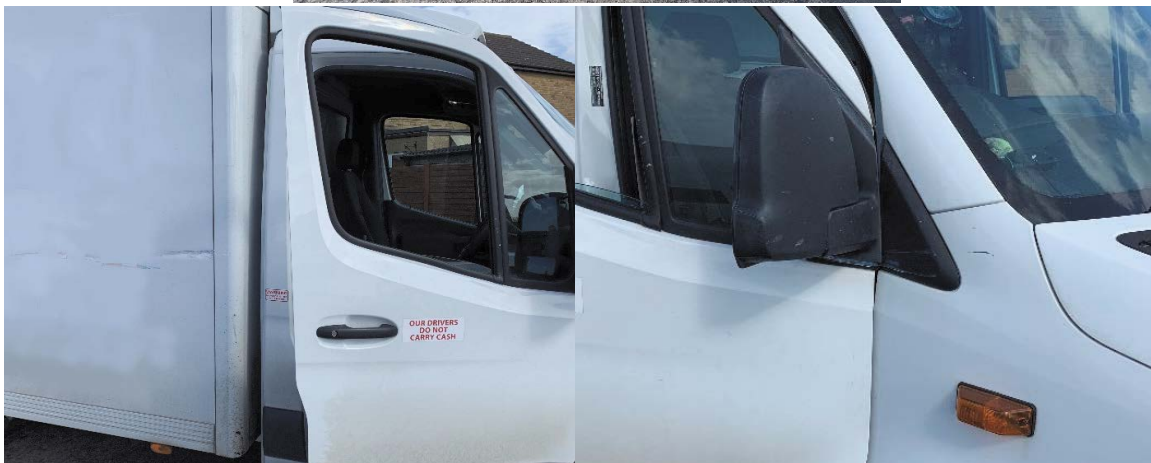
Figure 2

Having judged the gap to be sufficient for the aircraft wingspan, the pilot proceeded at a slow walking pace but clipped the port wingtip of G-EKIR on the side and wing mirror of the vehicle. The port wing navigation light and casing were damaged and there was paintwork scuffing to the wing tip area. The vehicle had damage to the right panel and below the right wing mirror. There were no injuries.

Damage to the aircraft wingtip (top) and to the vehicle panel side panel (left) and below the wing mirror (right) (Images used with permission)

With the vehicle parked on the taxiway by the cafe and another aircraft parked partially on the taxiway on the other side, there was not enough room for G-EKIR to pass. The pilot judged the gap to be sufficient for his aircraft and did not ask for assistance. The wingtip struck the van causing limited damage to both the vehicle and the wingtip of G-EKIR. There were no injuries.

The delivery company have instructed their drivers to park in the car park for deliveries to the cafe rather than entering the taxiway.

The airfield operator will review the signage at the entry to the airfield to ensure it is appropriate for ensuring users are aware they are entering an active airfield.
