# ***AAIB Bulletin***

# **8/2023**

<b>Aircraft Type and Registration:</b>	Piper PA-28-151 (Modified), G-BOTI	
<b>No &amp; Type of Engines:</b>	1 Lycoming O-320-D3G piston engine	
<b>Year of Manufacture:</b>	1975 (Serial no: 28-7515251)	
<b>Date &amp; Time (UTC):</b>	22 October 2022 at 1330 hrs	
<b>Location:</b>	9 nm final approach into Exeter Airport	
<b>Type of Flight:</b>	Private	
<b>Persons on Board:</b>	Crew - 1	Passengers - 1
<b>Injuries:</b>	Crew - None	Passengers - None
<b>Nature of Damage:</b>	None	
<b>Commander's Licence:</b>	Commercial Pilots Licence	
<b>Commander's Age:</b>	33 years	
<b>Commander's Flying Experience:</b>	331 hours (of which 40 were on type) Last 90 days - 21 hours Last 28 days - 16 hours	
<b>Information Source:</b>	AAIB Field Investigation

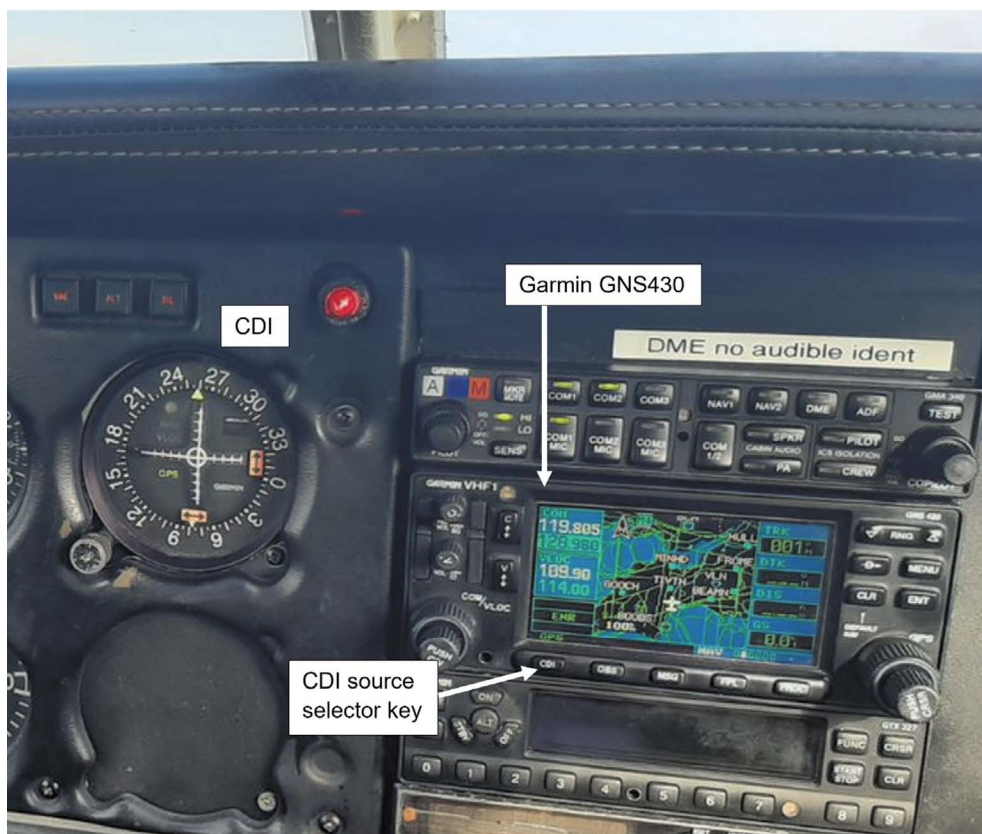
**Figure 6**

GNS 430 and CDI fitted to G-BOTI

The aircraft was returning from Biggin Hill where a 100-hour maintenance inspection had been carried out. In addition to the routine tasks, an avionics engineer worked a reported defect with Nav 1, the GNS 430; 'Nav 1 INOP (*identifying but not displaying VOR or glideslope*)'.

Using an IFR4000 test set, the engineer checked the operation of Nav 1. The VOR indication was recalibrated because it was found to be 5° out of alignment, but the glideslope was found to be working correctly even at low signal strengths. The defect was cleared and a further report on its operation during the next flight, the incident flight, was requested.

The CDI had been reported unserviceable prior to the maintenance activity, but it was tested immediately prior to the incident flight and no fault was found. It was reported unserviceable again after the incident flight and it is possible there was an unidentified, intermittent defect with the instrument.

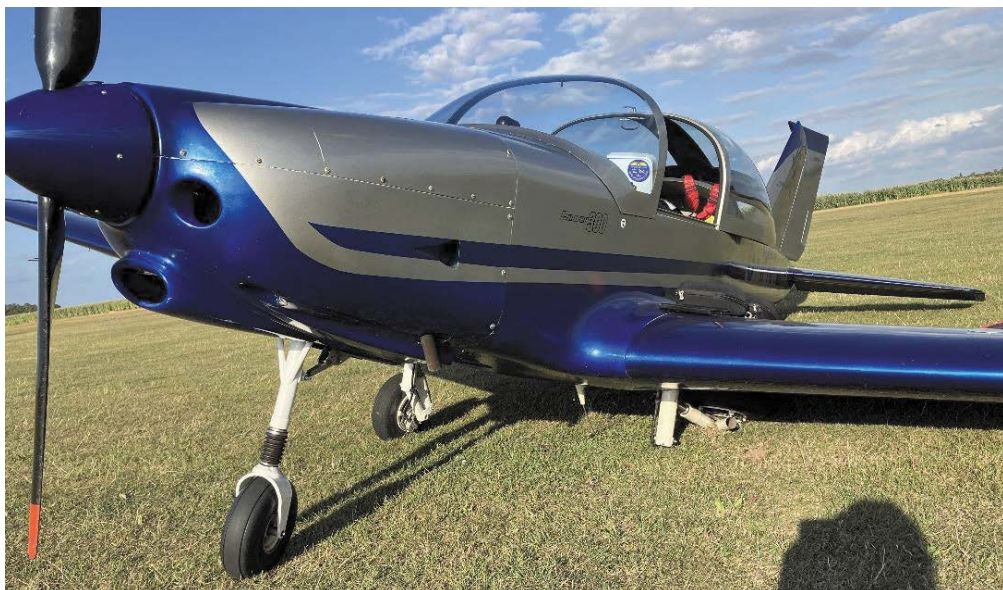
**Figure 1**  
G-IPKA once it had come to rest

Whilst taxiing after landing the left main landing gear collapsed due to the failure of the swinging leg. The leg had fractured in overload initiating close to the weld between the swinging leg and its pivot tube. As a result of this investigation the Light Aircraft Association (LAA) are reviewing design and manufacturing aspects of the type's landing gear, including whether on-going maintenance action is required.

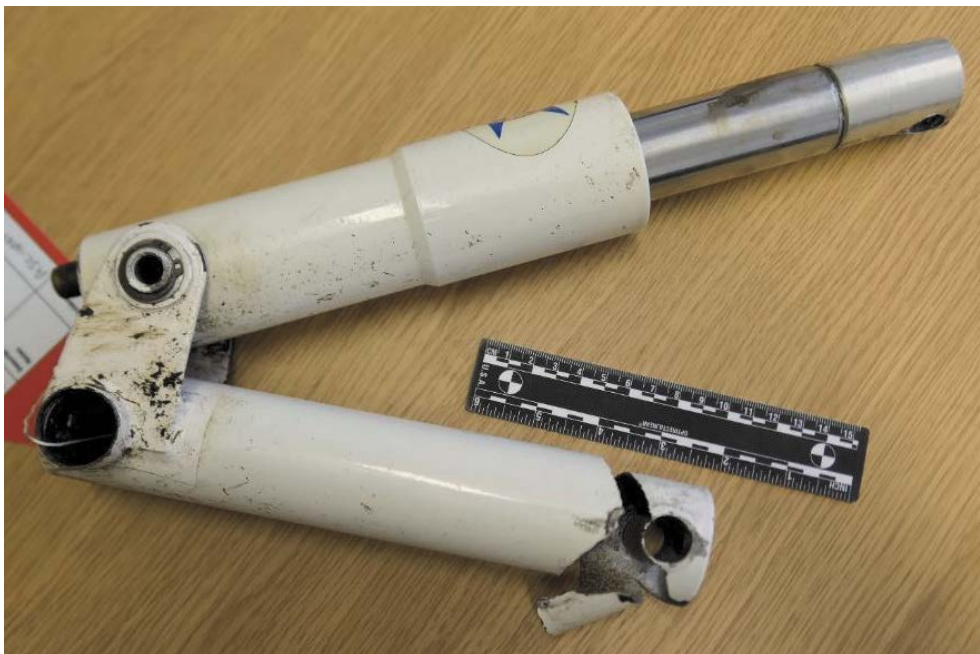
**Figure 3**

G-IPKA left main swinging arm and damper

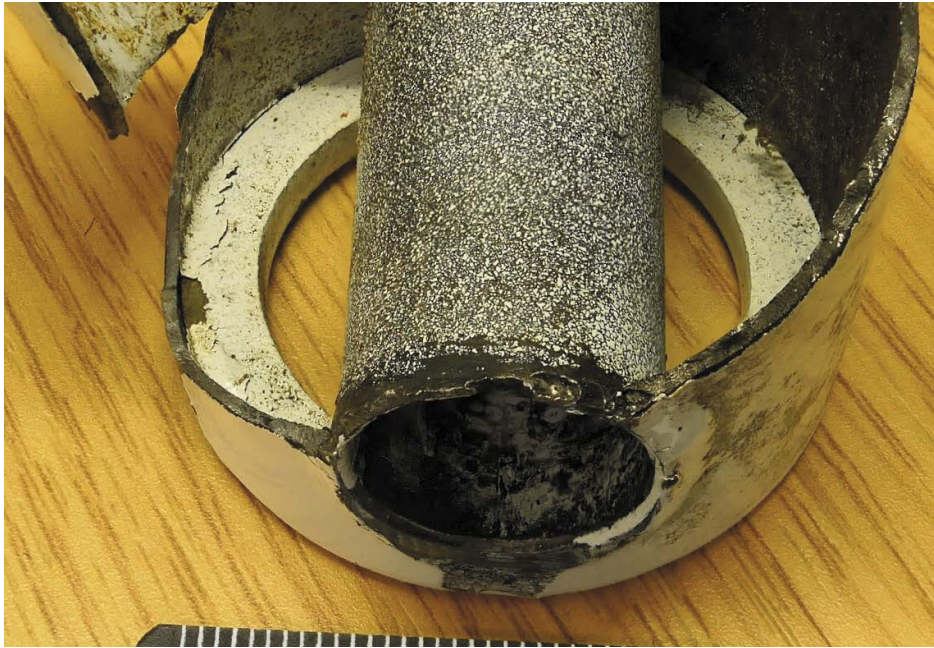
**Figure 4**

The swinging leg had failed around its full circumference, the crack initiating adjacent to the weld between the swinging leg tube and the upper pivot tube (Figure 4).

The fracture in the wall of the tube was indicative of overload, suggesting that the fracture had occurred rapidly. The inside of the tube, which is uncoated and had evidence of overspray on some of the inner surfaces, was lightly corroded.

The condition of the interface between the swinging leg tube and the pivot tube suggested the weld had not fully penetrated the parent material and is a possible factor in the initiation of the crack.

Swinging tube upper end

The crack initiated from the interface of pivot tube to swinging leg tube. Poor weld quality between two components can act as a stress raiser at the interface and could serve to locate a crack. If the landing gear was subjected to a heavy landing or an element of lateral loading during a crosswind landing, this could increase the stress at the interface between the swinging tube and the pivot tube and cause a crack to initiate and propagate rapidly.

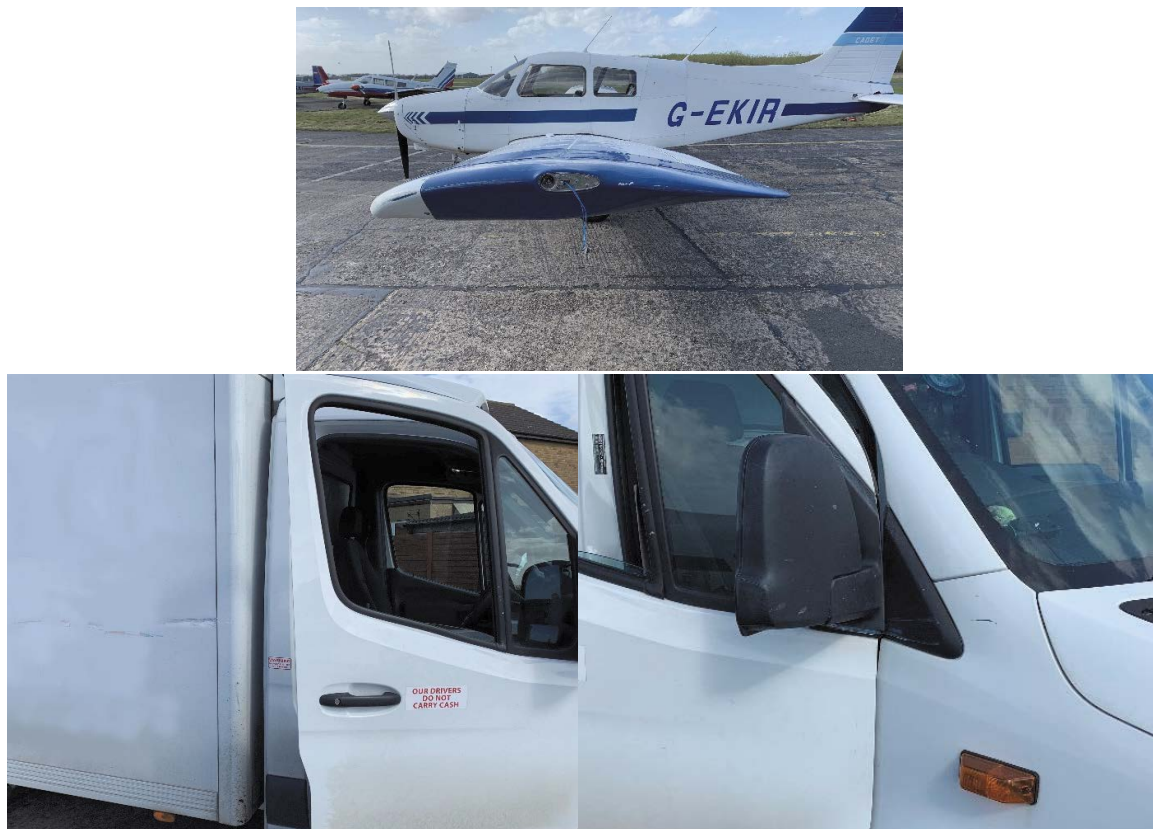
**Figure 2**

Having judged the gap to be sufficient for the aircraft wingspan, the pilot proceeded at a slow walking pace but clipped the port wingtip of G-EKIR on the side and wing mirror of the vehicle. The port wing navigation light and casing were damaged and there was paintwork scuffing to the wing tip area. The vehicle had damage to the right panel and below the right wing mirror. There were no injuries.

Damage to the aircraft wingtip (top) and to the vehicle panel side panel (left) and below the wing mirror (right)  
(Images used with permission)

With the vehicle parked on the taxiway by the cafe and another aircraft parked partially on the taxiway on the other side, there was not enough room for G-EKIR to pass. The pilot judged the gap to be sufficient for his aircraft and did not ask for assistance. The wingtip struck the van causing limited damage to both the vehicle and the wingtip of G-EKIR. There were no injuries.
