Accident

Aircraft Type and Registration:	Jodel DR1050-M1, G-BAEE	
No & Type of Engines:	1 Continental Motors Corp O-200-A piston engine	
Year of Manufacture:	1964 (Serial no: 579)	
Date & Time (UTC):	6 October 2022 at approximately 1135 hrs	
Location:	Near Jackrell's Farm airstrip, Horsham, West Sussex	
Type of Flight:	Private	
Persons on Board:	Crew - 1	Passengers - 1
Injuries:	Crew - 1 (Serious)	Passengers - 1 (Serious)
Nature of Damage:	Aircraft destroyed	
Commander's Licence:	Private Pilot's Licence	
Commander's Age:	85 years	
Commander's Flying Experience:	2,004 hours (of which at least 700 were on type) Last 90 days - 12 hours Last 28 days - 4 hours	
Information Source:	AAIB Field Investigation

Synopsis

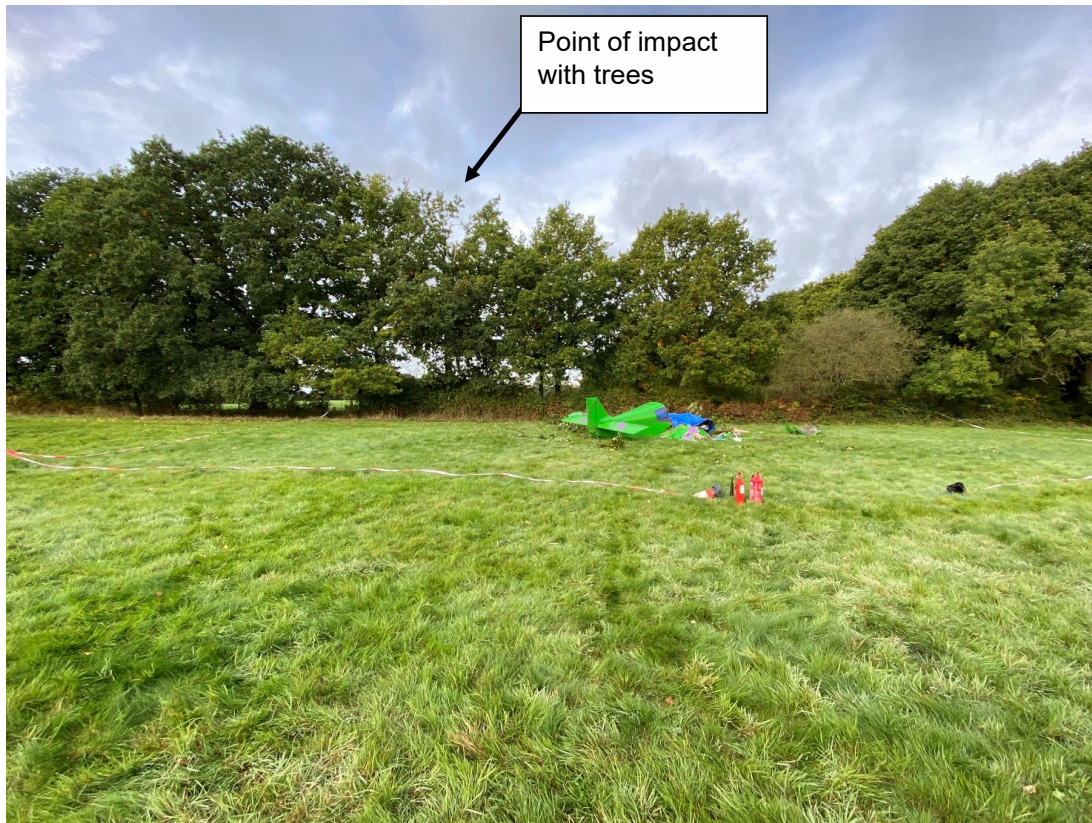
The accident site was located in a field just beyond and to the right of the departure end of grass Runway 03 at Jackrell's Farm airstrip. The aircraft was upright and all the aircraft structure was present except for the outer two thirds of the right wing. Damage to trees on the adjacent field boundary and tree debris on the accident site indicated that the aircraft had struck the trees, which were approximately 15 m tall. The outer portion of the right wing was found on the opposite side of the tree line, with some small items of aircraft skin found in the trees. A single impact mark on the right wing leading edge close to the wing tip was consistent with the wing having struck a tree. The force of the right wing impact with the tree caused the aircraft to yaw to the right, pivoting around the impact point before continuing to the ground.

There were no appreciable ground marks other than in the immediate impact area, which indicated a predominantly vertical descent in a level attitude.

Figure 1
Accident site

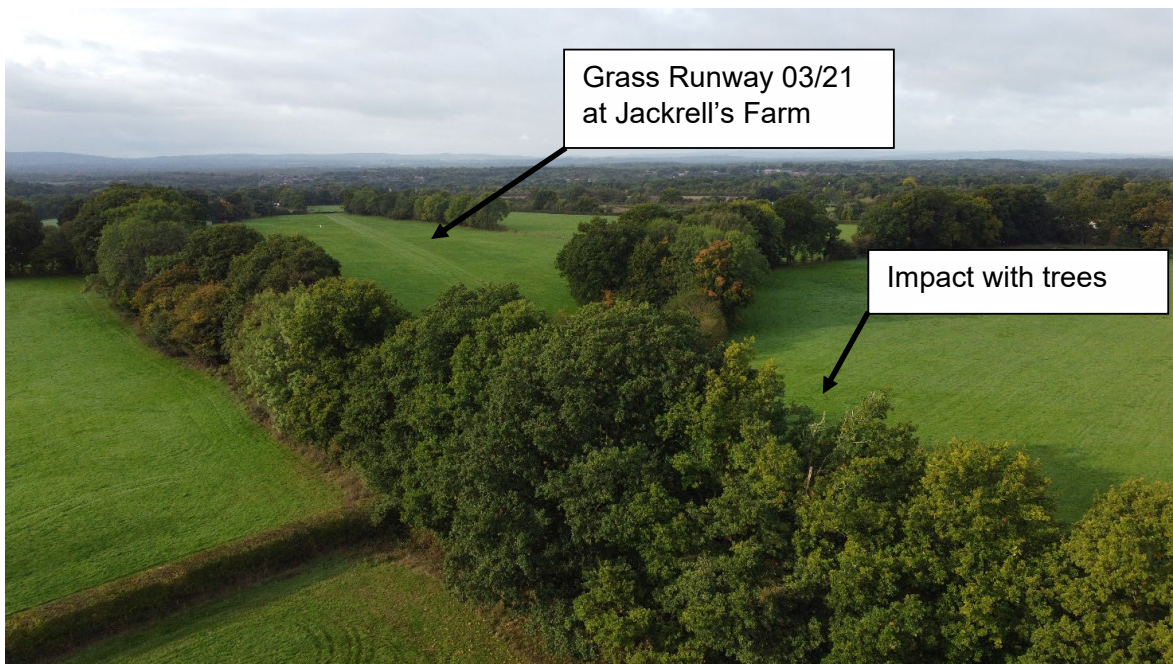
Figure 2
Aerial view toward Jackrell's Farm airstrip from the accident site

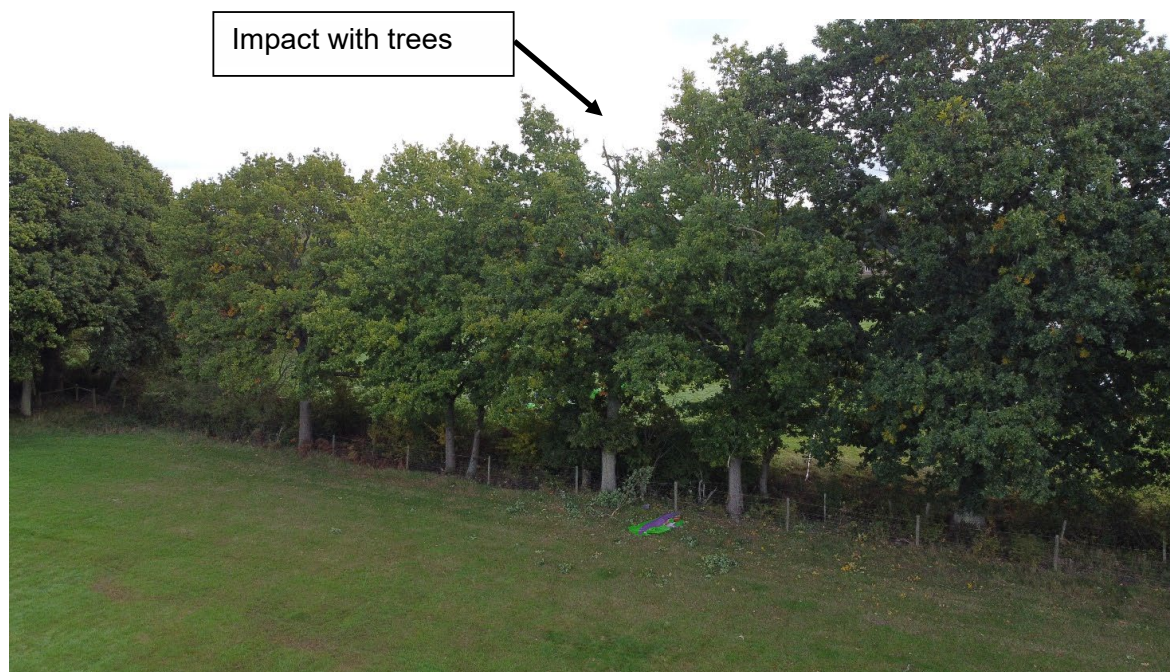
Figure 3

Tree line viewed from direction of aircraft travel

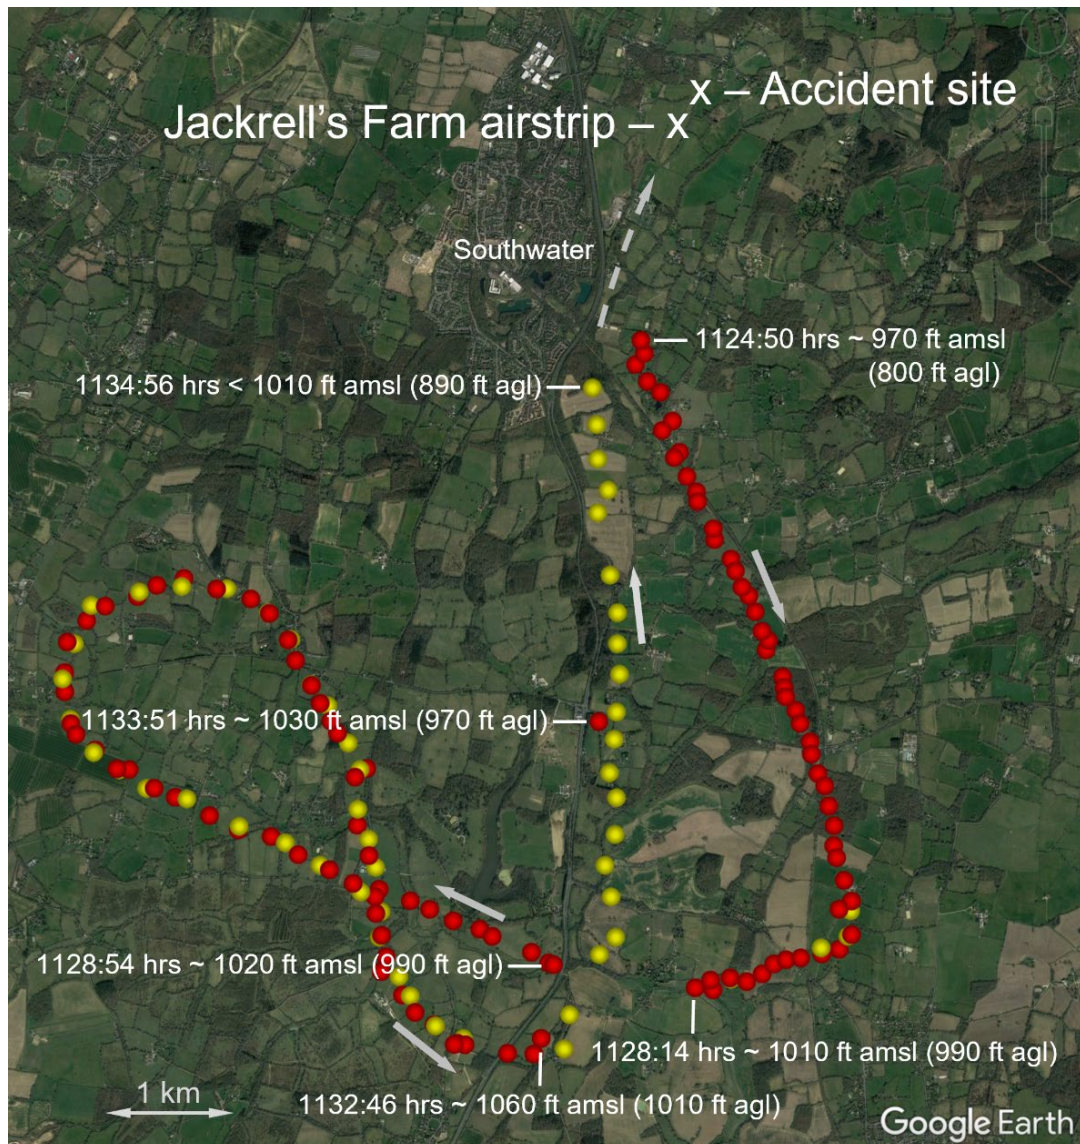
Figure 4

The radar stations at Gatwick and Pease Pottage detected the aircraft for parts of the accident flight south of the airstrip. The aircraft was equipped with a Mode S transponder but only primary radar returns were detected, indicating that the transponder was turned off and therefore no altitude information was recorded. Some altitudes can be inferred when the aircraft transitions in and out of the minimum height for radar coverage in the area based on the viewshed¹ from the Gatwick radar head, but not when in radar coverage with the transponder turned off. The first detection was at 1124:50 hrs as the aircraft climbed into line of sight of the Gatwick radar, implying the aircraft was at a height of about 800 ft agl. The last detection was about 10 minutes later at 1134:56 hrs, 1 nm south of the airstrip, at a height less than 890 ft agl.

Gatwick (red) and Pease Pottage (yellow) primary radar track of aircraft
