## ACCIDENT

<b>Aircraft Type and Registration:</b>	Schleicher ASW 20 L, G-CFRW	
<b>Year of Manufacture:</b>	1978 (Serial no: 20202)	
<b>Date &amp; Time (UTC):</b>	24 September 2022 at 0856 hrs	
<b>Location:</b>	Near Pulborough, West Sussex	
<b>Type of Flight:</b>	Private	
<b>Persons on Board:</b>	Crew - 1	Passengers - None
<b>Injuries:</b>	Crew - 1 (Fatal)	Passengers - N/A
<b>Nature of Damage:</b>	Aircraft destroyed	
<b>Commander's Licence:</b>	UK Part-FCL Sailplanes/Powered Sailplanes Flight Crew Licence	
<b>Commander's Age:</b>	21 years	
<b>Commander's Flying Experience:</b>	454 hours (of which 201 were on type) Last 90 days - 71 hours Last 28 days - 14 hours	
<b>Information Source:</b>	AAIB Field Investigation

## Synopsis

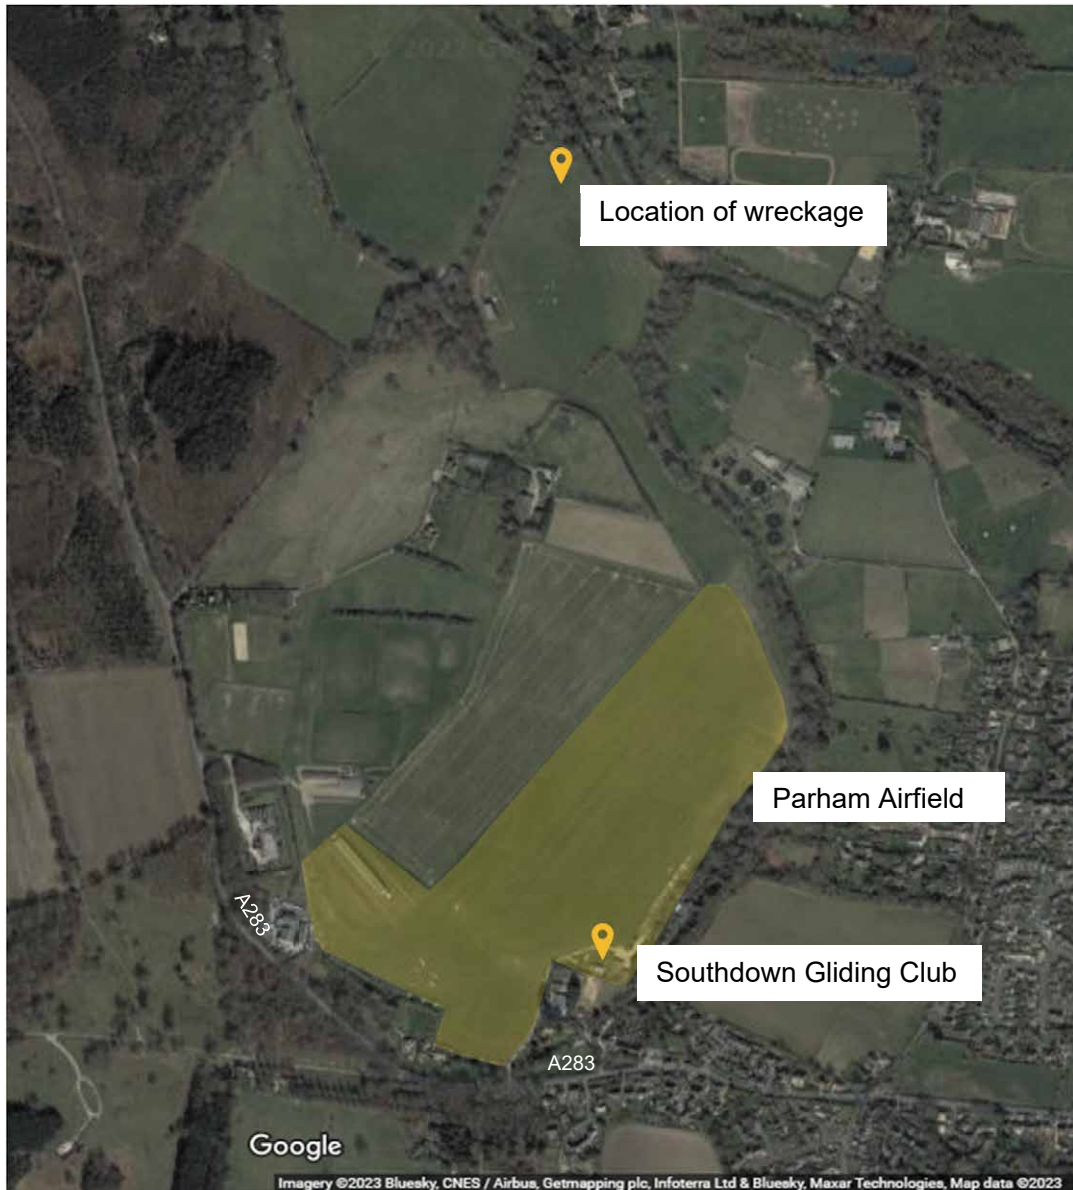
**Figure 4**

The aircraft wreckage was found in a field north of Parham Airfield (Figure 4).

Location of accident site
