Rail Accident Investigation Branch

Rail Accident Report

Runaway hand trolley at Ramsbottom, East Lancashire Railway 15 March 2018

Report 18/2018
November 2018

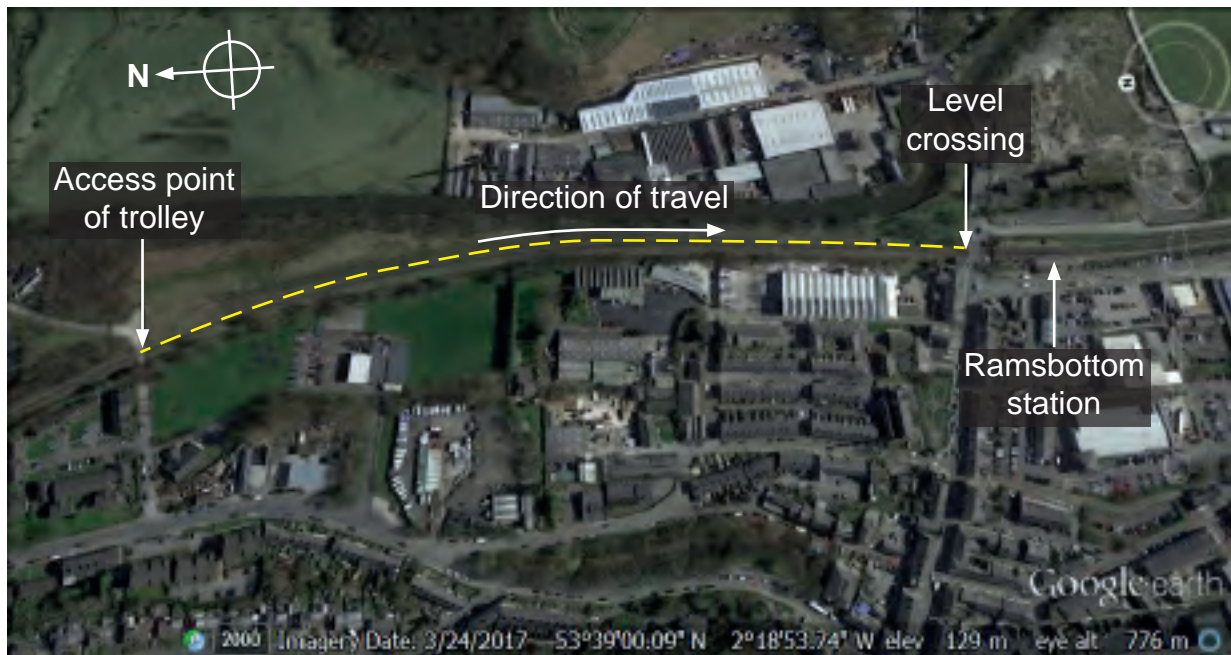
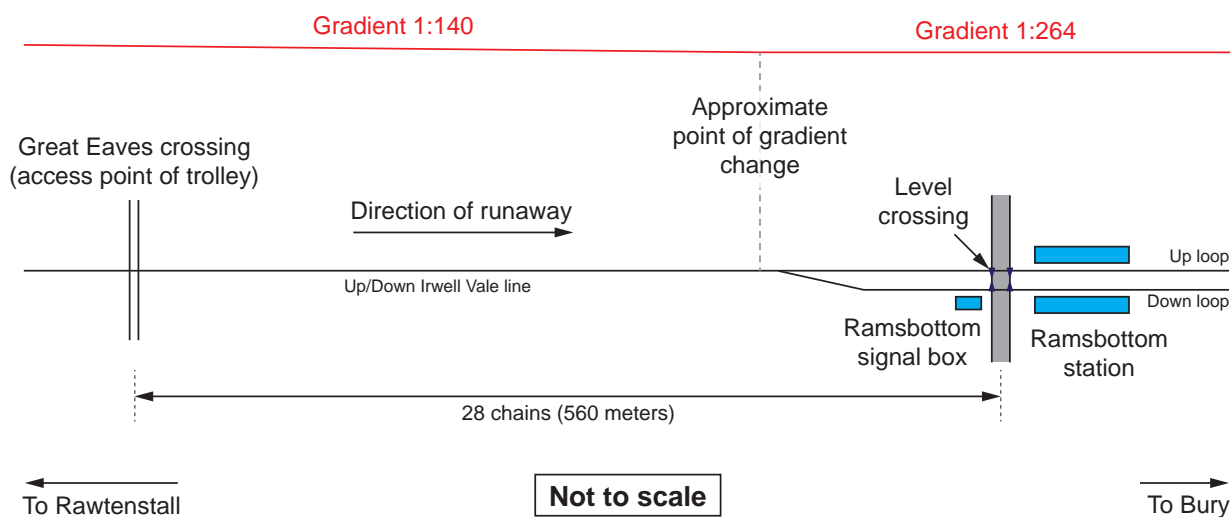
Figure 2: Diagram showing track layout

- 6 The incident began near Great Eaves Road level crossing, 28 chains (560 metres) north of Ramsbottom level crossing. This is on the section of single line running from north of Ramsbottom signal box to just south of Rawtenstall. At Ramsbottom signal box the line divides to create an 'Up' and a 'Down' loop through Ramsbottom station. Ramsbottom level crossing, where Bridge Street crosses the railway, is at the northern extent of the 'Up' and 'Down' loops (figure 2).
- 7 Travelling south (in the 'Up' direction) towards Ramsbottom the gradient is downhill. North of Ramsbottom the gradient is 1 in 140 although at Ramsbottom level crossing and station it is a shallower 1 in 264.

- 52 None of the four volunteers saw any significant risk in operating the unbraked, laden trolley on a gradient. This may have been because the gradient north of Ramsbottom (between 1 in 140 and 1 in 264) is so shallow as to not be immediately obvious to the untrained eye.

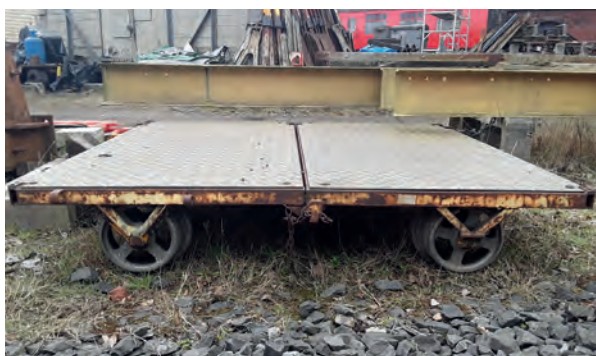
Figure 3: Photograph of similar hand trolley (courtesy of East Lancashire Railway)

10 The trolley involved was a four wheeled flatbed trolley typically used to transport materials or tools along the railway (figure 3). This type of trolley is made up of two sections for ease of handing. Trolleys of this type are normally transported in these sections and joined together on site. When new, the trolley was fitted with brakes. These would have been spring applied and released using a manually operated lever.

- 37 The condition of the trolley when it was donated is not known with certainty. However, ELR considers it likely that it was donated without brakes. Other similar trolleys at ELR had been donated without brakes.

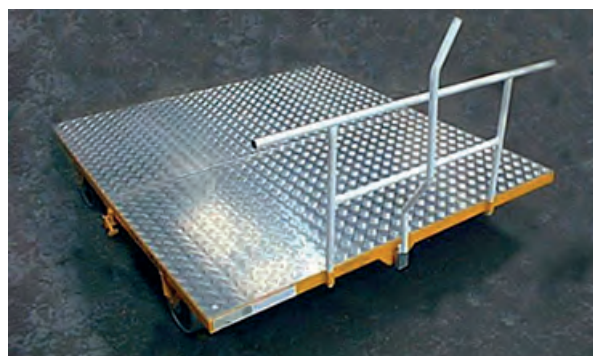
Figure 4: Photograph showing a correctly configured manually-propelled trolley

- 11 When new, a push-handle would have been provided to allow the operator(s) to propel the trolley (figure 4). The bottom ends of the push-handle are inserted into brackets fitted to the ends of the trolley deck. The trolley is intended to be propelled by one or more persons walking along behind it holding the brake off and pushing the push-handle. The trolley involved no longer had any brake shoes or springs fitted. It was still fitted with some parts of the braking system and brackets for the push-handle. No push-handle had been provided with the trolley on the day of the runaway.
- 12 Ramsbottom level crossing has two pairs of wooden crossing gates that are operated from the adjacent Ramsbottom signal box (figure 5). The operation of the crossing is not a factor in this incident.

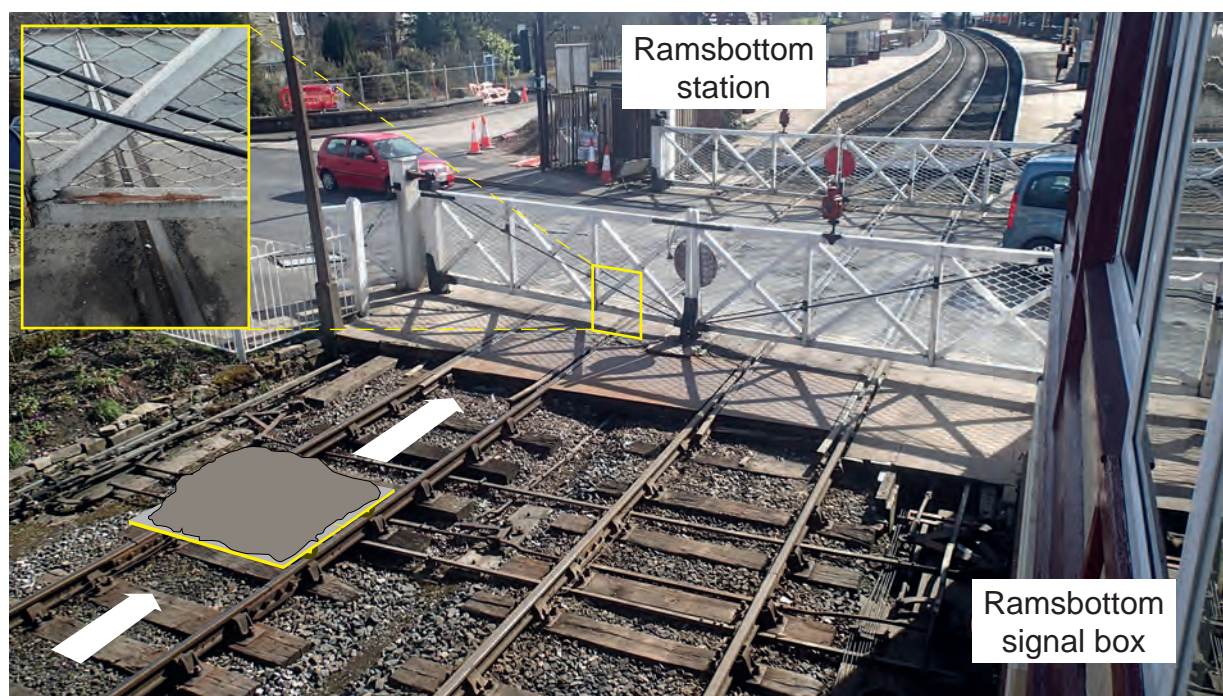
Figure 6: Representation of the trolley striking the level crossing gate (inset image courtesy of East Lancashire Railway)

- 24 The trolley started rolling along ahead of the two volunteers. It is not clear how far ahead of them it was or how far they had gone when they realised that the gap between them and the trolley was increasing. Up to this point they had not needed to stop the trolley and had not attempted to. When they realised it was running away one of them ran after it. He was unable to catch it, but saw it collide with the level crossing gates (figure 6).

- 25 The trolley struck the eastern gate on the north side of the crossing. It derailed and some ballast spilled onto the road. The impact damaged the woodwork and the gate mechanism causing the gate to be partially displaced across the road. A passing motorist was forced to alter course to avoid the gate. He stopped briefly and spoke with one of the volunteers.
