Rail Accident Report

Collision at London Waterloo 15 August 2017

Report 19/2018
November 2018

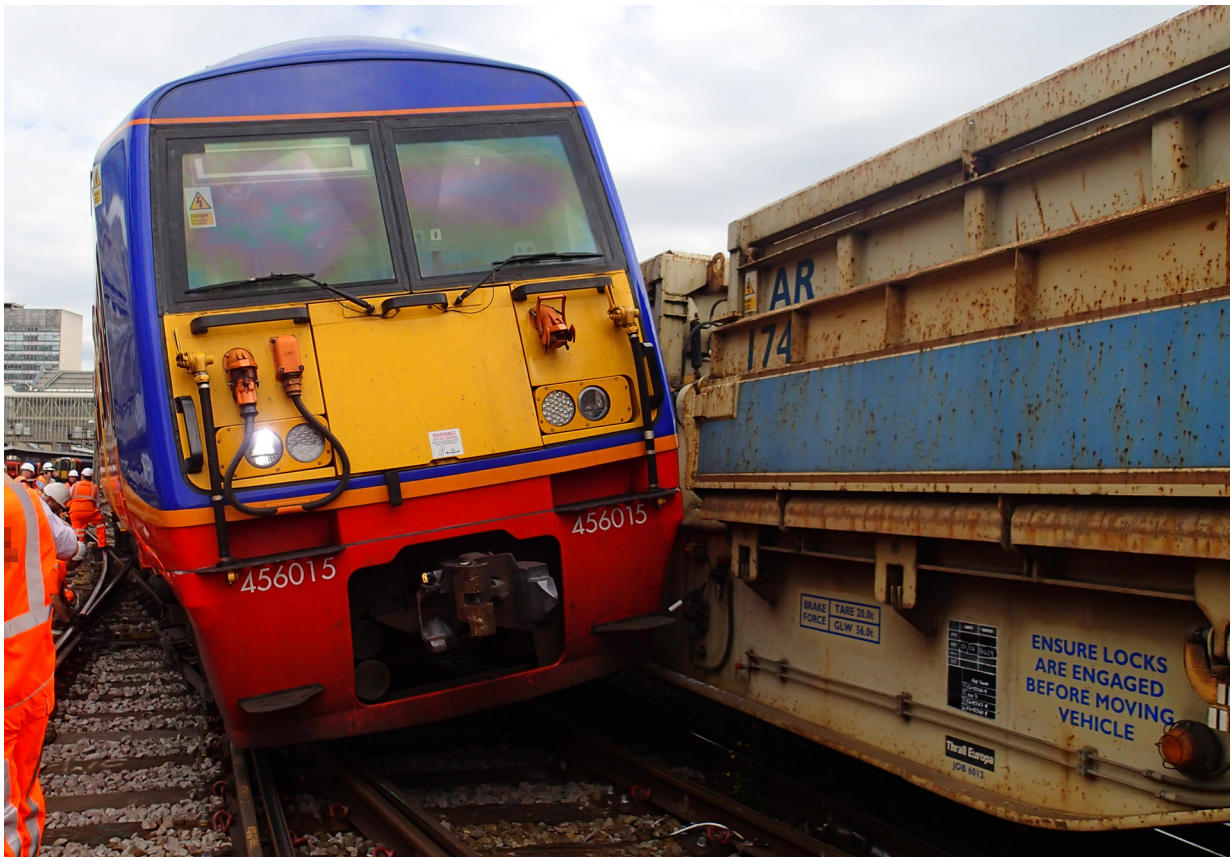
Figure 2: Passenger and engineering train after the collision

- 31 After the collision, the passenger train slid along the side of the engineering train for around four seconds before coming to a stop with the left-hand wheels of the leading coach above the rail and the right-hand side wheels remaining on the rail (figure 9).

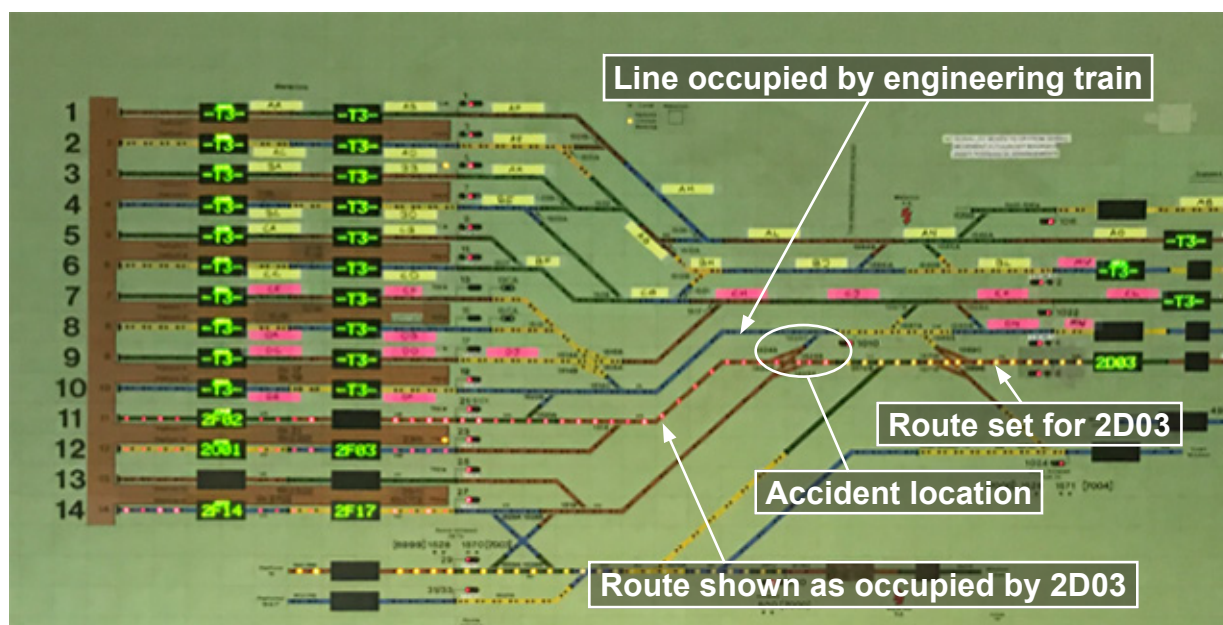
- 29 At 05:40 hrs the signaller set a route for train 2D03 to leave platform 11. The panel display at Wimbledon indicated that it was safe for the train to do this (figure 6). The train driver received a green signal with 'UR' displayed on the adjacent theatre indicator (figure 7). This indicated that it was safe for his train to leave the platform and proceed along the up main relief line. The train departed at 05:41 hrs.

Figure 6: Signaller's panel at Wimbledon showing the route out of platform 11 set for and occupied by train 2D03. (Indicators are not illuminated for the engineering train as inputs were not provided to these indicators during parts of the construction work.)

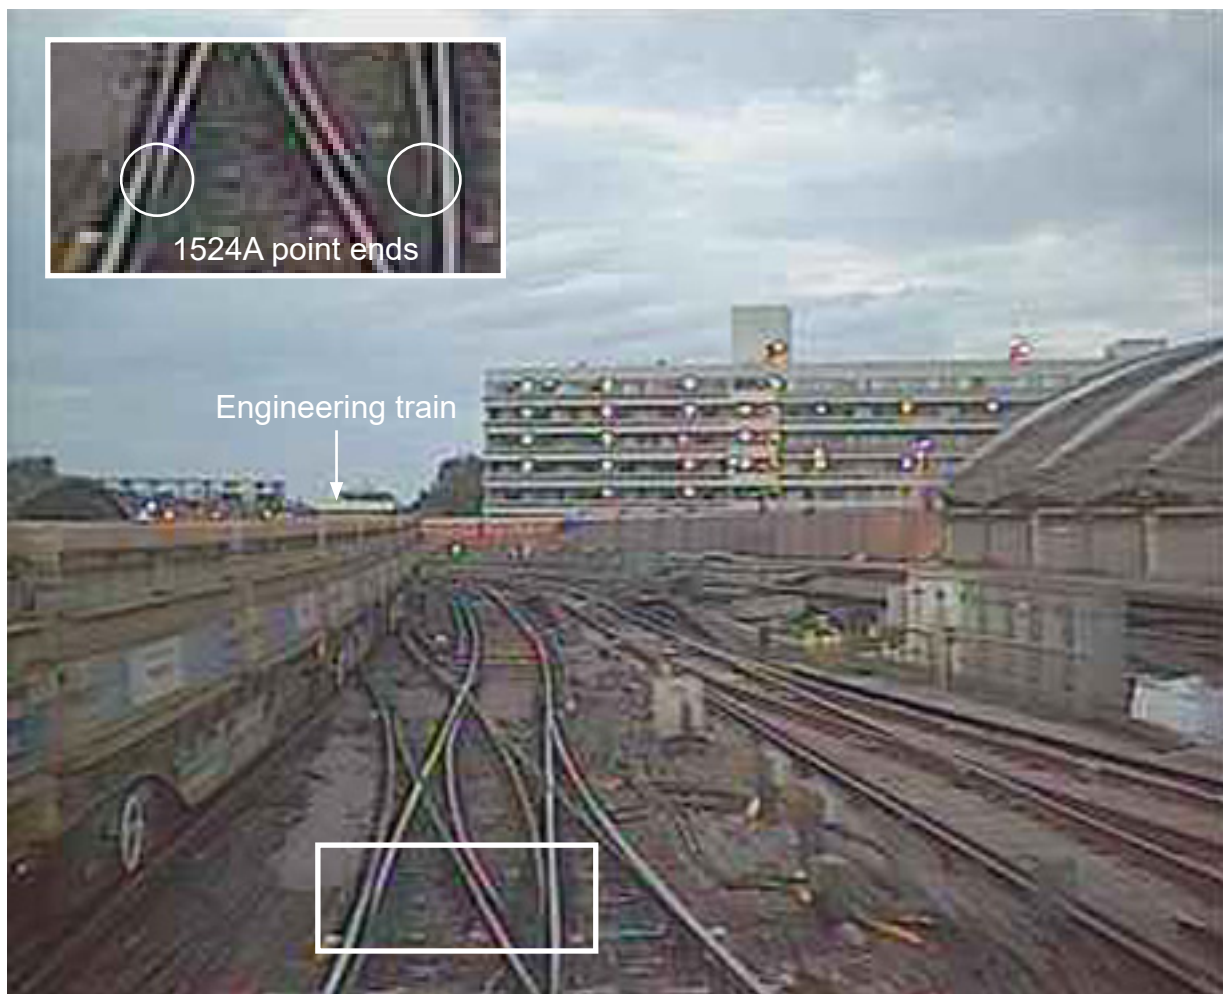
- 30 Soon after moving away from the platform, the train was travelling at about 15 mph (24 km/h) when the driver noticed that 1524 points were not correctly set and applied the train's brakes (figure 8). The points should have been set to direct the train straight on, but were incorrectly lying in an intermediate state and directed the train to the left and into the side of the engineering train. The collision occurred about three seconds after the brake application which had reduced the train's speed to 13 mph (21 km/h). Drivers are not required, and not expected, to check point positions in these circumstances. The driver of train 2D03 is to be commended for noticing that they were lying incorrectly and for his prompt brake application.

Figure 8: View from the train's forward facing CCTV showing 1524A points lying approximately midway between normal (wide gap at right-hand point end, no gap at left-hand point end) and reverse (gap only at left-hand point end)

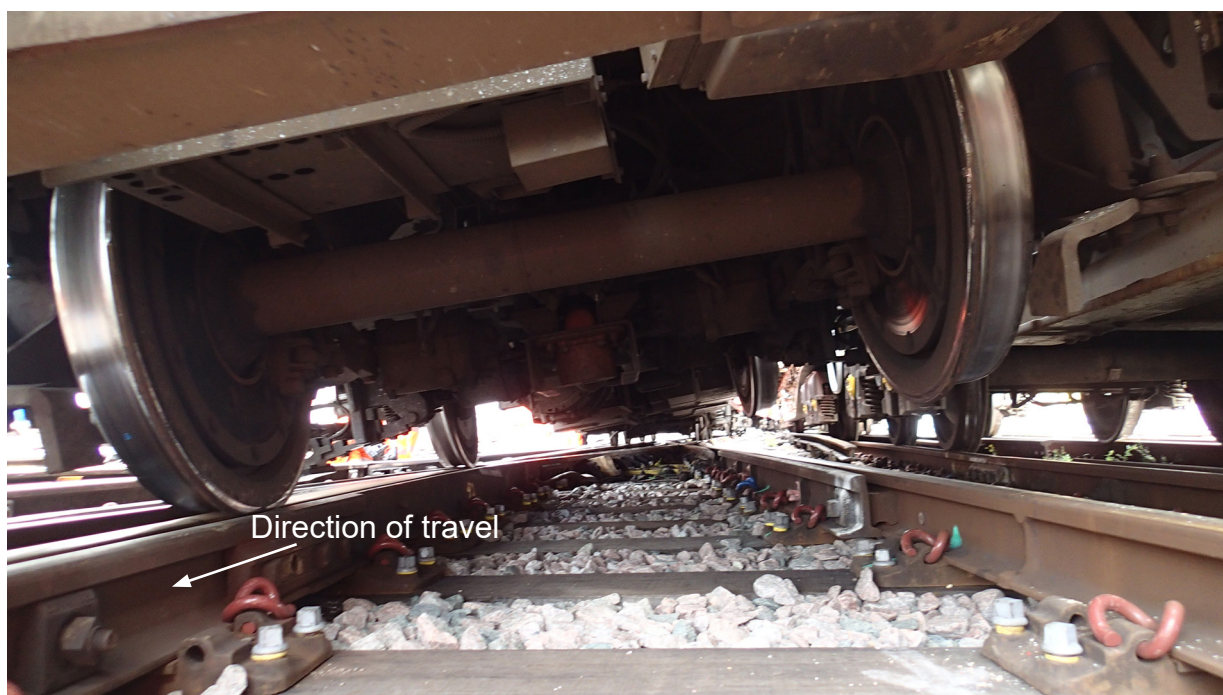
Figure 9: Train 2D03 with left (in direction of travel) wheels of the leading bogie above the rail

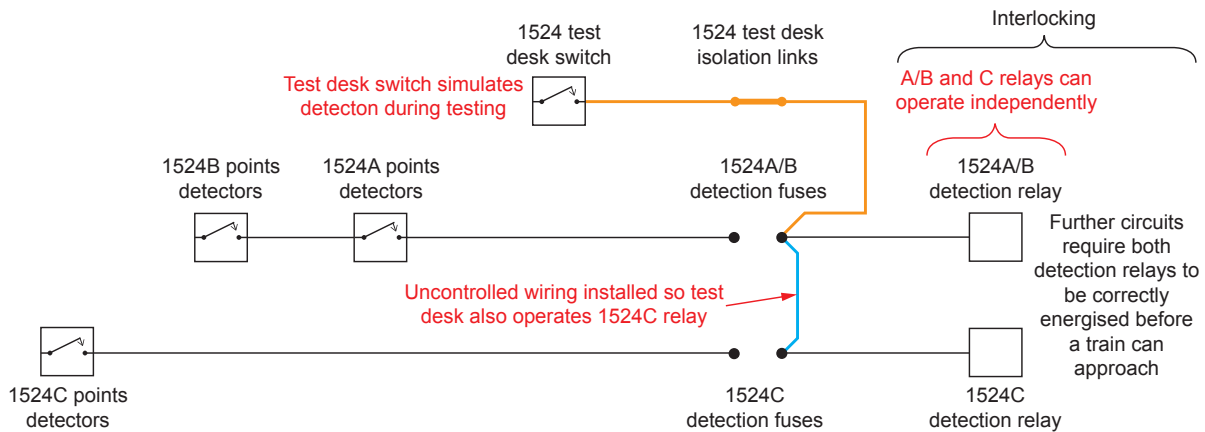
Figure 17: 1524 points in test mode after replacement of location case W14 and addition of uncontrolled wiring

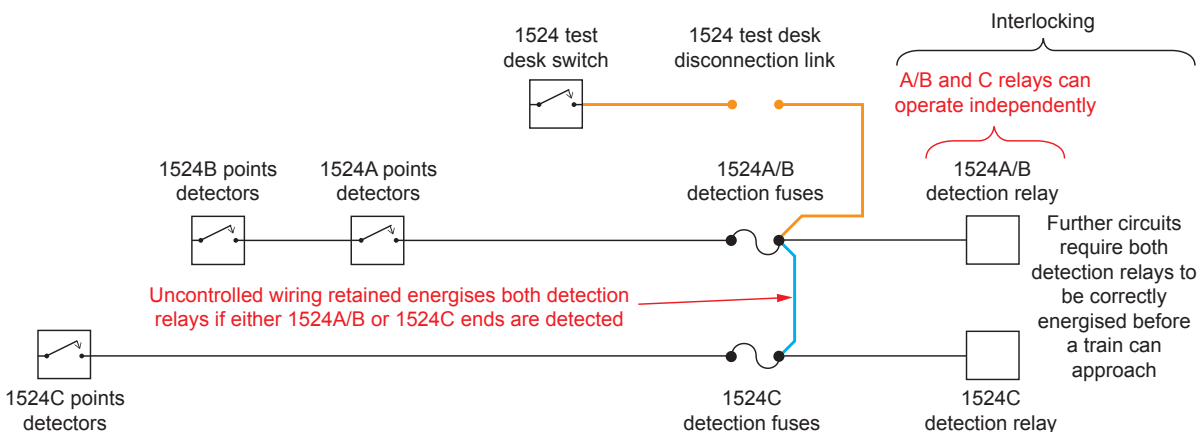
Figure 18: 1524 points detection at time of derailment

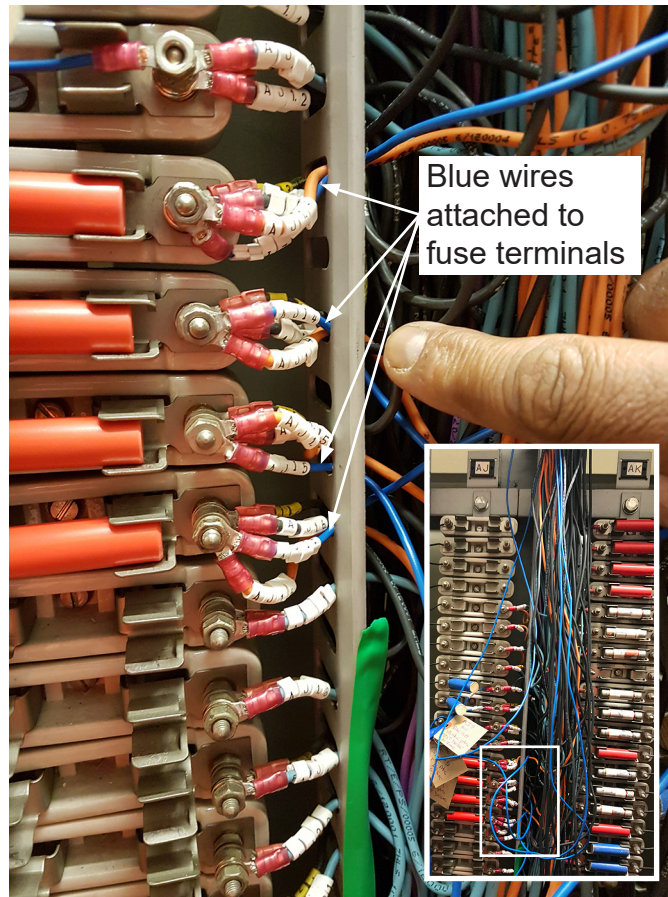
- 51 The individual testing licences cover a broad range of activities so certificates of competency are used to demonstrate that an individual has the technical skills and knowledge to carry out specific activities. The requirements for these certificates are defined by Network Rail standards NR/L2/SIG/30014/B410 'Signalling Works Testing Staff Competence Assessment' and NR/L2/SIG/30014/B110 'Signalling Works Testing IRSE Licensing Requirements'.

- 52 Employers' competency managers assess whether an individual has reached the required standard for each category on the certificate of competency by reference to their work experience and by interview. Certificates of competency generally last for two years and are renewed by a further review of experience and a further interview with an employer's competency manager.

Figure 19: Uncontrolled wiring attached to the fuses for 1524 points detection relays

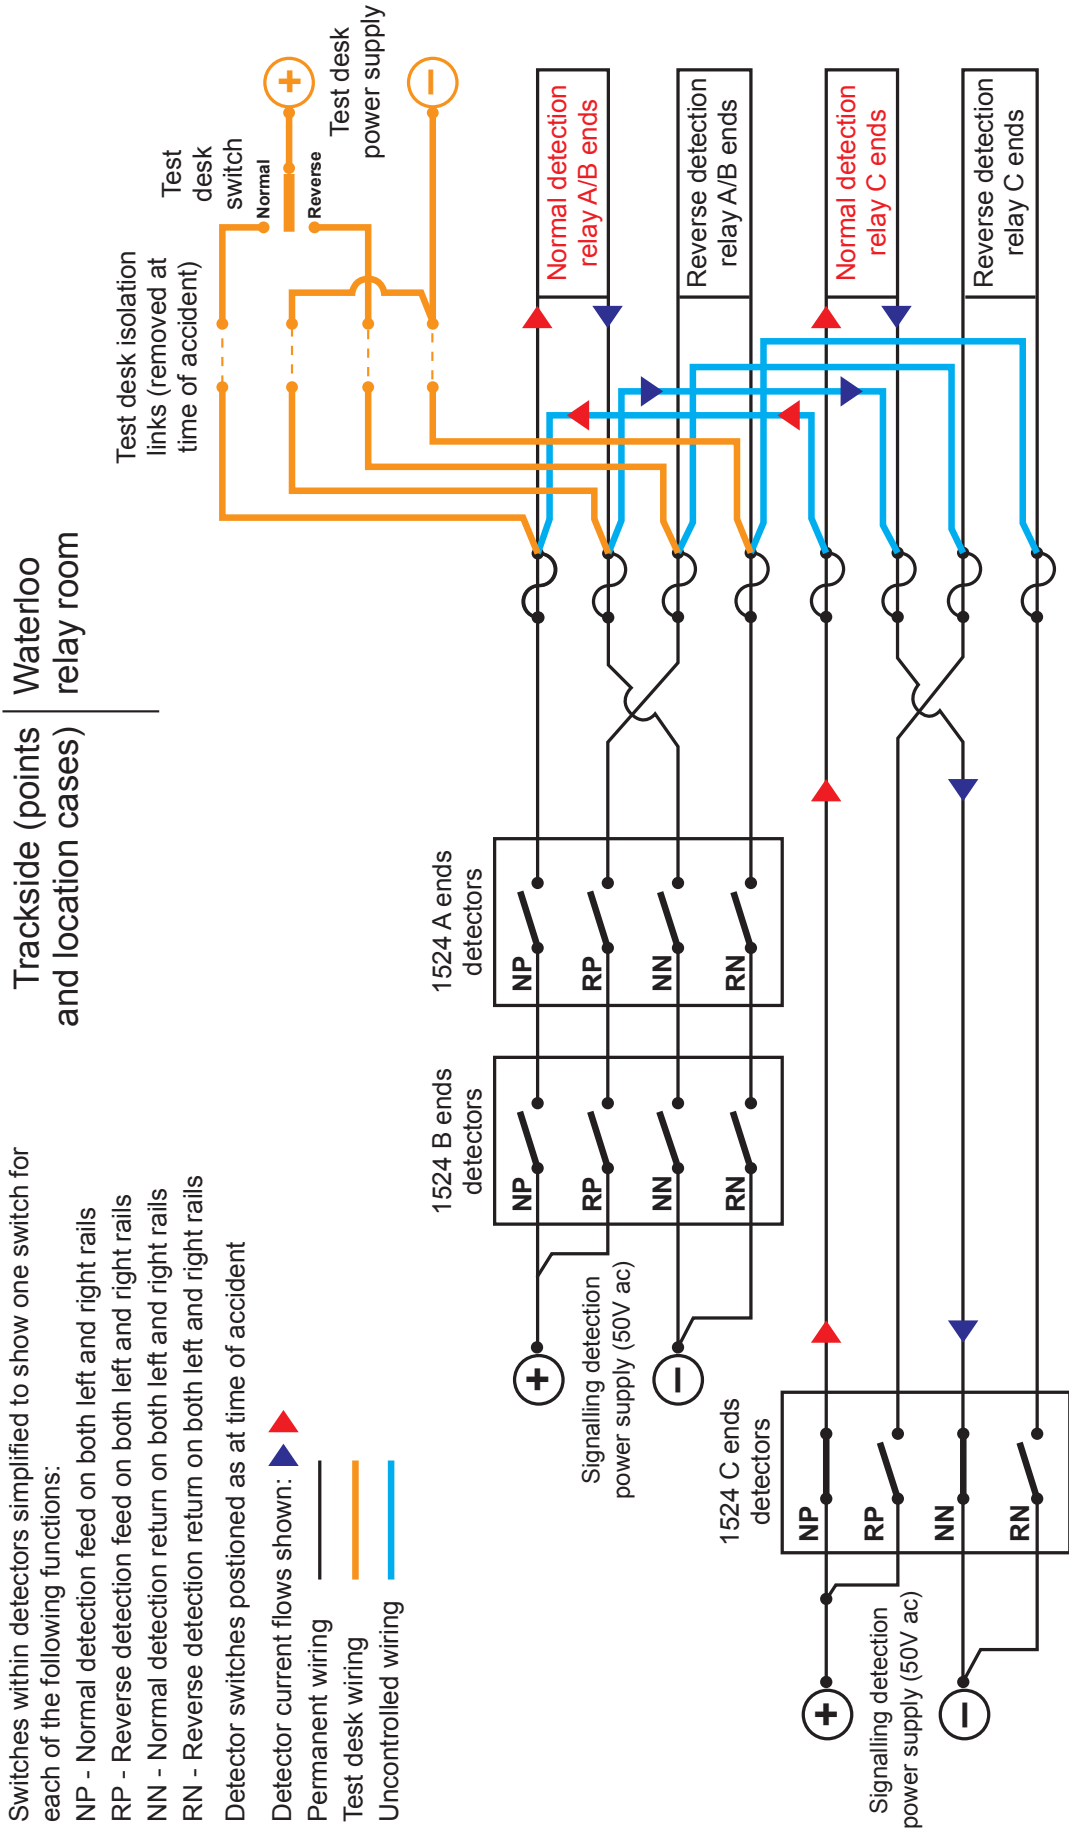
Appendix C - 1524 points wiring at the time of derailment

This diagram corresponds with the simplified arrangement shown on figure 18.
