Rail Accident Investigation Branch

Rail Accident Report

**Self-detrainment of passengers onto lines that were still open to traffic and electrically live at Lewisham, south-east London
2 March 2018**

Report 02/2019
March 2019

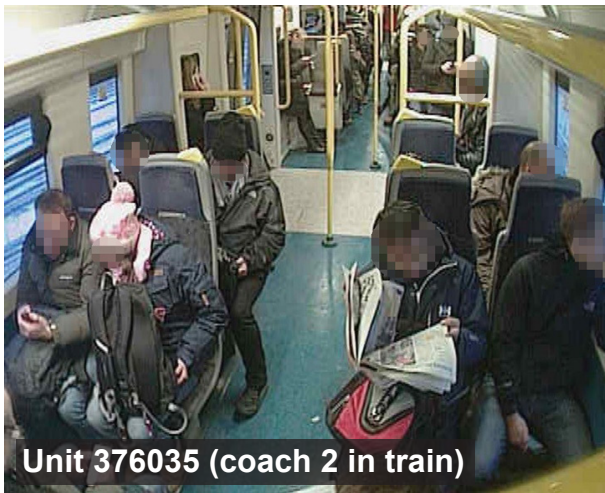
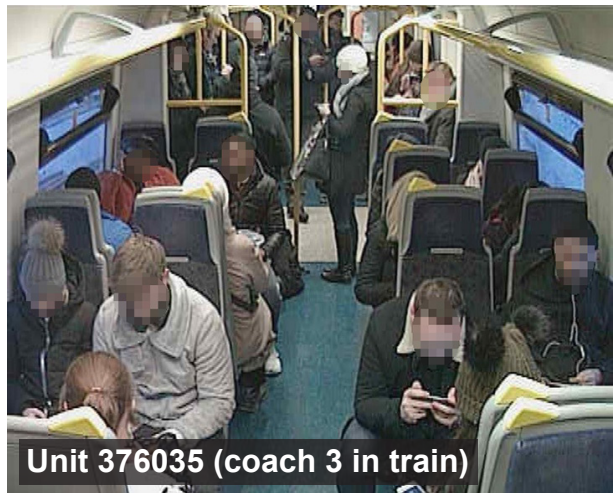
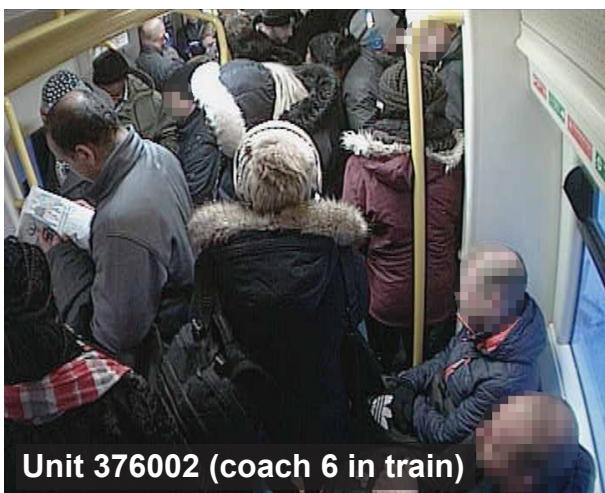
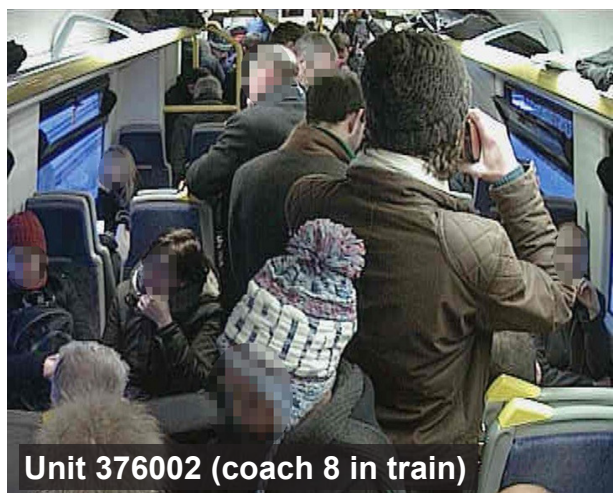
Figure 7: Images showing passenger occupation on leading and trailing units of train 2M50 (images courtesy of London and South East Railway Ltd)

- 22 Train 2M50, which was prevented from accessing platform 4 and from which the first passenger egress to track occurred, was also 10 coaches long. It was formed of two 5-coach class 376 'Electrostar' units (376035 and 376002) (figure 6). On-train CCTV showed that the trailing six coaches were crowded and that passengers were standing throughout. Although virtually all the seats were occupied on the leading four coaches, more standing space was available (figure 7).

100 Train 2M50 was held at L445 signal for 63 minutes before the first passenger detrained. During this time many passengers were standing in crowded conditions and were unable to judge how long they would remain trapped on board the train. In such circumstances it is understandable that some passengers became uncomfortable, frustrated or agitated.

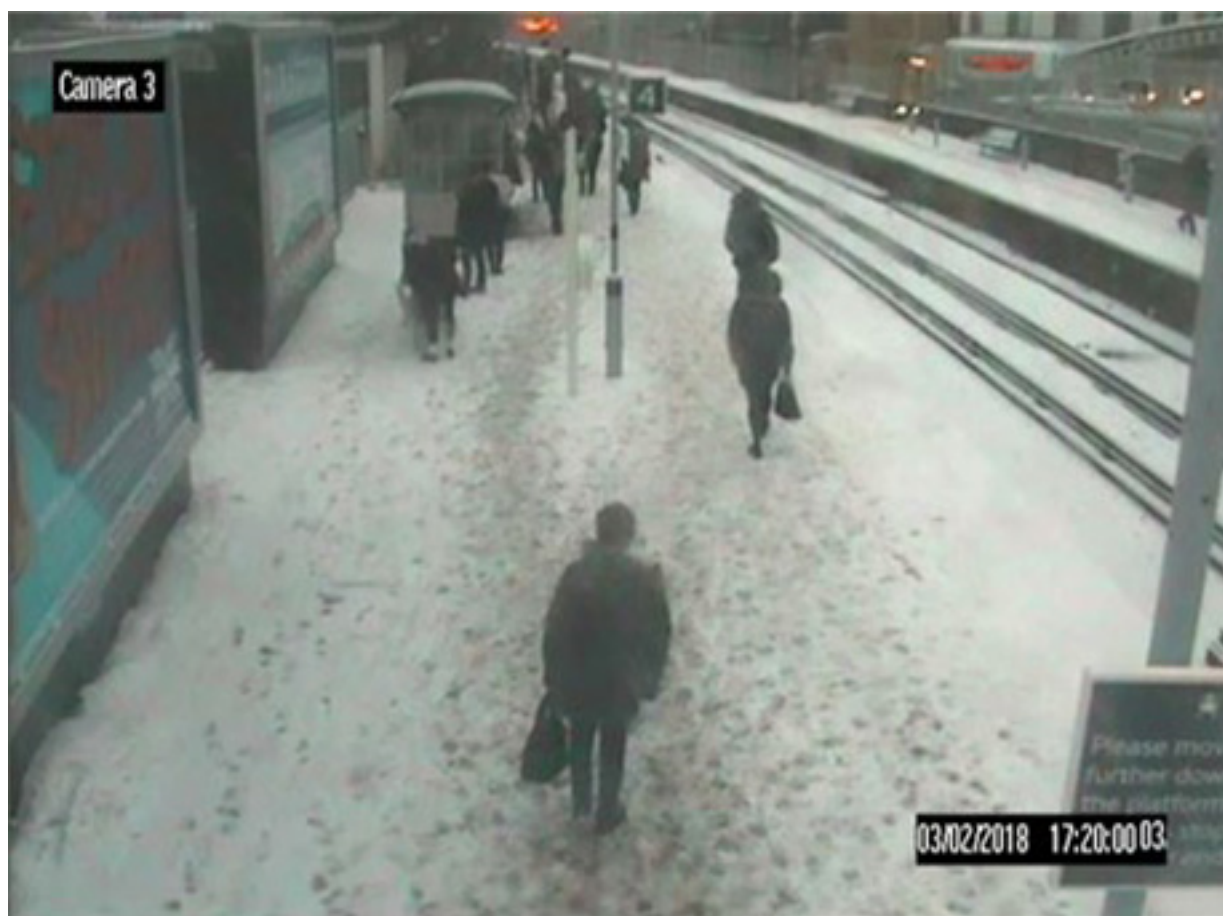
Figure 8: CCTV image of platform 4 at 17:20 hrs (image courtesy of London and South East Railway Ltd)

- 25 The incident occurred during a period of sustained cold wintry weather. Official weather observations for south London recorded an air temperature that had remained below 0 °C since the evening of Sunday 25 February, and at times had been as low as -9 °C.
- 26 In the hours before train 2M48 started to experience difficulty departing from Lewisham station, local weather stations recorded an air temperature of around -1.5 °C and a frost point that had been steadily rising to match it⁵. Station CCTV recorded the wintry conditions on Platform 4 and the North Kent lines at this time (figure 8).

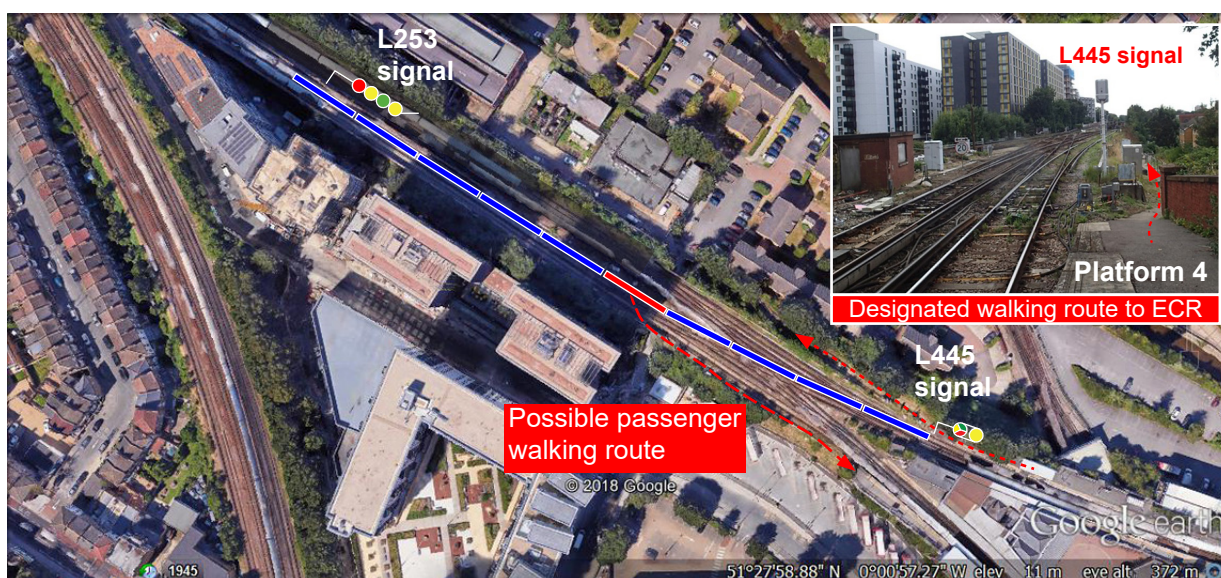
- 61 At 17:34:33 hrs the signalling data logger recorded that Signaller 1 set the route for train 2M50 to cross from the Down Kent Fast line onto the Down Tanners Hill line and proceed to Lewisham Junction. Train 2M50 arrived at the junction at 17:37 hrs and was held at L445 signal on the Down North Kent line waiting to enter platform 4. The 10 coaches of the train occupied the junction and extended onto the Down Lewisham line as far as L253 signal (figures 2 and 14).

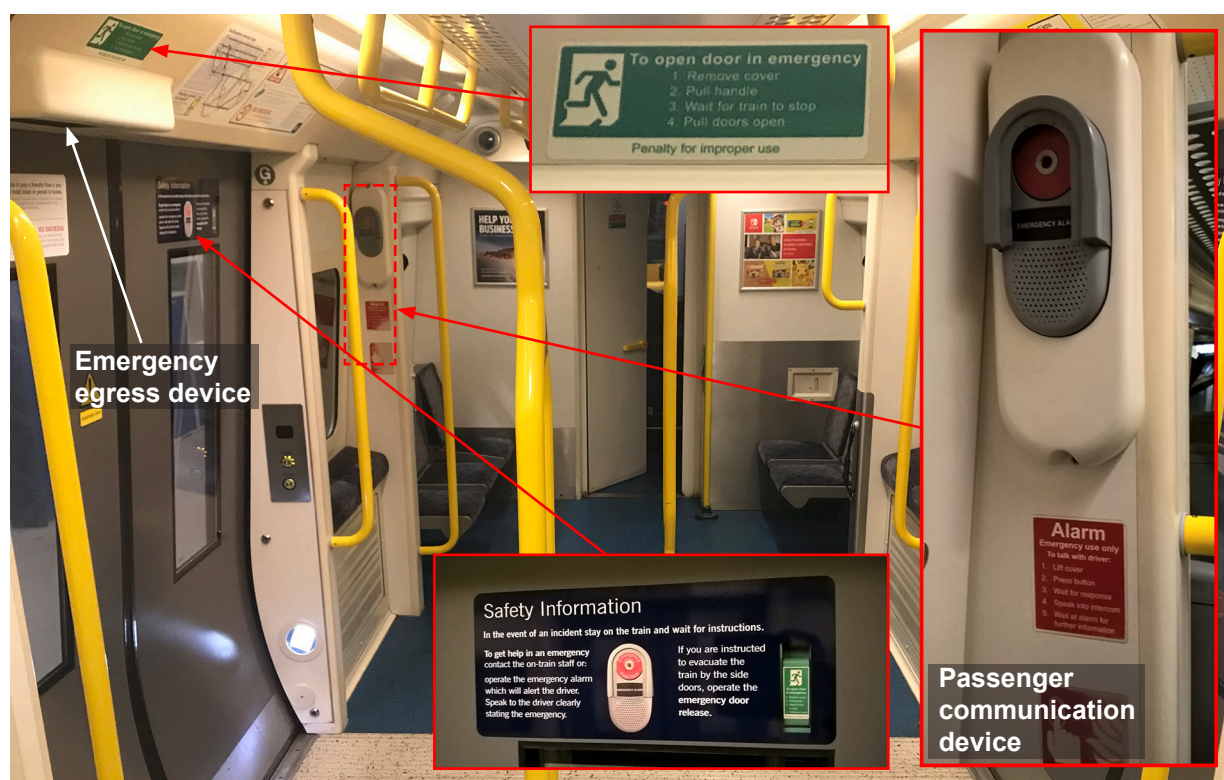
Figure 15: Passenger vestibule on class 376 unit (images courtesy of London and South East Railway Ltd)

- 95 Emergency egress devices are a standard requirement on passenger trains operating on Network Rail. They are provided at each set of external powered doors so that, in an emergency and irrespective of the state of vehicle power, passengers can open the doors²⁰. The devices are fitted in a panel above the doorway in the passenger vestibules of class 376 units. Separate passenger communication devices are provided in the vestibule so that passengers can speak with the driver (figure 15).

- 96 On-train CCTV recordings confirmed that the passenger that first got off train 2M50 decided to use an emergency egress device on the right-hand side of the fifth coach (paragraph 81). This was contrary to instructions on passenger safety information notices that Southeastern had fitted to the inside of the passenger doors, and to signs located immediately above each emergency egress device (figure 15). The initial detraining of passengers was also in spite of announcements made by the driver (paragraph 143).

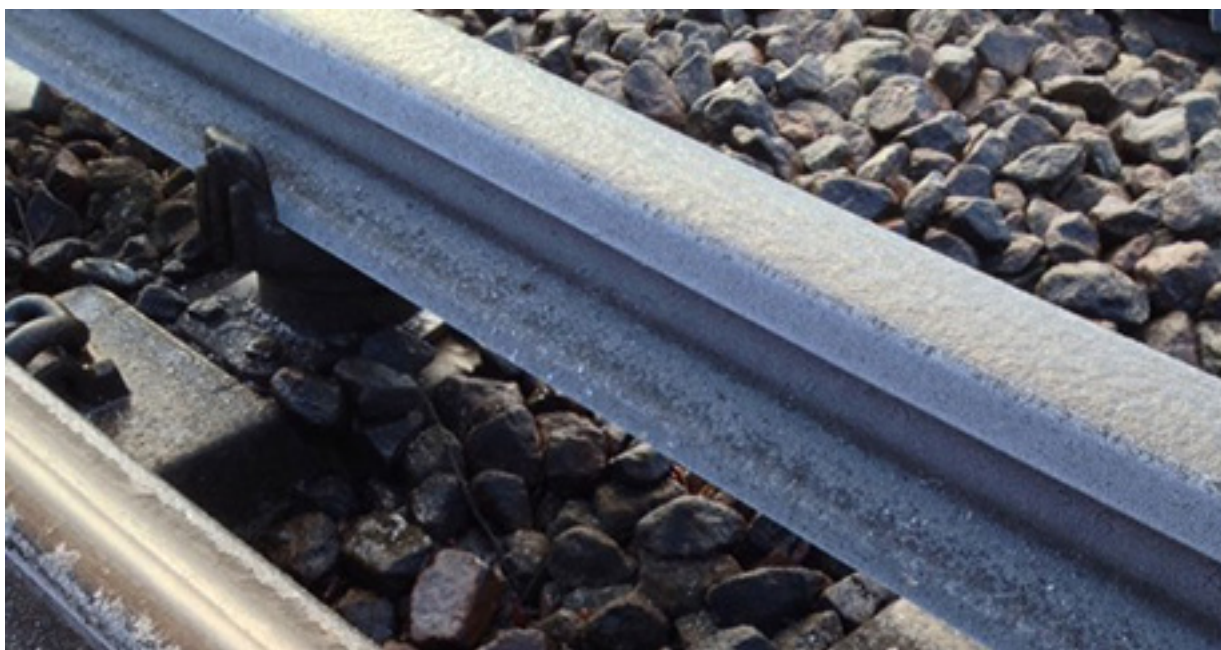
Figure 16: Typical ice and frost formation on the surface of a conductor rail (image courtesy of Network Rail)

106 The class 465 and 466 units that formed train 2M48 rely on electrical contact between the top surface of the conductor rail and the train shoe gear (paragraph 21). Since ice is generally a poor conductor of electricity, its accumulation on the conductor rail can result in an insulating layer that can lead to trains having difficulty drawing traction current. Figure 16 illustrates typical ice and frost formation on a conductor rail.

107 The weather conditions in the Lewisham area prior to train 2M48 departing from platform 4 were consistent with the formation of ice and frost on the surface of the conductor rail. The factors that led to the ice formation were:

- the frost point of the air rising to the surface temperature of the conductor rail; and
- rain freezing on the surface of the conductor rail.

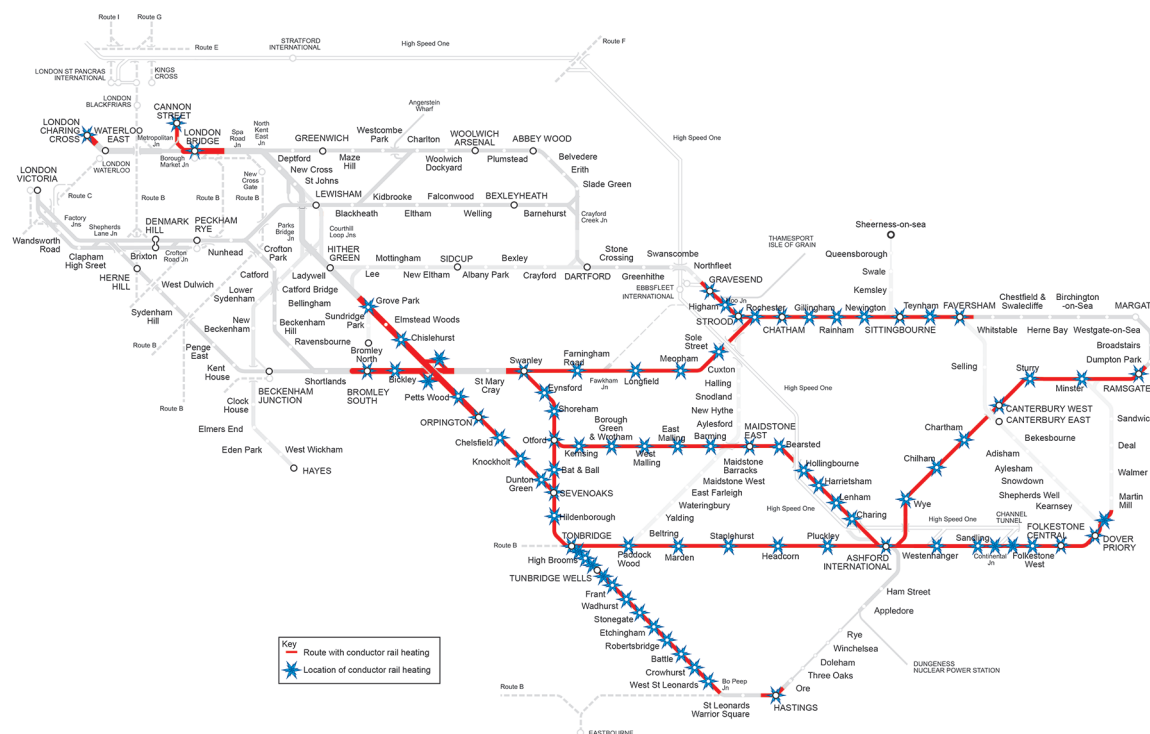
Figure 17: Map showing the location of conductor rail heating in the Kent Area (map courtesy of Network Rail)

110 Network Rail's conductor rail heating system uses electrical elements to melt ice and prevent it forming; the elements are surface-mounted on the web of the conductor rail. The heating system is powered by the DC traction power system and uses technology that is similar to systems that are used to heat points. It is designed to be installed at places where trains need to accelerate, such as stations and signals. Network Rail had installed conductor rail heating at a number of locations in its Kent Area, but these were mainly in central and south Kent (figure 17). Nearly all were outside London. No conductor rail heating was provided on the Down North Kent line at Lewisham station or at a number of other service-critical locations within London. Network Rail could provide no formal record of the criteria it used to decide on locations for the installed conductor rail heating. However, its engineers felt that they had probably been chosen on the basis that they were places where problems had been previously experienced. It is also likely that the high frequency of train services in urban areas would have been seen as reducing ice accumulation, because frequent trains would scrape ice from the conductor rail surface before it became thick enough to cause a problem.

- 111 On 2 March 2018, Network Rail advised that traction problems had been experienced at locations where conductor rail heating was installed. This suggests that the ice accumulation at Lewisham may have been particularly severe on that day. Although standard conductor rail heating may not have overcome all the traction difficulties encountered by train 2M48, its provision on the Down North Kent line in platform 4 is likely to have been beneficial in the circumstances.

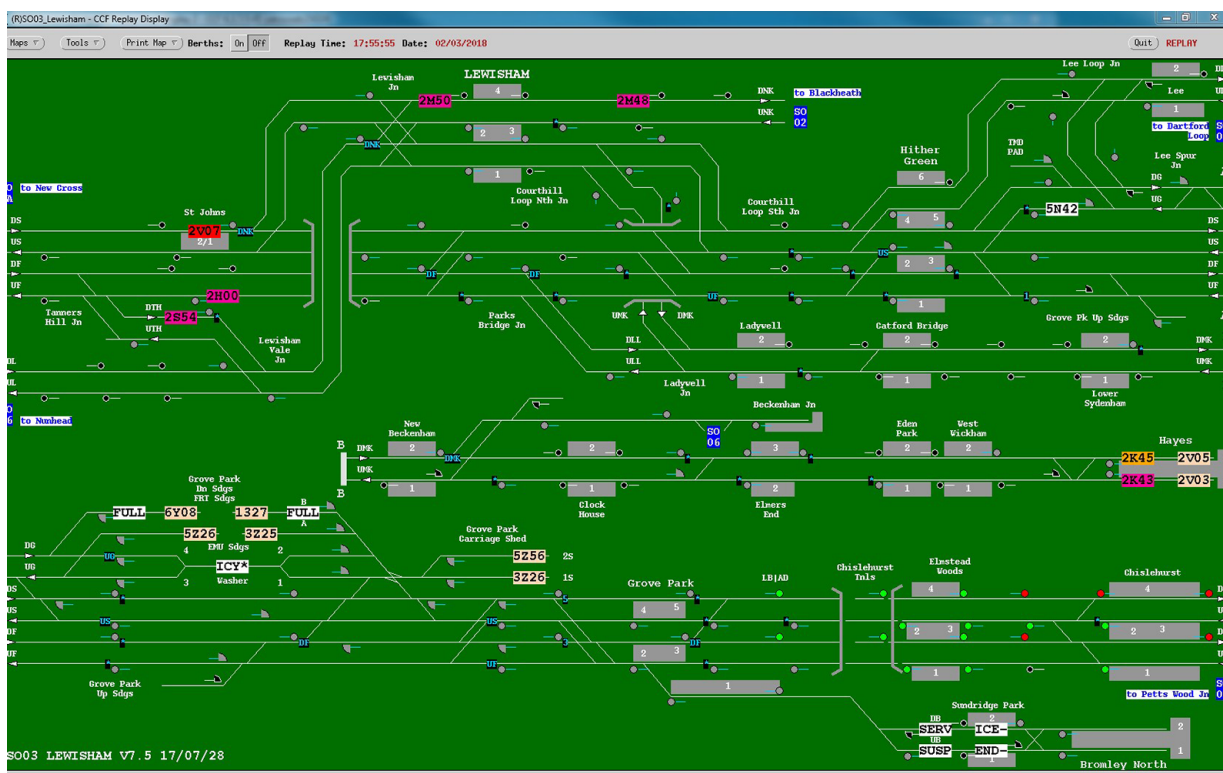
Figure 18: CCF screen image for Lewisham at 17:55 hrs on 2 March 2018. Note: this image was acquired using the playback facility in CCF (image courtesy of Network Rail)

125 Signallers on duty at panel 5 work in accordance with the Rule Book and the 'Special instructions to signallers at London Bridge Panel 5'. Neither of these documents define criteria for determining when a train should be considered unable to move or make adequate progress, nor the timeliness of the response or the action to be taken.

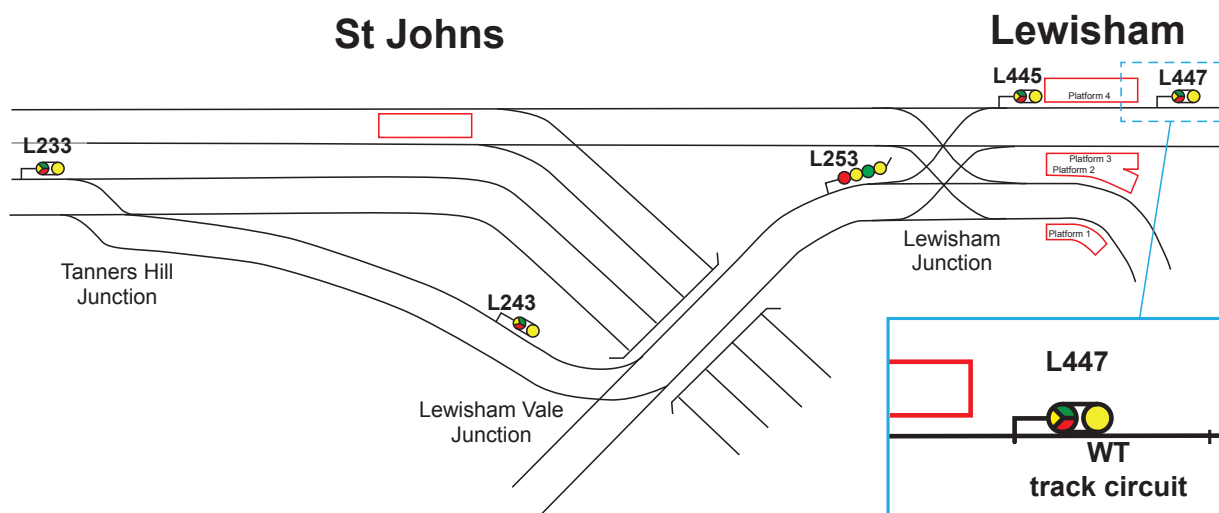
Figure 19: Signalling layout at Lewisham station

133 Train 2M50 was not held at a signal that would have allowed it to be subsequently diverted onto an alternative line.

135 In what would have been routine, Signaller 1 routed train 2M50 so that it closely followed train 2M48 into Lewisham by manually setting a route as far as L253 signal. L253 signal has an automatic working facility that signallers use to aid route setting into platform 4 (footnote 8). There is evidence that this facility was selected²⁷. This meant that the signalling system automatically extended the set route so that trains could reach platform 4 without the signaller needing to take further intervention. To have prevented the train being able to pass L253 signal the signaller would have needed to de-select the automatic working facility. The signalling data logs showed Signaller 1 set the route for train 2M50 around four minutes after train 2M48 had started to depart and two minutes after he had received a call from the driver of train 2M48 that he was having traction difficulties (paragraph 61). Shortly afterwards the signaller set the route for train 2S54 to approach L243 signal, following train 2M50 onto the Down Tanners Hill line (paragraph 62).

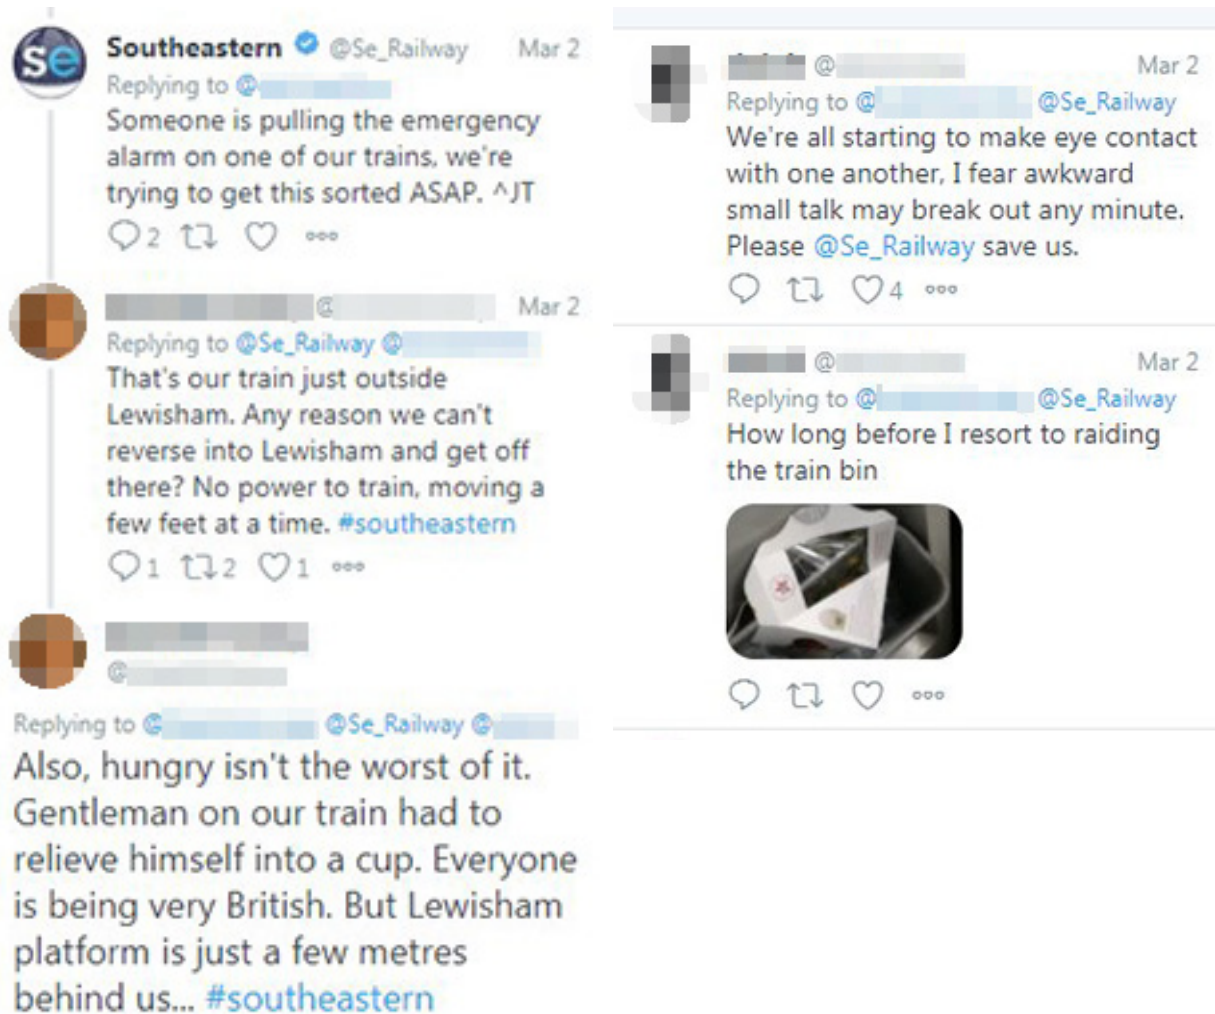
Figure 20: Typical tweets to Southeastern's Twitter account prior to 18:41 hrs

- 149 It would not necessarily be possible for passengers to know that an individual message related to the train they were on. However, the information being exchanged would probably have promoted a shared feeling of dissatisfaction and possibly thoughts of getting off the train. These, and other tweets sent over the course of the evening, may also have influenced others to leave stationary trains in the area.
