# **Rail Accident Report**

Track worker struck by a train at Stoats Nest Junction, near Purley 6 November 2018

> Report 07/2019 July 2019

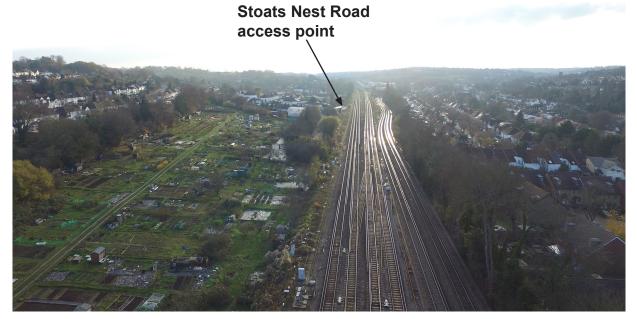
Figure 3: Image looking south towards Stoats Nest Road access point

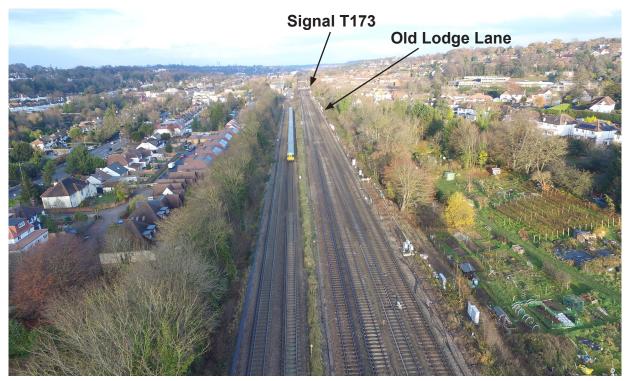
Figure 4: Image looking north towards Old Lodge Lane and signal T 173

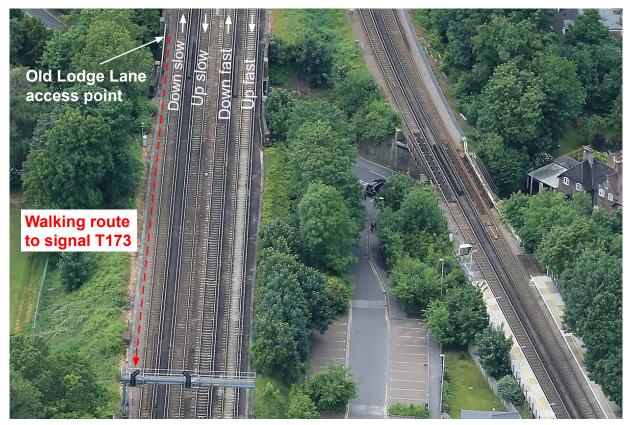
Figure 5: Routeview image showing Old Lodge Lane access point, up and down slow and fast lines and signal T173 (image courtesy of Network Rail)

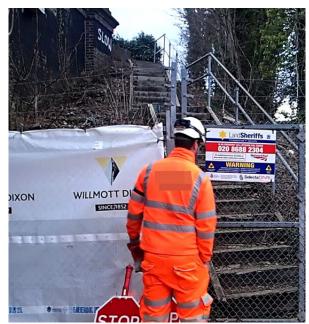
42 Around 00:18 hrs the COSS, now carrying the two possession limit boards and six detonators, entered the railway via the Old Lodge Lane access gate, and walked up the steps (figure 6) to the down slow cess. The COSS then walked towards signal T173 (figures 5 and 7).

Figure 6: Access gate at Old Lodge Lane

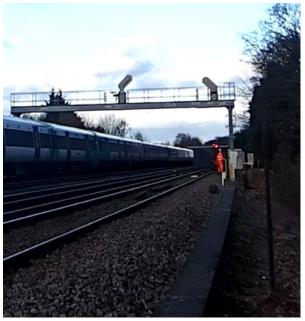
Figure 7: Signal T173 gantry

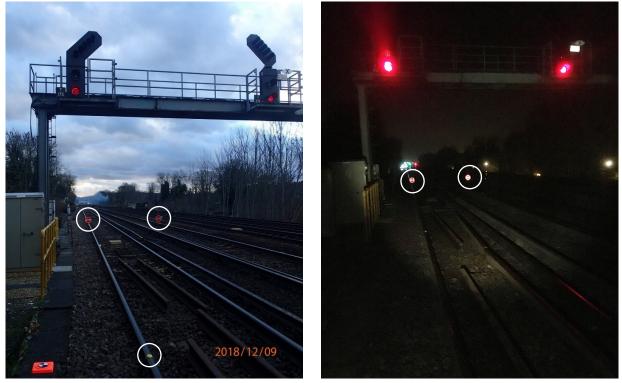
*Figure 9: (a) showing a reconstruction of the position of the possession limit boards and detonators and (b) showing signal T173 and the possession limit boards after the accident on 6 November 2018*

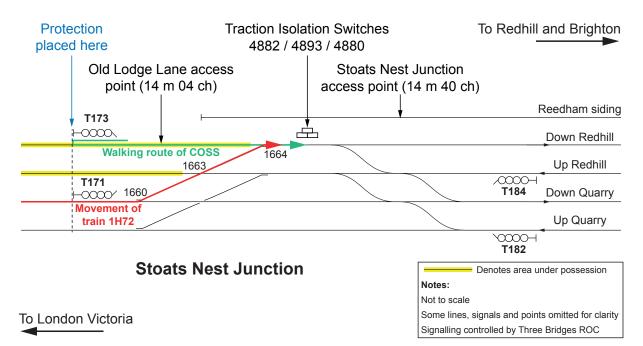
46 Between 00:24:39 hrs and 00:25:09 hrs, signalling data shows that another northbound train passed through the area on the up fast line. Based upon the times derived from the reconstruction, the RAIB believes the COSS, who had not returned to his vehicle, had now passed the pedestrian access point on Old Lodge Lane and was walking south on the down slow line towards points 1664 (figures 10 and 11).

Figure 10: Diagram showing the walking route taken by the COSS and path of train 1H72 prior to the accident

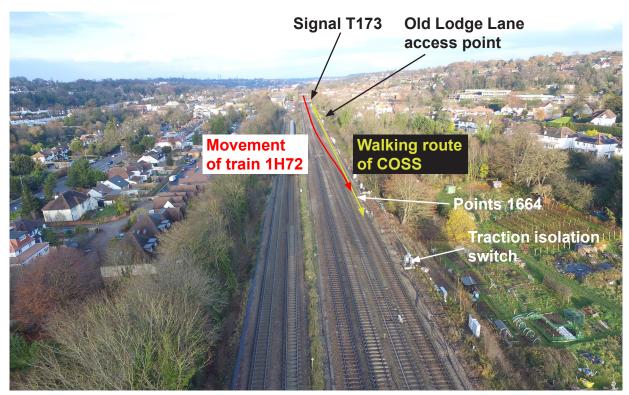
Figure 11: Aerial image showing locations of Old Lodge Lane access point, including the walking route taken by the COSS towards points 1664 (yellow line), the route of train 1H72 (red line) and the location of the trackside equipment

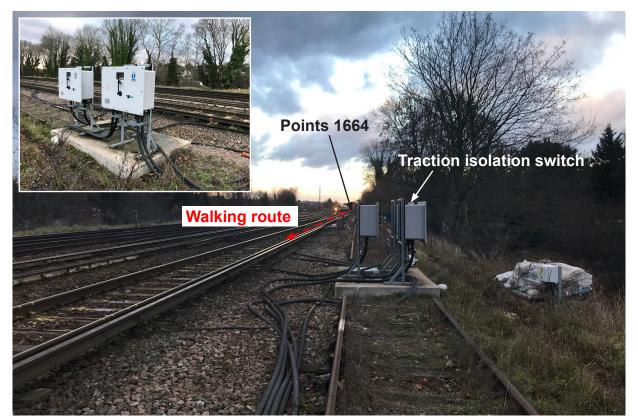
Figure 12: Image showing the location of the traction isolation switch equipment (inset image) in the cess running parallel to the down Redhill (slow) line

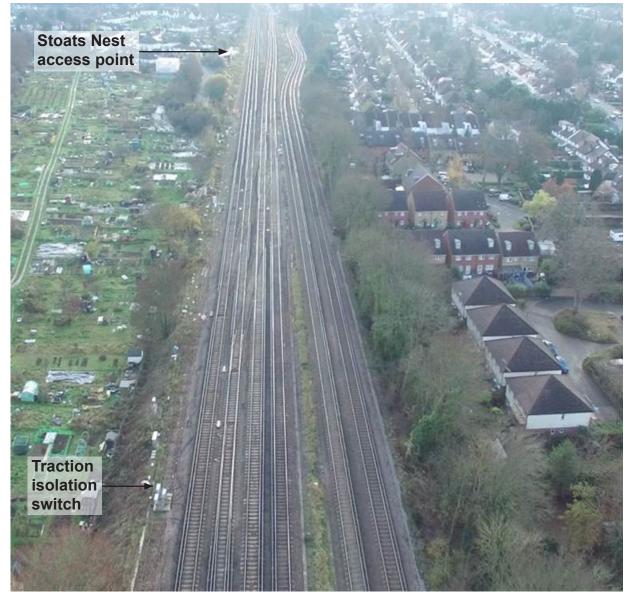
- e. The COSS was walking towards Stoats Nest Road access point to take a personal needs break. There were no welfare facilities at Stoats Nest Road access point so it would not appear to be a more likely personal needs break location than somewhere nearer the possession limit (figures 13 and 14).

Figure 13: Image showing the location of the traction isolation equipment and Stoats Nest Road access point

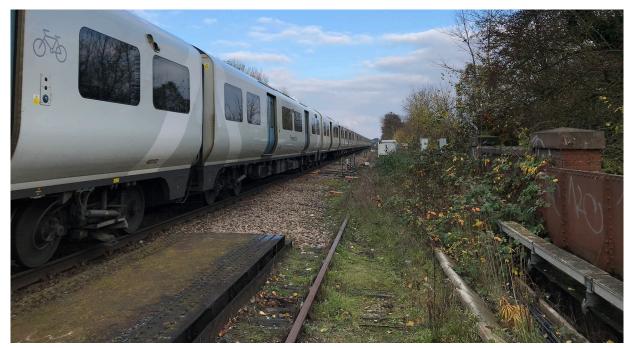
Figure 14: Image showing the down Redhill (slow) cess and walkway
