Rail Accident Investigation Branch

Rail Accident Report

**Fatal collision between a tram and a pedestrian,
near Saughton tram stop, Edinburgh
11 September 2018**

Report 09/2019
July 2019

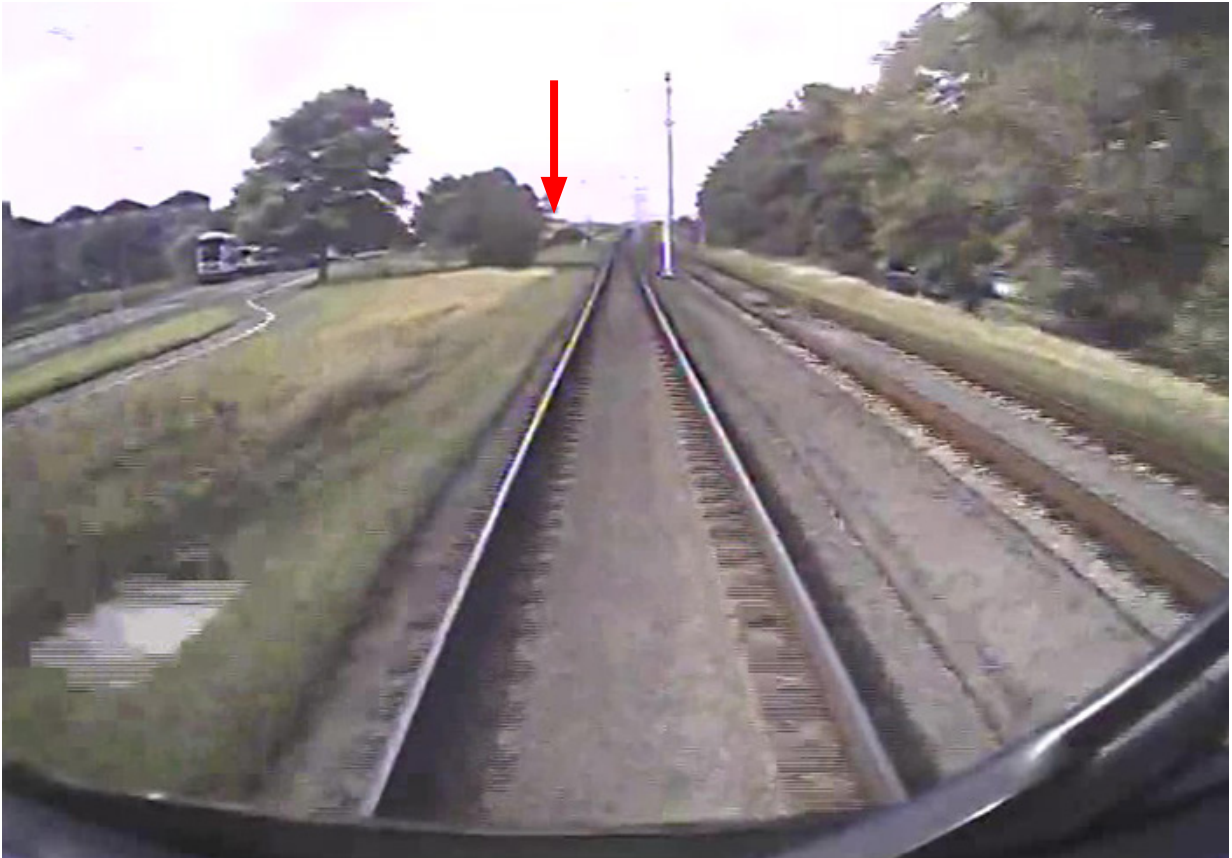
Figure 4: Image from the FFCCTV of tram 260 at around 73 metres from the crossing and 4.6 seconds before the collision. The arrow indicates the location from which the pedestrian emerges very shortly afterwards.

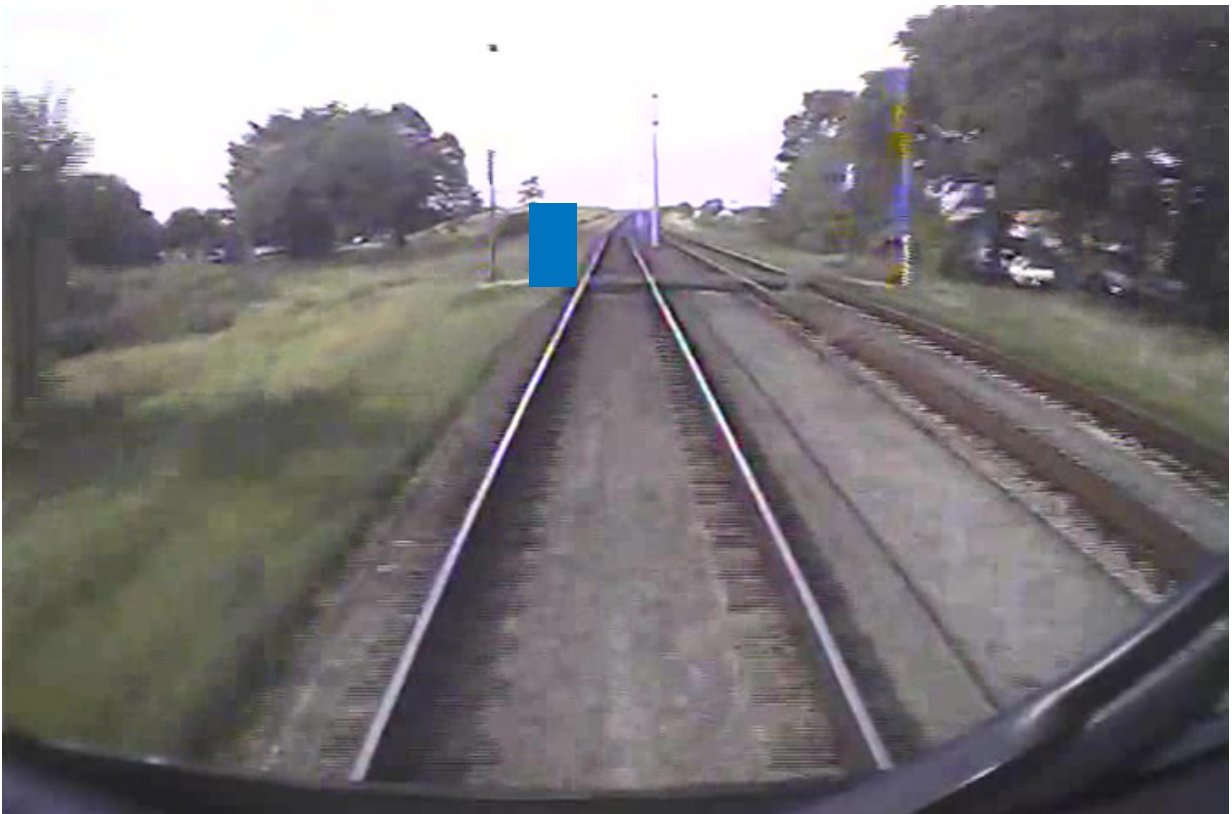
Figure 5: Edited image from the FFCCTV of tram 260 at around 18 metres from the crossing and 1.2 seconds before the collision. The rectangle indicates the location of the pedestrian.

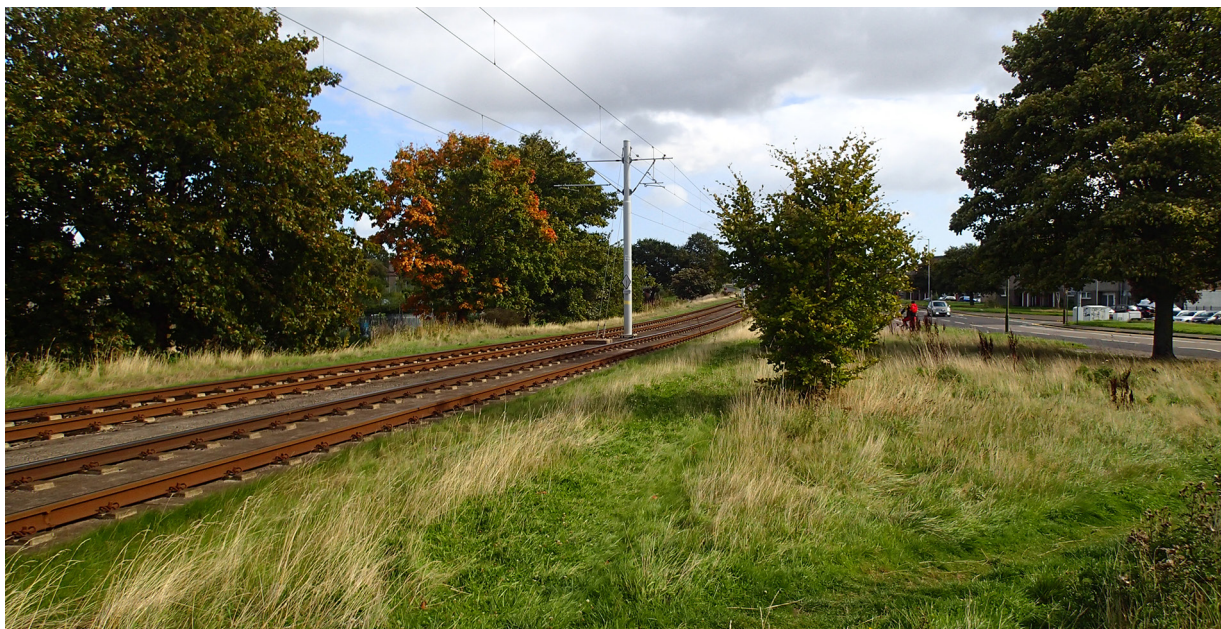
42 Photographs taken following the accident show that airport bound trams would be visible from the footpath when viewed from distances closer than approximately 6 metres from the nearest running rail of the crossing (figure 6). Images from the FFCCTV of the tram show that the pedestrian became visible when at this distance from the crossing, and the images suggest that the pedestrian did not look, or change his stride beyond this point until just before the collision.

Figure 6: The view to the east from the footpath at 6 metres from the crossing

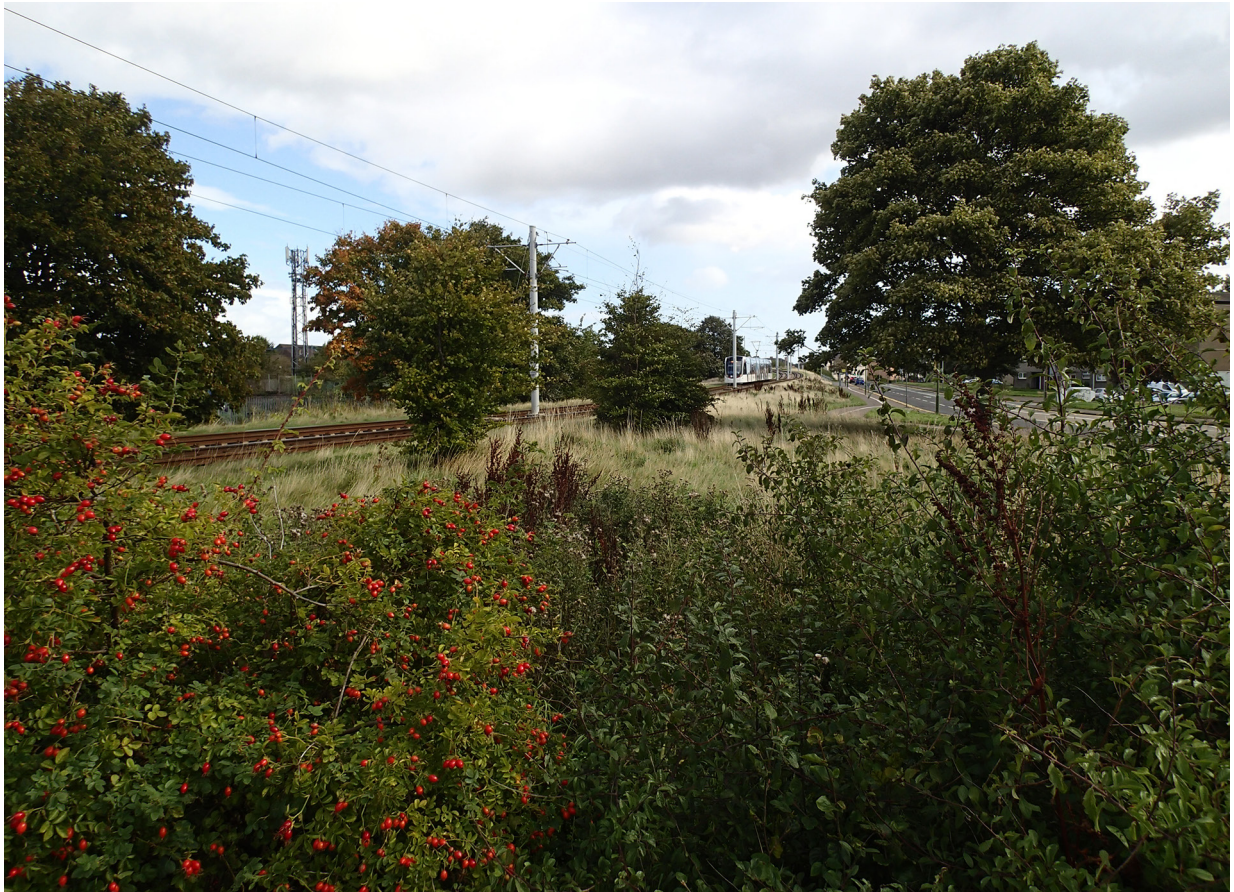
43 It is possible that the pedestrian may have looked for approaching trams while he was still some way away from the crossing as he walked towards it. However, clear views of the tramway to the east from the footpath are interrupted by bushes on the edge of the footpath (figure 7) and two trees adjacent to the track (figure 8).

Figure 7: The view to the east from the footpath at 14 metres from the crossing

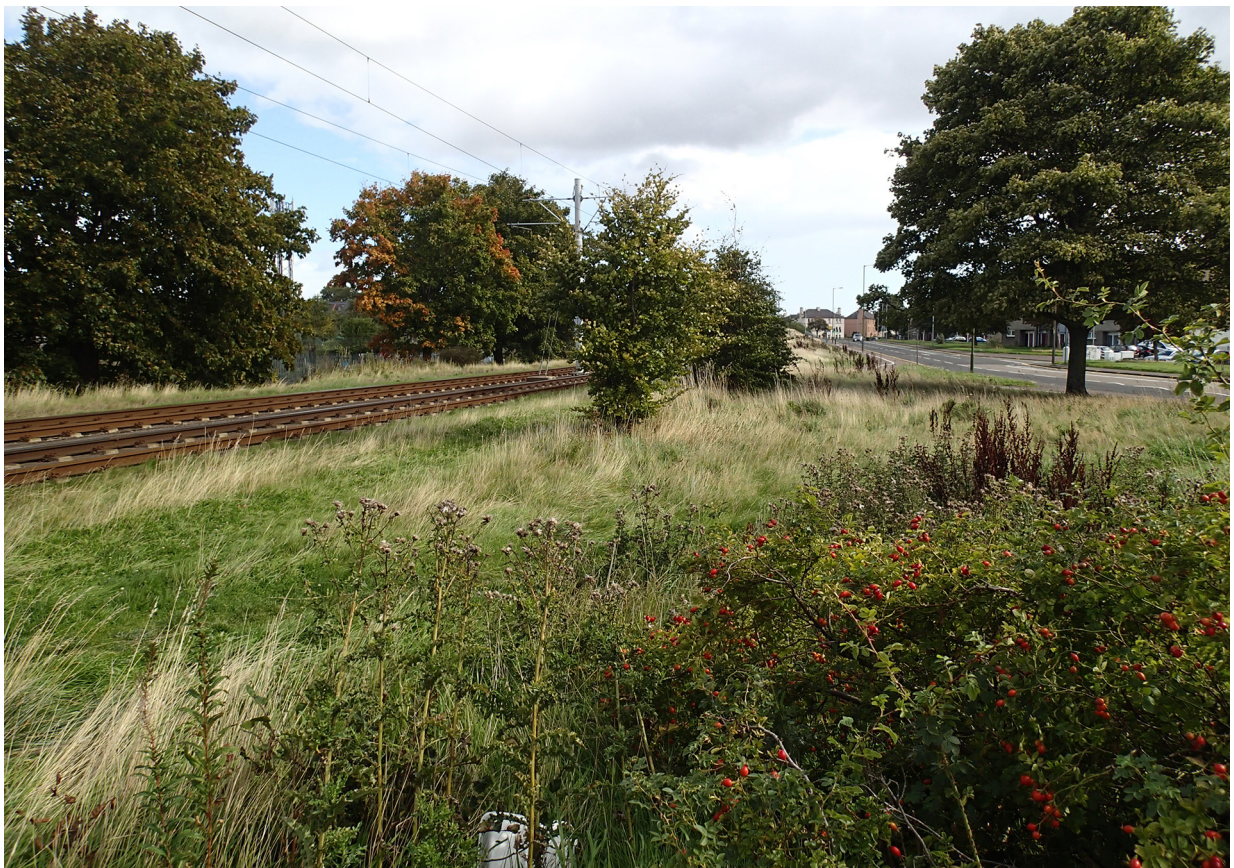
Figure 8: The view to the east from the footpath at 8 metres from the crossing

- 44 The bushes and trees also obscured an earlier sighting of the pedestrian by the tram driver. The trees have since been removed (paragraph 137).
- 45 The pedestrian had passed a D4 medical examination¹ required for driving public service vehicles in May 2017. That type of medical examination includes an assessment of both visual acuity and visual field. Although he had previously been diagnosed with a deep cataract in the left eye, this is not thought to be a factor because his vision was adequate for bus driving. Additionally, the CCTV evidence indicates that he did not turn his head towards the approaching tram just before he started crossing the tram lines.

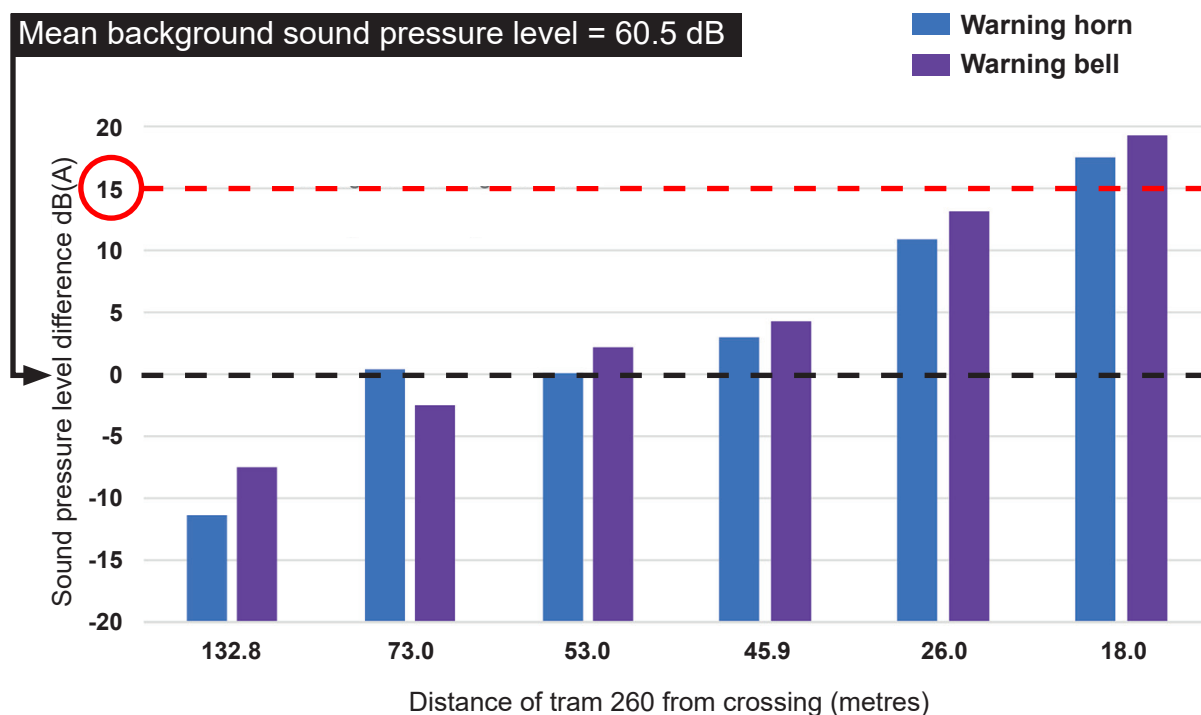
Figure 10: Sound pressure level differences of the bell and horn of tram 260 compared with the mean typical background sound level measured at the crossing, with zero on the y-axis being equivalent to the background sound pressure level of 60.5 dB(A). The red line represents a 15 dB(A) increase over the background level.

65 The test results also indicated that the sound pressure level of the horn is lower than that of the bell. Therefore, had the tram's warning horn been sounded earlier instead of the bell, it is unlikely to have been any more effective as a warning to the pedestrian.
