Rail Accident Report

**Serious operational irregularity at Bagillt user worked crossing, Flintshire, involving an abnormally heavy road vehicle
17 August 2018**

Report 11/2019
August 2019

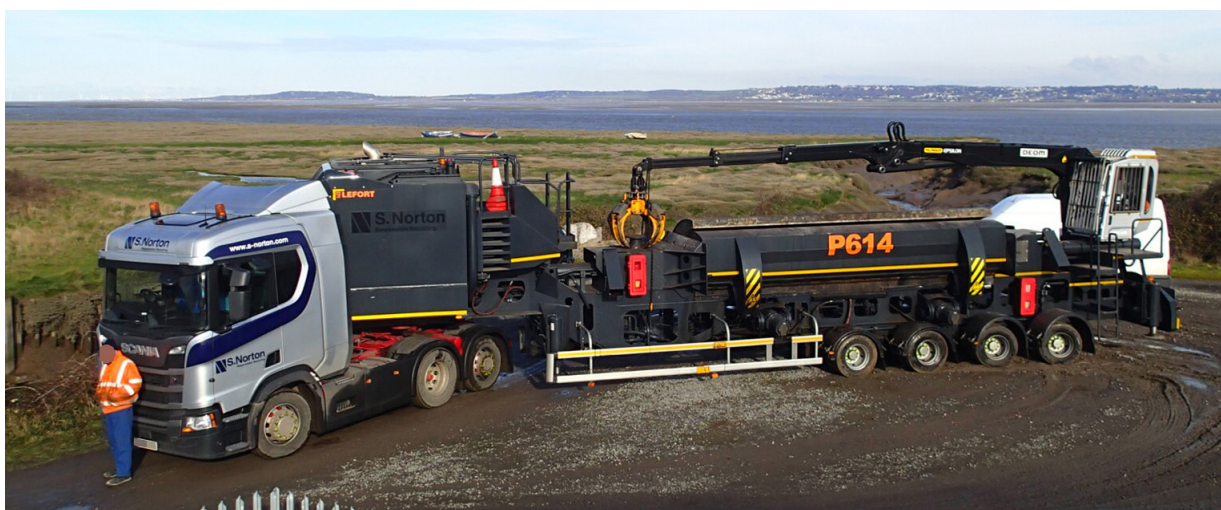
Figure 3: The baler

- 15 The combined tractor unit and semi-trailer is approximately 60.5 tonnes in weight, 19.1 metres long and 2.7 metres wide. Individual vehicles and vehicle combinations permitted to operate without special restrictions on public roads in the UK are usually limited by UK highway legislation to a maximum weight of 44 tonnes, a maximum length of 18.75 metres and a maximum width of 2.55 metres. Vehicles exceeding these criteria are described in this report as 'abnormal vehicles'.

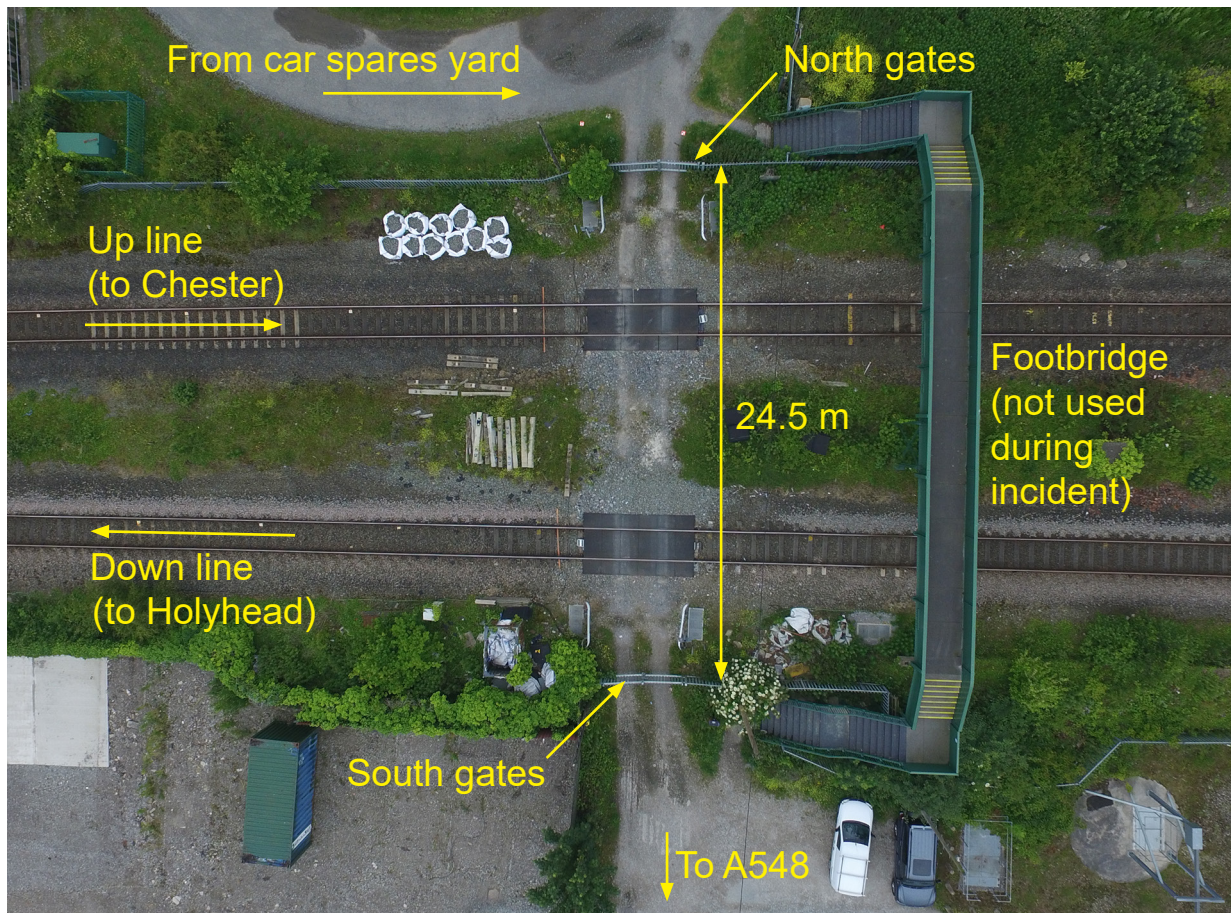
Figure 4: Overview of Bagillt UWC-T

- 16 Bagillt UWC-T has a pair of gates on each side of the railway situated 24.5 metres apart (figure 4). The crossing is equipped with a telephone outside each pair of gates which connect to the signaller's workstation supervising the crossing (figure 6, paragraph 19). Signs positioned inside the gates on both sides of the crossing tell users with vehicles or animals that they must telephone the signaller to obtain permission before opening the gates, crossing the railway and closing the gates. Vehicle users are required to obtain permission because sighting distances along the railway are not sufficient for users to see trains in time to determine if it is safe to cross.

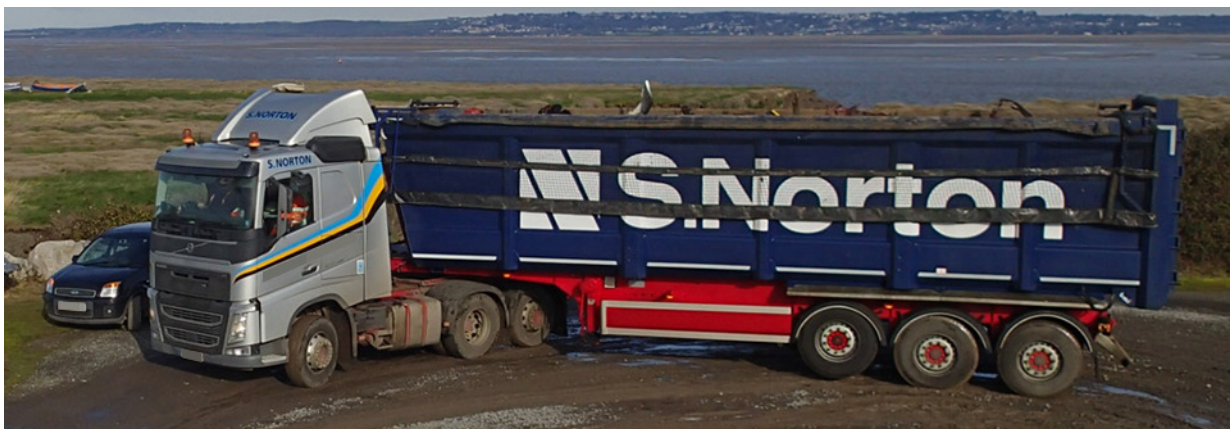
Figure 10: Typical heavy goods vehicle 'HGV' used on Bagillt UWC-T (not subject to special restrictions on the public highway)

- 53 Observations at Bagillt UWC-T showed that the crossing time for scrap metal lorries were only slightly less than the crossing time for the baler. A laden scrap metal lorry took 21 seconds and the baler took 28 seconds to travel from north to south over the crossing.
- 54 The crossing assistant stated that he usually described large vehicles as 'wagons' and that Network Rail staff had not asked him to clarify the size or weight of vehicles when they had previously observed him using the crossing. He also stated that no signaller and no Bagillt Car Spares staff had asked him to clarify the weight or size of the vehicle he was assisting to cross. No one had instructed him to treat the baler differently to the other vehicles used on the crossing, which were not abnormal vehicles.
