Rail Accident Investigation Branch

# Rail Accident Report

## **Serious operational irregularity at Balham 20 April 2019**

Report 01/2020  
February 2020

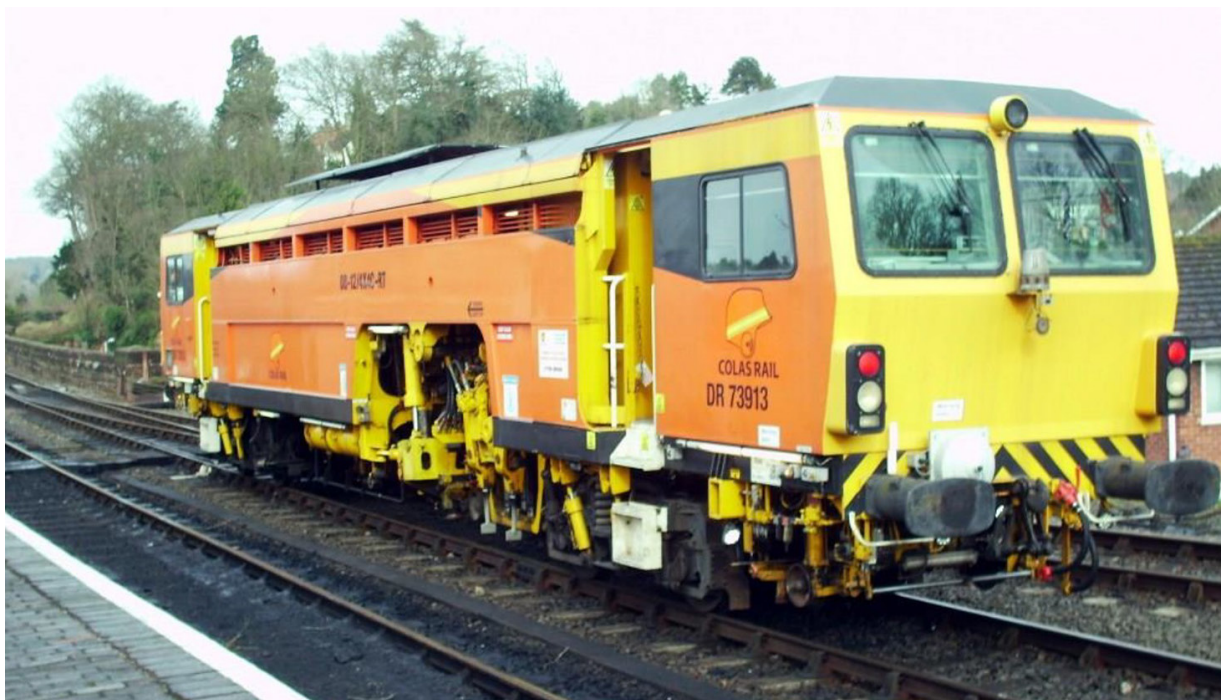
Figure 4: The tamper involved in the incident (courtesy of Colas Rail)

125 The tamper's forward-facing CCTV system was corrupted, and the Colas maintenance system had not identified the failure before the incident. It is important that CCTV systems on rail vehicles are functional. As well as providing evidence for the investigation of incidents, on some types of machine these systems provide forward visibility for operators during movement of the machine in one or both directions.

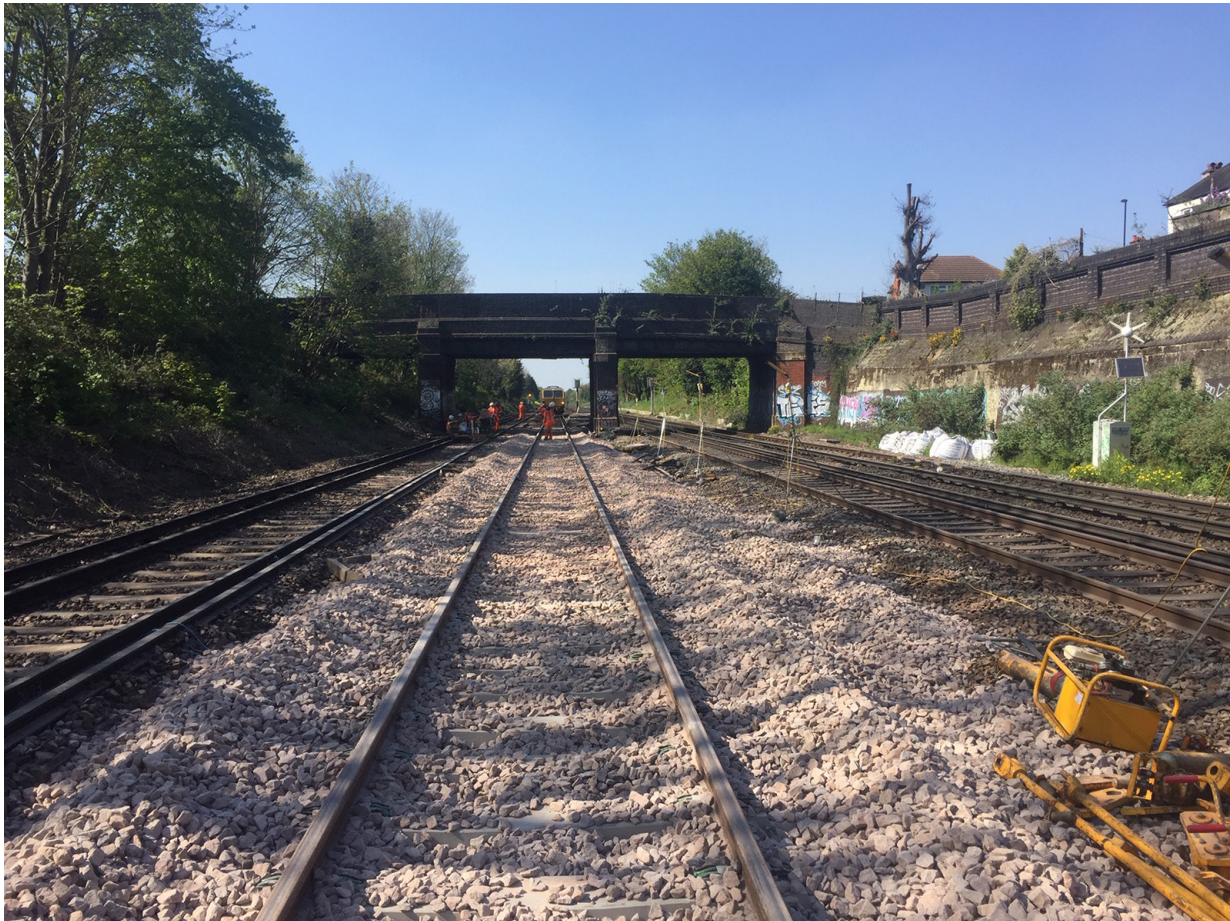
Figure 6: Train 6J91 within worksite B on the down Brighton fast line at Thornton Heath

- 35 The possession continued through Saturday morning, with train 9 entering the possession on the up Brighton fast line during the early hours. At 04:01 hrs, train 6J91, referred to as the tamper for the remainder of this report, entered the southern end of the possession on the down Brighton fast line, before entering worksite B. It was due to work in worksite B on the down Brighton fast line from south to north, colloquially referred to as 'Country to London' (C-L, see figure 5), the opposite direction to the normal use of this line (also sometimes referred to as running 'bang road'). The tamper was the only engineering train working on the down Brighton fast line.

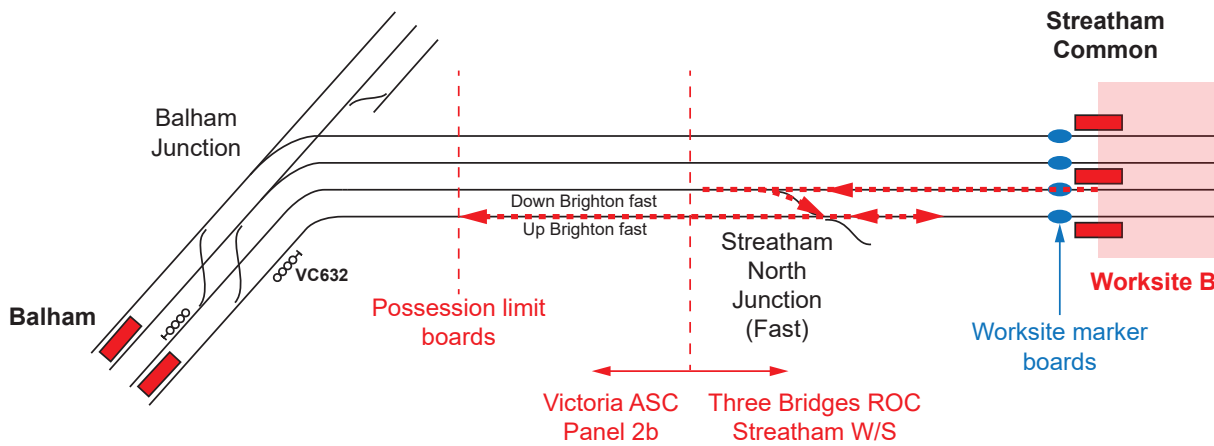
Figure 7: The planned route of train 6J91

- 41 As the boundary between the area of control of Victoria ASC and Three Bridges ROC (figure 7) was within the possession, the day PICOP would have needed to contact the signaller on the Streatham work station at Three Bridges ROC to arrange for the planned move of the tamper over points 334 from the down Brighton fast line to the up Brighton fast line. At 17:04 hrs the day PICOP called that signaller to enquire if the up Brighton fast line from signal TVC 660 at Streatham Common was clear to the northern limit of the possession and signal VC 632. The signaller confirmed that as far as he knew the route was clear, and requested the day PICOP to instruct the tamper driver to observe and check any points in the route.

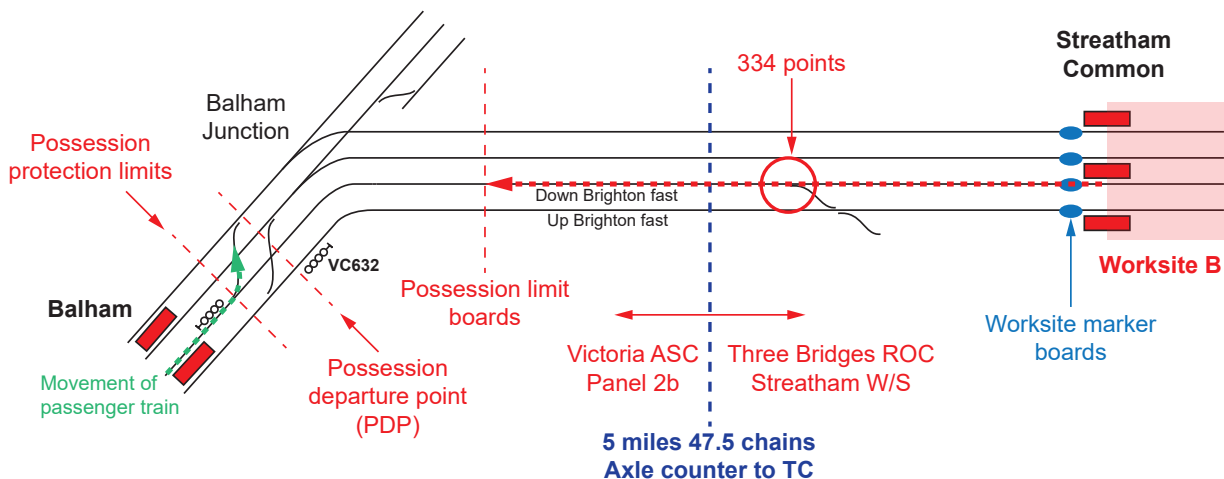
Figure 8: The actual route of train 6J91

- 43 At around 17:24 hrs, the ESA called the day PICOP, who returned the call at 17:33 hrs. The ESA passed his phone to the conductor driver, who had now taken charge of the movements of the tamper. The day PICOP instructed the conductor driver to proceed to the detonator protection once the worksite marker board was lifted. The ESA moved the worksite marker board and the tamper left worksite B at 17:34 hrs travelling in the up direction on the down Brighton fast line, arriving at the PLBs south of Balham Junction at 17.40 hrs (figure 8). When it arrived there, there was no COSS or possession support assistant present. The tamper was not scheduled to leave the possession until 19:00 hrs.

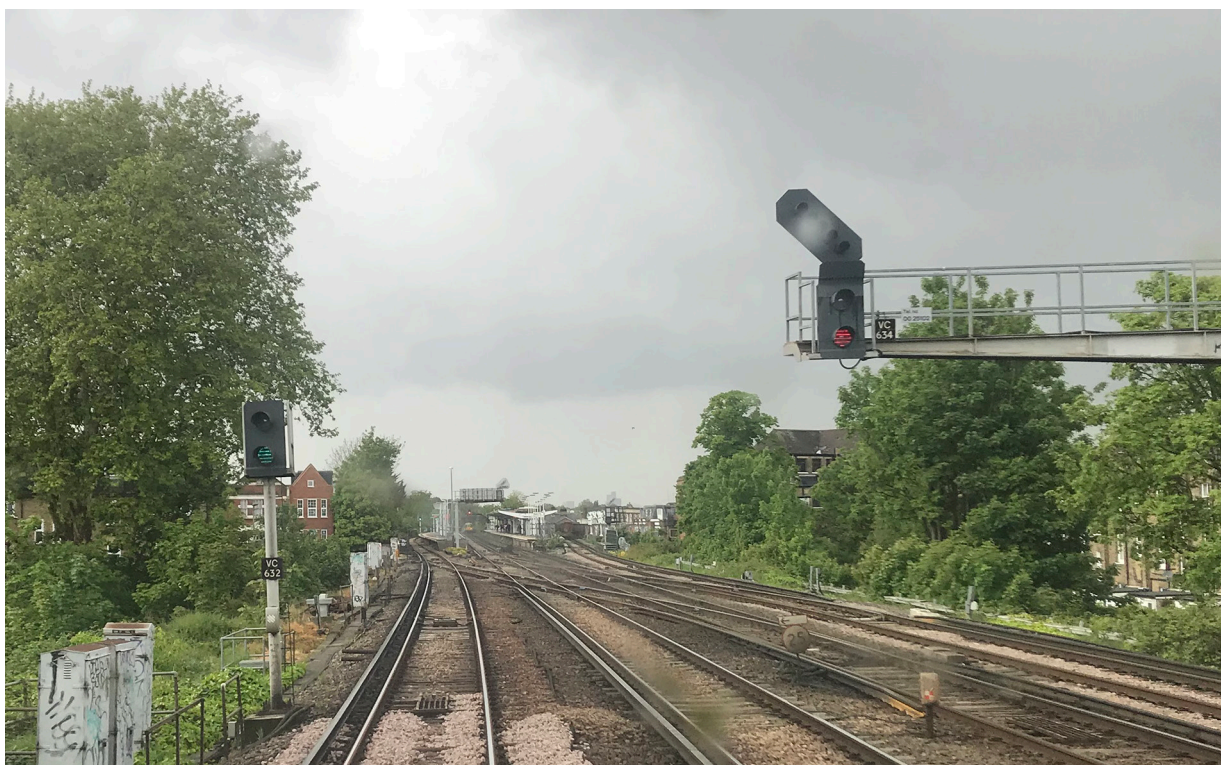
Figure 14: View looking north towards Balham station, with signal VC 632 on the up Brighton fast line (left) and VC 634 on the up Brighton slow line (right)

74 When the tamper arrived at the PLBs, there was an opportunity for its correct location to have been identified. The conductor driver's phone calls did not meet Network Rail's requirements for safety critical communications, as was evident from the recordings of his conversations with signallers 1 and 2, and when he received the instructions for the tamper to leave the possession (paragraphs 134 to 135). Although he evidently referred to the train running document during his conversation with signaller 2 (figure 11), he did not identify that the tamper had not been crossed over to the up Brighton fast line as planned. The conductor driver and tamper driver did not challenge the signallers, and followed the instructions they were given. However, the conductor driver could not explain why he did not notice signal VC 632 on the adjacent line or instruct the tamper driver to stop adjacent to it (figure 14). RAIB considers that this may have been because signal VC632 did not apply to the line that the tamper was on, and so the conductor driver did not consider that it was likely to be relevant to him.
