Rail Accident Investigation Branch

# Rail Accident Report

**Signal passed at danger at Loughborough  
South Junction, Leicestershire  
26 March 2020**

Report 10/2020  
November 2020

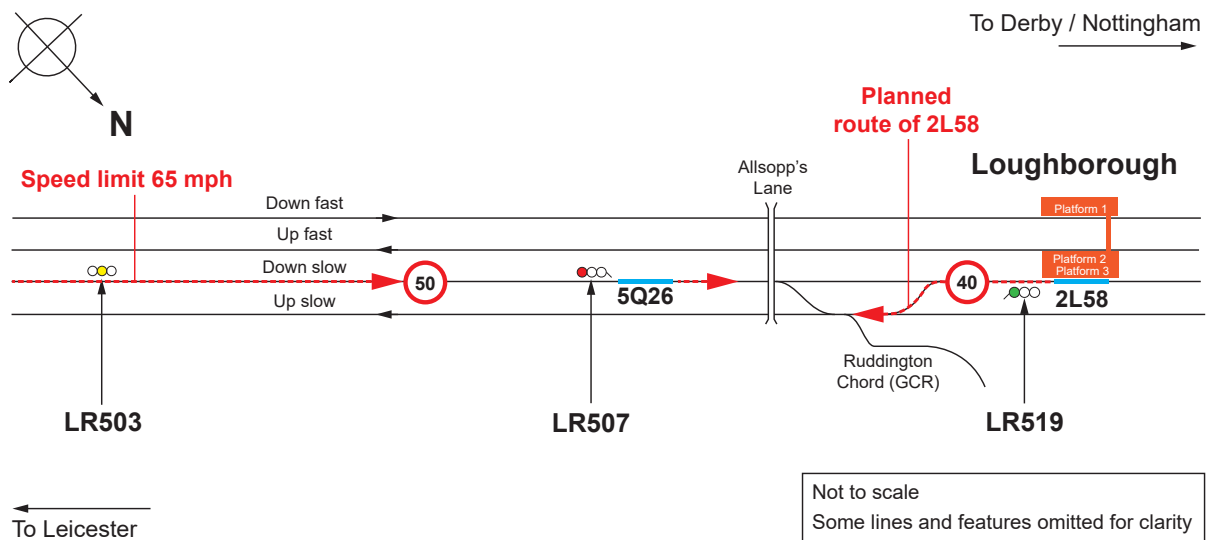
- 6 The railway at this location comprises four tracks: the up and down fast lines, and the up and down slow lines (figure 2). On the down slow line approaching Loughborough station, the maximum permitted speed is initially 65 mph (105 km/h), reducing to 50 mph (80 km/h) around 300 metres on the approach to signal LR507, then reduces again to 40 mph (64 km/h) just before Loughborough station. There is a gently falling gradient (1 in 508) until Loughborough station, where the track levels out.
- 7 Automatic warning system (AWS; see paragraph 36) equipment is fitted 186 metres on the approach to the sign indicating the start of the 50 mph speed restriction; this is to draw drivers' attention to a warning sign, co-located with the 50 mph board, for the 40 mph limit ahead.

Figure 2: Track layout on the approach to Loughborough, showing significant features referenced in the text

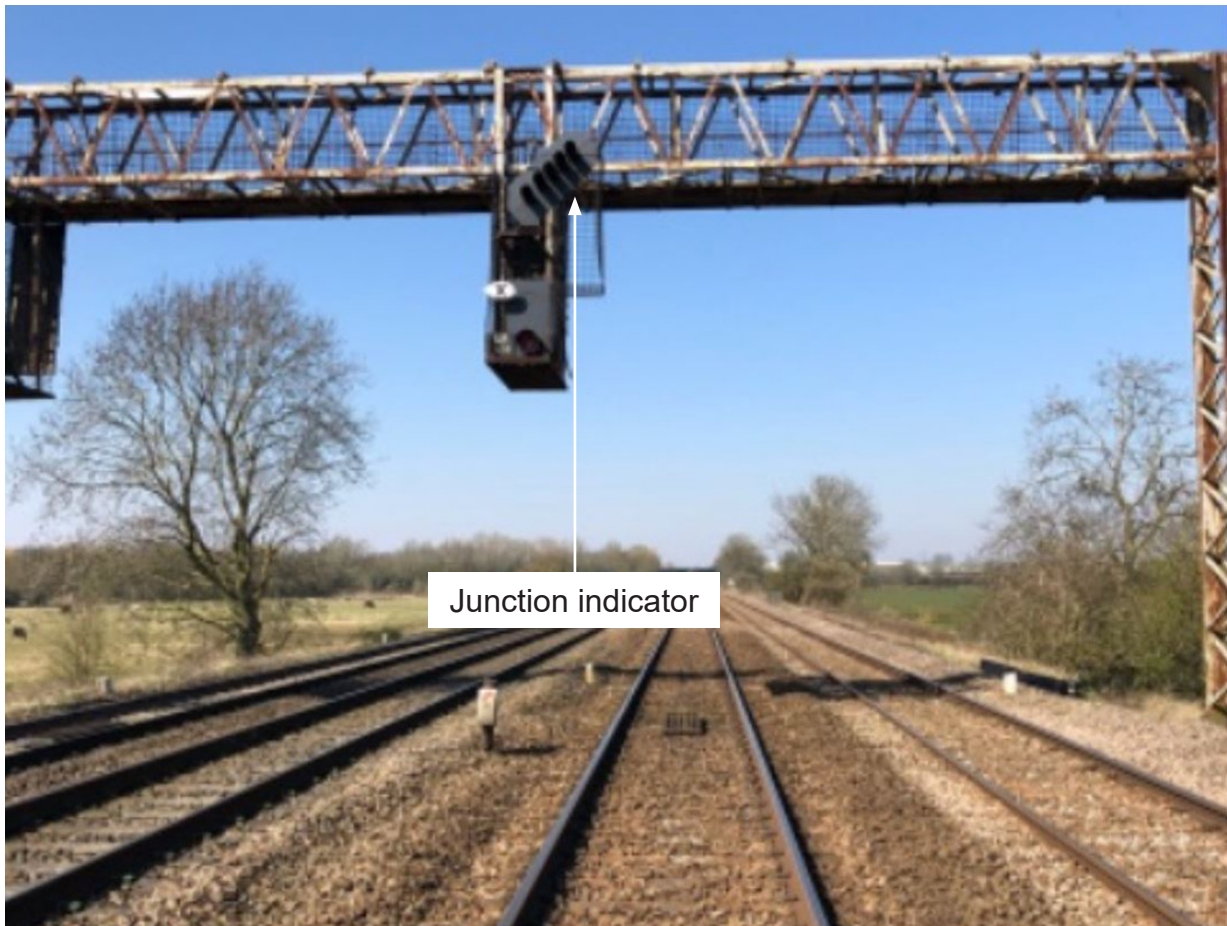
- 16 Signal LR507 is a three-aspect LED type signal with a position four junction indicator, mounted on a gantry above the down slow line (figure 3). The same gantry also carries signal LR505 for the down fast line.

- 19 There has been no previous recorded incidence of signal LR507 being passed at danger. A post-incident assessment found no issues with signal sighting that may have contributed to the incident; the assessment determined that the available reading distance for LR507 (that is, how far away the signal could actually be seen from) was 800 metres, while the minimum reading distance (that required in signal sighting standards for safe operation of the railway) was 183 metres.

Figure 3: Signal LR507 with position 4 junction indicator (picture courtesy of Network Rail)

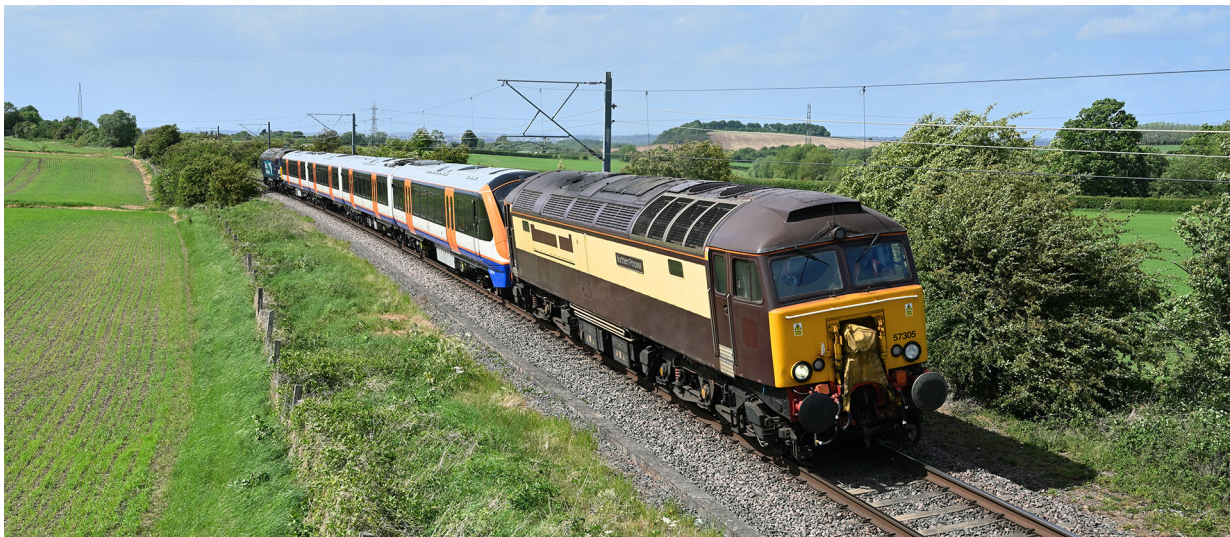
| Recommendation | 26 |

*Figure 6: The train during RAIB's reconstruction at RIDC Melton on 22 May 2020 (image courtesy of Jason Cross)*

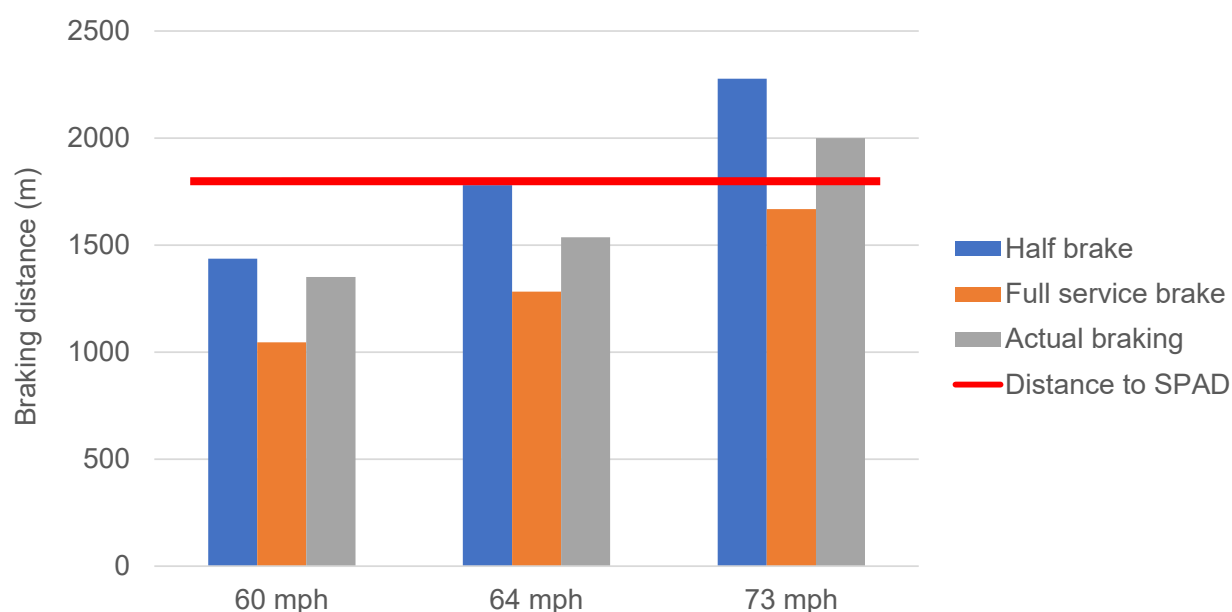
| Appendix B - Investigation details | 29 |

This page is intentionally left blank

Figure 7: Graph of the brake test results, showing the distance to stop from different speeds and levels of braking, as well as the distance to the red signal from driver's declared initial braking point
