Rail Accident Investigation Branch

# Rail Accident Report

## **Derailment of a freight train near Wanstead Park, London 23 January 2020**

Report 12/2020  
November 2020

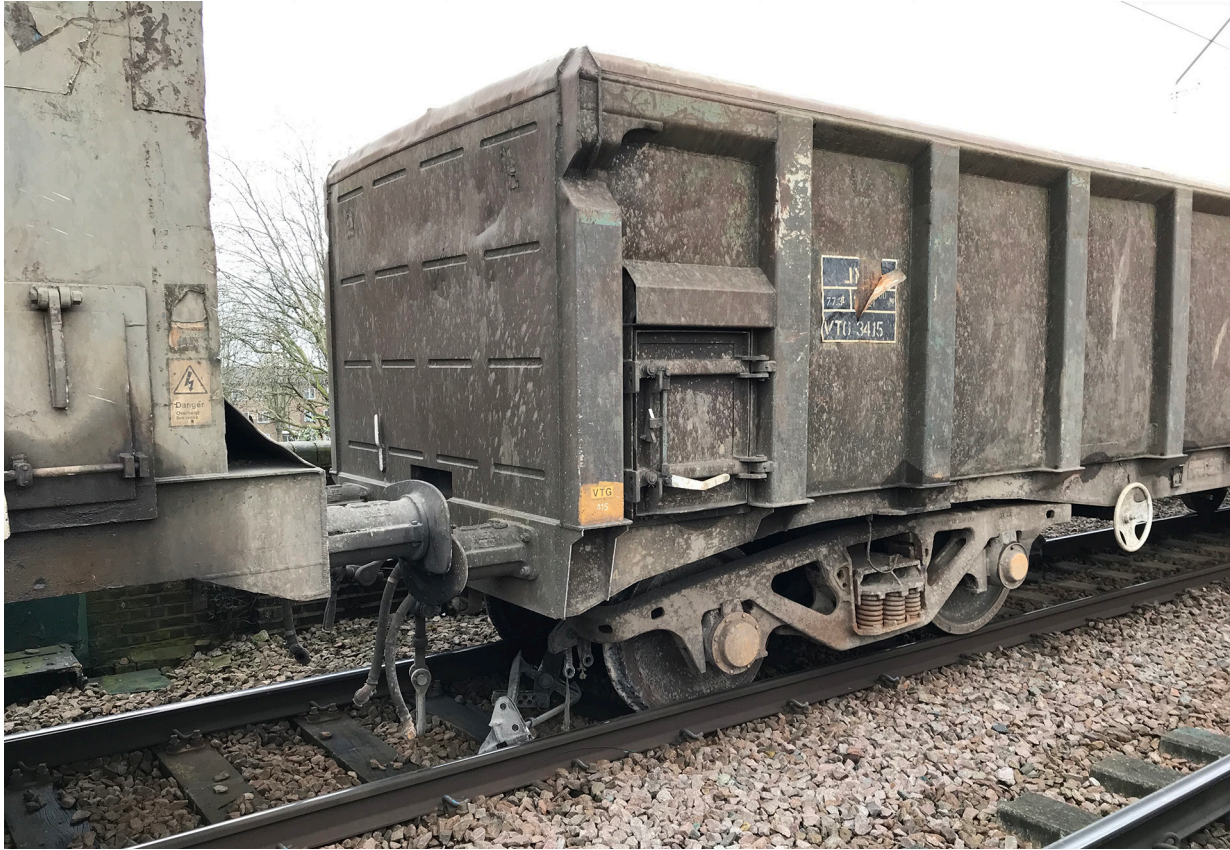
- 18 Wagon 3415, the first wagon to derail, was a JNA bogie box wagon, weighing 27.4 tonnes tare. Its load carrying capacity was limited to 74.2 tonnes so that its gross loaded weight did not exceed 101.6 tonnes, the maximum permitted on Network Rail infrastructure. The wagon was fitted with Davis & Lloyd - ESC1 3-piece bogies, and wheels with a P6 wheel profile (figure 4).

Figure 4: Wagon number 3415 with its rear wheelset derailed to the left. Part of wagon number 3114 is also visible

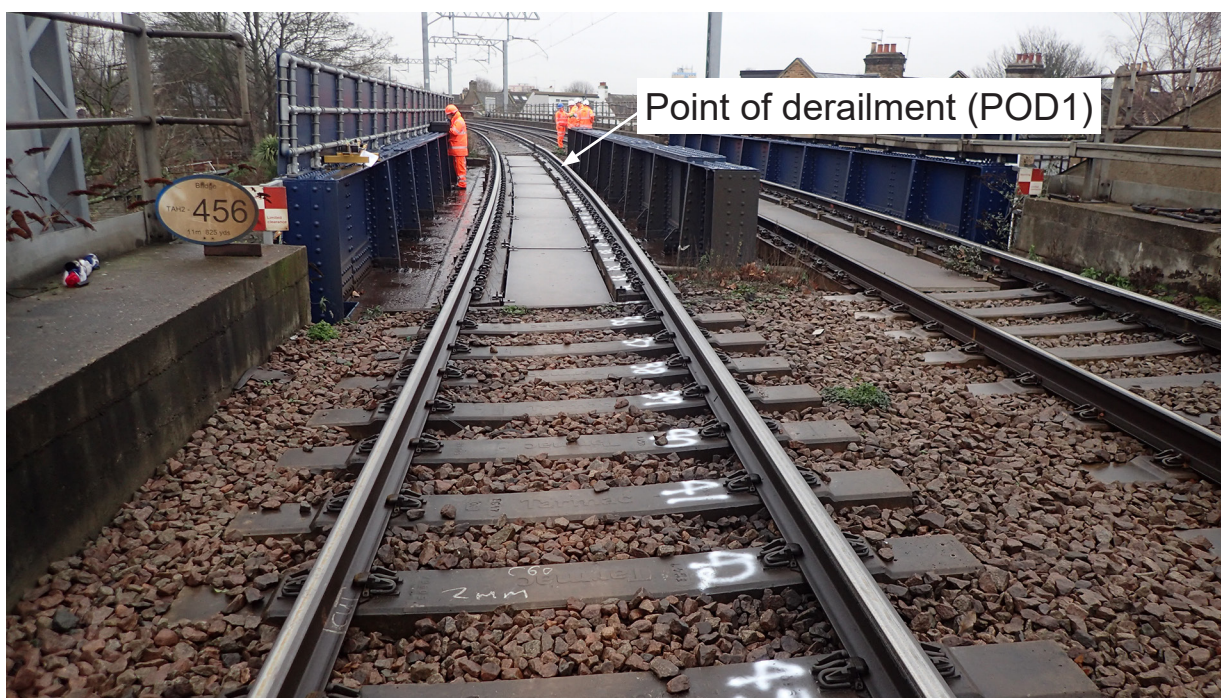
Figure 5: Bridge 456 following the accident but before removal of the deck walkway

- 68 It is probable that the rot was partly a consequence of rust flakes collecting on the deck and trapping moisture around the base of the timbers. Evidence that this was occurring is provided by photographs taken during an inspection in June 2018 (figure 22). Some of this debris was removed during bridge strengthening and refurbishment works completed later that year. It is also probable that evaporation of water from the bridge deck and some faces of the longitudinal timbers was restricted by the solid walkway installed between the rails on the up line in 2008, which restricted ventilation (figure 5).

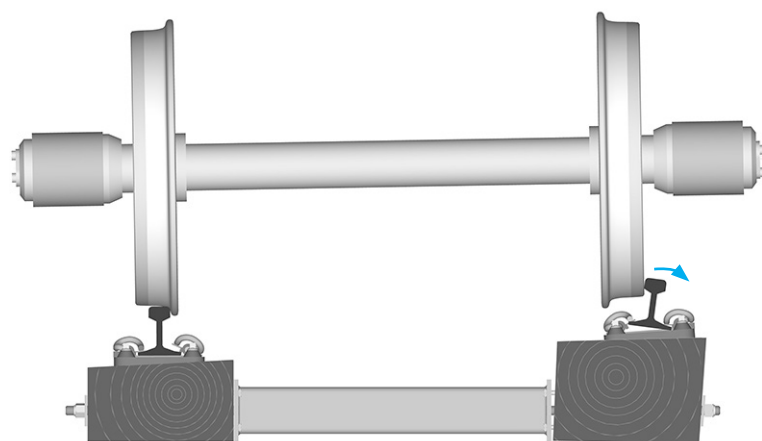
- 38 The right-hand wheel of the rearmost wheelset on wagon 3415 derailed as it passed over bridge 456 (figure 7). Less than a second later, the left-hand wheel on the leading wheelset of following wagon 3114 also derailed causing both rails to rotate outwards (figure 8). The driver was unaware of these events and maintained full power. The train gradually accelerated to 35 mph (56 km/h).
- 39 Wagon 3114, the second derailed wagon, re-railed itself after travelling approximately 230 metres and crossing two other longitudinal timber bridges. Rerailing occurred before Wanstead Park station, as the left-hand curve started to transition into a right-hand curve.

Gauge widening occurred due a combination of the rotation and compression of the right-hand timbers, baseplate movement (shuffle) and rail rotation

Figure 7: Arrangement of wagon 3415's derailed wheelset immediately after initial point of derailment

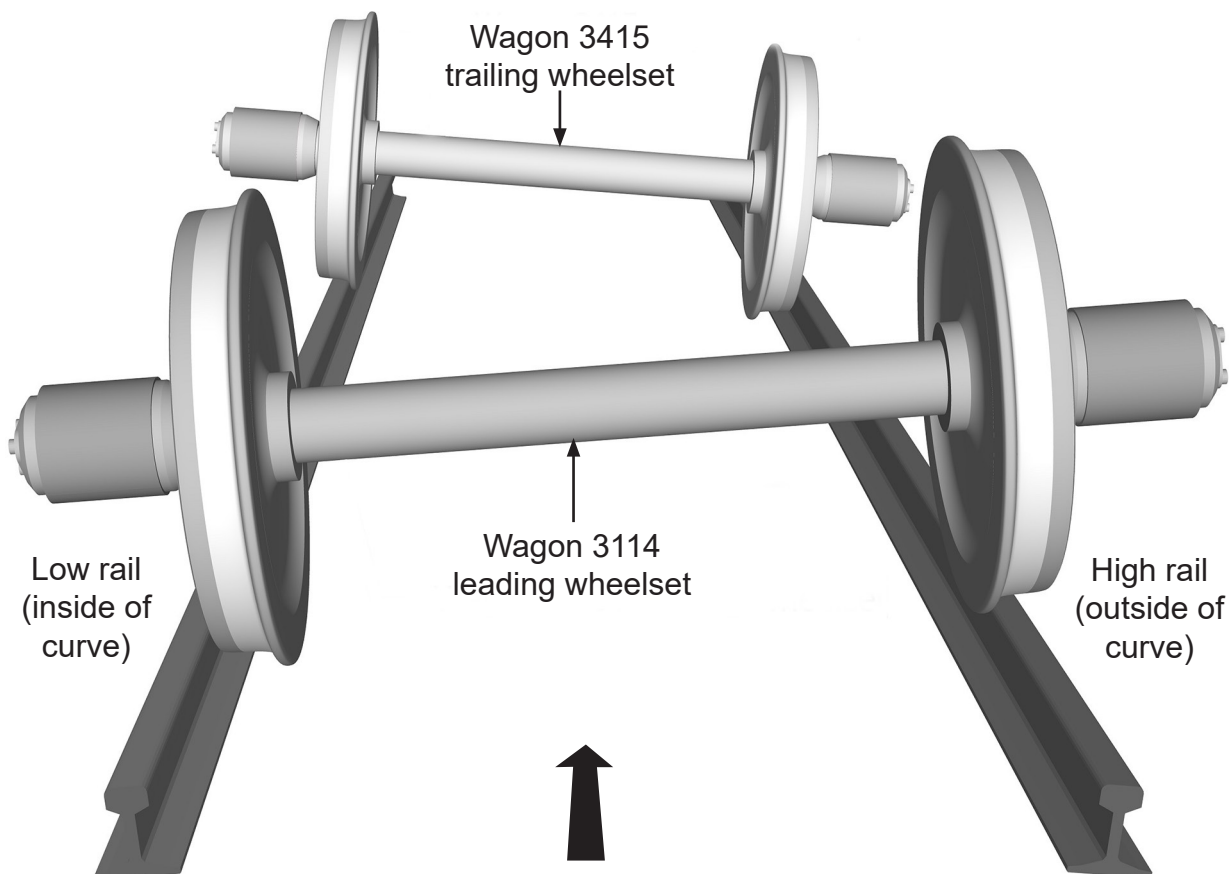
Figure 8: Arrangement of two derailed wheelsets after second derailment with both rails rotated outwards

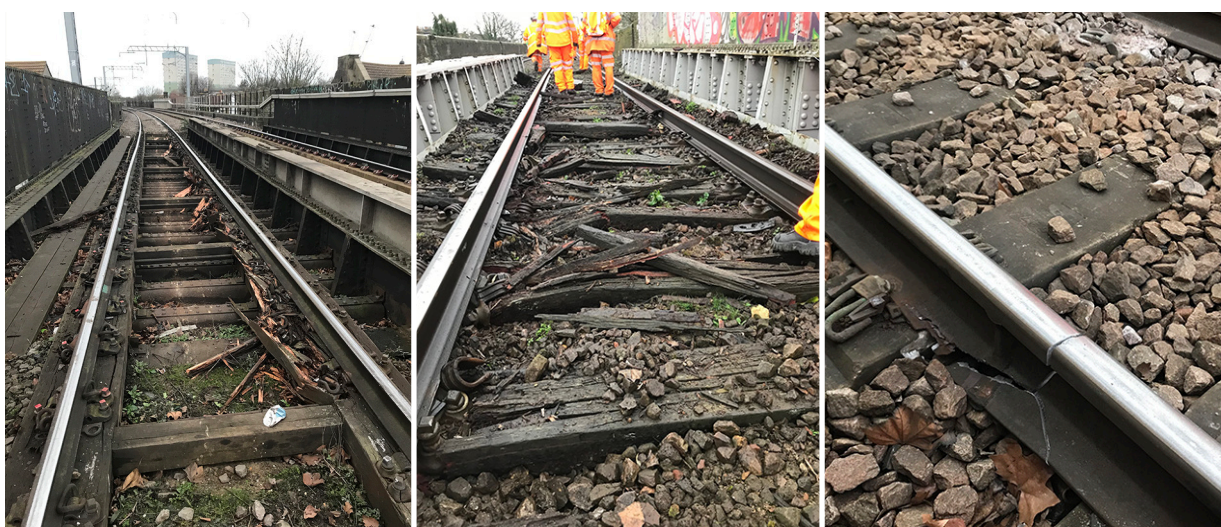
40 Wagon 3415 continued with its rear right-hand wheel derailed and running inside the right-hand rail for approximately 450 metres. As the train traversed a right-hand curve through Wanstead Park station, marks on the railhead indicate that the associated left-hand wheel climbed over the railhead and derailed to the left. The wagon then continued with both wheels of the rear wheelset of the trailing bogie derailed to the left. In this condition it crossed a further seven longitudinal timber bridges and damaged the track (figures 9, 10 and 11).

Figures 9, 10 and 11: Examples of track damage between point of derailment and location where train stopped

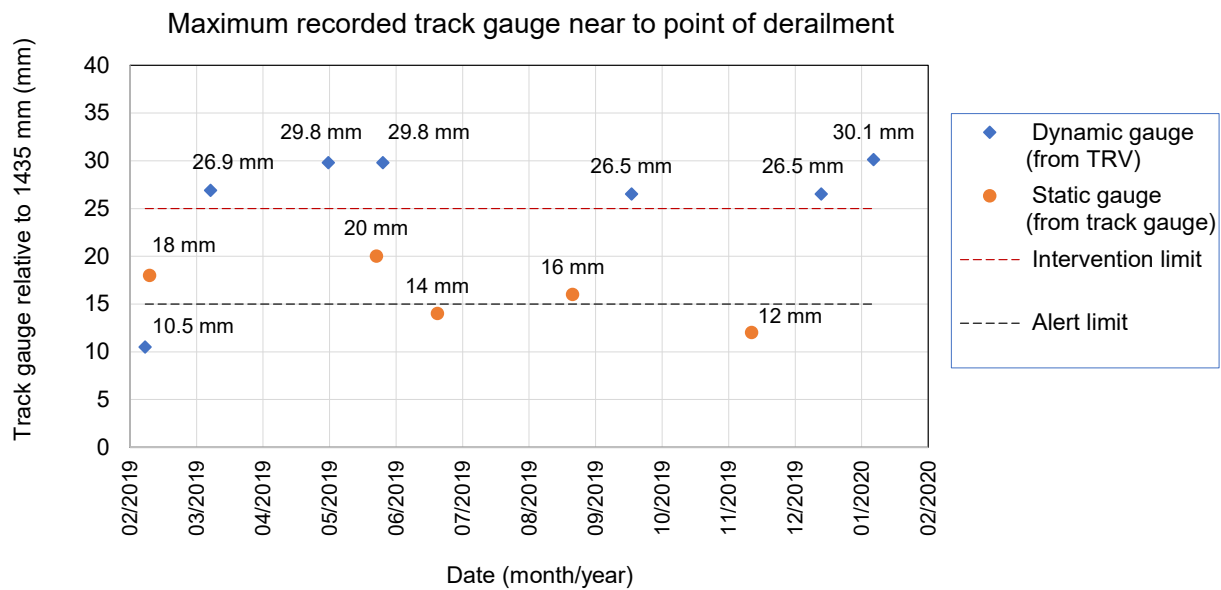
- 59 Evidence of inadequate rail restraint over a period of time is provided by Network Rail’s track gauge measurements. The gauge across bridge 456 had exceeded the alert limit since at least June 2018 when static gauge of up to 1455 mm was recorded during a detailed inspection (paragraph 96), equivalent to wide gauge of 20 mm. Track recording vehicles had recorded dynamic gauge exceeding the intervention limit at about the same location since March 2019 (figure 13). The difference between static and dynamic gauge demonstrates that the track was flexible enough for the gauge to widen significantly under train loading. Issues associated with the management of track gauge are discussed at paragraph 95 onwards.

Figure 13: Maximum static and dynamic gauge recorded near point of derailment on each site inspection and track recording vehicle run.

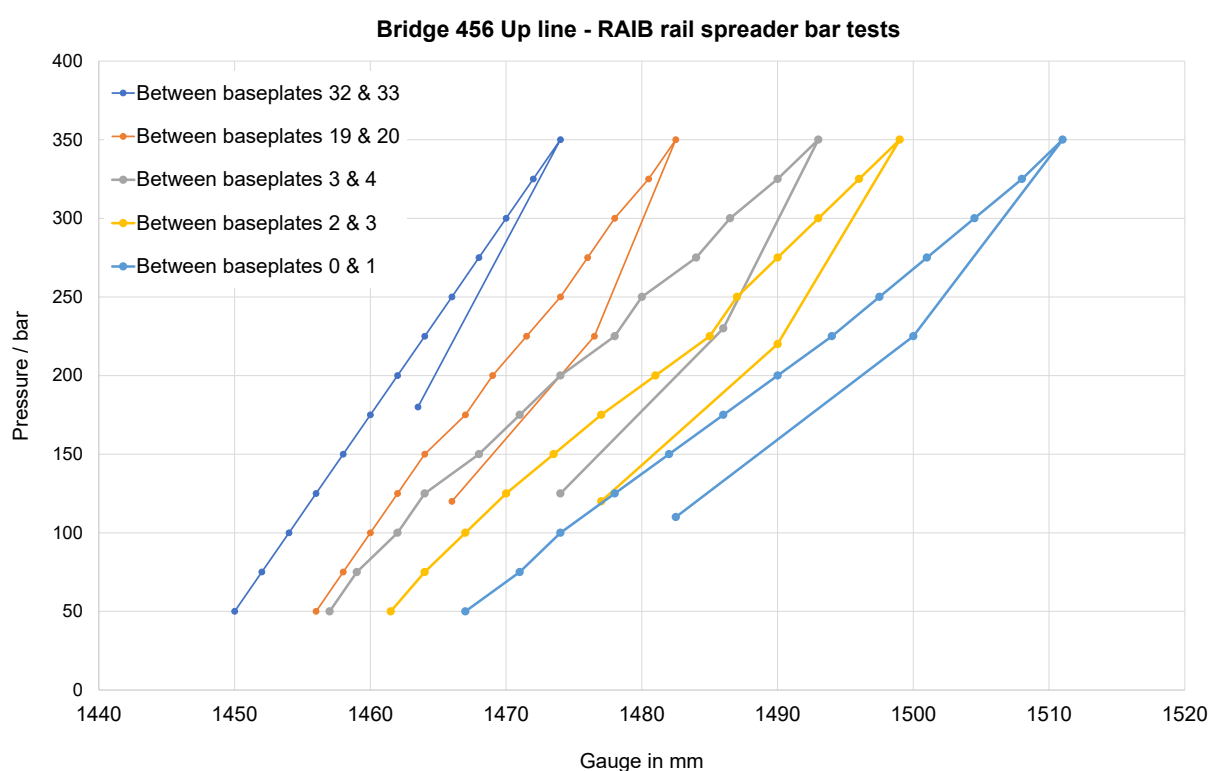
60 RAIB took post-accident measurements on the bridge to determine if the stiffness of the track varied on approach to the point of derailment. A hydraulic ram was installed between the rails, and the pressure was increased in increments, creating spreading forces up to 50 kN (equivalent to 5 tonnes). This test was repeated at five locations across the bridge. The results show that the rails were less able to resist movement under the lateral forces imposed by moving trains as the point of derailment was approached (figure 14). These results are broadly consistent with Network Rail's track gauge measurements. However, it should be noted that accident damage meant that measured stiffness in the area of significant damage will be less than before the accident and, due to distribution of load along the rails, measured stiffness will also be lower than pre-accident values on the approach to this area.

Figure 14: Change in track stiffness between baseplates. These were numbered from 34 at the start of the bridge to 0 at the point of derailment (POD1).

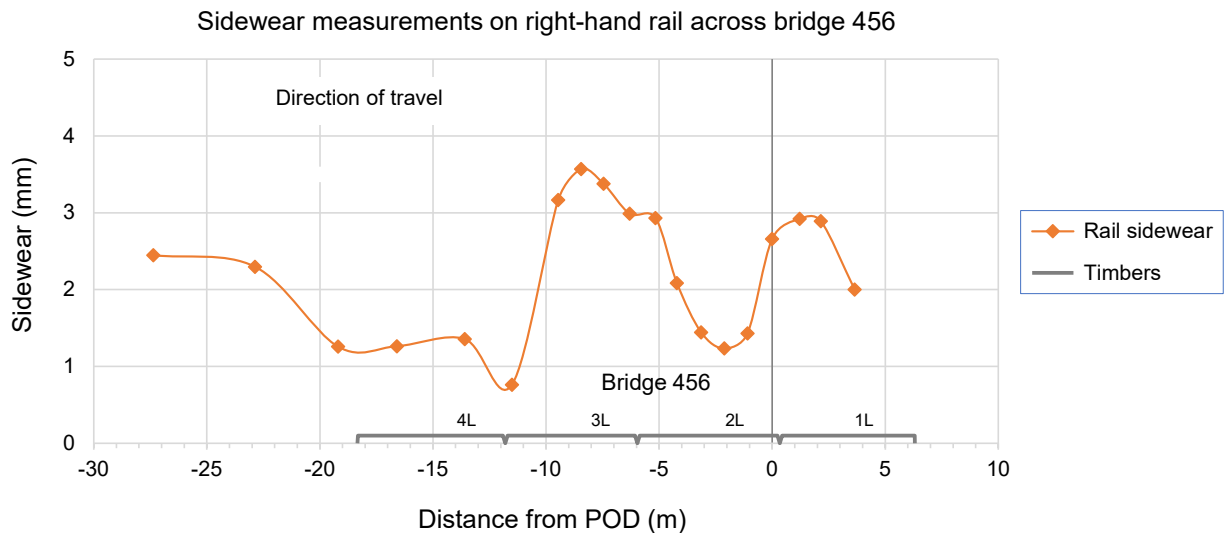
61 Further evidence of pre-accident track movement is provided by the right-hand rail's railhead profile, which varied in shape across the bridge (figure 15). A new rail is rolled to a constant profile, but the wear from passing train wheels, particularly on the outside rail on curved track, will gradually change this shape. The rail showed a relatively consistent amount of wear on the side of the railhead (sidewear), but a pronounced change occurred a few metres before the point of derailment. In this area, there was less sidewear, suggesting that lateral loads from train wheels caused the rail to move away from the wheel flanges. The consequential reduction in lateral force exerted on the outer rail by the wheel flange would have reduced the amount of rail wear.

Figure 15: Change in rail wear

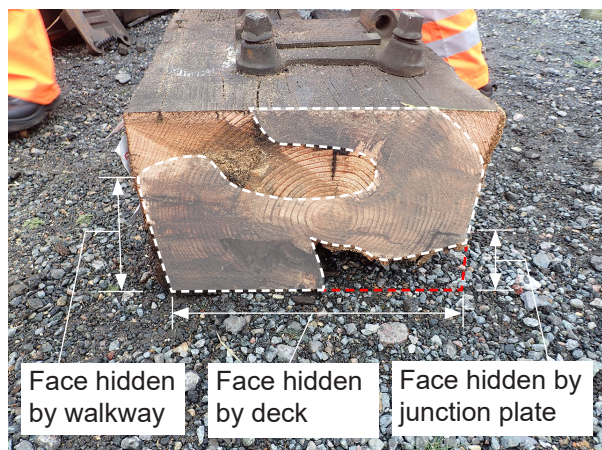
63 The section of timber 2L supporting the track at the point of derailment (figure 18 and figure 19) was cut into sections and examined. It was found to be saturated with water and extremely soft. A long probe was pushed into the wood at several locations without meeting resistance and part of the timber disintegrated while being moved during the examination. There was evidence of baseplate screw holes having been plugged and re-drilled, indicating that a previous attempt had been made to restore the track gauge at this location. This method of re-gauging can only be regarded as a temporary measure in softwood as there is often insufficient sound material to withstand the forces imposed.

Figure 18: Section through timber 2L at the point of derailment. The area of decayed timber is indicated by the white dashed line.

- the extent of decay recorded in timber 2L for approximately 2 metres approaching the point of derailment was up to 70% loss of the cross section
  - the amount of decay in timbers 1L and 2L would have resulted in these timbers being at risk of deforming either permanently, or when loaded.

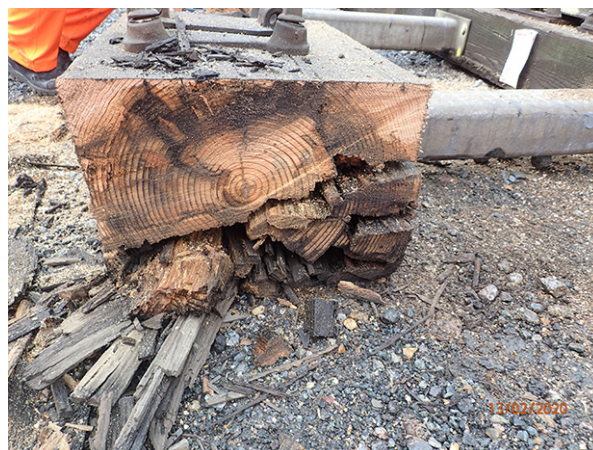
Figure 19: Section through timber 2L immediately before the point of derailment

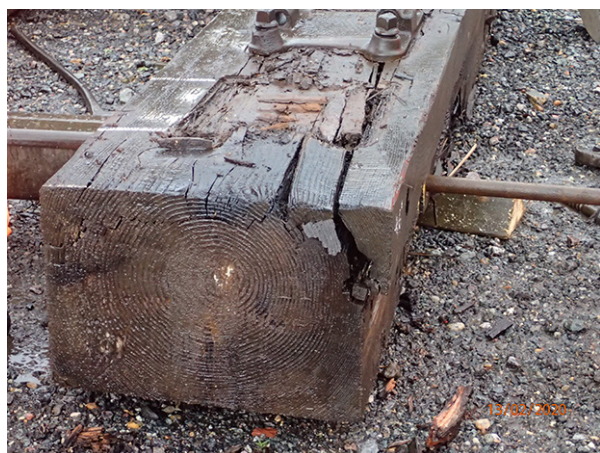
64 The section of Timber 1L (figure 20) immediately after the point of derailment had evidence of a longstanding corner fracture (split) and moisture ingress. This was in the area where the leading right-hand wheel of wagon 3415's trailing bogie was probably pushing against the rail (see paragraph 111) at the moment the trailing right-hand wheel derailed. The longitudinal fracture ran through the outermost baseplate screws. It is likely that this fracture was caused by lateral loads imposed by the screws and stresses associated with natural timber shrinkage around the screws.

Figure 20: Timber 1L before cutting, but following removal of the first baseplate beyond the point of derailment

73 The track's ability to resist gauge widening on bridge 456 is likely to have worsened when the vertical split in timber 1L joined up with a horizontal split, displacing a section of timber (figure 20). Some of the gauge widening forces which could not be resisted by timber 1L will have been transferred by the rail into the adjacent section of timber 2L which was already weakened by decay.

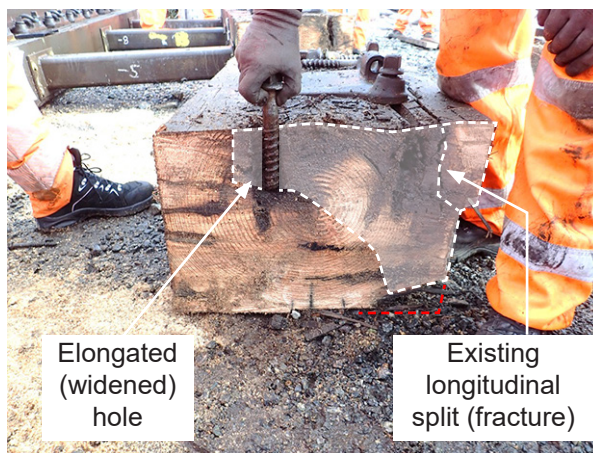
Figure 21: Timber 1L after cutting at the position of the first baseplate beyond the point of derailment. The area of decayed timber is indicated by the white dashed line.

65 The split in timber 1L had been identified and recorded during a detailed inspection in June 2019 (refer to paragraph 105). The post-accident examination found evidence of fungi growing within the wood indicating the presence of air. The presence of a split along the line of the large screws securing the rail baseplates meant that the outer row of screws became ineffective in securing the rail. The additional horizontal force applied to the inner row of baseplate screws had caused their holes to become oval shaped, as the metal screw pressed into the partly-decayed wood due to lateral loading from trains (figure 21).

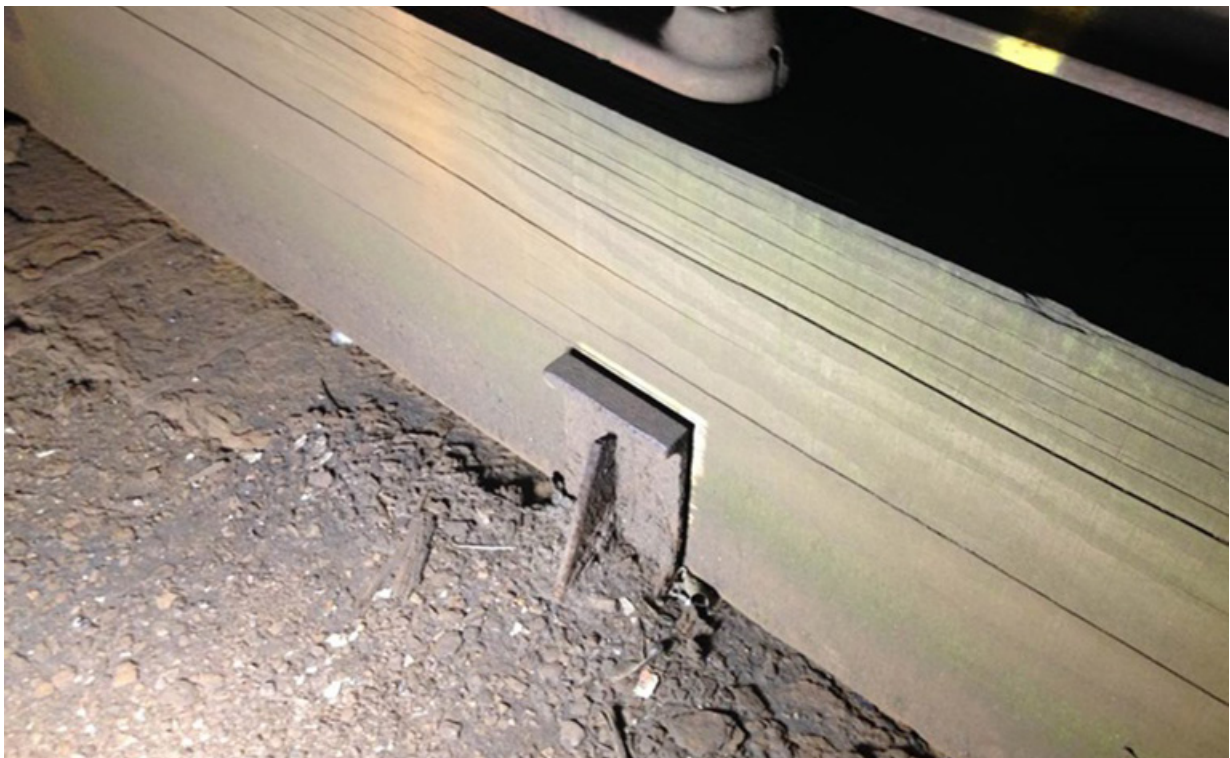
Figure 22: Photograph from detailed inspection report dated 7 June 2018 showing a restraining cleat and rust flakes on the bridge deck prior to deck refurbishment (courtesy of Network Rail)

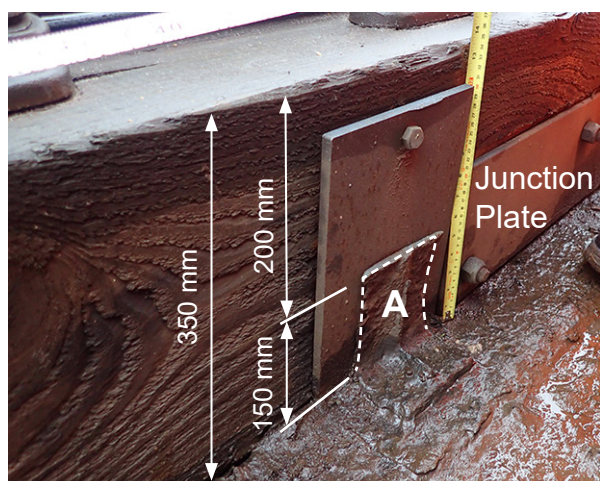
- 70 The height of the cleats retaining the right-hand rail timbers was less than 50% of the timbers' depth (figure 23). The combined effect of the cleat height and tie rod position was to leave the upper section of the timbers 4L-1L with no lateral restraint except that provided by transferring load downwards through the decayed timber. The tie rods connecting the timbers together to maintain track gauge were set horizontally. They passed through the left-hand timbers at mid-height, but consequently were below mid-height for the deeper right-hand timbers (figure 24).

Figure 23: The position of a cleat (marked 'A') restraining timber 2L with a metal packing behind, and a junction plate connecting timber 2L to timber 1L

- 72 Junction plates connecting the timbers also extended for only part of the timbers' depth (figure 23). This meant that the outside plate connecting 2L and 1L provided no support to the upper part of the timber and this is a possible reason for the longitudinal split developing in this area. The combination of decayed timber and limited direct support from the tie rods and cleats, possibly exacerbated by the junction plate arrangement, meant that lateral loading from train wheels would result in relatively large movements of the right-hand rail.

- 71 A revision to standard NR/L2/TRK/3038 (issue 6) published in 2014, requires new or replacement cleats to be designed with a minimum height of not less than  $\frac{2}{3}$  the depth of the longitudinal bearer. Although this requirement was not retrospective, it gives an indication of the importance of the relative height of the cleats in restraining the timbers, particularly on curved track where the track is subject to lateral forces.

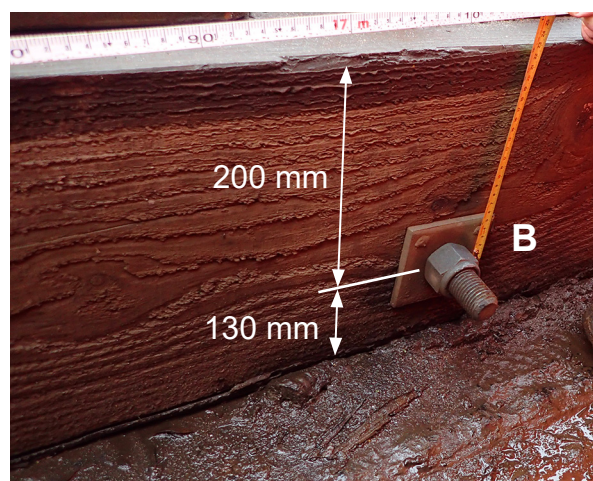
Figure 24: The position of a tie rod (marked 'B') restraining timber 2L

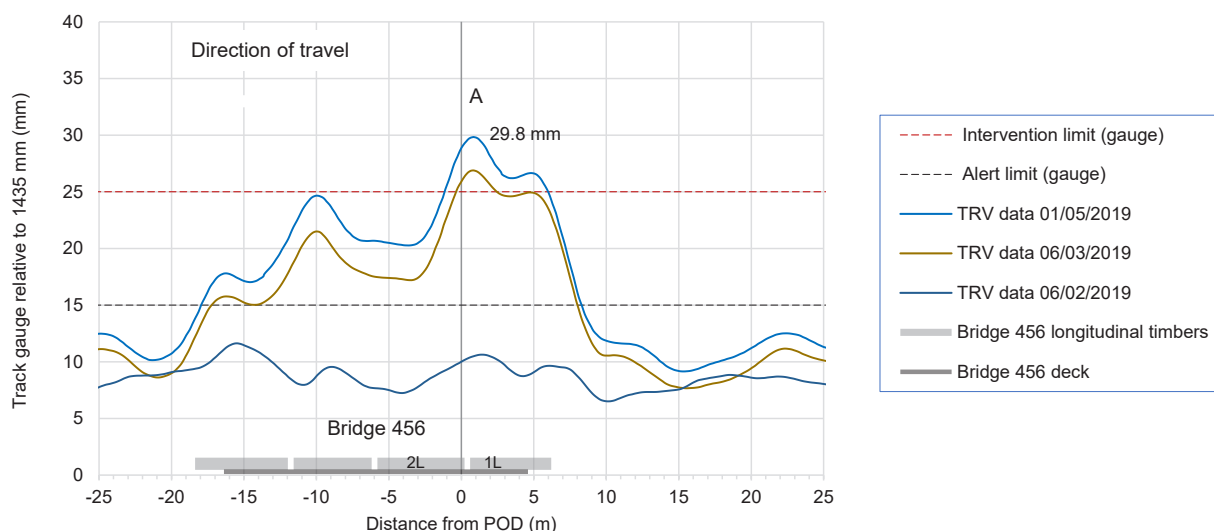
79 On 1 May 2019, the next track recording vehicle run recorded a wide gauge fault of 29.8 mm in the same location, exhibiting a similar 'shape' to the data recorded on 6 March (figure 25). This was the first recognised indication of a gauge fault exceeding the intervention limit at this location, and was shown on the trace and listed on the fault report.

Figure 25: Track gauge recorded by track recording vehicle runs on 6 February, 6 March and 1 May 2019. The wide gauge peaks at the same location (marked 'A') close to the joint between timbers 2L and 1L and just ahead of the initial point of derailment.

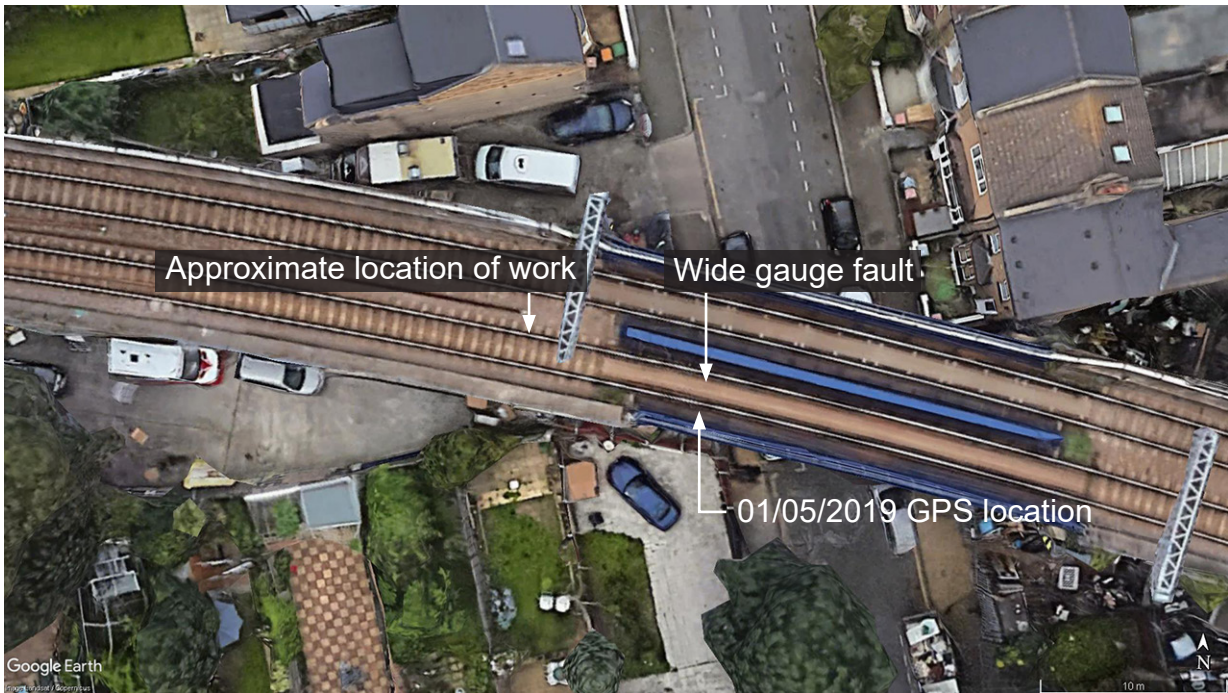
- 80 On 23 May 2019, track maintenance staff from Barking depot, led by the team leader [track maintenance], attended site during an overnight possession of the line. The team leader stated that they used an approved app on a Network Rail mobile phone to locate the fault. This app works by manually entering the GPS co-ordinates, and this causes the phone to vibrate when within five metres of the site, and the display to change colour when within three metres, giving staff a three to five metre radius around the reported site to locate and inspect the fault. The process is dependent on the mobile phone's accuracy when receiving the GPS signal. In this case, although the GPS co-ordinates put the fault on bridge 456 (figure 26), staff undertook work about eight metres west of the actual fault location and on a section of track with concrete sleepers.

Figure 26: Google Earth image showing location of track recording vehicle-generated GPS co-ordinates and the approximate location that re-gauging work was carried out.

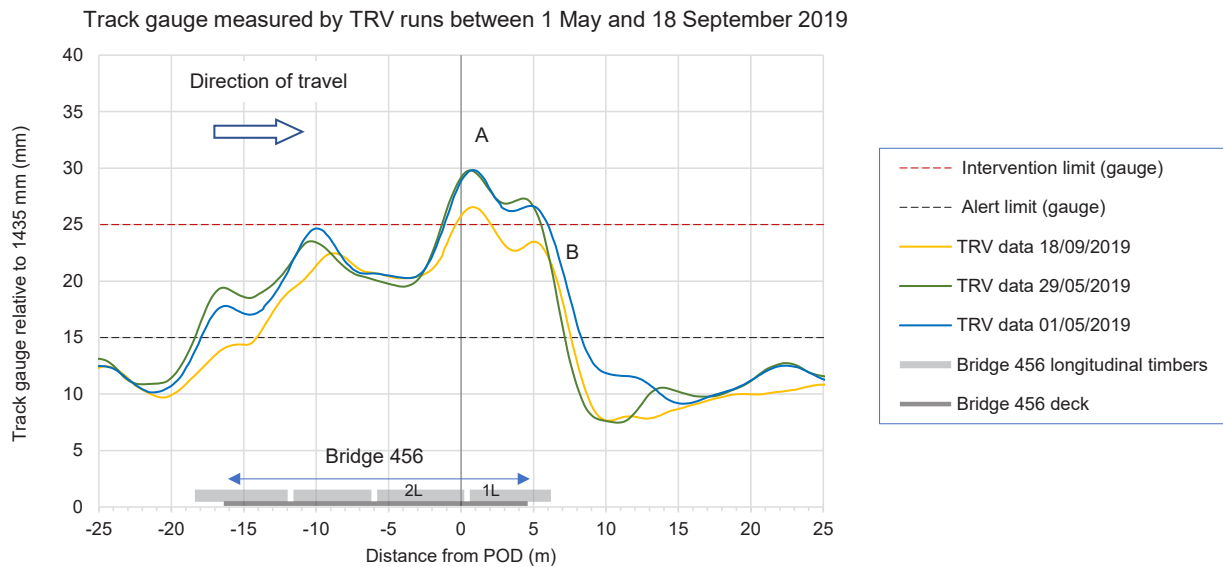
Figure 27: Track gauge data recorded by track recording vehicle runs on 1 May, 29 May and 18 September 2019. The graphs show that the gauge profile is a similar shape with a peak value (marked 'A'). Wide gauge exceeding the Alert limit is shown continuing off the bridge (marked 'B').

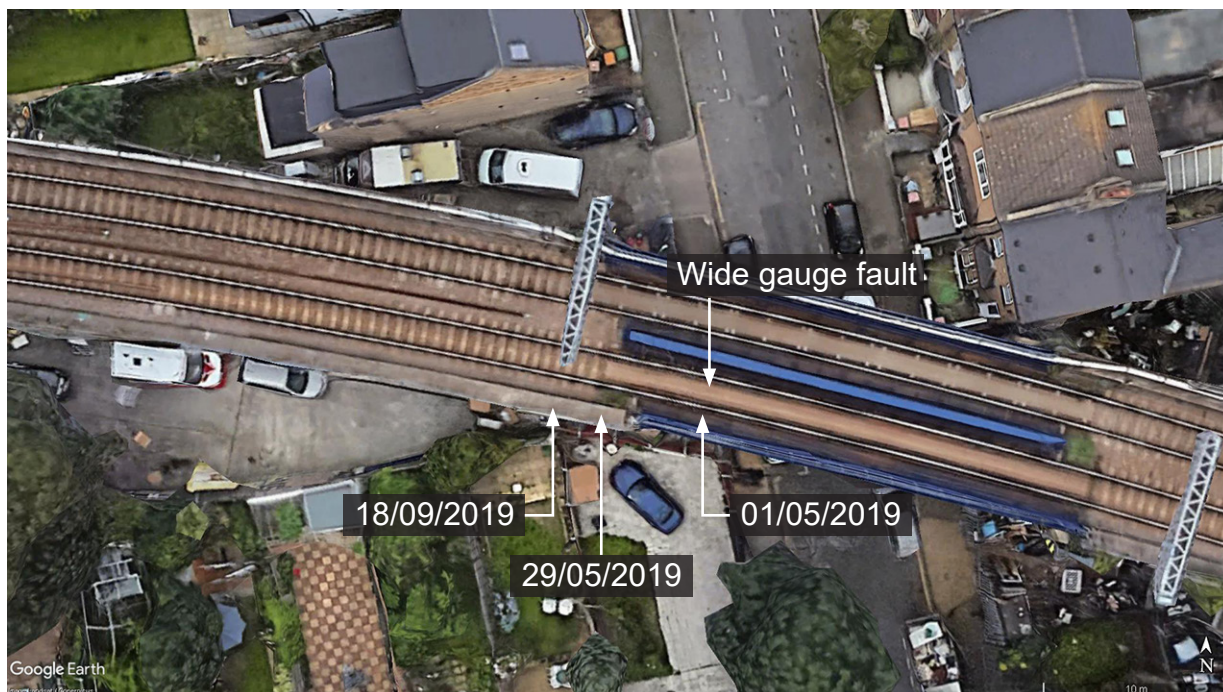
- 84 On 18 September, the next track recording vehicle run identified a wide gauge fault of 26.5 mm in a similar location to the faults recorded on 1 May and 29 May. However, this time, the GPS co-ordinates printed on the fault report put the fault further off the bridge. A team from Barking depot attended on 29 September led by an assistant team leader. They renewed more nylon insulation pads on the concrete-slepered track off the bridge.

Figure 28: Google Earth image showing location of track recording vehicle-generated GPS co-ordinates compared with location of the wide gauge fault

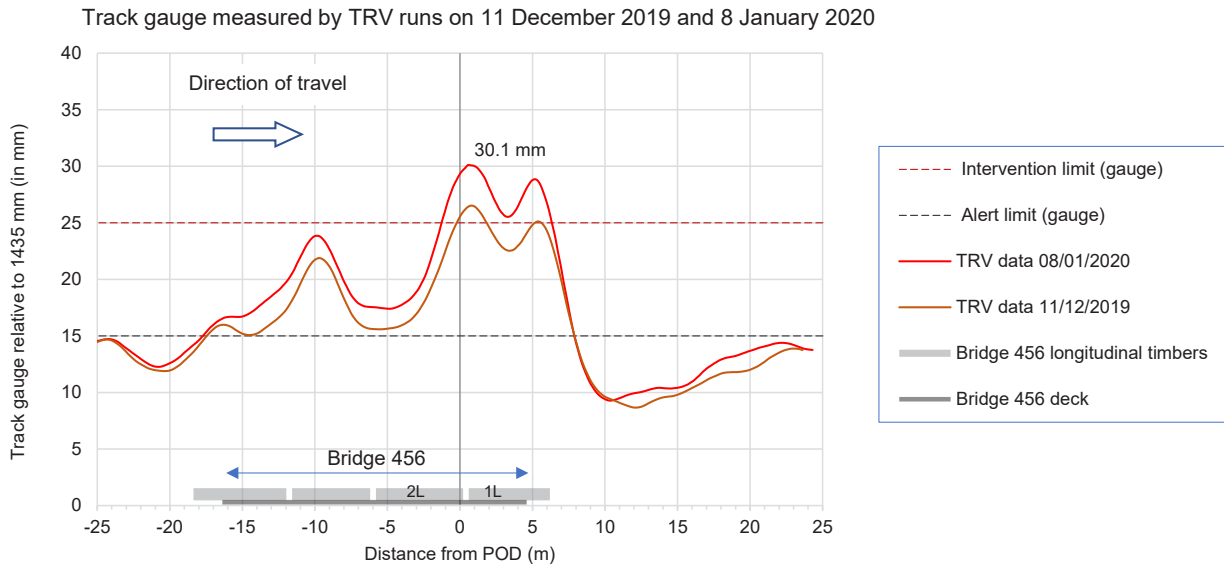
- 87 For the next two track recording vehicle runs on 11 December 2019 and 8 January 2020, wide gauge faults of 26.5 mm and 30.1 mm respectively were recorded on bridge 456. On both occasions, the fault exceeded the intervention limit (figure 29 and figure 30) but was missing from the associated fault report.
- 88 The same issue caused both omissions and is explained by an extract from the track recording vehicle trace for 8 Jan 2020 (figure 31). This shows wide gauge faults, automatically highlighted in red on the trace, corresponding with bridges 456 and 448 located within a section of continuous wide gauge. The wide gauge fault of 30.1 mm on bridge 456 is less severe than the wide gauge fault of 34.4 mm recorded on bridge 448.

Figure 29: Track gauge data recorded by track recording vehicle runs on 11 December 2019 and 8 January 2020. The peak wide gauge fault value recorded on 8 January 2020 is indicated.

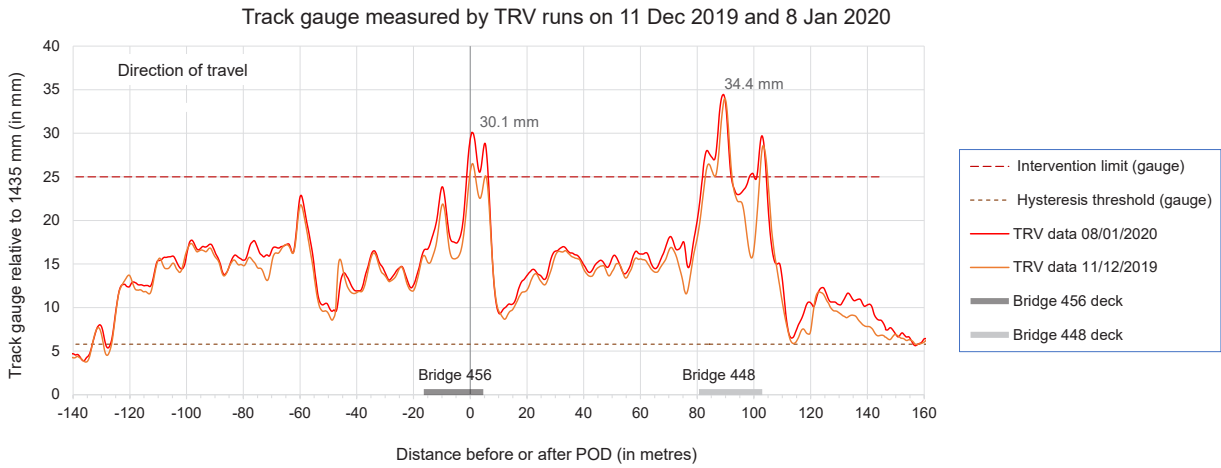
Figure 30: Track gauge data recorded by track recording vehicle runs on 11 December 2019 and 8 January 2020, but extending over a longer distance than figure 29. The peak wide gauge faults at bridges 456 and 448 on 8 January 2020 are indicated together with the hysteresis threshold.

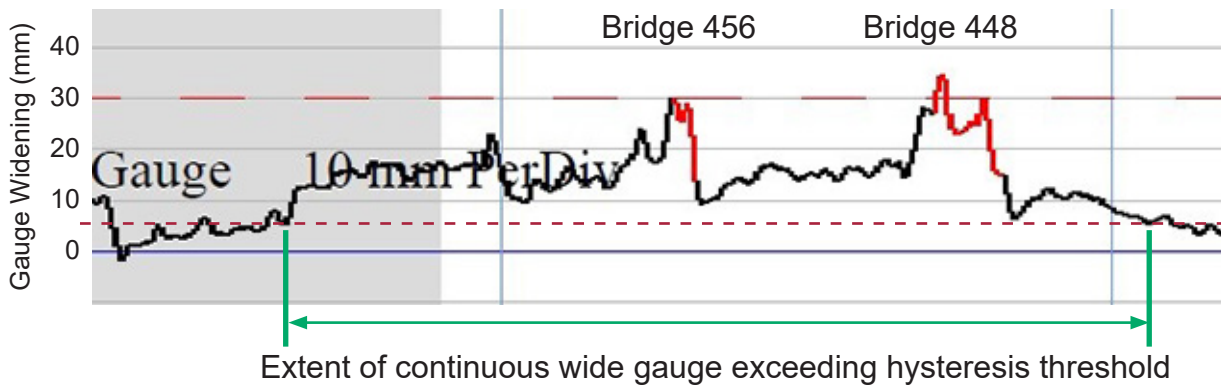
Figure 31: Extract from the track recording vehicle trace recorded on 8 January 2020 showing track gauge. Faults exceeding the intervention limit (25 mm) are automatically highlighted in red. The hysteresis threshold (5.8 mm) and the positions of bridges 456 and 448 have been added.

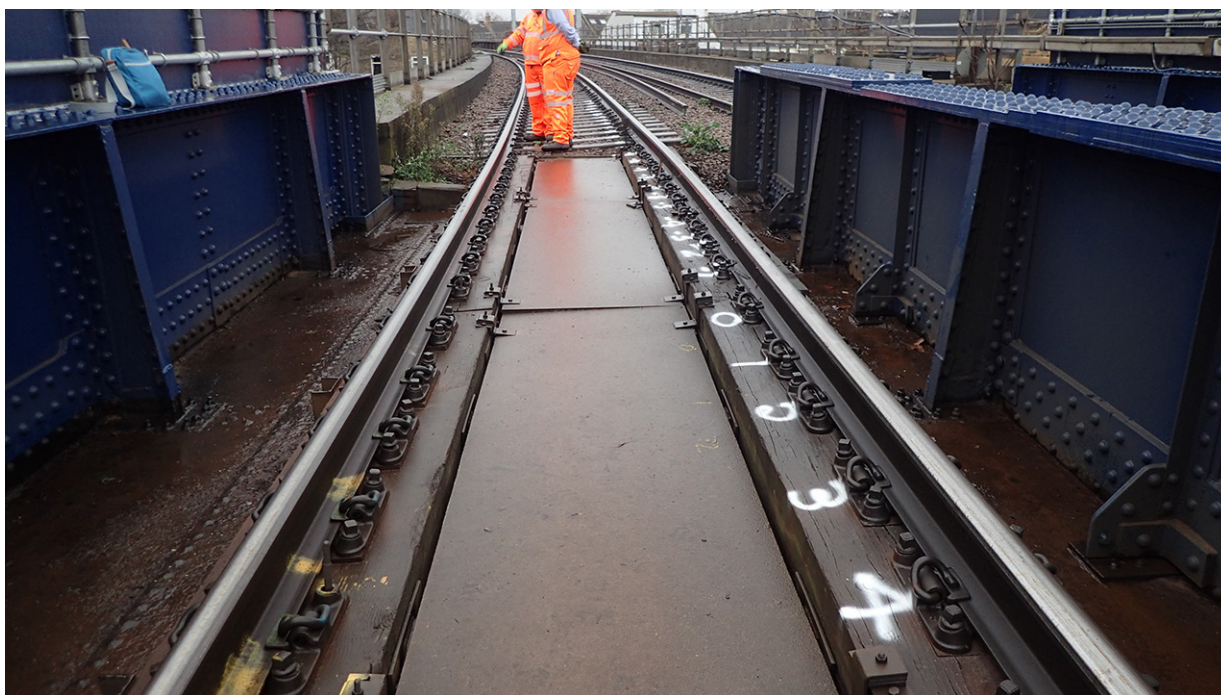
- 101 The presence of fixed walkways was an ongoing issue at four spans on the Barking to Gospel Oak line where there were walkways installed, including bridges 456 and 448. The team leader stated that walkways were never removed for inspections (figure 32). The walkway on bridge 456 had been installed to assist staff walking along the track, but as the bridge was located on a section of track where access was prohibited except during a possession or line blockage, it was rarely used. As there was insufficient time during a possession to remove/reinstall the walkways and complete a detailed examination, the TME planned to have the walkways removed permanently during 2020.

Figure 32: View of bridge 456 deck following the accident, but before the walkway was removed. With the walkway in place, the inside faces of the longitudinal timbers were not visible for inspection.

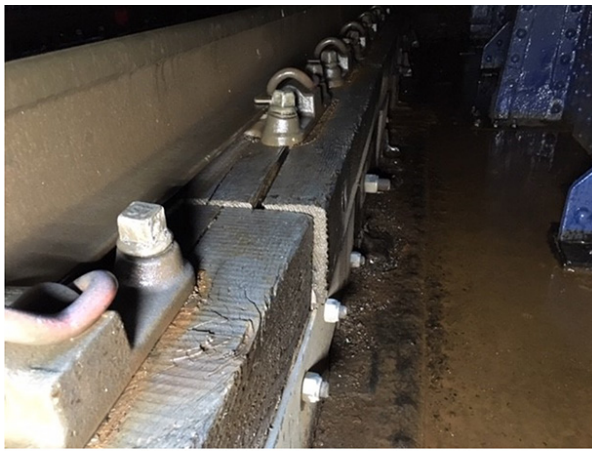
Up road split

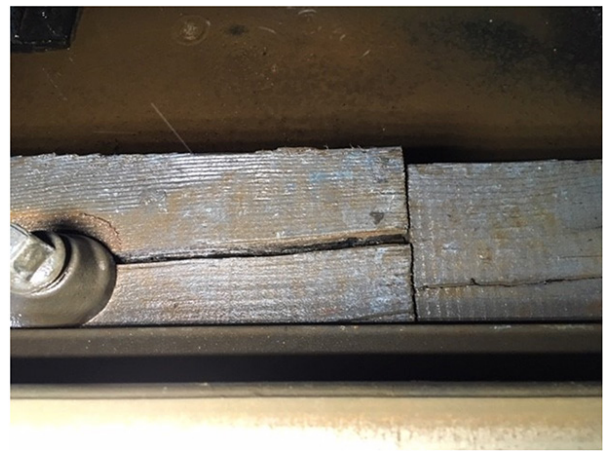
15mm split UP road 6ft timber 1

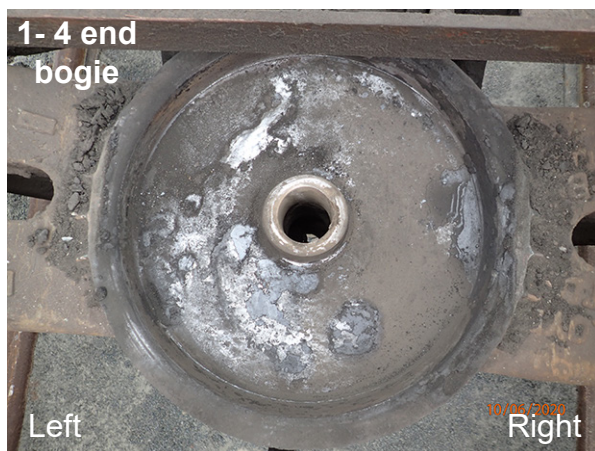
Figure 38: The 1-4 end bogie centre pivot on wagon 3415

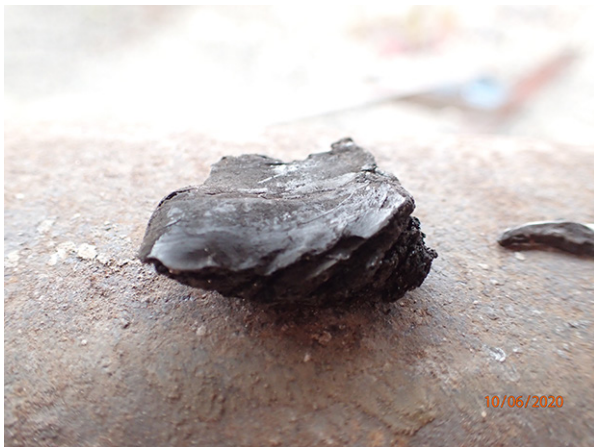
Figure 40: Part of the grease plug extracted from the 1-4 end top centre pivot recess on wagon 3415

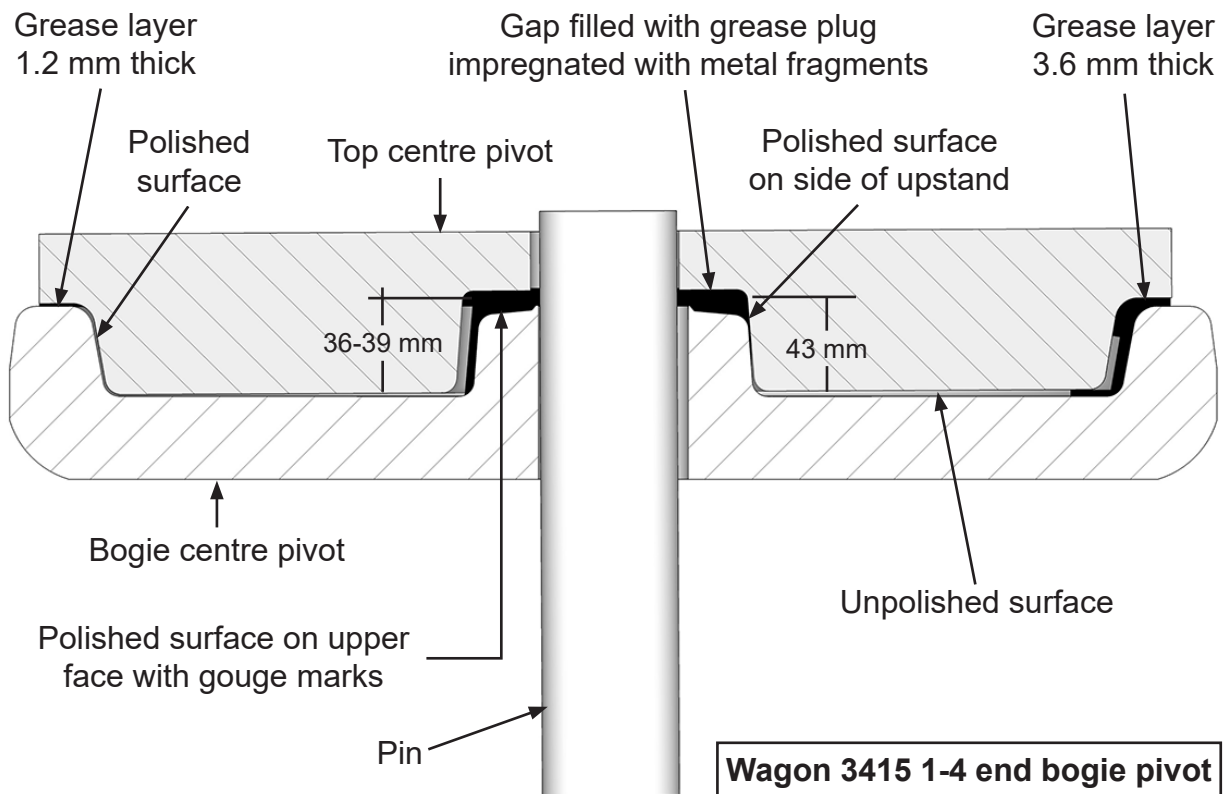
119 The bogie centre pivots incorporate a central upstand, 40 mm high and 108 mm diameter with a 63 mm diameter hole to contain a pin. The upstand fits into a recess in the top centre pivot. On the 2-3 end, the top centre pivot recess measured 43 mm deep, into which the 40 mm high upstand could fit without making contact at the top when the large horizontal faces of the castings were in contact. On the 1-4 end, the recess was also 43 mm deep, but it contained a 5mm thick plug of hardened debris-impregnated grease which had the effect of reducing its depth to 38 mm (figure 40 and figure 41). The grease plug pressed against the top of the upstand and carried part of the load intended to be carried on the large horizontal faces. This prevented the bearing from being correctly seated on the horizontal surfaces (figure 42 and figure 43).

Figure 42: Diagram showing the wrongly seated 1-4 end (left) bogie centre pivot on wagon 3415

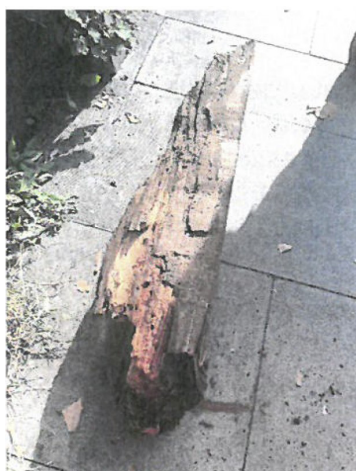
Figure 1: Timber section found on pavement

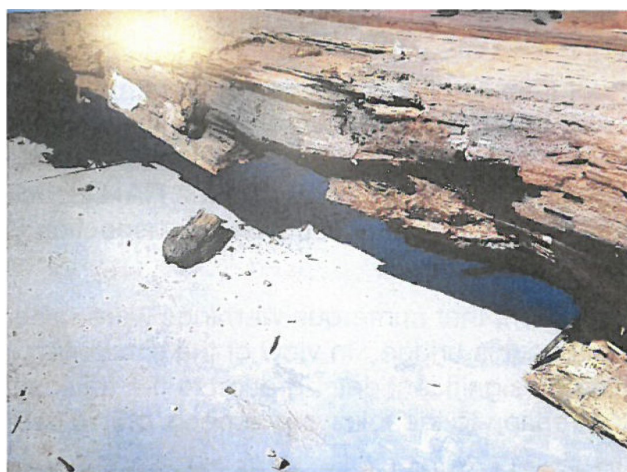
Figure 2: Condition of longitudinal timber on removal

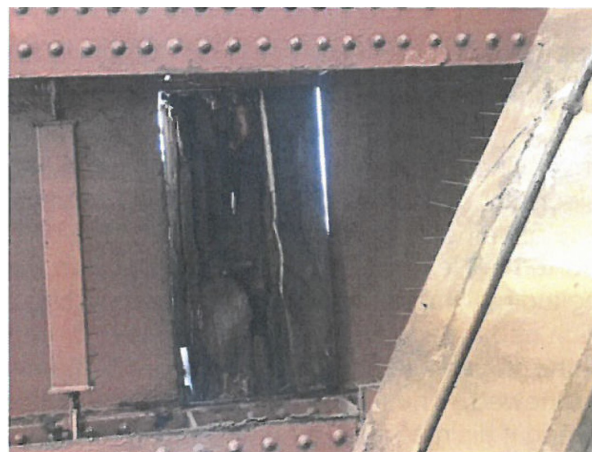
Figure 4: damaged timber from below. Daylight is visible.
