# Rail Accident Report

## **Passenger train collision with a derailed locomotive at Bromsgrove 23 March 2020**

Report 14/2020  
November 2020

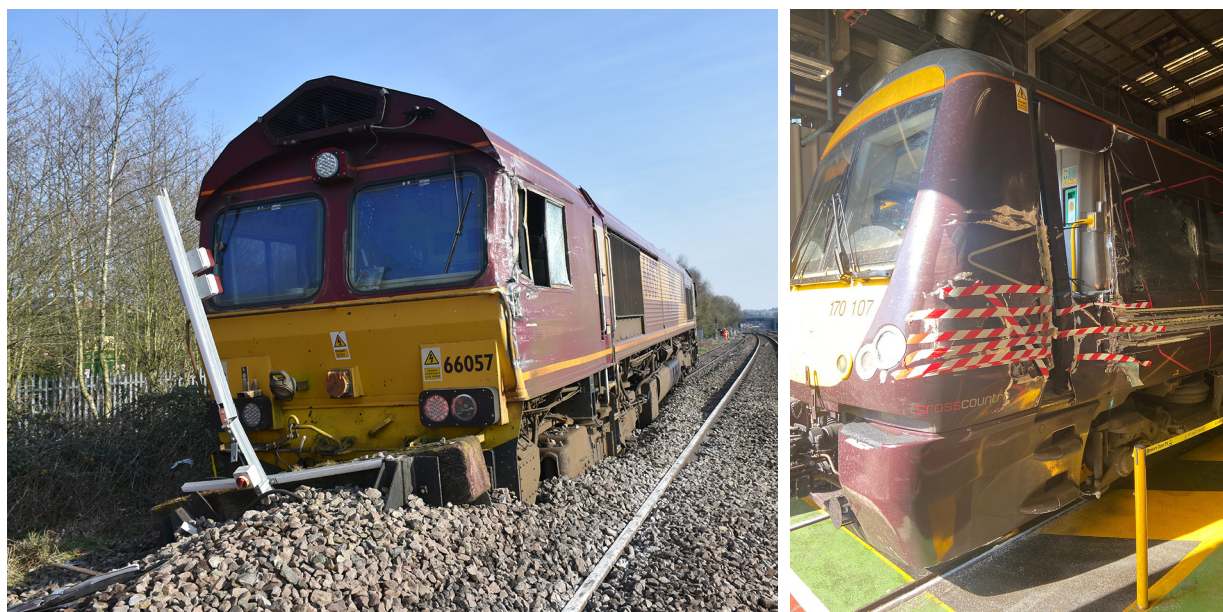
- 4 No-one was hurt.
- 5 The passenger train suffered extensive damage to one side of all three vehicles. The front left corner of the leading vehicle was particularly damaged in the area of the driver's door. The locomotive suffered damage to the front left corner of the leading cab. There was also damage to the underside of the locomotive and this resulted in a diesel fuel spill during recovery (figure 1).

Figure 1: The locomotive and the passenger train after the accident (second image courtesy of CrossCountry)

- 36 The locomotive tore the buffer stop off the end of the siding, pushing it for about 20 metres before coming to a stop. The locomotive ran off the end of the track, ploughing into the ballast, with only the last two sets of wheels remaining on the track. As it ran on, unguided by the track, the locomotive deviated to the left, coming to a stop with its front left corner about 600 mm away from the nearest running rail of the up Gloucester main line (figure 1).

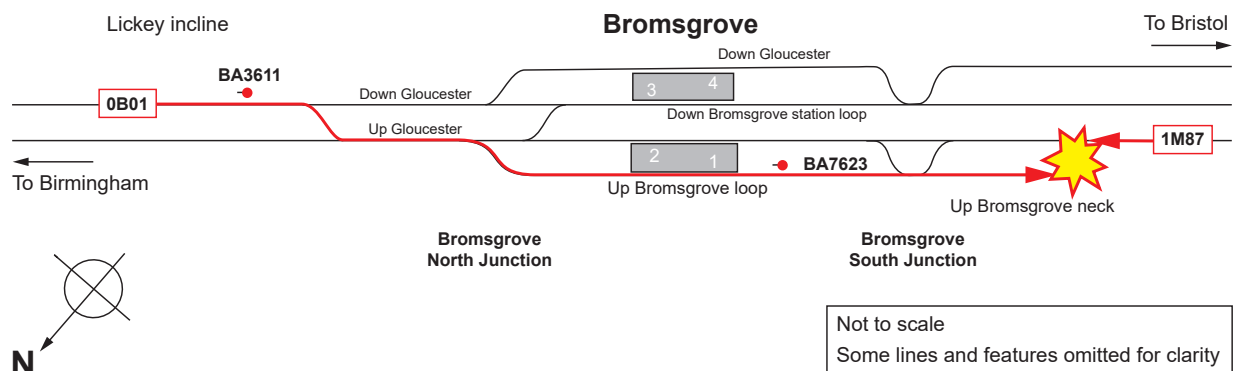
Figure 3: Track layout at Bromsgrove, showing the route of both trains

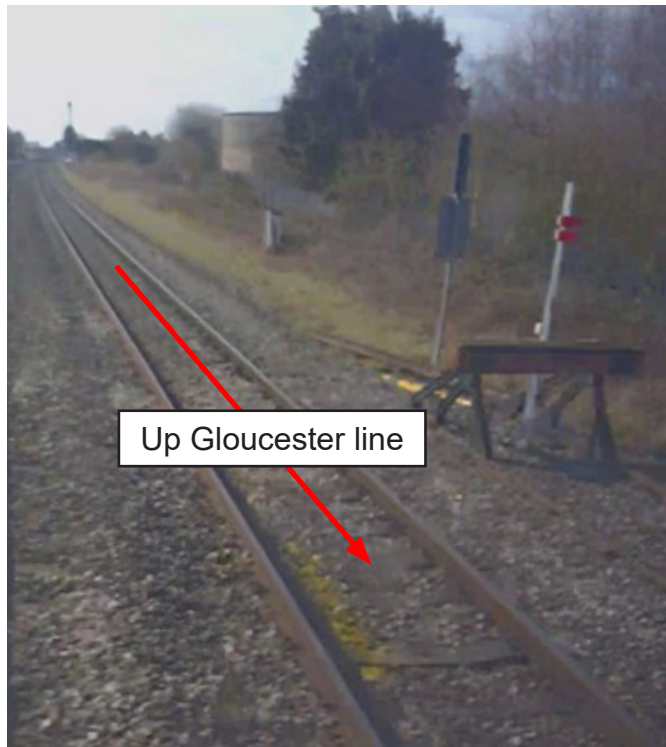
Figure 4: Up Bromsgrove neck buffer stop (image courtesy of CrossCountry)

- 18 The buffer stop consisted of a metal framework that was fixed to the jointed rails. It did not contain any sliding friction elements or hydraulic buffers. It was fitted with two permanently illuminated red lights (figure 4).
- 19 The buffer stop was installed in its current location (figure 5) around 2004, as identified from historic satellite imagery. Prior to this, the siding had ended in a buffer stop located about 90 metres further south.

- 59 The locomotive hit the buffer stop at 21 mph (34 km/h), which was 40% above the maximum permitted speed in the up Bromsgrove neck. The result was that the locomotive detached the buffer stop from the end of the siding and pushed its structure ahead of it. The locomotive ran off the end of the rails and ploughed through the ground ahead of it, causing the ballast to pile up. This caused the locomotive to slow to a stop. It would also have influenced the direction in which the locomotive travelled, with this effect being largely random. In this accident, it caused the locomotive to deviate towards the up Gloucester line.
