Rail Accident Investigation Branch

Rail Accident Report

**Near miss between a passenger train and cars at Norwich Road level crossing, New Rackheath, Norfolk
24 November 2019**

Report 15/2020
December 2020

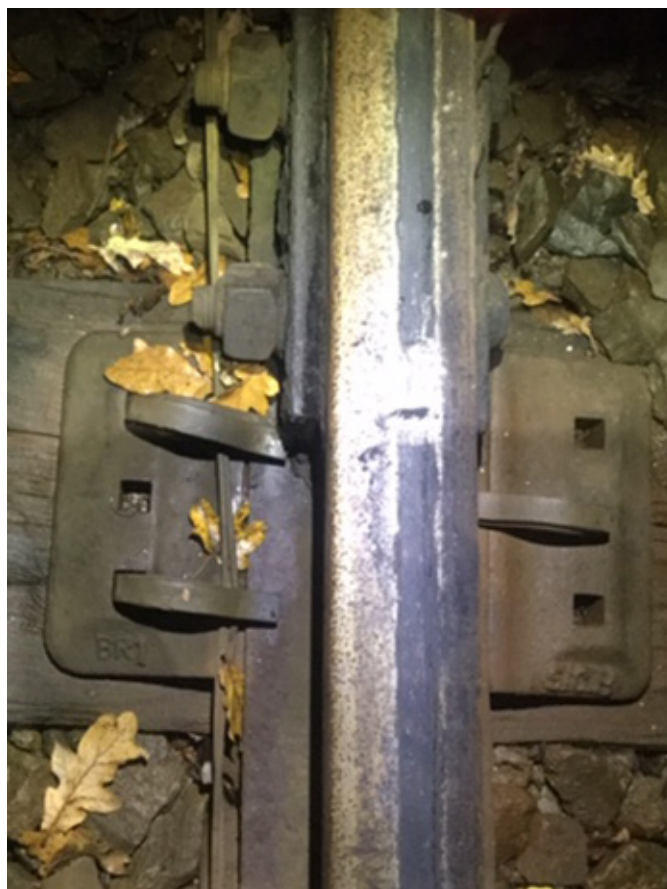
Figure 8: The railhead on approach to Norwich Road after the incident on 24 November 2019 (courtesy of Network Rail)

72 Photographs taken by Network Rail of the track on approach to the crossing on the evening of the incident, show a dark coating on parts of the rails (figure 8). Although some of this contamination was taken from the surface of the railhead, Network Rail did not preserve any samples (for reasons which RAIB has not been able to establish), so no analysis of the material was possible.

- 75 Given the local ecology and the nature of the contamination, it is highly likely that the railhead contamination on the rails on approach to Norwich Road level crossing was mainly caused by fallen leaves. If so, the dark areas visible in figure 8 would have affected the wheel-rail interface (as described by T354).

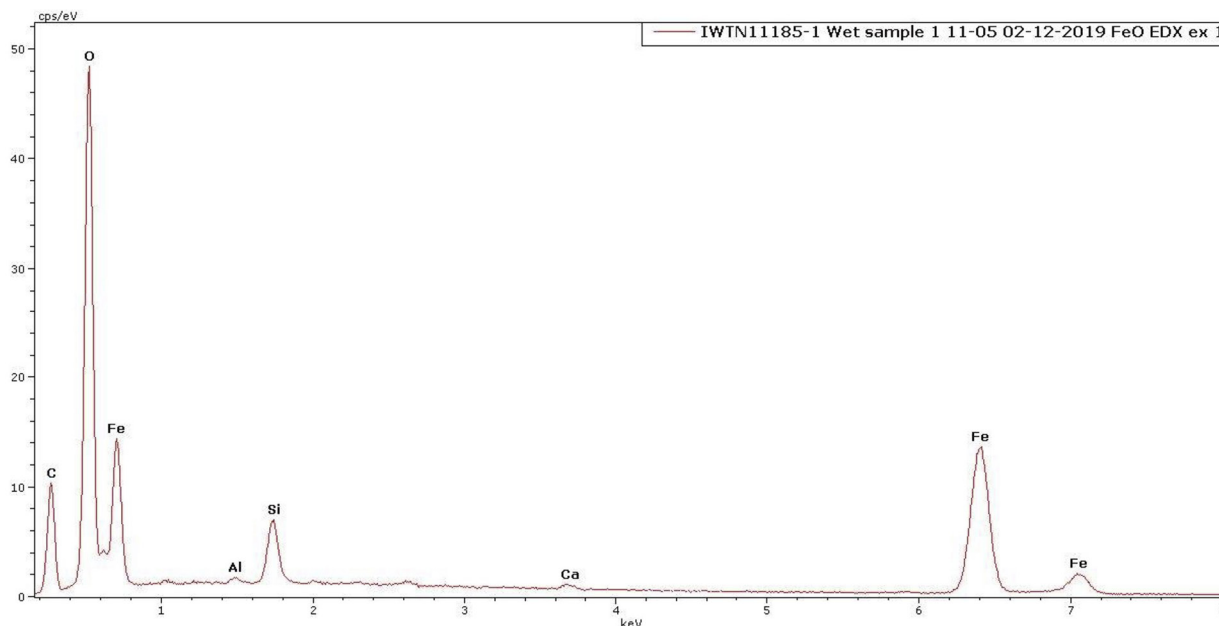
Figure 9: The chemical analysis of railhead contamination samples taken on 2 December at Rackheath Road (courtesy of Intertek)

- 73 Analysis of samples taken from the rail on 2 December 2019 on the approach to Rackheath Road level crossing reported that the sample's principal constituent was microscopic carbon-based residue, but it was not possible to establish the origin of this material. There was also some iron oxide and silica material present (figure 9), which were likely to have been from rust and sand.

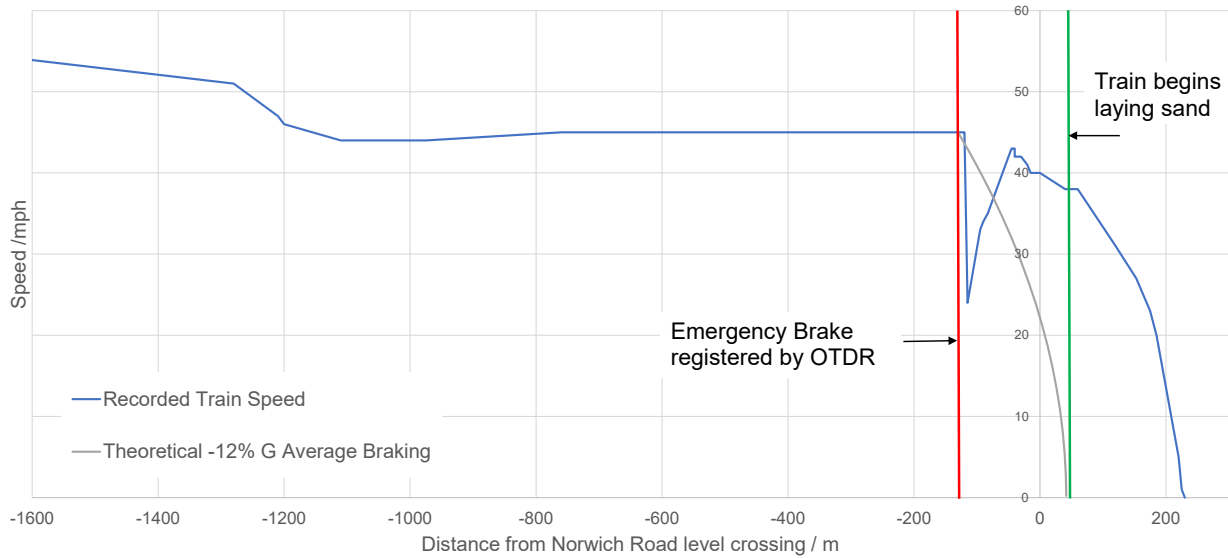
Figure 10: Recorded speed of the incident train from the limit of approach to Norwich Road level crossing until its stopping position, around 230 metres past the crossing

- 76 At the time of the incident, evidence of low adhesion, almost certainly caused by railhead contamination, is provided by analysis of the train's speed and distance covered (figure 10). Data extracted from the OTDR shows that after the driver applied the emergency brake, the train achieved an average deceleration rate of only 2.2% g for the first 190 metres, with considerable wheel slide protection (WSP) activity registered for all 12 axles. In full emergency braking, a modern train would be expected to achieve a deceleration rate of up to 12% g. During this period the speed recorded by the OTDR was erratic, indicating that wheel slide was occurring on the speed-recording axle.

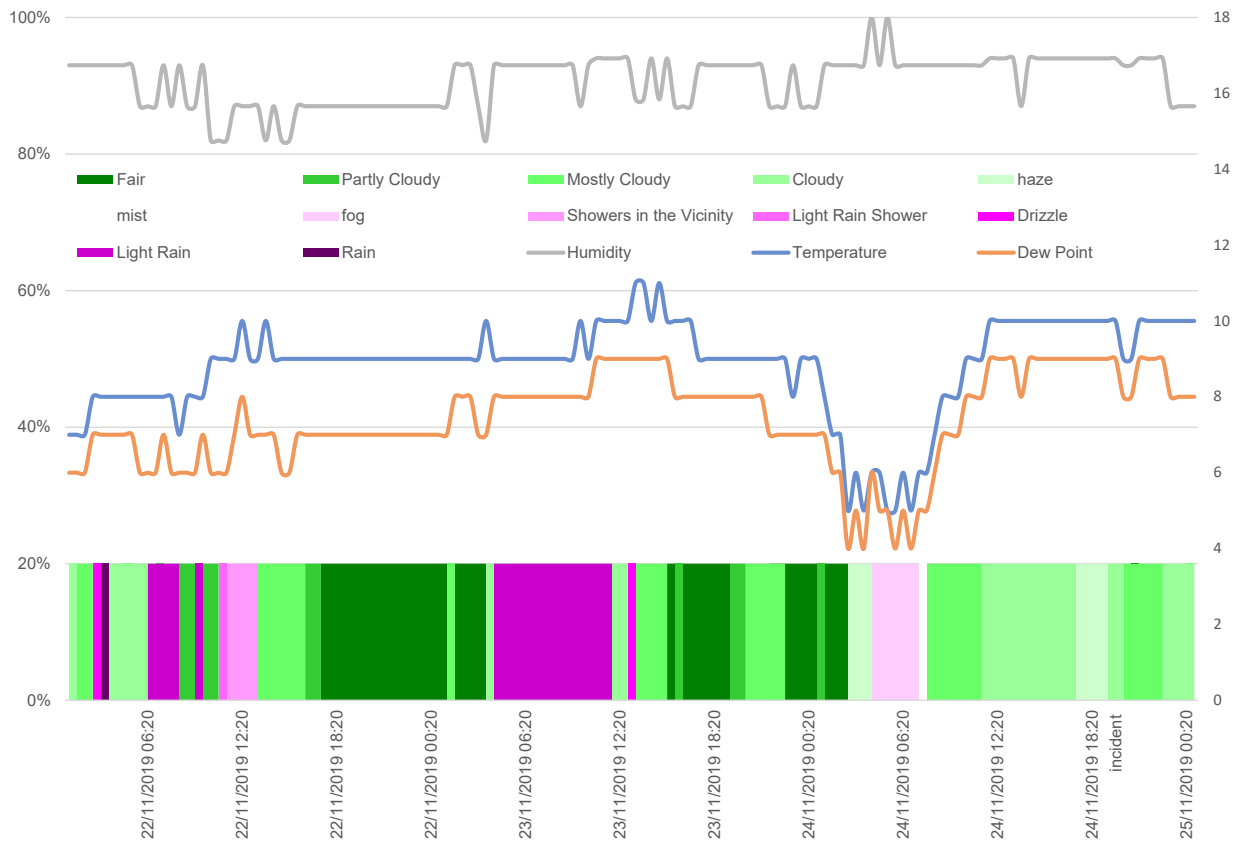
Figure 12: Temperature, dew point and humidity in the 48 hours prior to the incident, taken at Norwich airport, around 6.5 km (4 miles) from Norwich Road level crossing

79 Weather records show that there was no measurable rainfall in the 48 hours before the incident. This is significant because moisture would have helped to keep the film of contaminant mobile and able to be displaced by train wheels. Instead, the moisture levels in the Norwich area during the two days before the incident were consistent with previously damp leaves adhering to rails and then drying to form a film of electrically insulating contamination (figure 12).

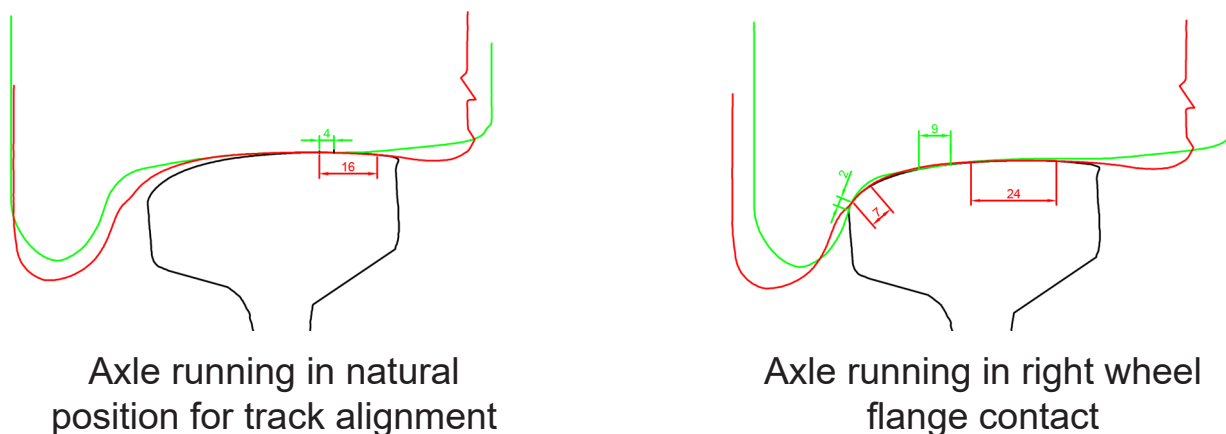
Figure 13: Outlines of the class 755 (green) and class 153 (red) wheel on the rail profile on approach to Norwich Road crossing

- The new class 755 units would ride on a band around 4 mm wide near the centre of the railhead if the wheelset was centred on the track, as would be expected on the straight track in this area. If the wheelset were making flange contact with either rail, there would be two narrow contact points, to the inside of the centre of the railhead and at the bottom of the running edge (figure 13).

- The worn class 153 wheelset would ride on a band around 16 mm wide from the centre to the outside of the railhead if the wheelset was centred on the track, and would make contact across most of the railhead surface from the running edge outwards if in flange contact.

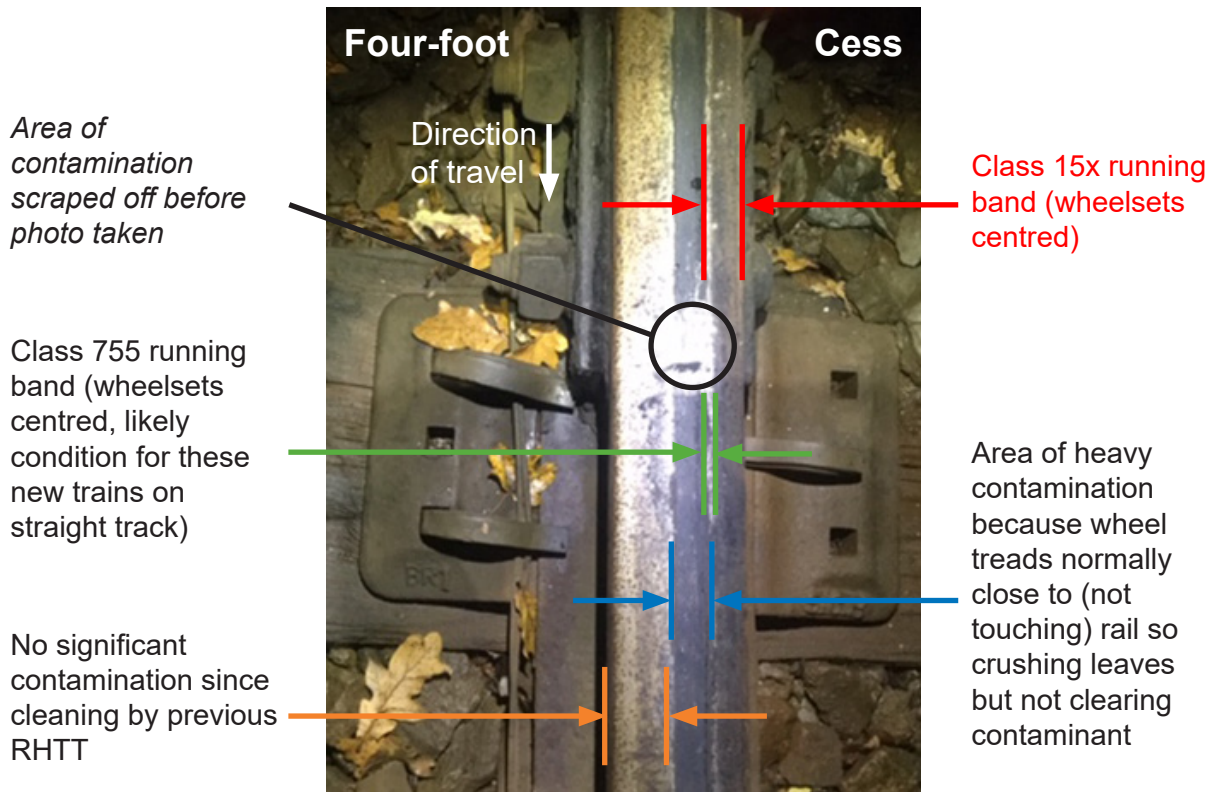
Figure 14: Railhead on the night of the incident with positions of contact patches for class 755 and other stock

- 92 The photographs taken by Network Rail on the night of the incident show a narrow clear metal running band on the railhead consistent with the contact patch observed for class 755 trains (paragraph 91), and there was also a partially clean area consistent with class 153 and other older stock running (figure 14). The area to the inside of the centre of the railhead shows heavy contamination.

- 94 However, if a train is running on a narrow contact patch, only a small contaminated area of railhead can impede electrical connection. It is also the case that even if a good electrical contact is being made on a narrow running band, small, expected, lateral movements by the train's wheels will generally result in the contact patch moving onto adjacent contaminated parts of the railhead. Even though the class 755 trains had more wheelsets than units previously using the line, this does not appear to have improved the electrical contact.
