Rail Accident Investigation Branch

Rail Accident Report

Runaway and derailment of a wagon at Clitheroe, Lancashire 9 March 2020

Report 16/2020
December 2020

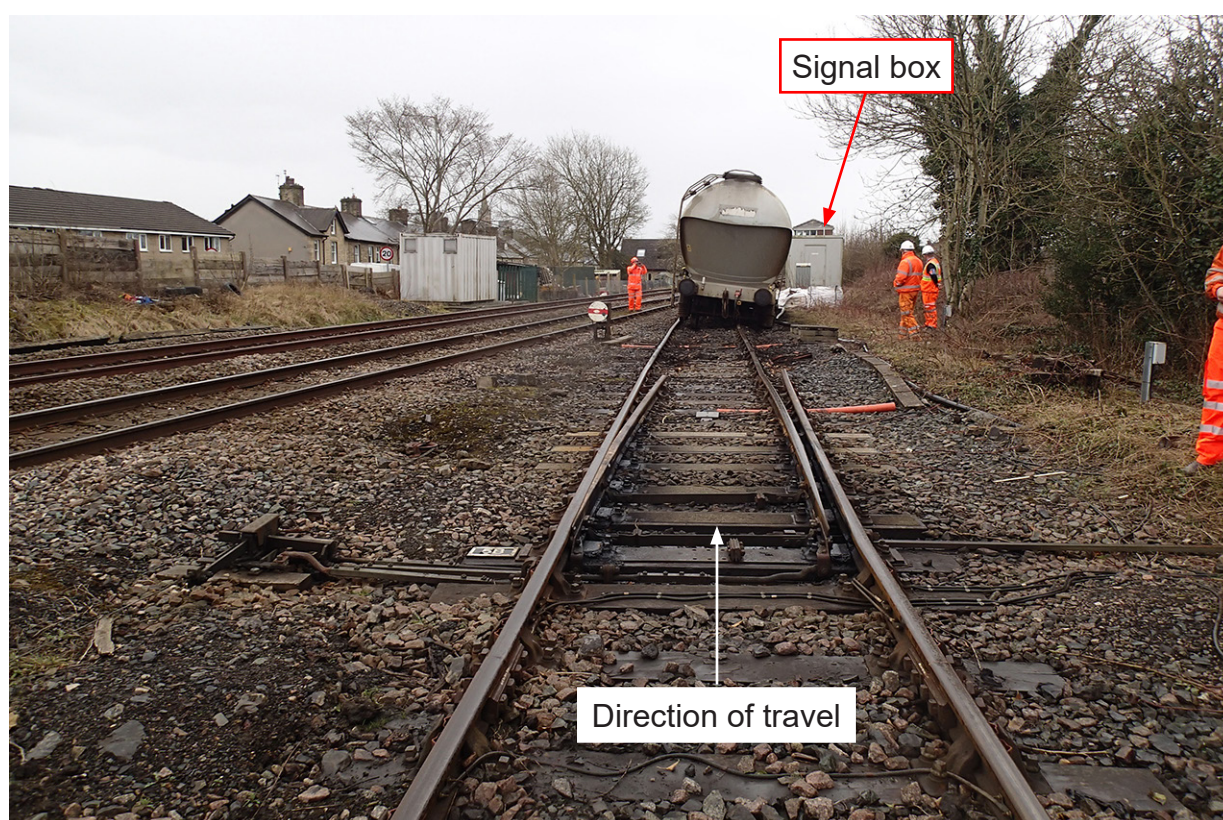
Figure 3: The derailed wagon beyond the trap points

- 5 On reaching Horrocksford Junction, the wagon derailed at the end of the run-out rails associated with a set of trap points (figure 3). The trap points worked as intended to prevent such unauthorised movements from reaching the main line. The derailed wagon stopped clear of the main line and no trains were nearby when the derailment occurred. The wagon travelled a total distance of about 0.75 miles (1.2 km).

- 6 Minor damage was sustained by the wagon and damage was caused to the track where the wagon ran derailed. The wagon was recovered during the night following the accident. Repairs to the track to allow access to the branch line and cement works were completed at 07:36 hrs on 13 March.

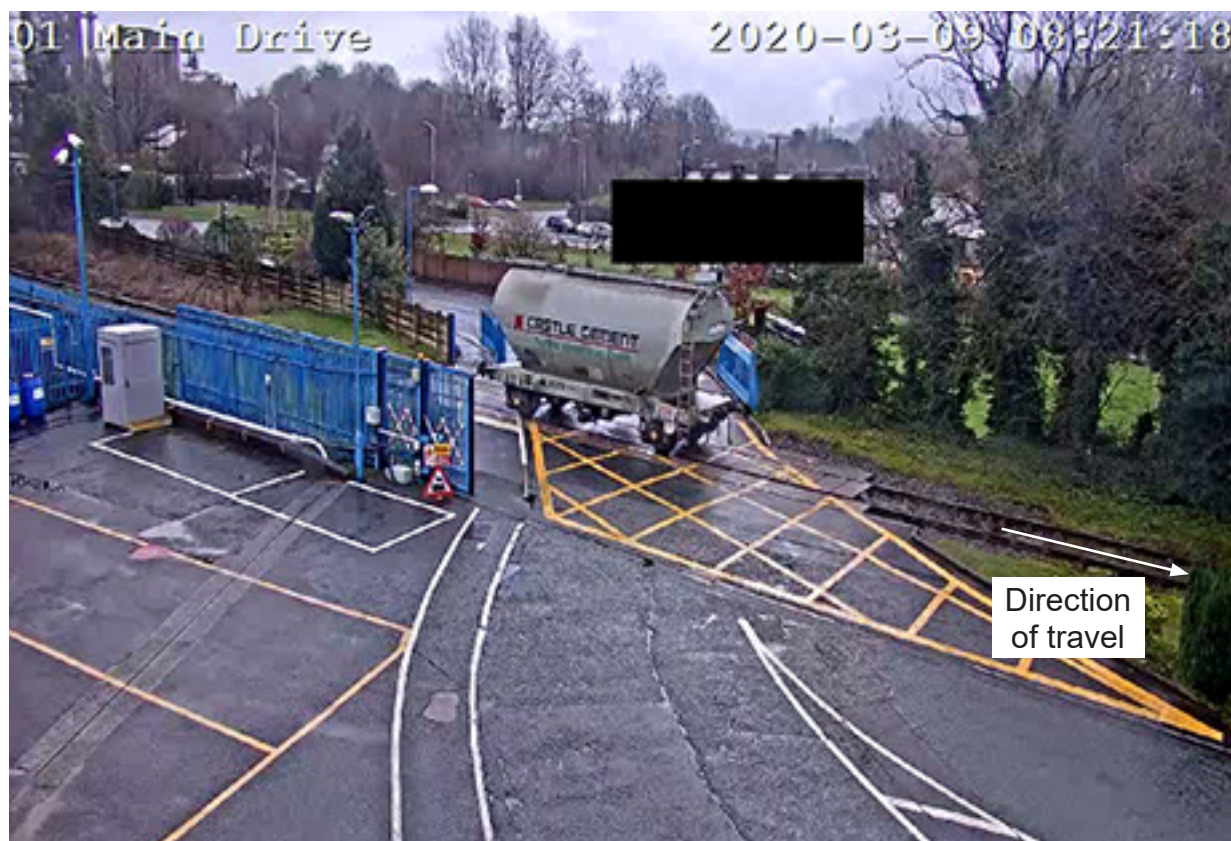
Figure 9: CCTV image of the wagon passing over the Johnson Matthey level crossing (image courtesy of Johnson Matthey)

- 40 At 08:21 hrs the wagon passed over the Johnson Matthey level crossing (figure 9). At the same time, the assistant train manager arrived at the level crossing in his car. He got out and ran alongside the wagon. He attempted to stop it but found the handbrake wheel would not turn any further in the direction needed to apply the brake. He returned to his car, got his mobile phone and made an emergency call to the signaller at Horrocksford Junction signal box to report that a runaway wagon was heading that way.

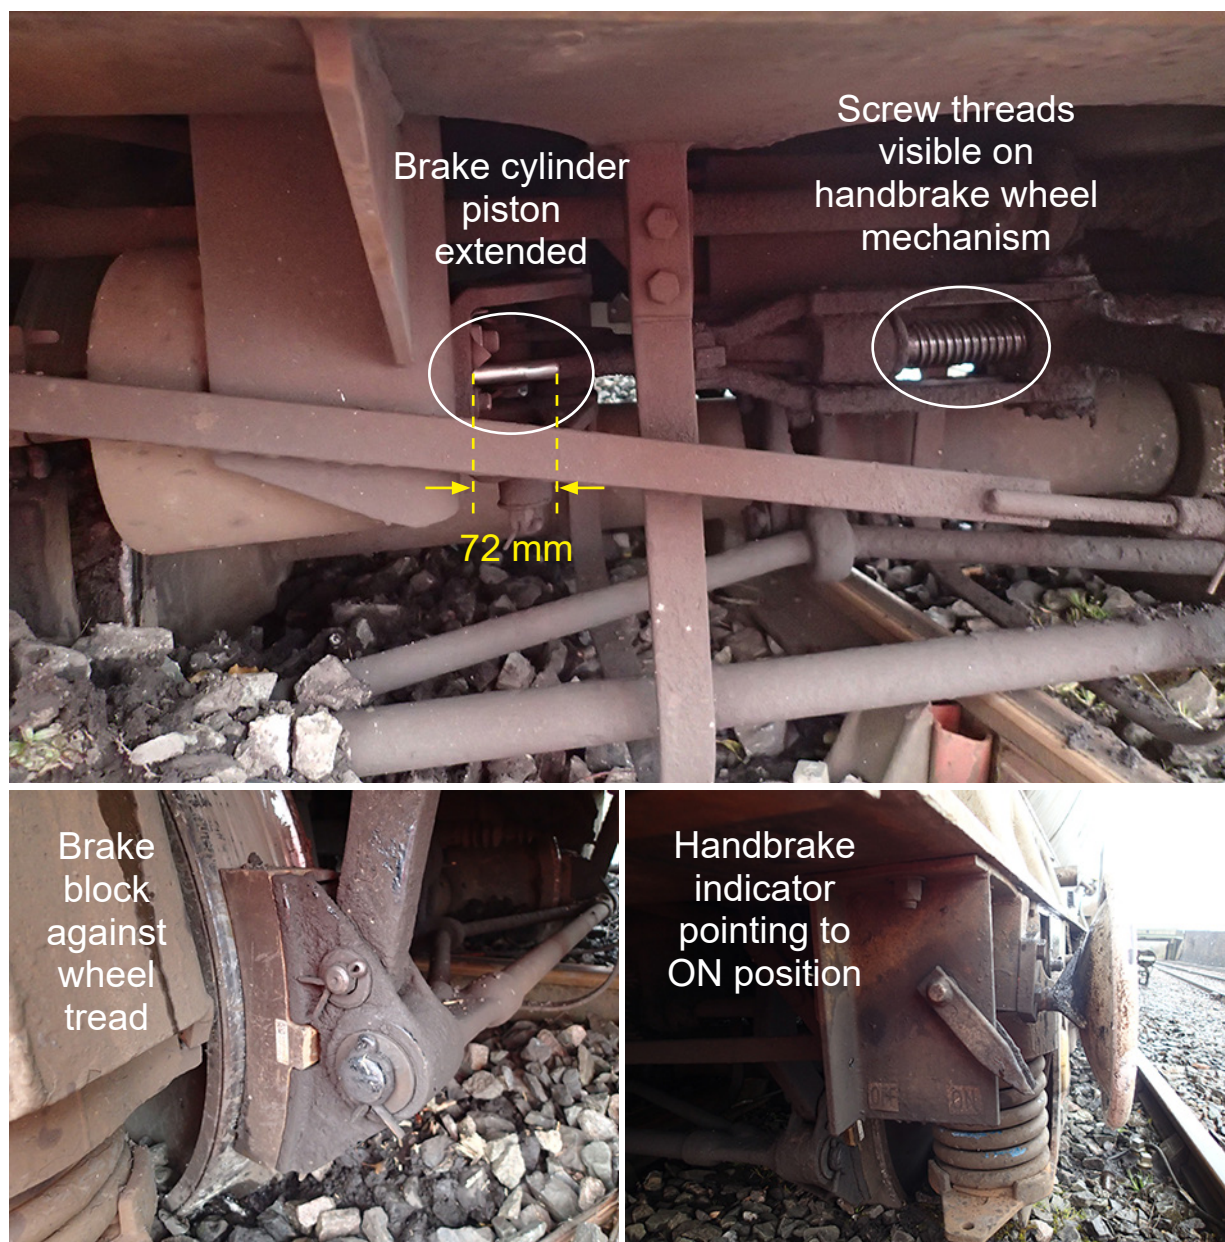
Figure 10: The positions of the wagon's handbrake indicator, handbrake mechanism, brake cylinder piston and brake blocks as found by RAIB after the accident

- 45 Witness evidence indicates that the trainee rail operator applied the wagon's handbrake and that the assistant train manager checked it when they stabled the wagon. When RAIB inspected the wagon at Horrocksford Junction after the accident, it found that the handbrake indicators were pointing to the handbrake being in its applied position. RAIB also noted that the positions of the handbrake mechanism and brake cylinder piston showed the handbrake was in its applied position (figure 10).

- 61 RAIB examined the wagon on the day of the accident and recorded that there were 13 screw threads visible on the handbrake mechanism, and the mechanism had pulled the brake cylinder piston out by 72 mm (figure 10). RAIB found it took $7\frac{1}{2}$ turns on the handbrake wheel to fully release the handbrake (paragraph 45). VTG vehicle maintenance instructions state it should take 6 turns on the handbrake wheel, plus or minus one turn, to move between the fully released and fully applied positions. When the handbrake was applied again, a maximum of 6 turns were possible to fully apply the handbrake.

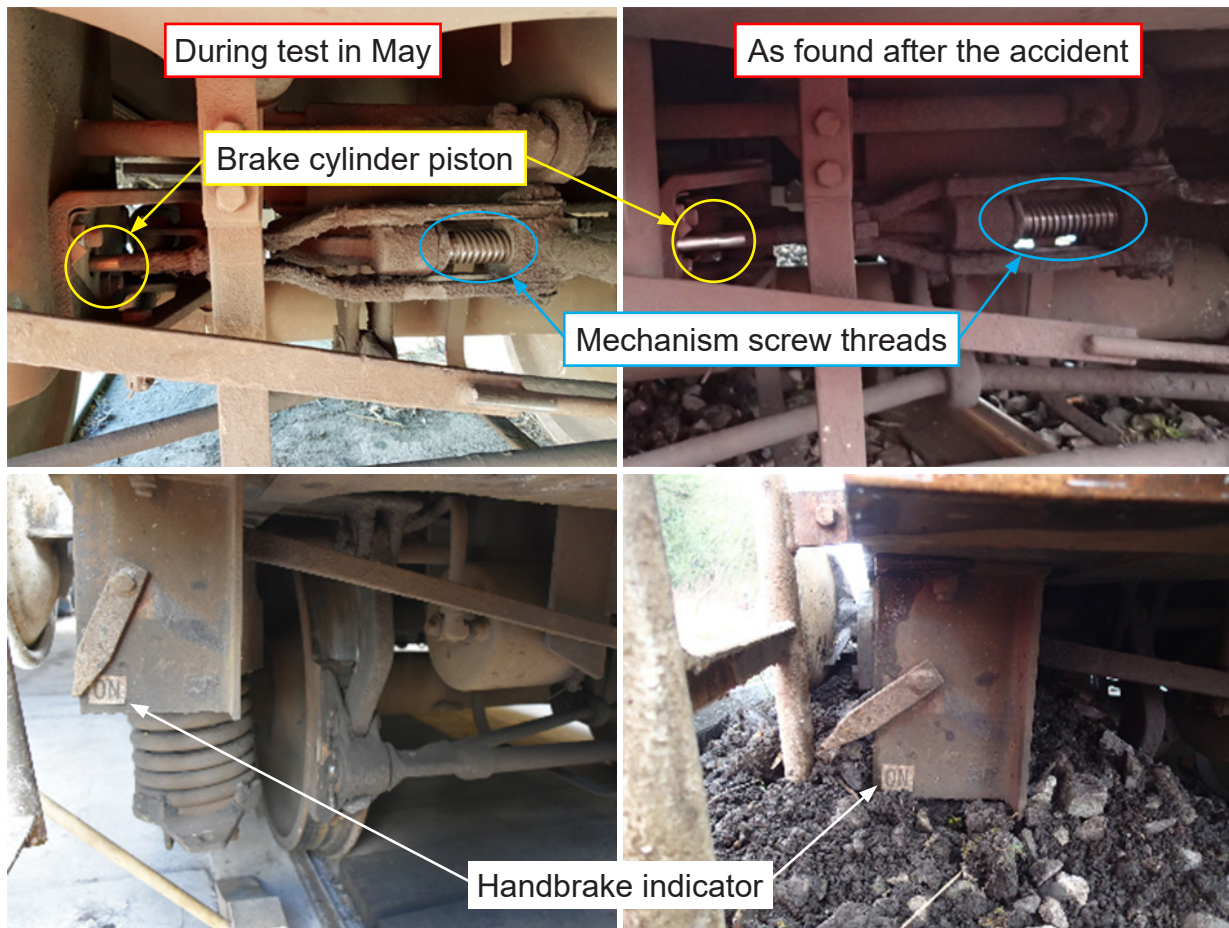
Figure 14: Comparison of the positions of the handbrake components during testing and as found after the accident

- 64 The difference in the positions of the handbrake mechanism as found after the accident and during the testing, should mean that greater brake force was generated on the day of the accident than was measured during testing. However, RAIB's calculations (paragraph 53) and tests (paragraph 62) showed this was not the case.

- 65 The only component between the handbrake mechanism, which pulls on the brake cylinder piston, and the brake blocks, that can affect the amount of brake effort generated, is the slack adjuster. Its function is to automatically take up any slack in the brake rigging caused by the brake blocks wearing in service. The slack adjuster does this by rotating on threaded rods which are attached to each end of it (figure 13). By automatically adjusting the length of these threaded rods, the slack adjuster maintains a gap of 4 mm between the brake blocks and wheel treads when the brakes are released. By maintaining a consistent gap as the brake blocks wear, the brake blocks provide a consistent braking effort for a given brake application, irrespective of brake block wear.

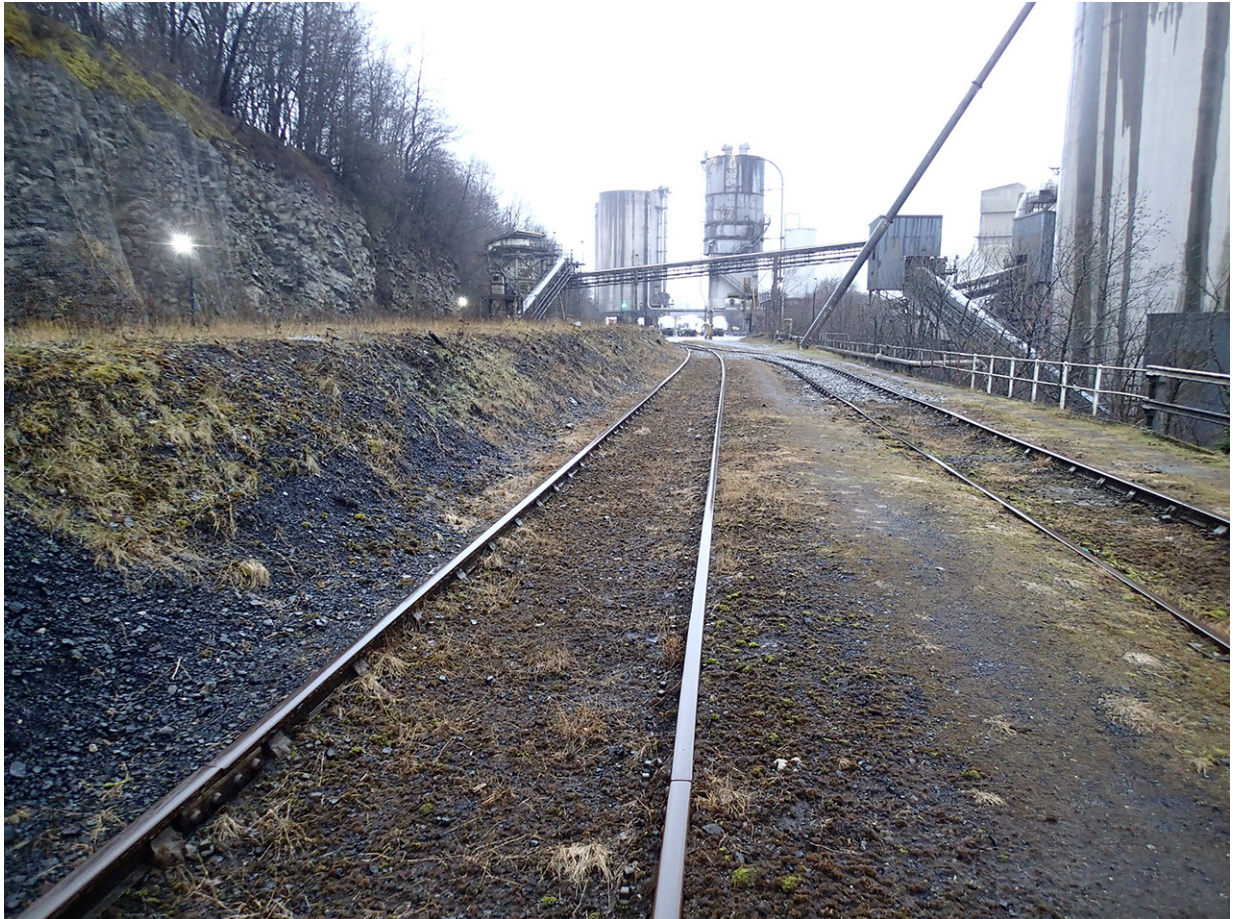
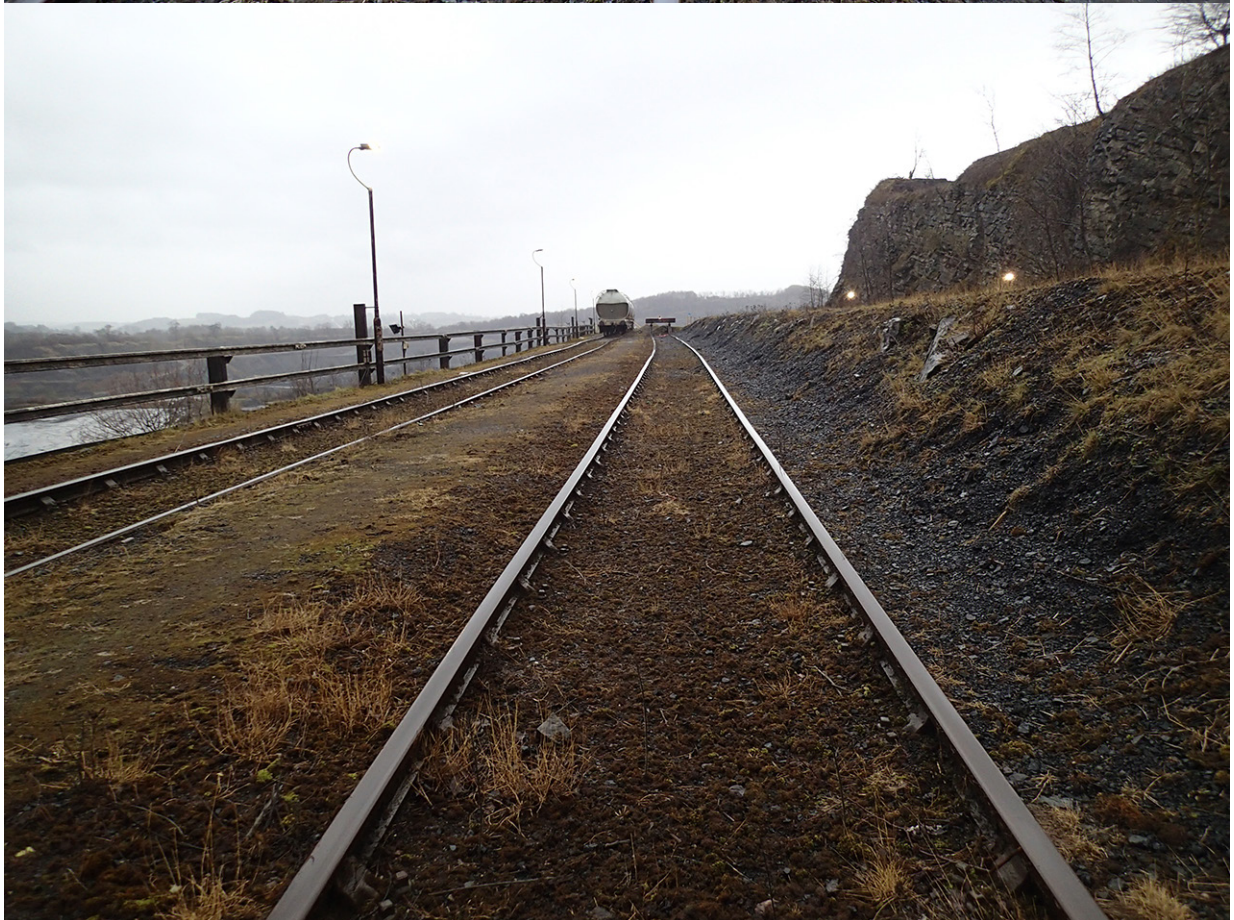
Figure 15: The view in both directions from where wagon VTG10601 was left stabled

- 82 The local operations manual did not include any instructions or guidance about where to stable wagons within the long or short sidings. The ground staff stabled the wagon about 33 metres from the fouling point in the siding (paragraph 54). This left the wagon on a gradient falling towards the exit to the cement works. If the ground staff had stabled the wagon within 50 metres of the buffer stop in the short siding (figure 17), it would not have run away out of the siding. They did not do this, because they expected that staff from Dents would soon be coming along that morning to move the wagon into the maintenance siding (paragraph 87).

- 83 The only information in the local operations manual about the gradients within the cement works refers to the gradient falling either side of the loading silo. This implies that the gradient in both sidings will fall throughout towards the buffer stops. This is incorrect, as the gradient actually falls towards the exit of the cement works for about the first 125 metres in each siding (figure 16) and only starts to level out and fall towards the buffer stops about 70 metres from the fouling point.

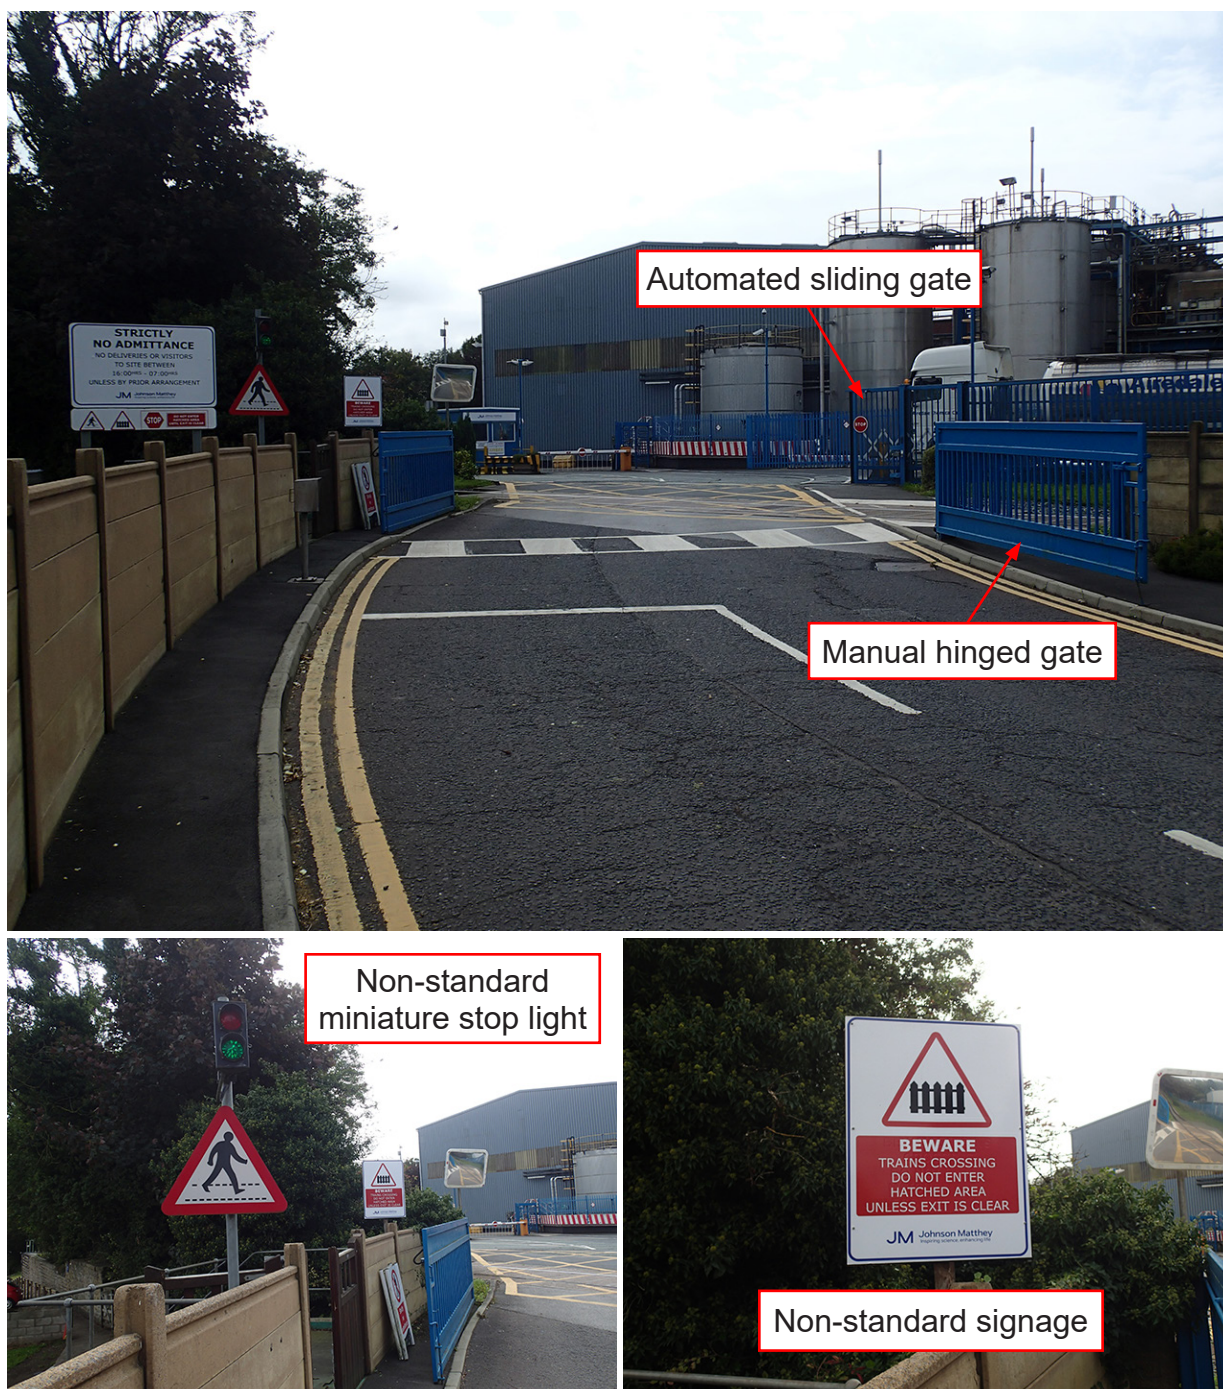
Figure 17: The non-standard features at the Johnson Matthey level crossing

- 112 The crossing itself has some non-standard features (figure 17) which the owners of the chemical works have installed and maintained themselves over the years. Its gates are operated by the GB Railfreight ground staff, who then give the train permission to cross. The gate on one side is a powered sliding gate, while the gate on the other side is hinged and manually opened and closed by the ground staff. The level crossing has a non-standard miniature stop light on only one side, that displays a red or green light to road users, and there is also non-standard signage for road users and pedestrians on each side.
