Rail Accident Investigation Branch

Rail Accident Report

**Person struck by a train at Eden Park station,
south-east London
26 February 2020**

Report 01/2021
February 2021

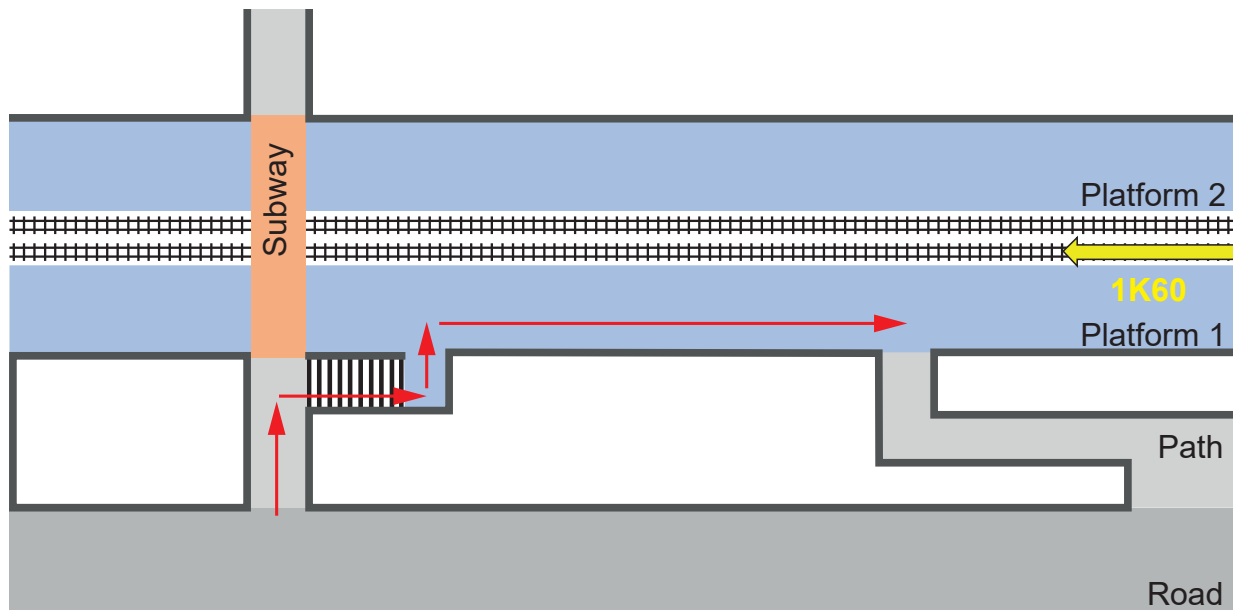
Figure 2: Schematic diagram of person's route to platform 1 (red arrow) within Eden Park station up to around one minute before the accident

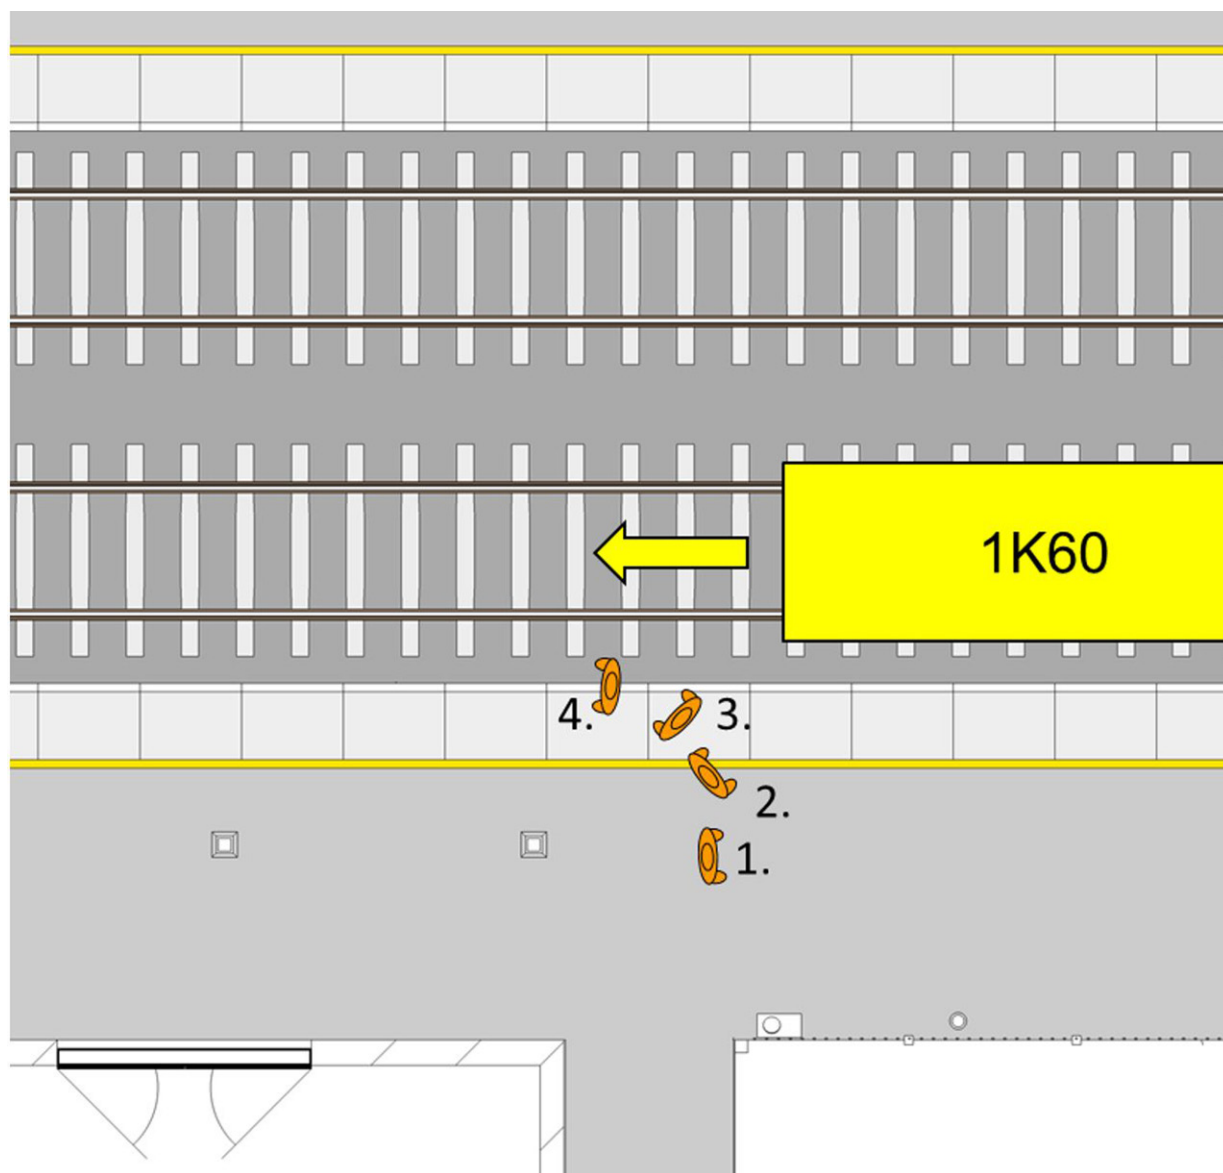
Figure 3: Schematic diagram of person's movements
