# Rail Accident Report

**Fatal accident at Waterloo Underground station,  
London  
26 May 2020**

Report 05/2021  
September 2021

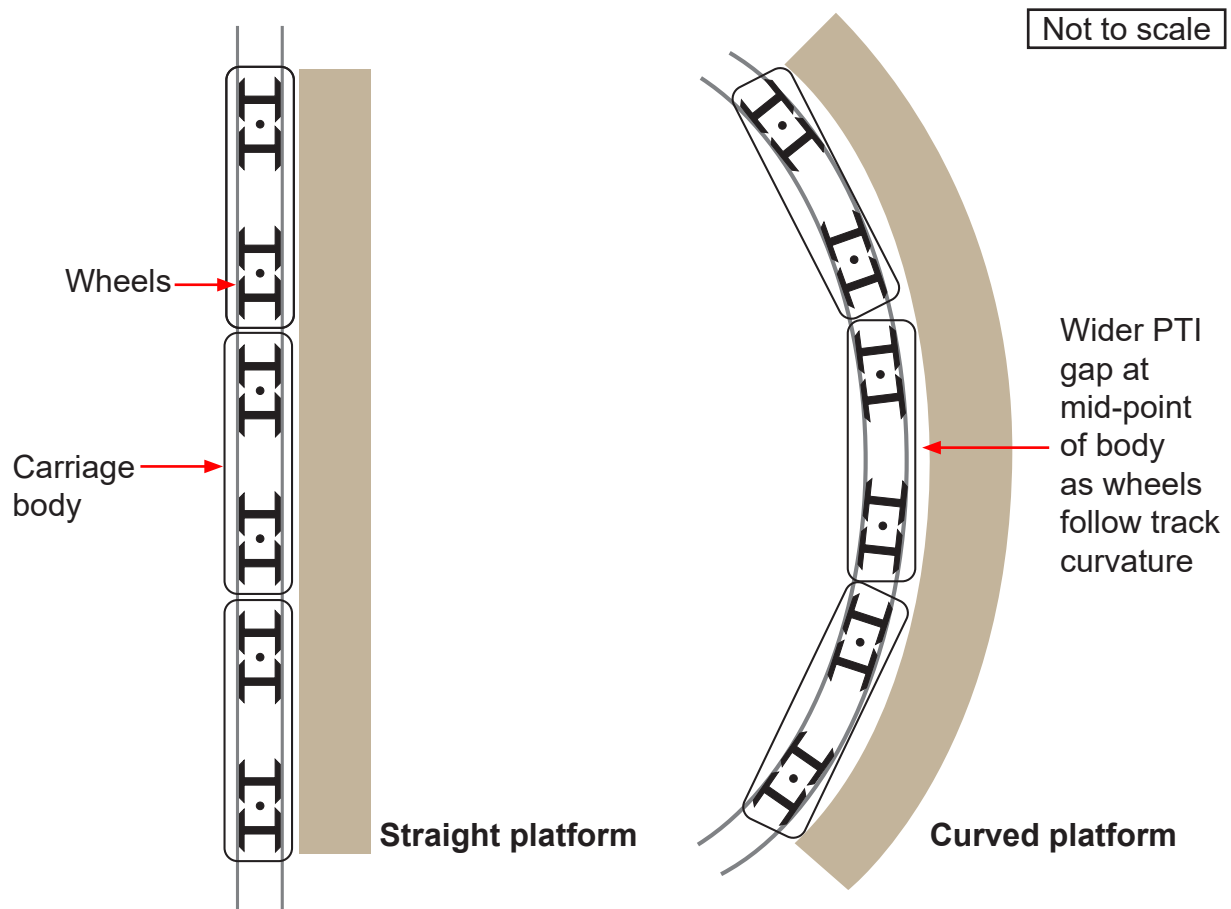
- 6 The railway is tightly curved to the left (in the direction of travel of trains) through the platform, and this results in larger gaps between the platform and the train in some parts of the platform than would be found at a straight platform (figures 2 and 3). A lineside signal on the approach to the station controlled the movement of trains into the platform area and another signal, about 10 metres beyond the departure end of the platform, controlled movements out of the platform towards the next station.

Figure 2: Diagram showing increased gap between the train and platform as a consequence of track curvature

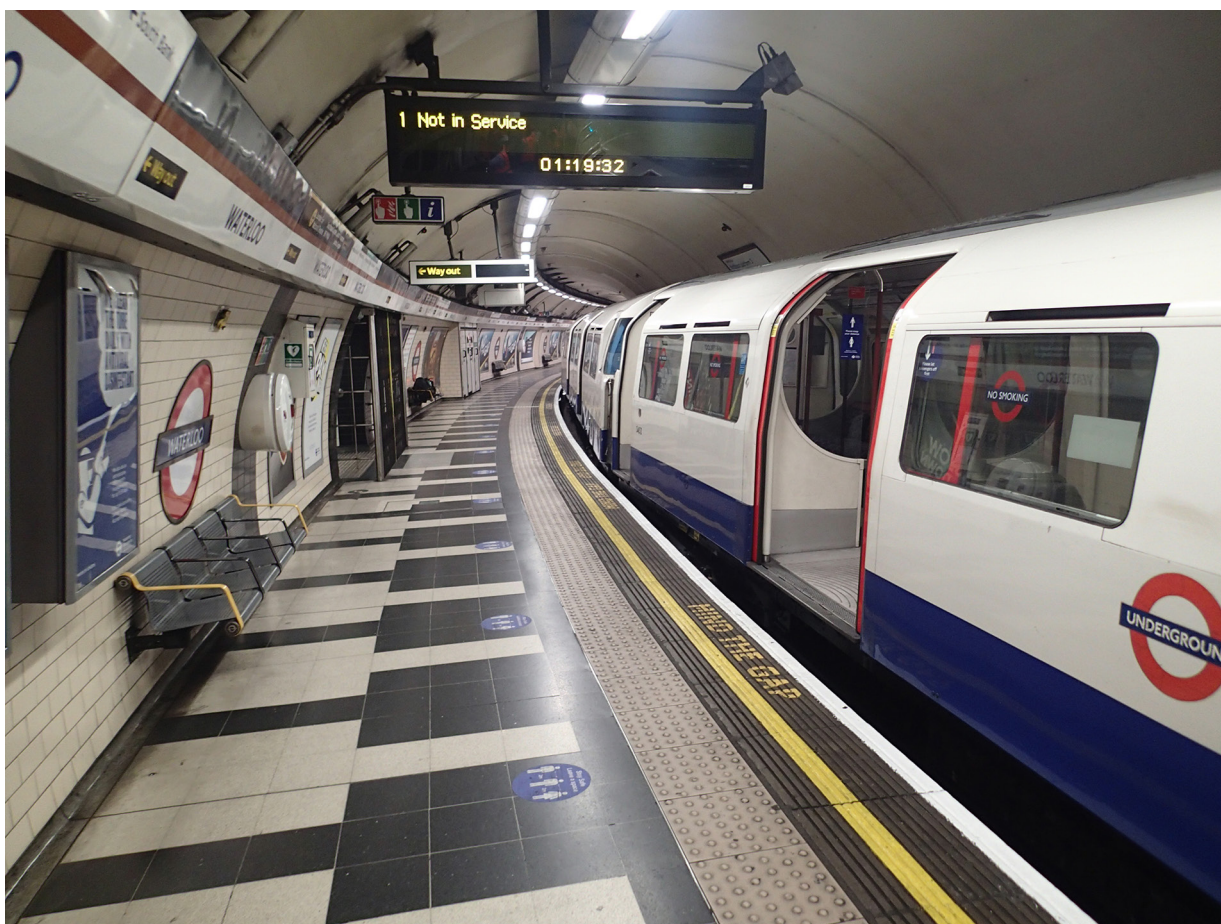
Figure 3: View of Waterloo Bakerloo platform 3 looking south showing the platform curvature and gap between platform and vehicle body

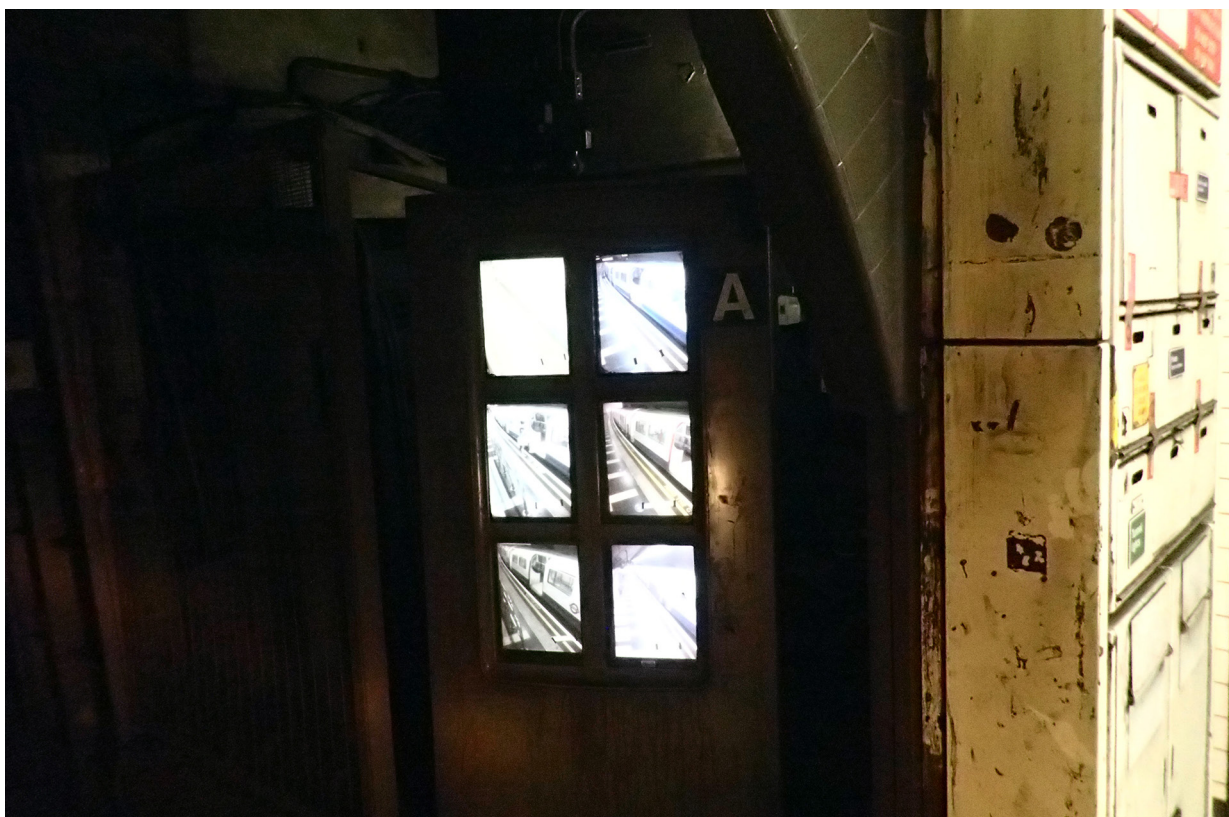
Figure 5: OPO monitors provided inside the tunnel at Waterloo Bakerloo line platform 3

- 47 At Waterloo Bakerloo line platform 3, the six OPO monitors that allow train operators to view the full length of the PTI (paragraph 12) were positioned behind a glass screen approximately 3.2 metres from the train operator's driving position (station CCTV images show that train 210 had stopped in the correct position at the time of the accident). The monitors are inspected each morning to confirm that the cameras are correctly aligned and the images are displayed distinctly. The monitors were checked at 04:55 hrs on the day of the accident and no defects were recorded.

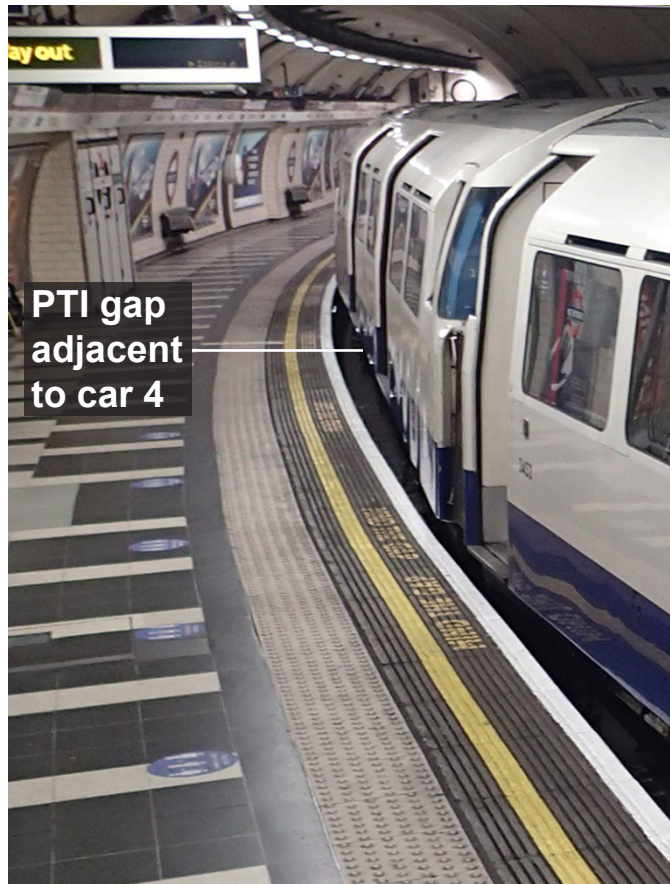
Figure 6: Platform-train interface gap adjacent to carriage 4 at Waterloo Bakerloo line platform 3

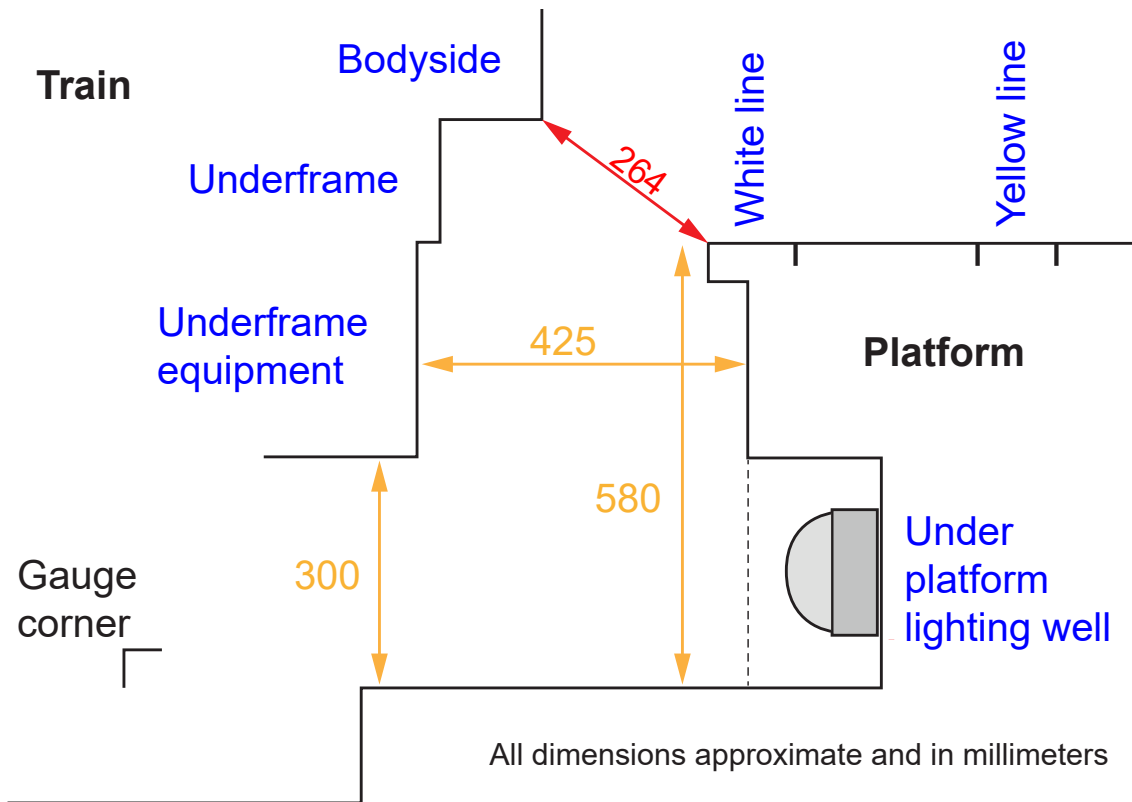
- 36 When the Bakerloo line was constructed at the start of the 20<sup>th</sup> century, the northbound track alignment through Waterloo station incorporated a tight curve with a radius of between 133 metres and 156 metres. This curve creates a large PTI gap close to the middle of the carriages (figure 6). With a train of this type stationary in the platform, RAIB found the gap to be approximately 264 mm when measured diagonally between the lower corner of the train body and the edge of the platform at the mid-point of the fourth carriage, the area in which the passenger fell (figure 7).

- 38 Once in the PTI gap, the passenger was unable to get out. This was probably at least in part because there was limited space between the platform, the train and the track (figure 8). The task could have been made more challenging by pre-existing mobility limitations which were described (by the passenger's family) as being due to previous leg injuries, any injuries sustained in the fall, or a combination of both.

Figure 7: Cross-section between the platform and mid-point of carriage 4 at Waterloo Bakerloo line platform 3

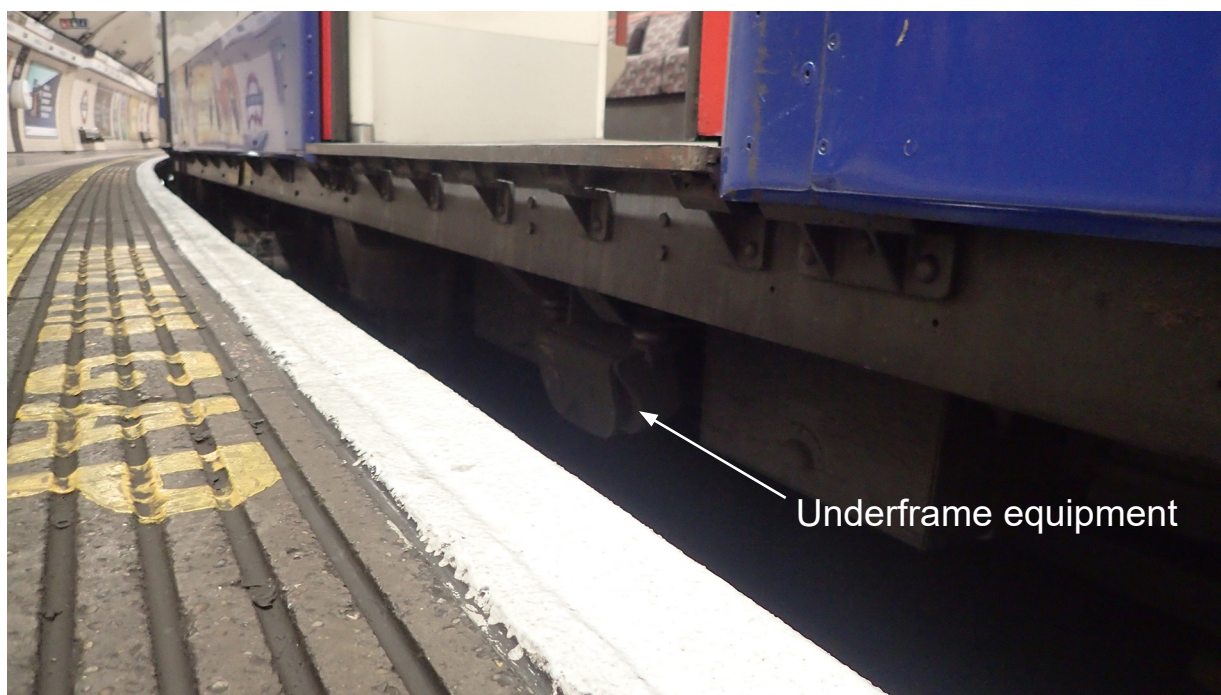
Figure 8: Proximity of under-train equipment to platform edge

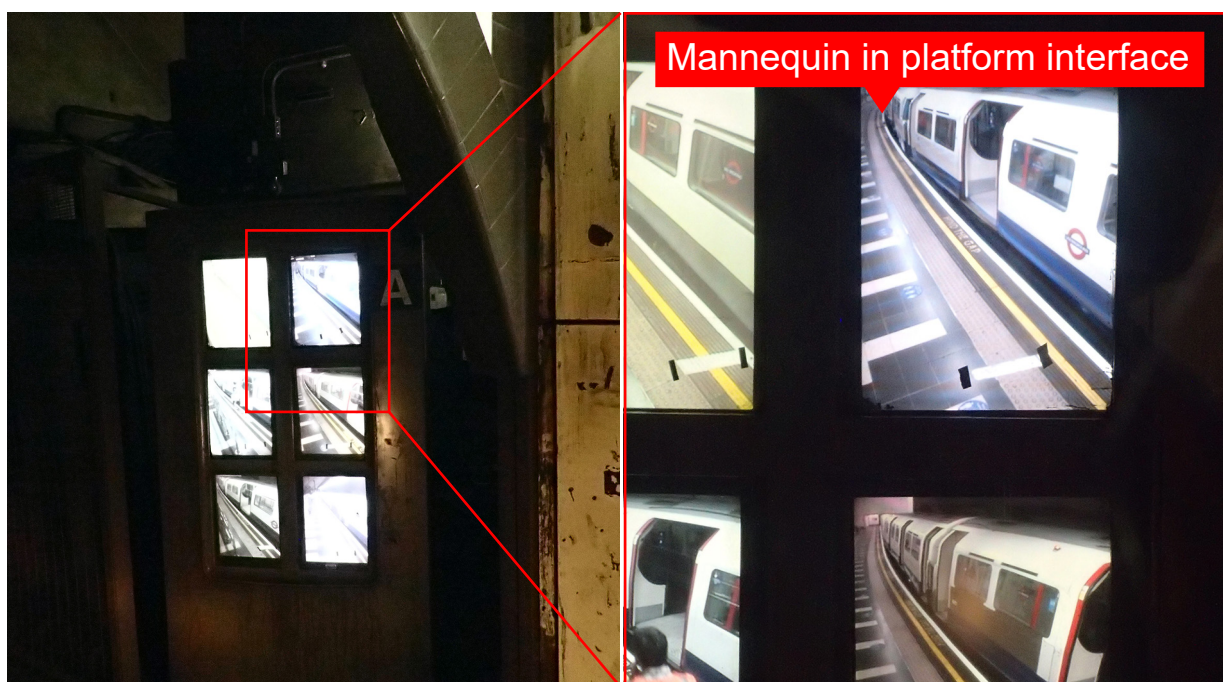
- 49 At the time of despatch, the image of the passenger would have been in the top left-hand corner of the top right OPO monitor. The passenger was wearing dark clothes and only his head and arms were above platform level. One of his arms was out across the platform and this arm would have been the only part of his body visible on the OPO monitor. Given these factors, the simulation showed that it would have been very difficult for the train operator to detect the passenger. RAIB photo-edited an OPO monitor image to show there would be little difference in image with and without the passenger's arm and head above the platform (figure 10).

Figure 9: Layout of OPO monitors and position of passenger during despatch adopted by mannequin as would have been presented to operator of train 210 (inset)

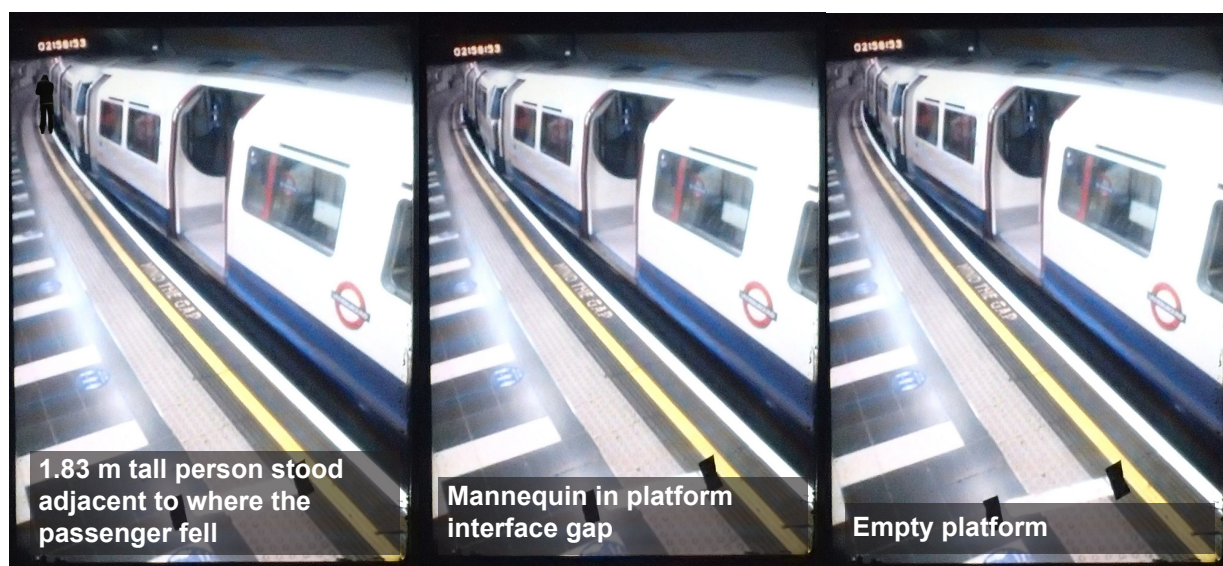
Figure 10: OPO monitor images

- 52 RAIB measured the height of the monitor image at Waterloo and found that a 1.83 metres person, at the furthest point from the camera, would appear about 28 mm high and a 1.6 metres person would be about 7.2% of the overall monitor size. LUL has stated that, in accordance with its processes,<sup>8</sup> new standards are not applied retrospectively unless a safety shortcoming is identified.

- 53 A replacement OPO platform CCTV system, compliant with the 1997 standard (or the 2003 revision), combined with more modern cameras and monitors, would have provided a larger and higher quality image. Although this would have improved the conspicuity of the passenger's arms across the platform white line, it is likely that the passenger's dark-skinned head would have remained difficult to distinguish against the dark background. Given that the image of the passenger's arm(s) would still occupy only a very small fraction of a monitor screen that was located 3.2 metres from the driving position, it is uncertain, but considered unlikely by RAIB, that the train operator would have noticed the presence of the passenger had more modern cameras and monitors been installed in the same positions as the current equipment.

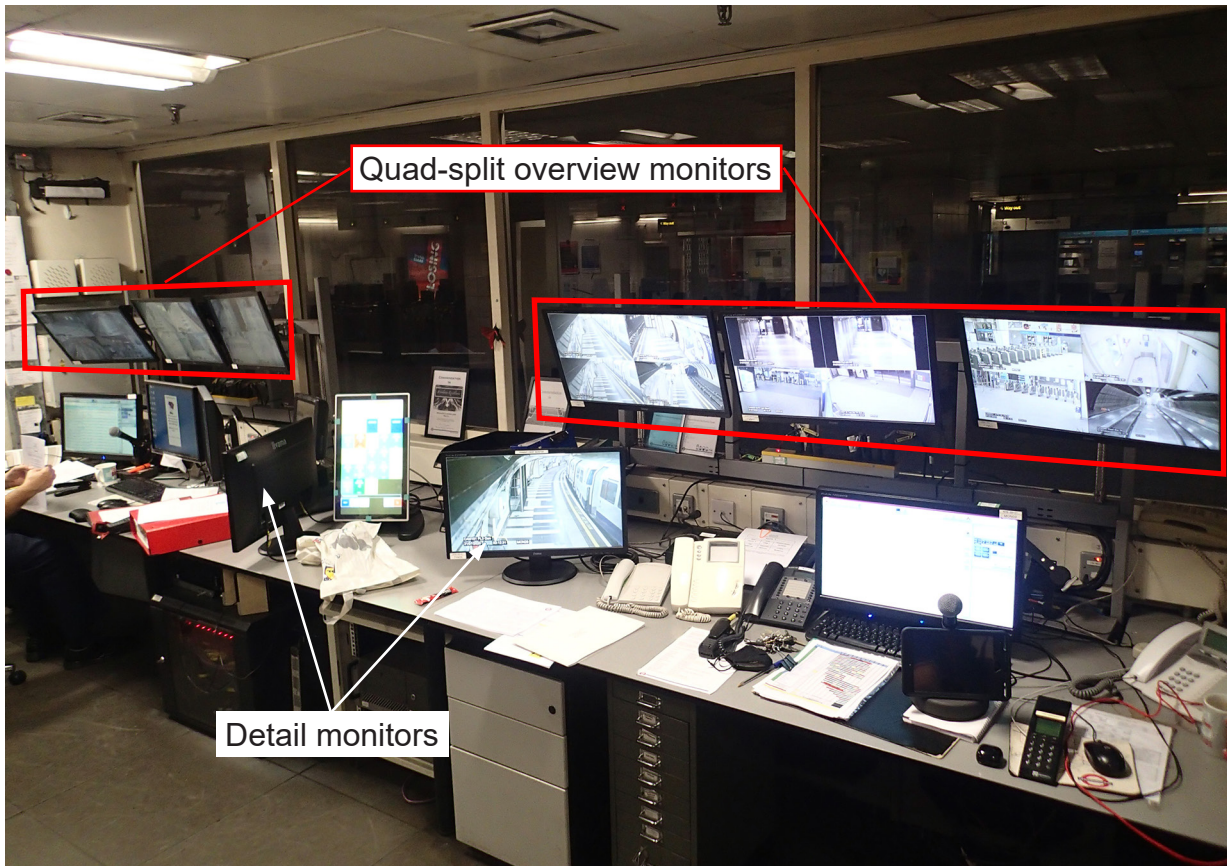
- 62 There are two CCTV workstations in the station supervisor's office, each comprising three 'quad-split' overview screens, so each workstation can show twelve images (figure 11). The system is configured such that the image captured by each camera will appear for approximately five seconds in sequence. This automatic refresh sequence can be interrupted by many triggers such as an alarm or fire door being opened, which LUL states is a frequent occurrence. There is also an additional detail monitor at each workstation which can show any one of the camera images at the request of the system operator.

- 63 Camera 181 of the station CCTV system is on Bakerloo line platform 3 and captured the whole accident sequence, including the period between the departure of train 210 and the arrival of train 214. It is probable, but not certain, that part of this sequence was shown on the system monitors, but if so, it is not known if this would have been in time to stop train 210 from departing or to stop train 214 from entering the station area.

Figure 11: CCTV workstations at Waterloo station control room

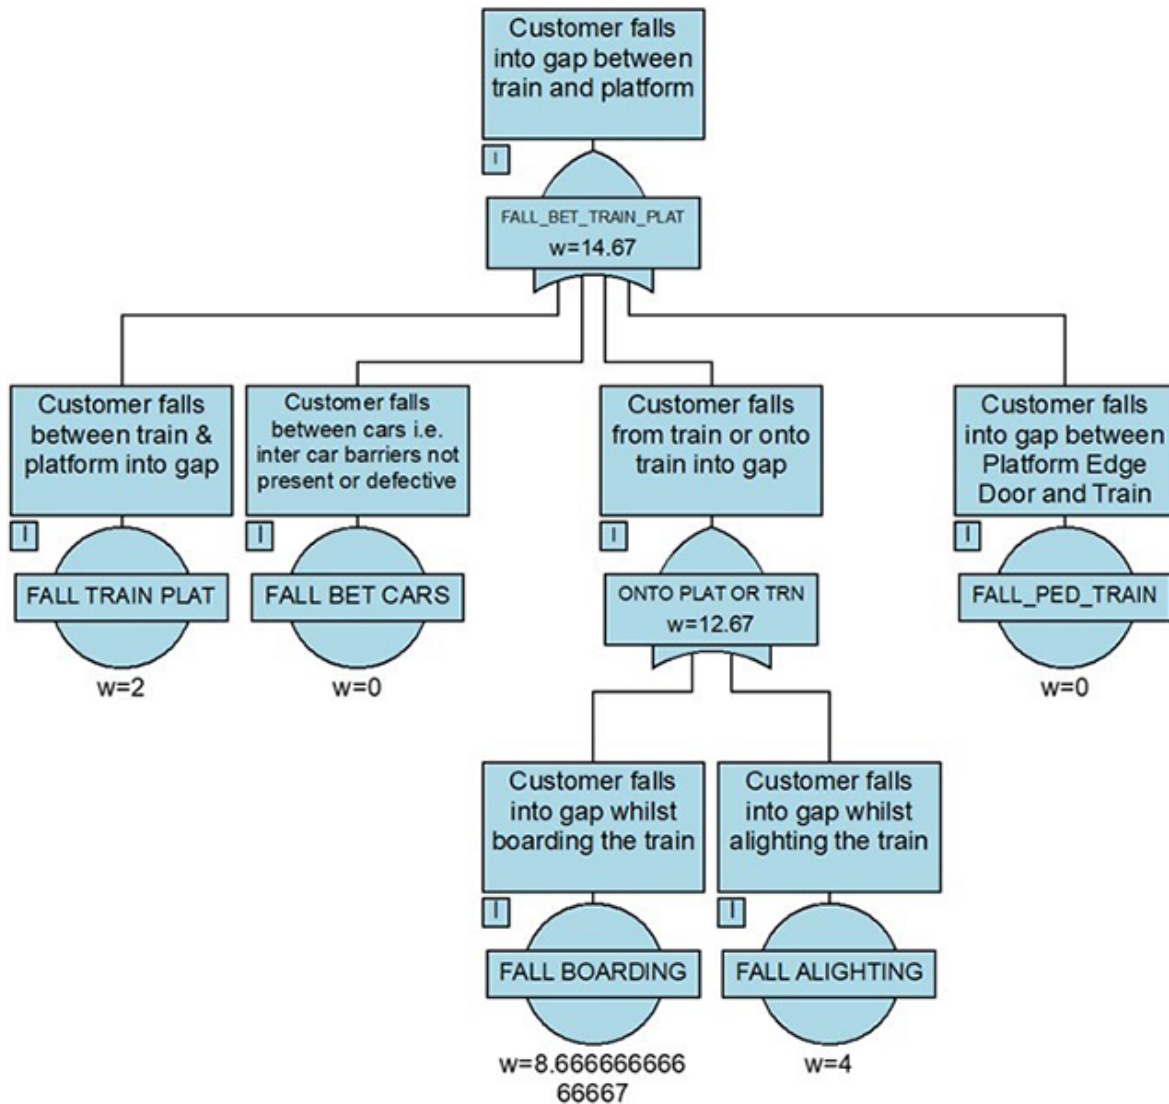
<sup>10</sup> The type of event which occurred on 26 May 2020 would be described in the fault tree analysis as: ‘customer falls between train and platform into gap while not stepping on or off the train, or where there is insufficient data to determine if the passenger involved was boarding or alighting’.

Figure 12: LUQRA fault tree analysis used to calculate likelihood of a fall into the PTI gap on the Bakerloo line
