Rail Accident Investigation Branch

# Rail Accident Report

## **Freight train derailment at Sheffield station 11 November 2020**

Report 07/2021  
October 2021

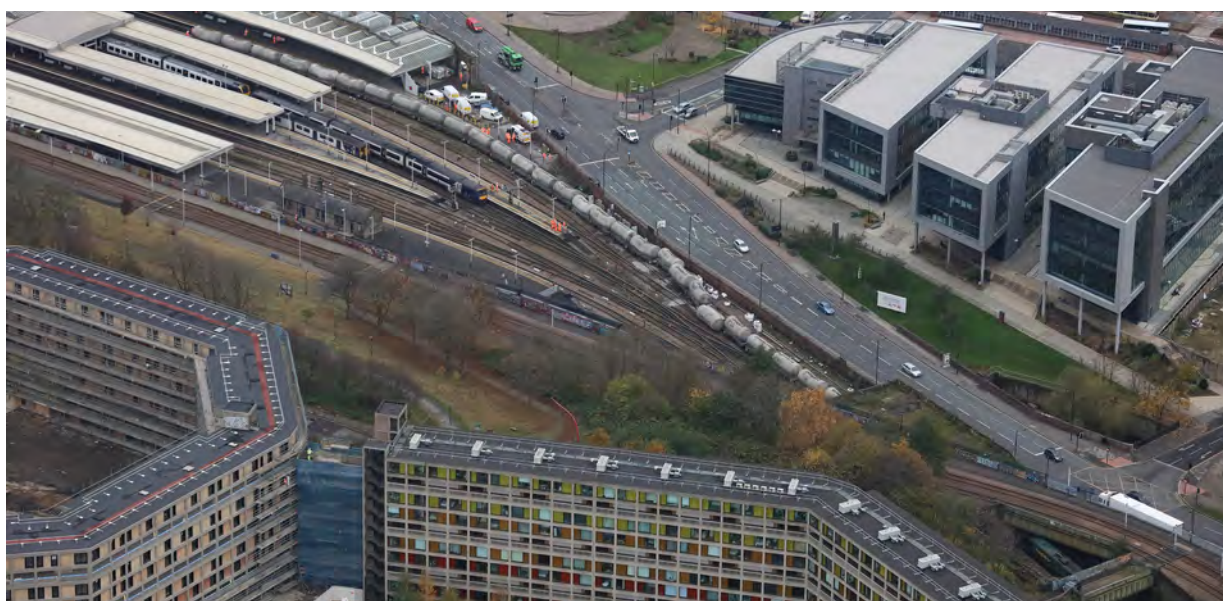
At 02:44 hrs on Wednesday 11 November 2020, 16 wagons of a freight train that was conveying cement powder from Hope, Derbyshire, to Dewsbury, West Yorkshire, derailed at the north end of Sheffield station. A number of wagons were damaged and there was significant damage to the track, resulting in a partial closure of the station. No one was injured.

Figure 2: Aerial overview of the derailed train (image courtesy of Network Rail Air Operations team)

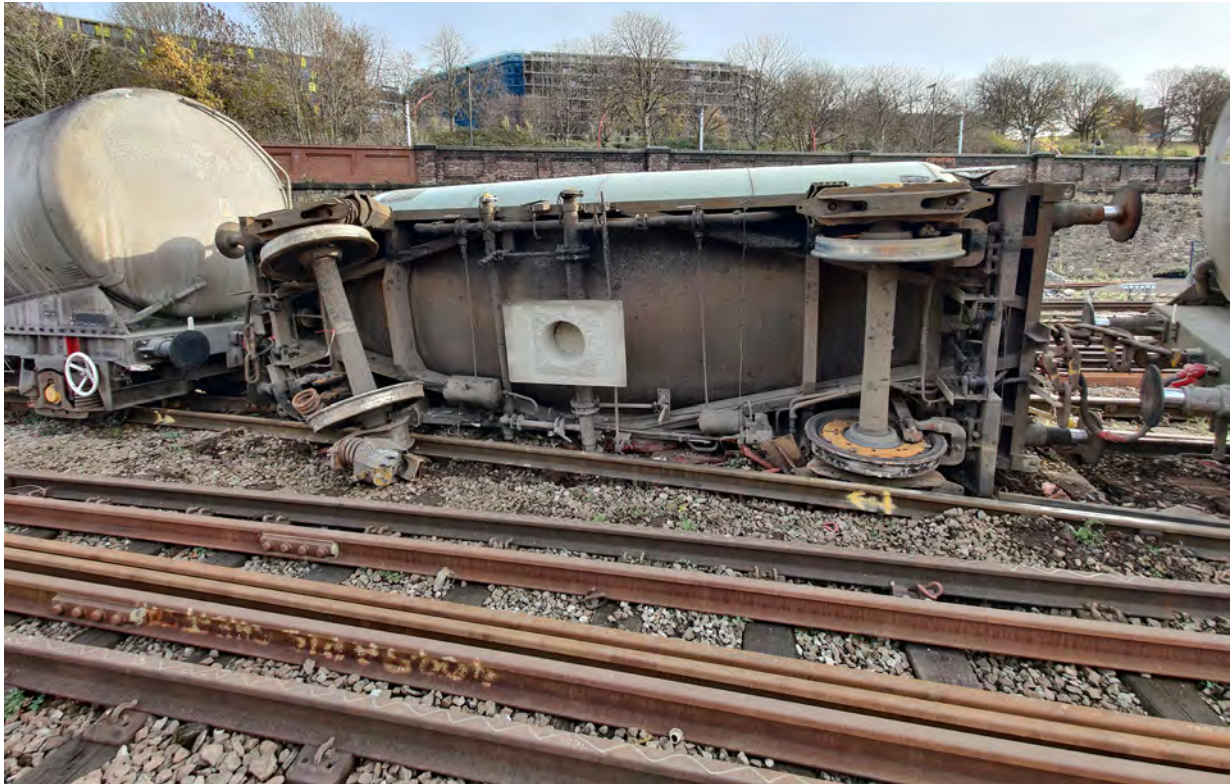
Figure 3: Wagon BCC10756 toppled on its side

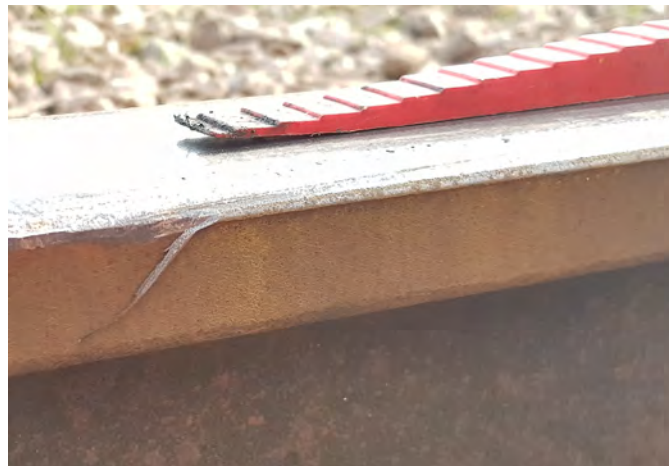
- 28 Rail marks showed that the right-hand wheels of several wagons dropped off the head of the right-hand rail, into the four-foot, at this location, referred to as the point of derailment (figure 8). These wheels then ran derailed, with their corresponding left-hand wheels still on the left-hand rail, for several metres until reaching the switch heel. This is the location where the movable switch rail is fixed, via a heel block, to its outer stock rail (figure 7). Rail marks showed that the left-hand wheels on the derailed wheelsets climbed over the left-hand rail into derailment and the right-hand wheels remained derailed.

*Figure 8: Wheel mark on the inside edge of the right-hand rail showing the first drop-in at the point of derailment (the red step gauge is only present to indicate the point of derailment)*

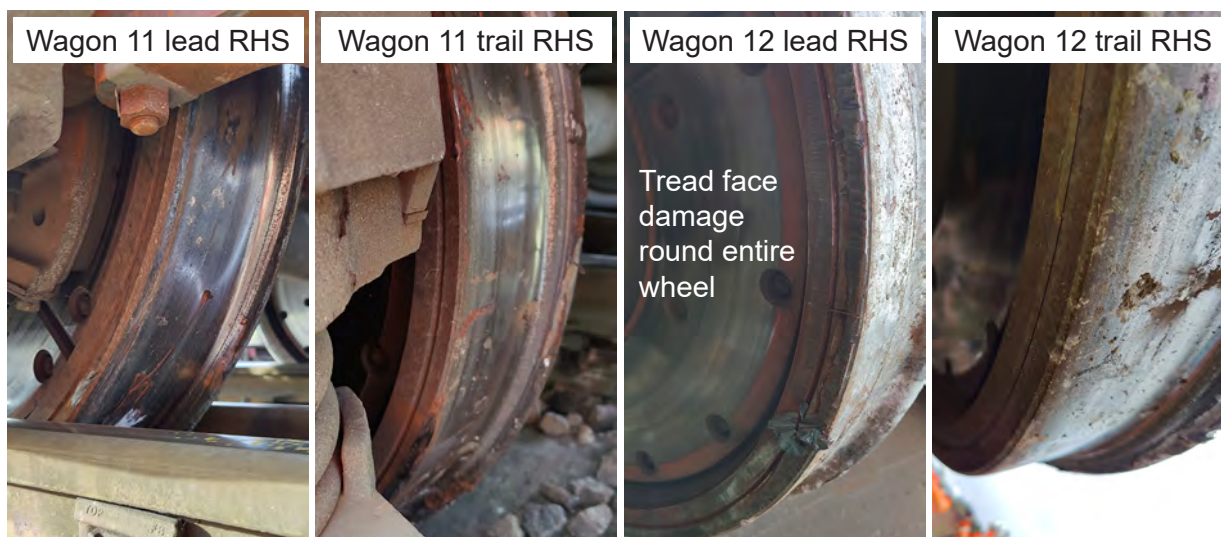
- 29 Examination of the derailed wagons showed damage on the outside face of the wheels consistent with several right-hand wheels having dropped into the four-foot (figure 9). The leading right-hand wheel of wagon 12 suffered the worst damage, indicating that it is likely to have been the first to derail into the wide gauge. Subsequent wheels also dropped into the wide gauge, but the damage was less severe. Their derailment was made more likely by the gauge having been further widened by the derailed leading wheelset on wagon 12 dropping in ahead of them.

Figure 9: Tread face damage on the right-hand leading wheel of wagon 11 compared to wagon 12

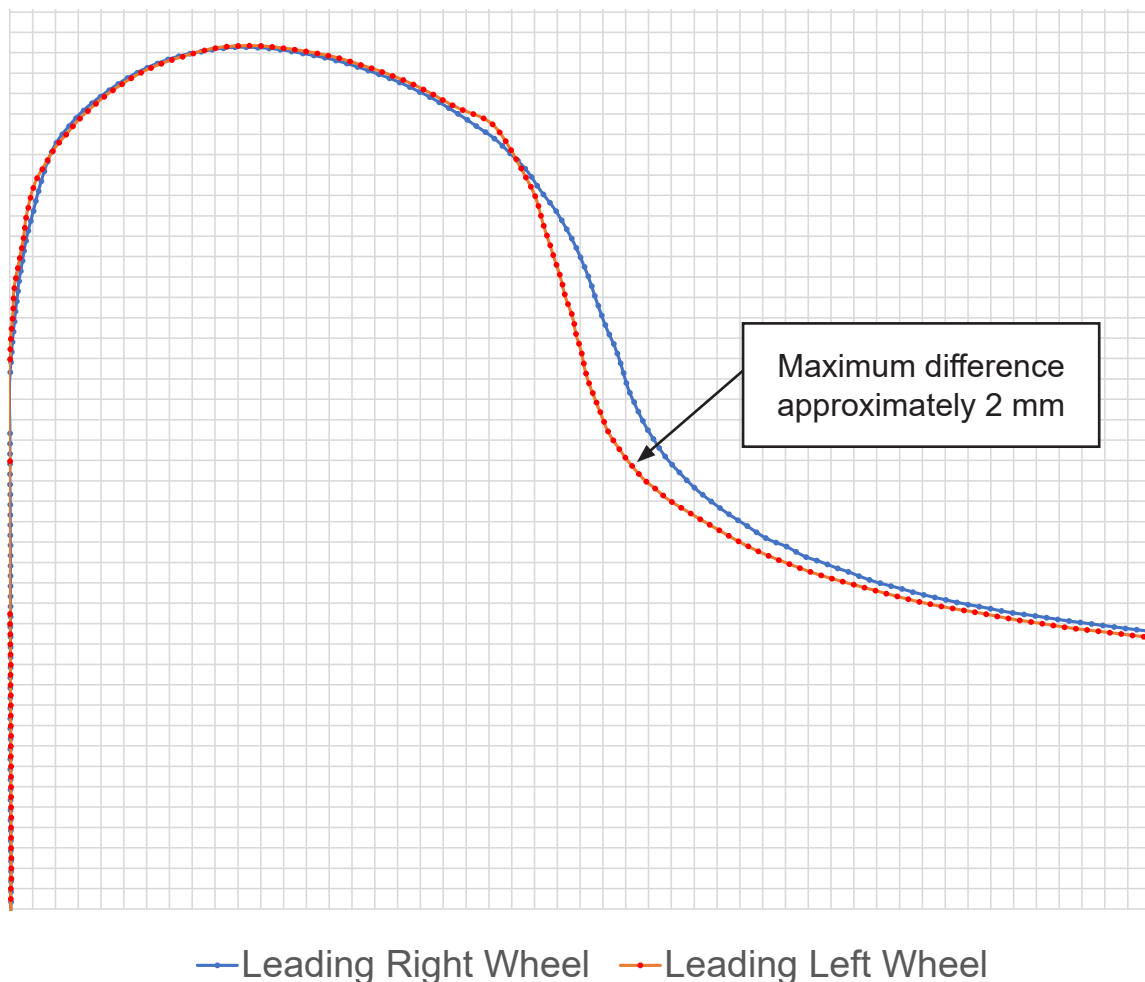
- 35 It was noted that the wheel flanges on the left-hand wheels on both wheelsets were slightly thinner than those on the right-hand wheels (figure 10). However, they were all well within the acceptable maintenance specification limits. It is possible that a thinner left-hand wheel flange could result in the wheelset being positioned slightly further to the outside rail on a right-hand curve, such as at the point of derailment. This means that the associated wheel tread corner on the right-hand wheel would also be positioned slightly closer to the four-foot on the right-hand rail, and so be fractionally more at risk of derailment (figure 11). The estimated difference in position on the twelfth wagon is only about 1-2 mm.

Figure 10: Comparison of wheel flange thicknesses on wagon 12

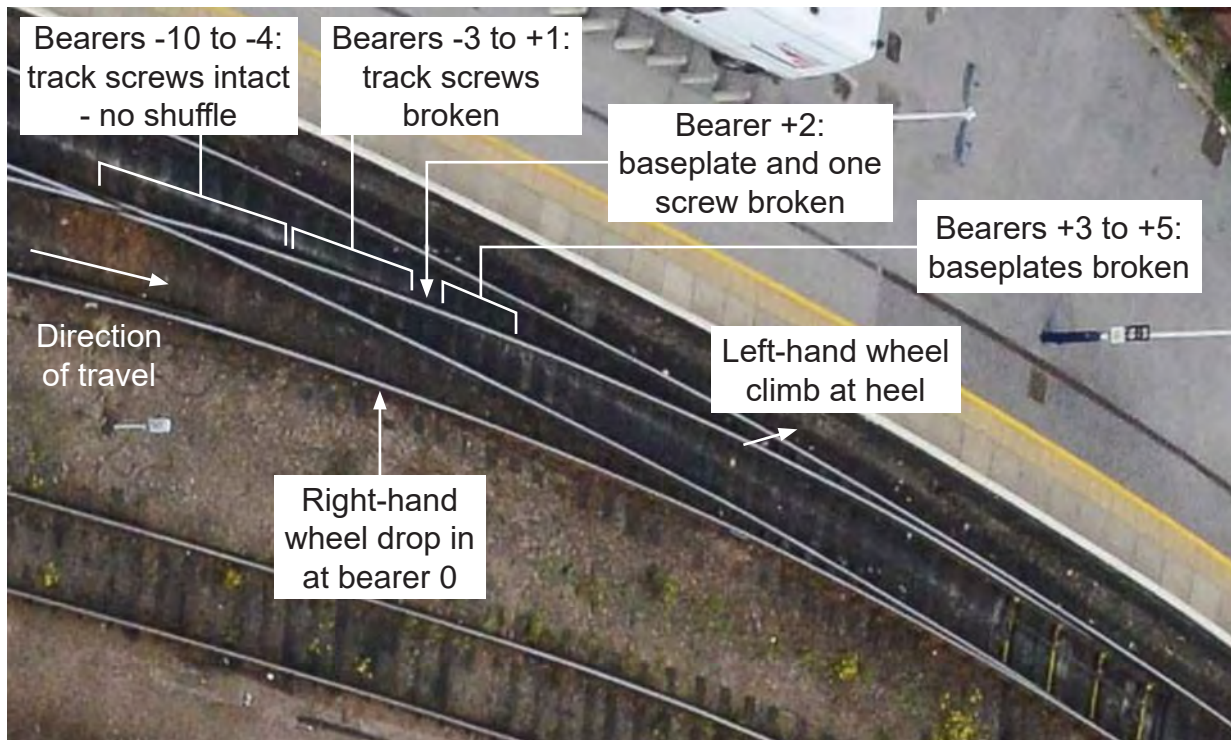
- 43 Figure 14 shows 4062 points and the direction of travel of the train. The point of the derailment, where the first wheel dropped between the rails, is labelled as bearer 0. The locations of the track screws that were found to be broken are also shown. All the track screws on the outer rail (left-hand in the direction of travel) were broken from bearers -3 to +1, with negative numbers indicating bearers before the point of derailment and positive numbers, bearers after it. Bearer +2 had one broken screw and the baseplate had also fractured. The baseplates on bearers +3 to +5 were also broken, while their screws remained intact. The newness of the baseplate fractures indicates that these almost certainly failed during the derailment, as the derailed wheelsets tried to force the rails apart.

Figure 14: Diagram showing track screws that had failed in 4062 points (background image courtesy of Network Rail)

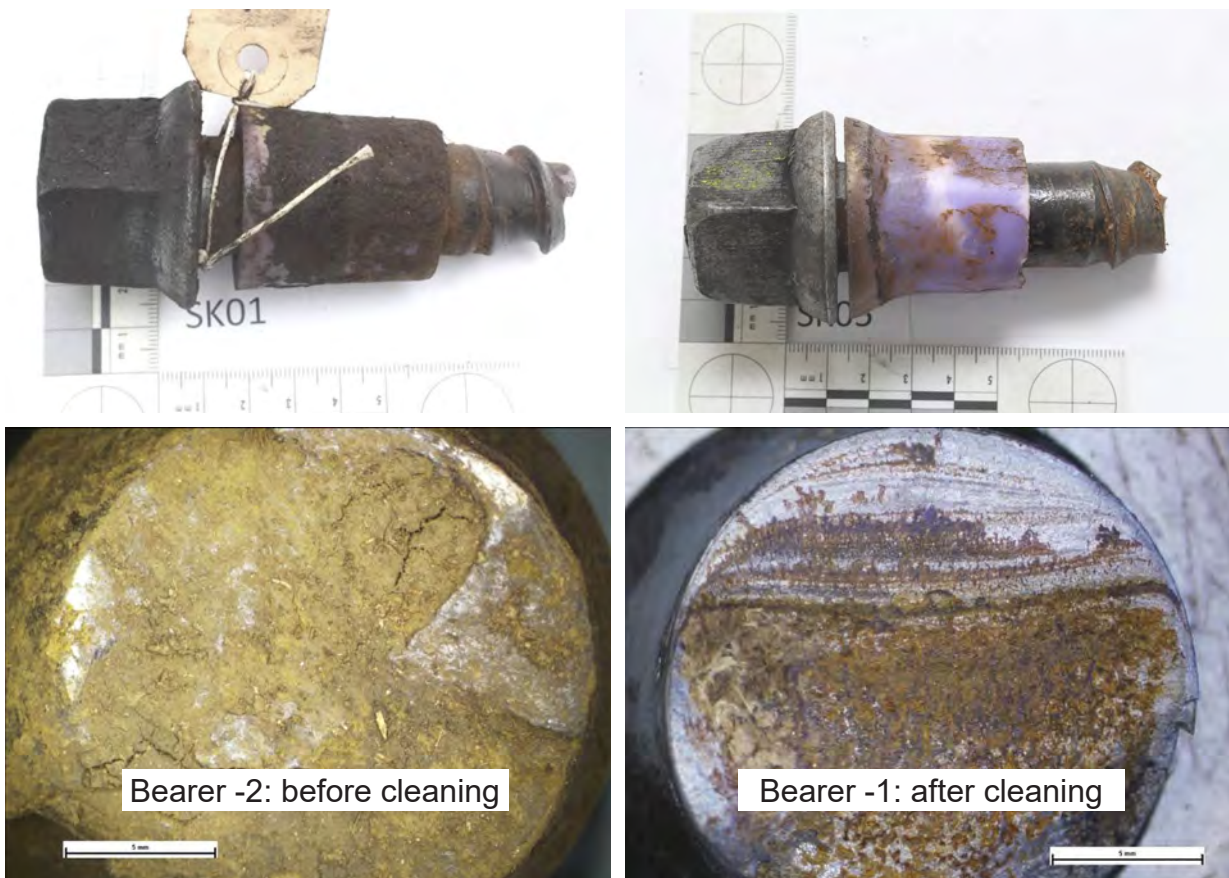
- 45 This identified that the screws were largely compliant with the specifications in the drawing (figure 13). One screw (from bearer -1) had slightly reduced mechanical properties. However, because this screw was among the last to fail, it is unlikely that its characteristics contributed to the failure of any of the other compliant screws. The study also concluded that all the screws had failed as a result of cyclical unidirectional bending, leading to fatigue cracking, followed by a mechanical overload failure of the residual material thickness.

- 46 The amount of corrosion on the fracture face surfaces indicated that the breaks had occurred weeks, or perhaps months, before the derailment (figure 15). This was further evidenced by the presence of marks showing repeated relative movement between the two fracture faces on each screw. None of the screws had failed immediately prior to the derailment.

Figure 15: Examples of broken track screws, showing fracture surfaces during examination

- 51 In summary, the repeated lateral loading of the outer rail under the passage of loaded freight trains led to fatigue cracking of the track screws and subsequent failure over an extended period, despite the track screws being compliant with standards.

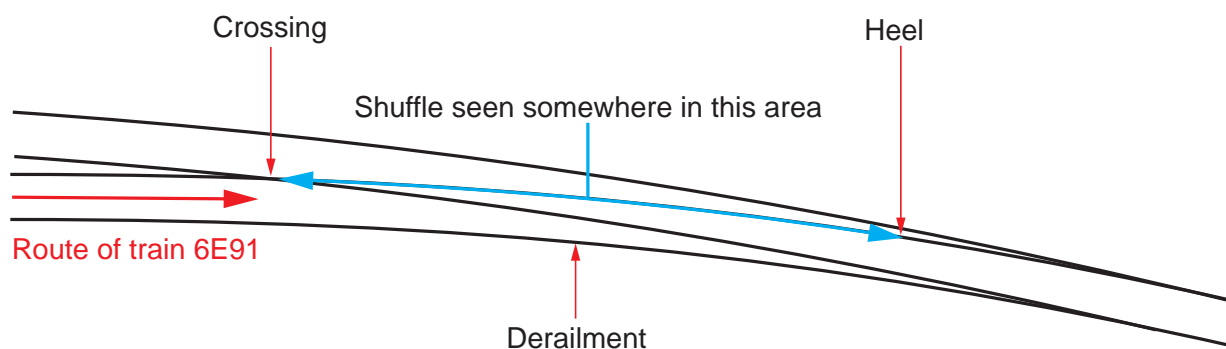
- 59 On the last four BVI record sheets, no defects were recorded as having been found at 4062 points. These were undertaken on 4 November and on 28, 21 and 14 October. However, the BVI patroller's record for 7 October noted that there was 'baseplate shuffle at the heel of 4062 points'. Baseplate shuffle is a term used to describe the wear marks on a timber bearer that indicate that a baseplate has been moving relative to the bearer it is fastened to. Witness evidence indicated that the note referred to shuffle located between the heel of the points (at the fixed end of the movable switch rail) and the crossing (figure 16). However, from the evidence available, RAIB has not been able to determine the exact location of the shuffle within this 15 to 20 metre distance, or the amount of shuffle, although this was likely to have been less than 10 mm. It is worth observing that the BVI on 7 October was undertaken by a patroller who does not routinely patrol Sheffield station, and was therefore perhaps more likely to record all defects and not omit any minor defects that were repeatedly present during previous inspections.

Figure 16: Approximate location of the identified shuffle in 4062 points on 7 October 2020

- 60 This BVI record was reviewed by a supervisor, and a maintenance intervention to address the observed shuffle was entered into the depot's list of forthcoming work. This intervention was due to be completed within a period of three months from the BVI on 7 October 2020.

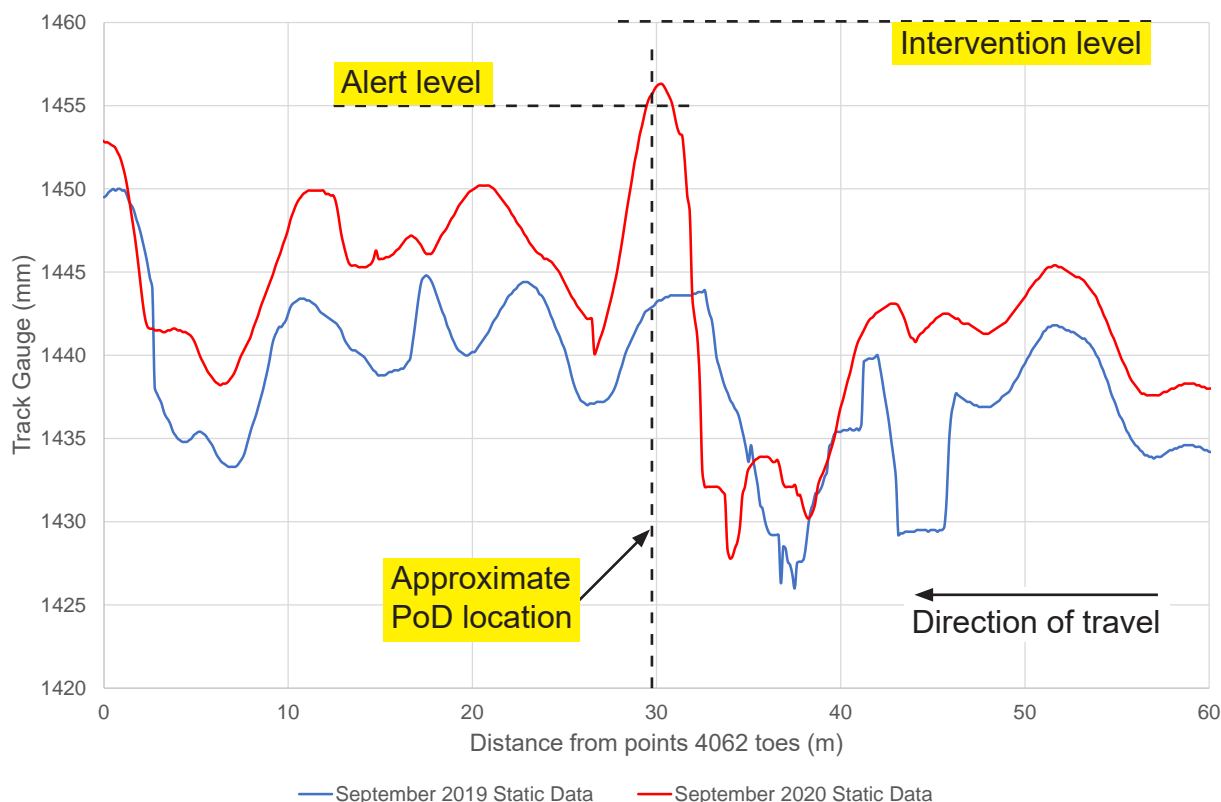
70 There was a slight exceedance of the alert limit (1455 mm) in the vicinity of the point of derailment in September 2020. Alert limit faults are not allocated a timescale by which they need to be repaired, but they are intended to be corrected as part of the planned maintenance activities. Sheffield depot had not undertaken any corrective action in response to this alarm notification prior to the derailment.

Figure 17: Static geometry measurements at 4062 points

- 71 The September 2020 gauge at the point of derailment was approximately 13 mm wider than that recorded at the same location in September 2019. However, this would only have been apparent to the TME if he had carried out a detailed comparison of the data from the two dates. The TME only undertook such comparisons to identify trends where he recognised that there was a risk of deterioration, but this was not recognised as being such a location.

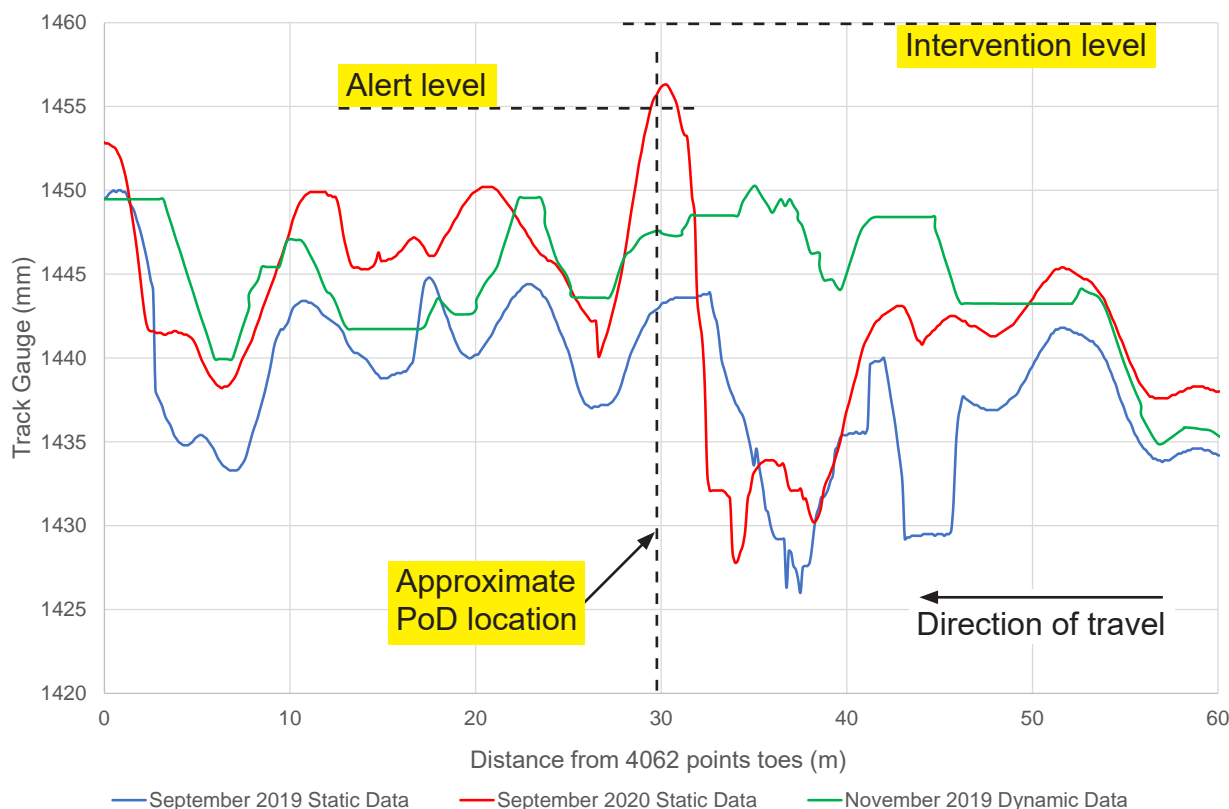
Figure 19: Dynamic geometry compared with static geometry at 4062 points

79 Comparison with the static geometry data from September 2019 and September 2020 (paragraph 68) shows that the deterioration in gauge only becomes visible in the September 2020 static data. There was no dynamic data measured after August 2019 to determine when this trend started to appear and to suggest when the track screws had started to fail, or to indicate the actual gauge experienced by passing trains.

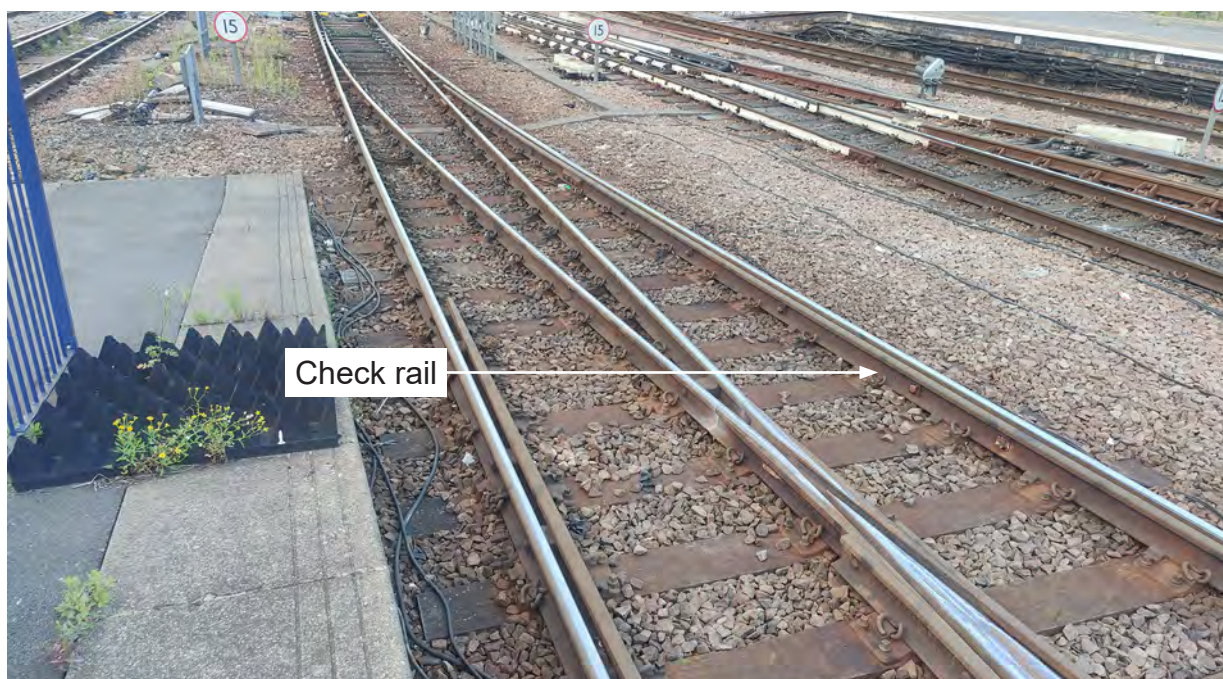
Figure 21: Check rail fitted within 4064 points
