Rail Accident Investigation Branch

# Rail Accident Report

## Near miss at Coltishall Lane User Worked Level Crossing, Norfolk 21 January 2021

Report 03/2022  
April 2022

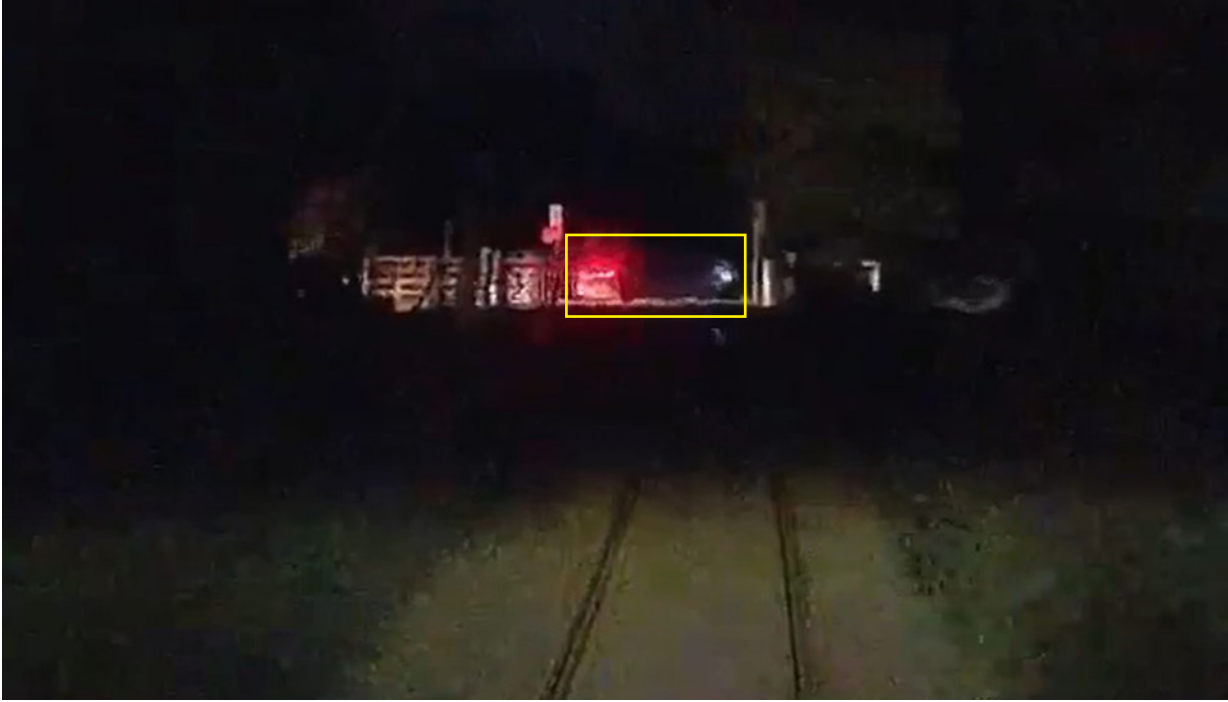
Figure 2: CCTV image from the train around three seconds before its arrival at the crossing showing a car (boxed outline) in the middle of the crossing travelling from left to right

- 27 Around three seconds before the train's arrival at the crossing, this car was in the centre of the crossing (figure 2). The train, with its emergency brake applied, was by now travelling at around 65 mph (105 km/h). The car is seen, in the images, to move clear of the crossing around one second later.

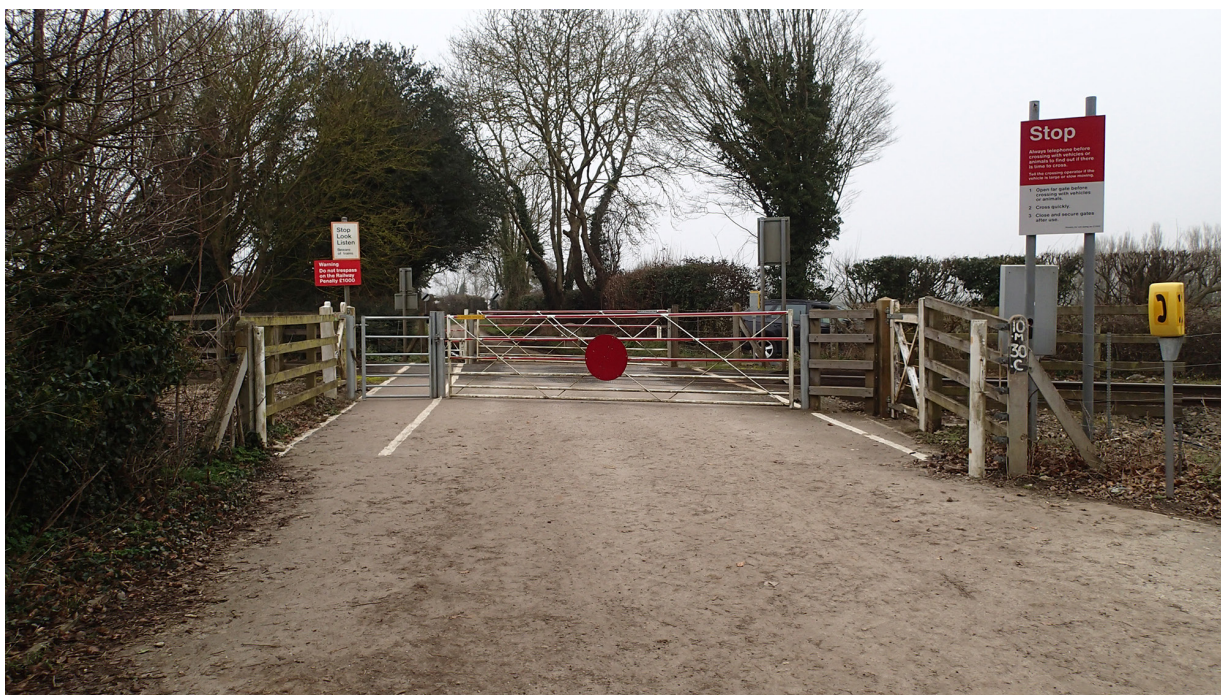
- 14 Coltishall Lane level crossing is a user worked crossing with telephones (UWC(T)). It has a road gate on each approach (figure 3). It also has pedestrian gates located adjacent to the road gates, which allow access to those on foot. The crossing gates are manually operated by any road users wishing to cross.

Figure 3: Coltishall Lane user worked crossing viewed from the east, in daylight with closed gates

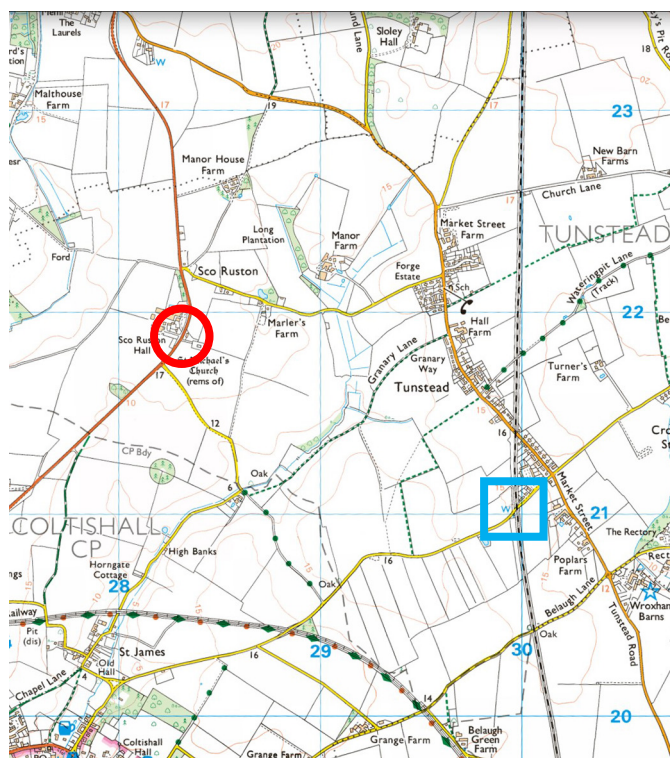
Figure 4: Approximate location of the earlier road accident shown in red circle with Coltishall Lane user worked crossing shown in blue square

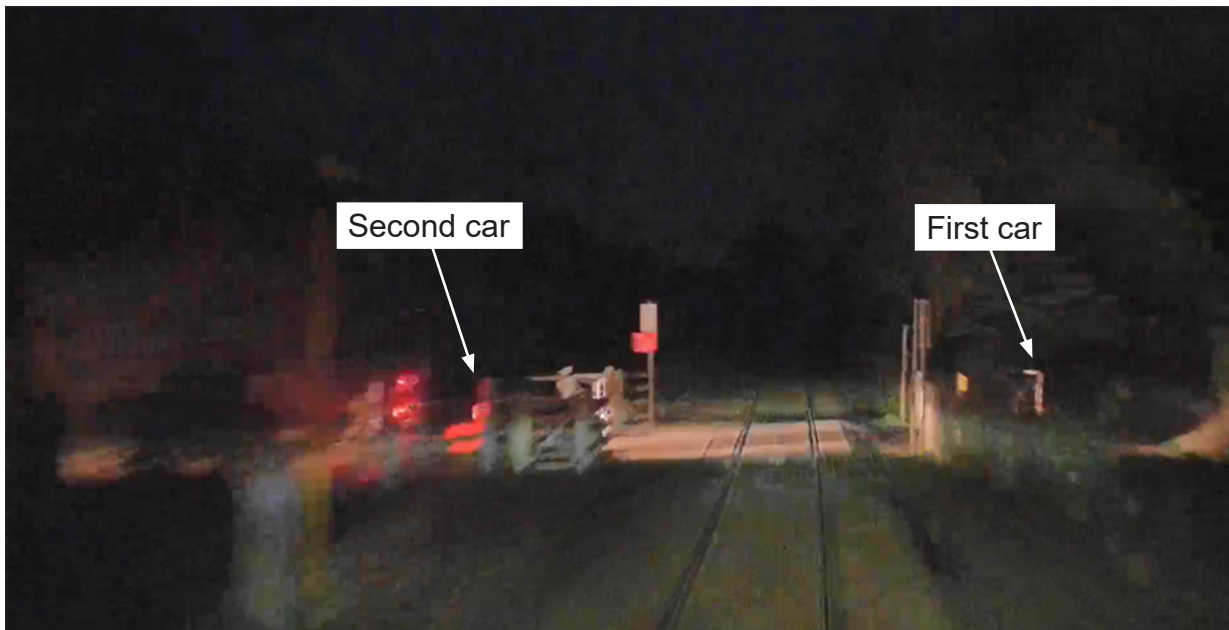
- 28 Around one second before the train reached the crossing, the front of another vehicle, travelling in the same direction as the first, passed beyond the line of the east side gate (figure 5). The images show that the second car's brake lights had illuminated and that it had stopped before reaching the railway line. The train travelled over the crossing at 58 mph (93 km/h).

Figure 5: The second car stopping clear of the railway line around one second before the train's arrival

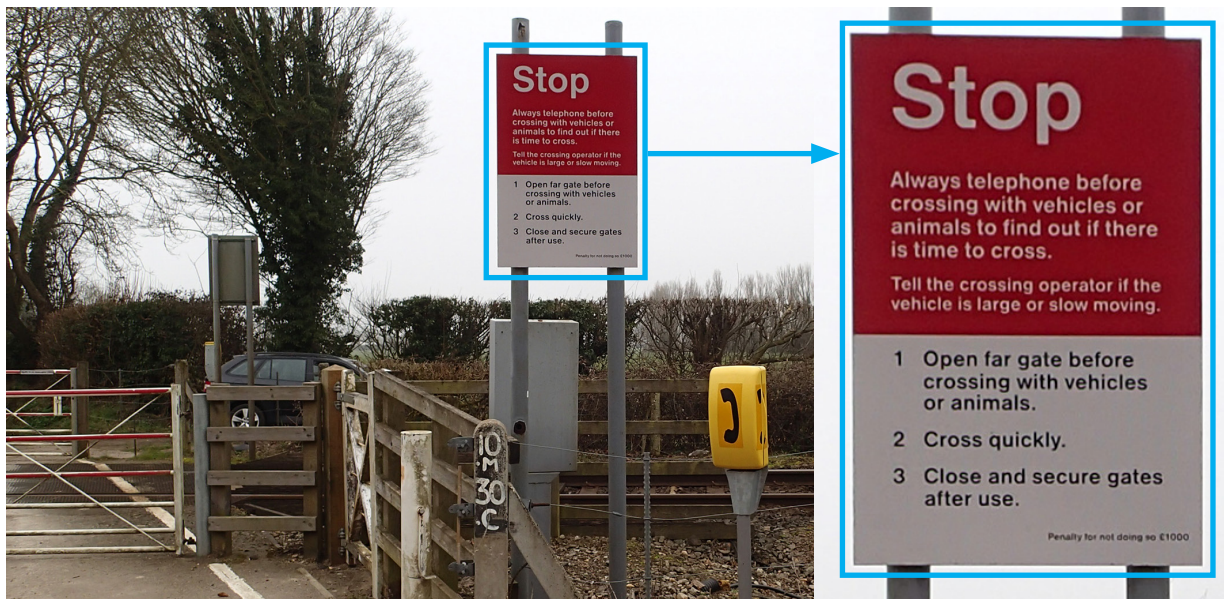
Figure 6: Diagram 103 sign on the east side of the crossing

49 The diagram 103 sign is divided into two parts. The upper part comprises white text on a red background, instructing users to stop and telephone the signaller before crossing with vehicles or animals, and to tell the crossing operator if the vehicle is large or slow-moving. The lower part of the sign comprises black text on a white background with a numbered list of instructions for opening and closing the gates.

- The instructions are not concise, and they do not capture the reader's attention. The most important instruction on the sign, to contact the signaller for permission to cross, is not a numbered instruction, and it is therefore easy to overlook. In addition, this instruction is difficult to pick out in the white text on the red background.

Network Rail, the Office of Rail and Road and the Department for Transport, as part of the current initiatives on improving signage at vehicular user worked crossings on private roads, should consider the suitability of these signs for vehicular user worked crossings on public roads, or on crossings that share features similar to those identified in this investigation, taking into account the findings of Recommendation 1 (paragraph 117a,ii).

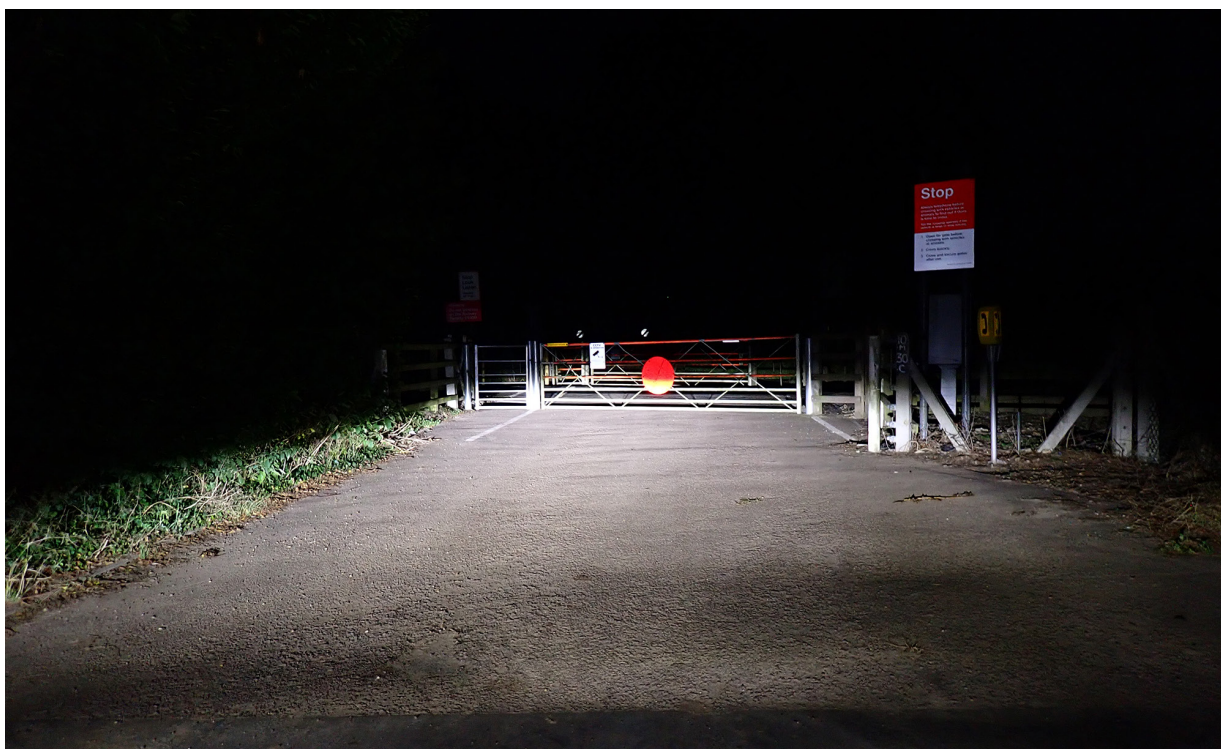
- 51 RAIB observed the diagram 103 sign at Coltishall Lane level crossing in darkness, illuminated by a car's dipped headlights (as these are likely to be used if there are other road users in the vicinity ahead). At ten metres from the crossing gate (figure 7), the diagram 103 sign is lit by the headlights, but is too far away to be legible. At five metres from the gate (figure 8), the positioning of the sign to the right-hand side of the road means it is no longer well illuminated by dipped headlights, nor is it in the car driver's primary field of view (the equivalent sign on the west side of the crossing is situated on the left-hand side of the road, and the instructions on this sign were also not followed by vehicle drivers). It is possible, therefore, that the signs would not attract the attention of some crossing users in road vehicles, especially in darkness, and taking account of the way drivers may behave if there is a queue of traffic behind them (see paragraph 58).

Figure 7: The view of the east side of the crossing from 10 metres away in darkness with gates closed. (The white sign on the gate has been added since the date of the incident)

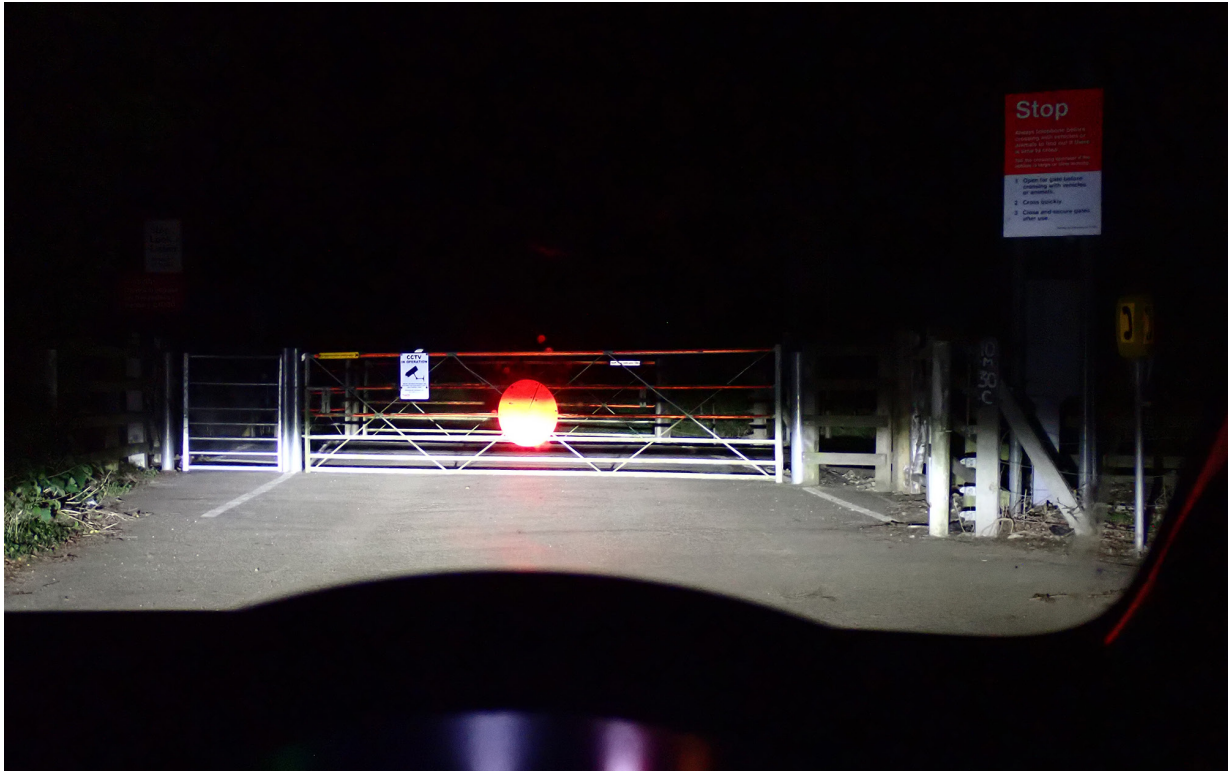
Figure 8: The view of the east side of the crossing from 5 metres away in darkness with gates closed. (The white sign on the gate has been added since the date of the incident)

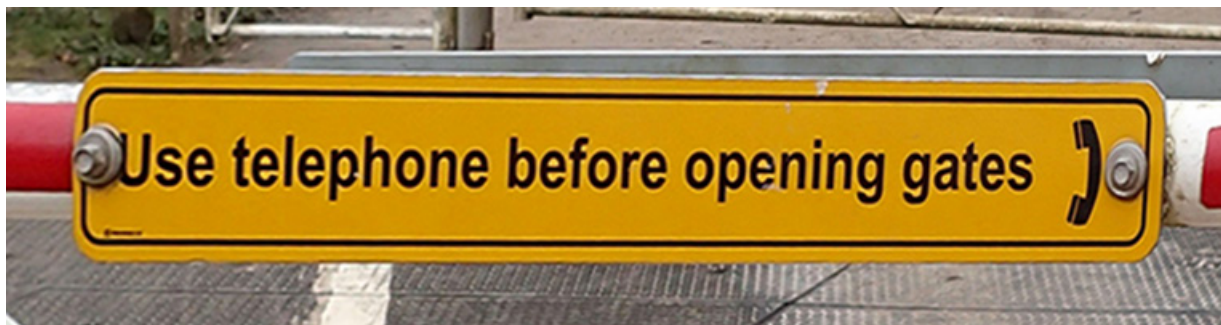
Figure 9: The additional sign added to the road gates close to the latch

- 79 Two physical changes were made to the crossing in 2017. The first, in March 2017, was the addition of a sign fitted to each gate near the latch (figure 9). The second, completed by November 2017, was moving the east-side gate three metres closer to the railway line as proposed in the risk assessment (see paragraph 77d).
